Semi-Annual Environmental Monitoring
Report

January 1 - June 30, 2018, Including 2017 Reporting.

Kyrgyz Republic:
CAREC Transport Corridor 3 (Bishkek-Osh Road)
Improvement Project, Phase 4

Prepared by
EPTISA Servicios De Ingeniería S.L.
Eptisa Muhendislik and RAM Engineering

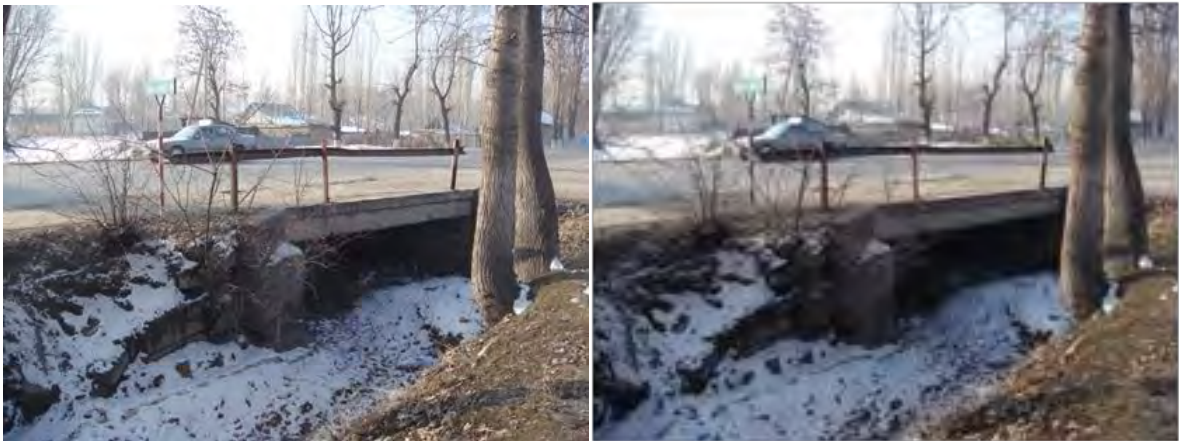
31. The canal was also designed for the passage of mudflows formed in the foothill zone as a result of storm. The canal capacity is up to 6-8 m³/s. However, at present, the canal's functions are severely limited due to the fact that the canal bed is filled with mud by debris, and below the road is built up with residential buildings.

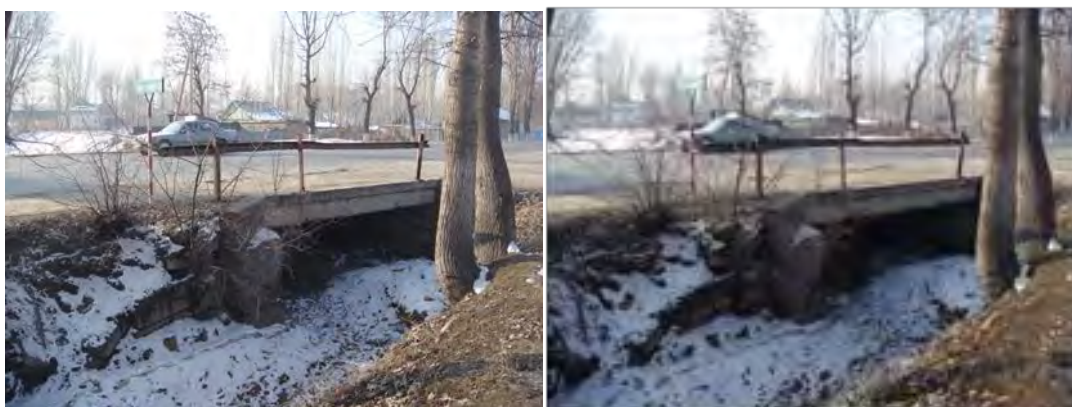
35. Canal crossing the road - this is the canal of the Krepostnaya (40.39 km), at the entrance to the Belovodskoye village can be noted on the section. The canal is intended not so much for watering agricultural land, subjacent villages, as for the discharge of the area (mudflow) runoff, formed in the foothill zone during hailstorm.

36. The canal is heavily overgrown with tree and shrub vegetation, half filled with mud by sediments. The canal capacity is about 18 m³/s. Bridge passage through the canal is required to be completely replaced. At the exit from Belovodskoe village, on the boundary of Petrovka village, there is a bridge structure, which serves to pass a part of the maximum flood passing along the Aksu river (43.5).

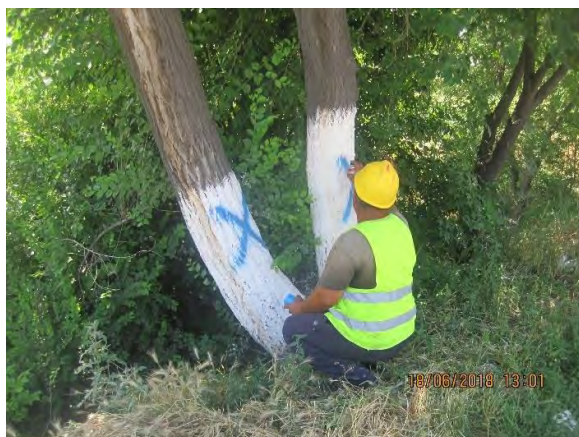
103. **Jan. - June 2018-** By June 2018 the Contractor had marked trees at the Sect. 2.1 but only along three of the >14 km of roadway, namely km 21+300 to km 24+300. As a result the request by the contractor to cut trees along the entire 14.2 km was not approved (Letter No. 202-011 of 25.06.2018). EPTISA indicated the procedures established by ADB were not being adhered to and therefore permission could not be given at this time.

104. As of the end of June 2018, this item remains unresolved.

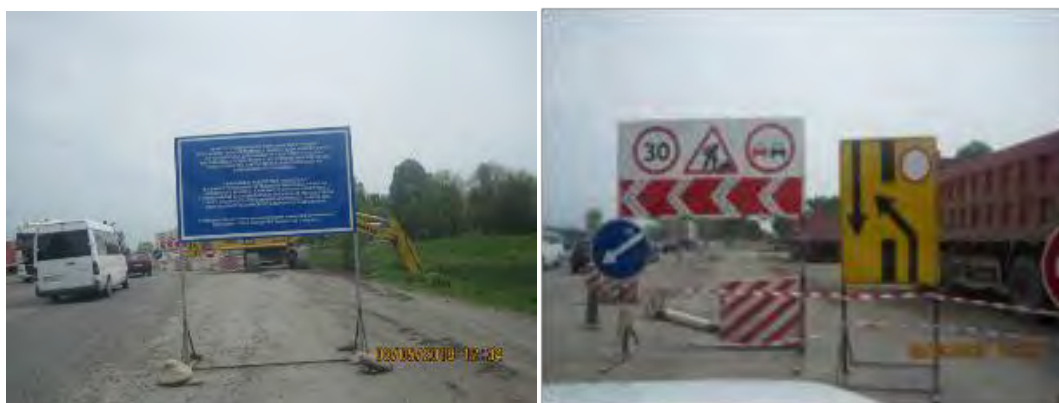
Figure 11. Construction area roadside signage

124. Also, in places where there are steep slopes, work was carried out to install 165m of retaining walls. In order to ensure the safety of traffic, the site of work is fenced; barriers and signs of traffic safety are installed. New night lighting devices have been installed.

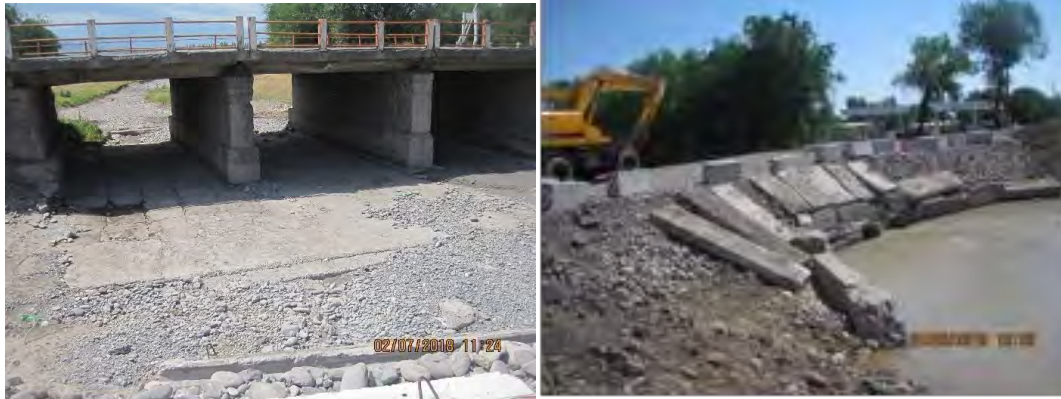
130. **The Bridge over Ak-Suu River-** In May construction works on the bridge on the Ak-Suu River have been started. A bypass bridge across the river is being built. Construction was overseen by the road safety specialists. With the beginning of the rains, water appeared in the river.

131. Currently, the bridge width has been extended from 7 to 15 meter, based on EPTISA's instruction. But during the construction provision for pedestrians was not provided. The contractor is undertaking this work now.

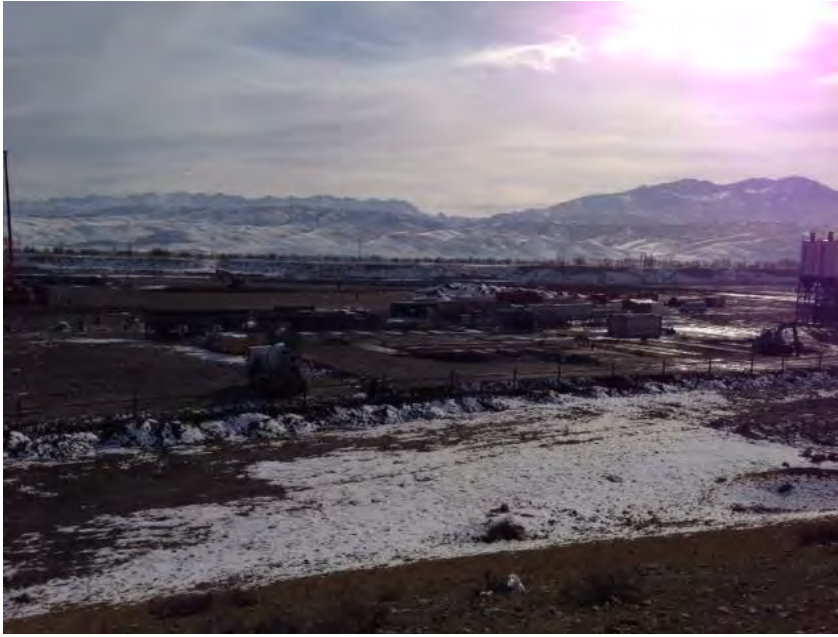
Figure 12 Ak Suu2 site for the materials processing operation-Dec. 2017.

149. **CEMWP No. 2.7.1, 2.7.3 and SSEMP Annexes 12 and 14-** The contractor has contained all materials processing activities in a large and remote (8 km) area of the Ak Suu 2 borrow site (Figure 12). That area houses the aggregate processing and crushing facility, the concrete batch plant as well as the asphalt production plant.

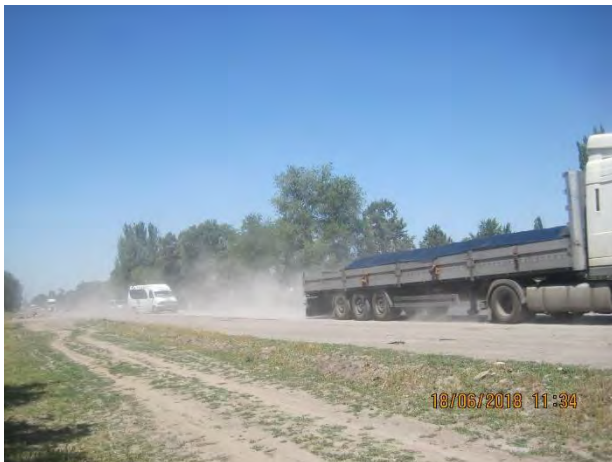
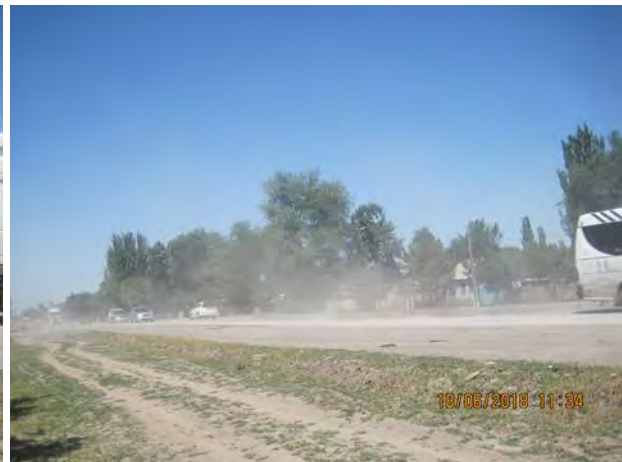
There are watering machines on the construction sites constantly. Hydraulic irrigation of the construction site is regularly carried out.

The increase in air temperature has led to increased dust formation on the road, but despite repeated warnings of the Contractor about the need to strengthen the hydraulic irrigation, situation does not change. Citizens are complaining for increased dust formation

In view of the situation, it was the Contractor was instructed to increase the intensity of watering the road, including the roadside, in the construction site from 6 am to 20 pm, without a break for lunch. To do this, it is necessary to make a schedule for watering the road, specifying the interval between irrigation, and monitoring the compliance with the irrigation interval with watering machines. About this letter of non-compliance was sent to the Contractor No. EP-CR5-HN-529 of 19.06.2018.

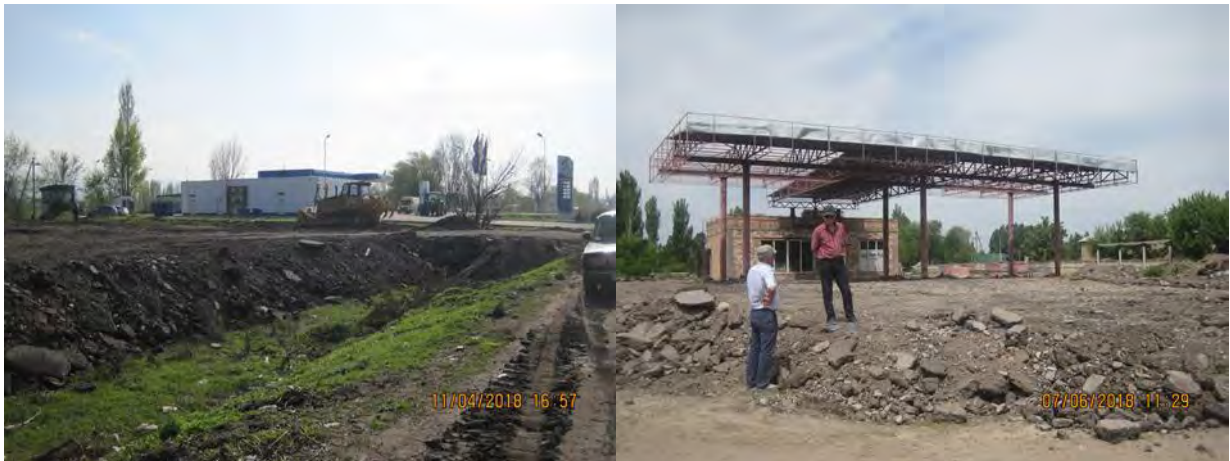
With the beginning of the work on sites 1-1 and 1-3 there was a problem with the disposal of old asphalt.

The problem of crushing the old asphalt remains unresolved, that's why old asphalt on the Site 1-1 almost is not exported to backfill of rural streets, as in the villages there is no equipment for leveling large pieces of old asphalt. Part of the asphalt was exported to private areas at the request of citizens. The owners of the sites carried out the planning of the sites themselves.

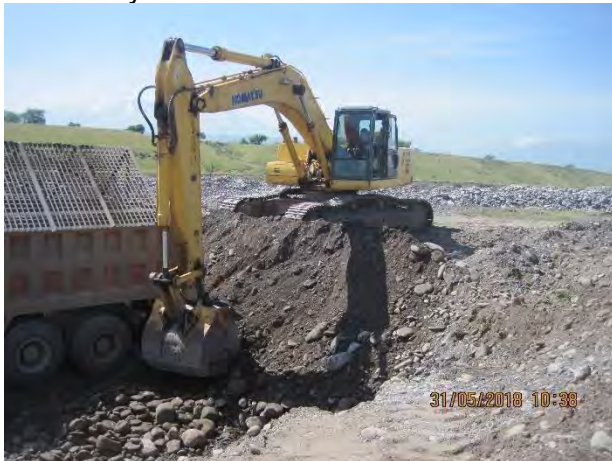
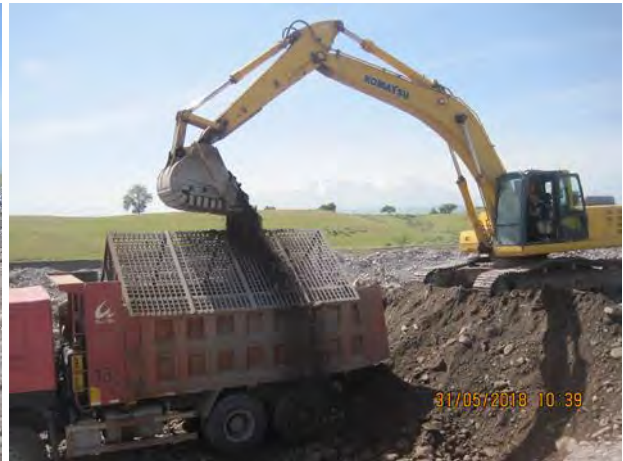
Ak-Suu 2 borrow-pit

The depth of development of the AK-Suu 2 borrow-pit does not exceed the project set 2.5 m. Earlier in the Ak-Suu 2 borrow-pit, work on the development of the borrow-pit was carried out with safety violations (the excavator is on a bench). Twice warnings were made to the excavator operator, but when leaving the borrow-pit it was found that the work continues to be carried out with safety violations.

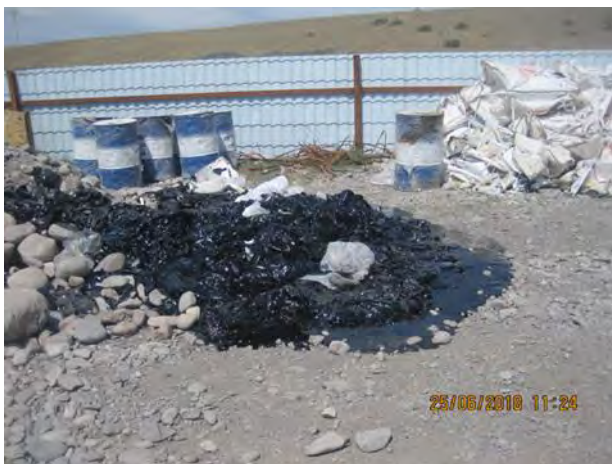
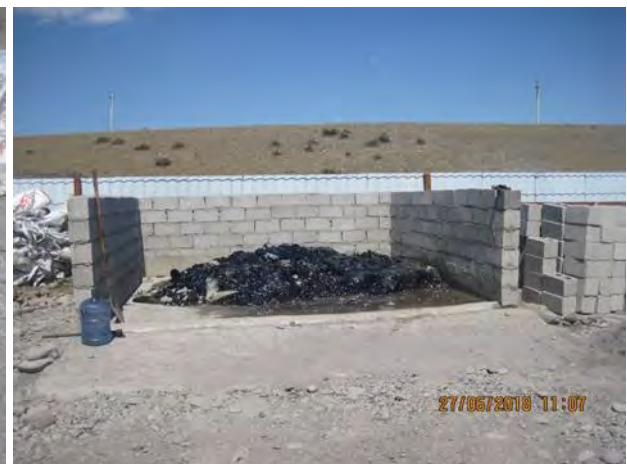
The bitumen was discharged on the ground without the observance of environmental measures. Visual inspection established that some of the package when unloading suffered, in consequence, has been the leakage of bitumen on the ground. This was reported in a letter № EP-CR5-HN-439 of 17.05 2018.

Packages from used bitumen are stored directly on the ground. All this contributes to the contamination of soil and groundwater. It is urgent to collect all the bitumen that has been spilled. Prepare a platform with a hard surface and a canopy for storing packages from bitumen. Before the canopy is completed, it is necessary to store the bituminous packages on a waterproof foundation. About what the letter №ER-CR5-HN-540 of 22.06. 2018 was sent to the Contractor.

The Contractor started construction of a canopy for storage of unused bitumen and bitumen packaging. But despite the fact that the leakage of bitumen to the ground were partially removed, but with an increase in air temperature, there are new leaks of bitumen in the areas of storage of bitumen. All this contributes to the pollution of soil and groundwater. It is urgent to collect all the bitumen spilled on the ground. Assign responsibility for oversight of the territory storage of bitumen and the timely collection of leakage of bitumen from the ground (letter no. EP-CR5-HN-540 of 22.06.2018).

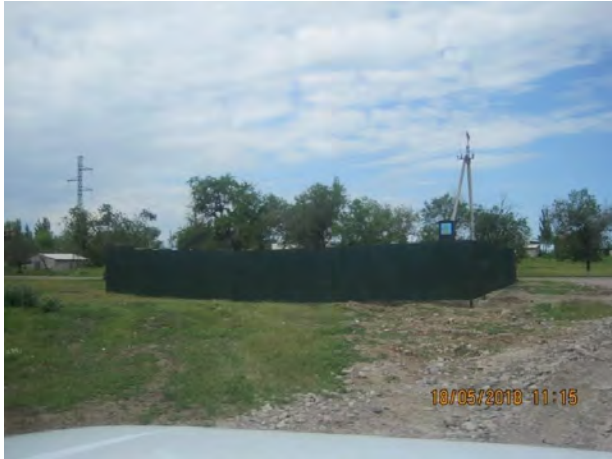
To supply the plant with water, a well was drilled and a pipeline was laid to the plant. Currently, there are no problems with water at the plant.

In the photo, the fenced area of the well.

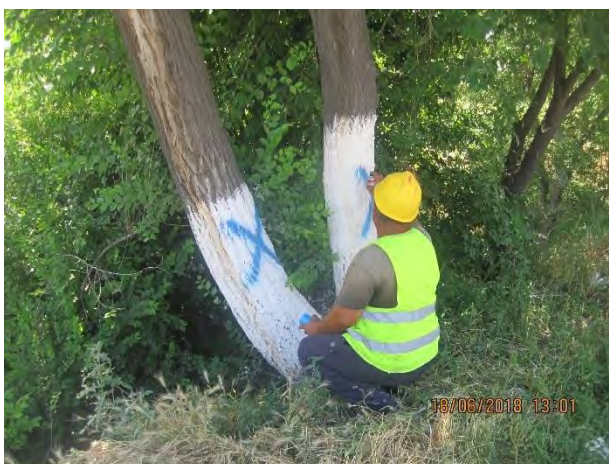
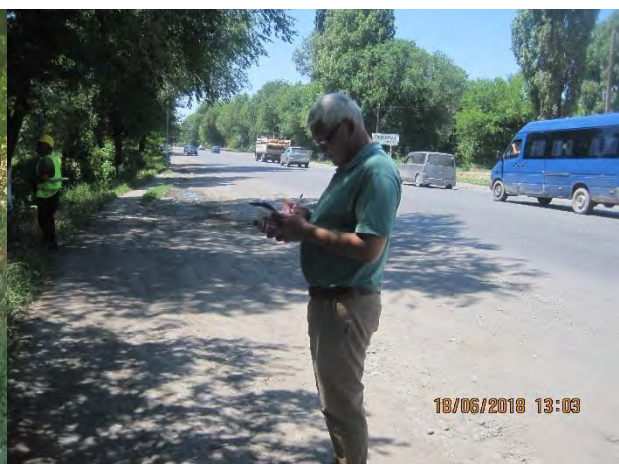
The Contractor marking trees at the section 2.1 at the trees only on 3 km of the site from km 21+300 to km 24+300 and asks a request for cutting down this trees, with sending a letter №202-011 of 25.06.2018. Eptisa is answered that according to the procedures established by ADB for permission for cutting down of trees should be marking trees in the area, and get permission for cutting down from the local authorities and environmental authorities to develop a Plan of planting trees in the area.

The sites on which it is planned to cut down trees in 2018

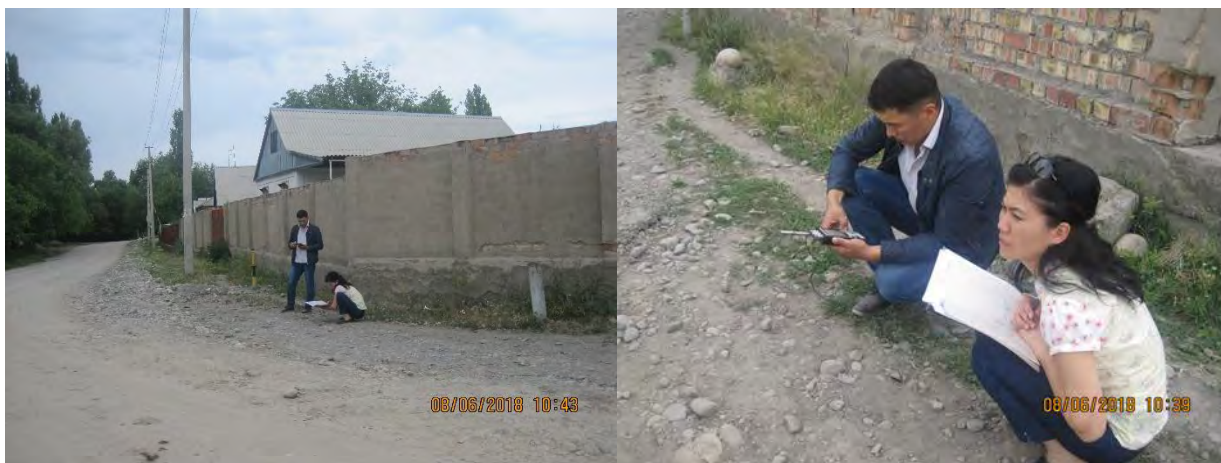
On 8 June, noise and vibration monitoring was carried out by the laboratory of LLC "Profilab" in the area of the bridge construction on the Sokuluk River. In the area of construction of the bridge on the Sokuluk River work of driving piles is being conducted, which causes vibration in the nearby of the houses. The laboratory made measurements of noise and vibration in a nearby house, as well as the surrounding area.
