# **Semi-annual Environmental Monitoring Report**

Kyrgyz Republic:  
CAREC Transport Corridor 3 (Bishkek-Osh Road)  
Improvement Project, Phase 4

Prepared by Ministry of Transport and Road KR  
in consort with EPTISA Servicios De Ingeniería S.L.  
Eptisa Muhendislik and RAM Engineering

January 2018

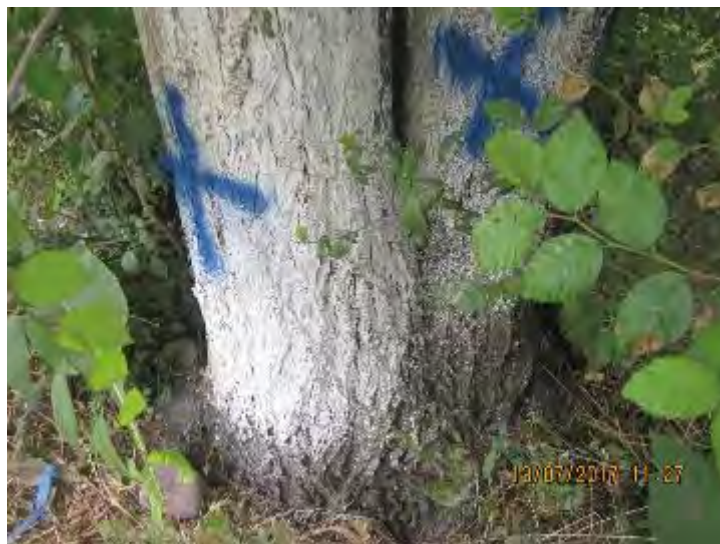
Figure 7. Example of tree marking

94. To insure that only trees needing to be cut were felled, all trees to be cut were marked with a blue X (Figure 7), and within Right-Of-Way boundaries defined by survey stakes in all four sections.

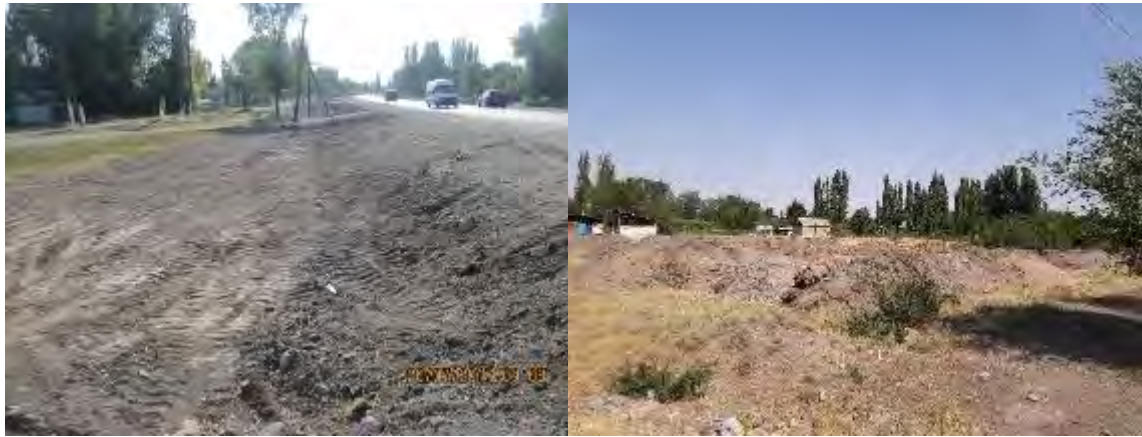
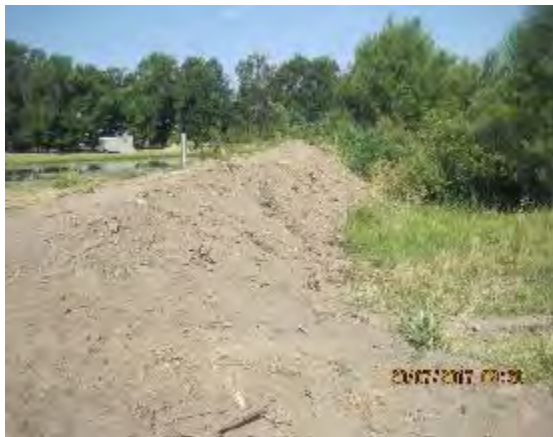
Figure 9 Topsoil Storage Areas Section 1

103. The area along the shoulders where the trees and trunks were removed was exposed to the elements and all topsoil was removed and stored at secure sites where it was readily available for reuse (Figure 9). The contractor's and EPTISA's national environmental specialists have been carefully documenting this activity.

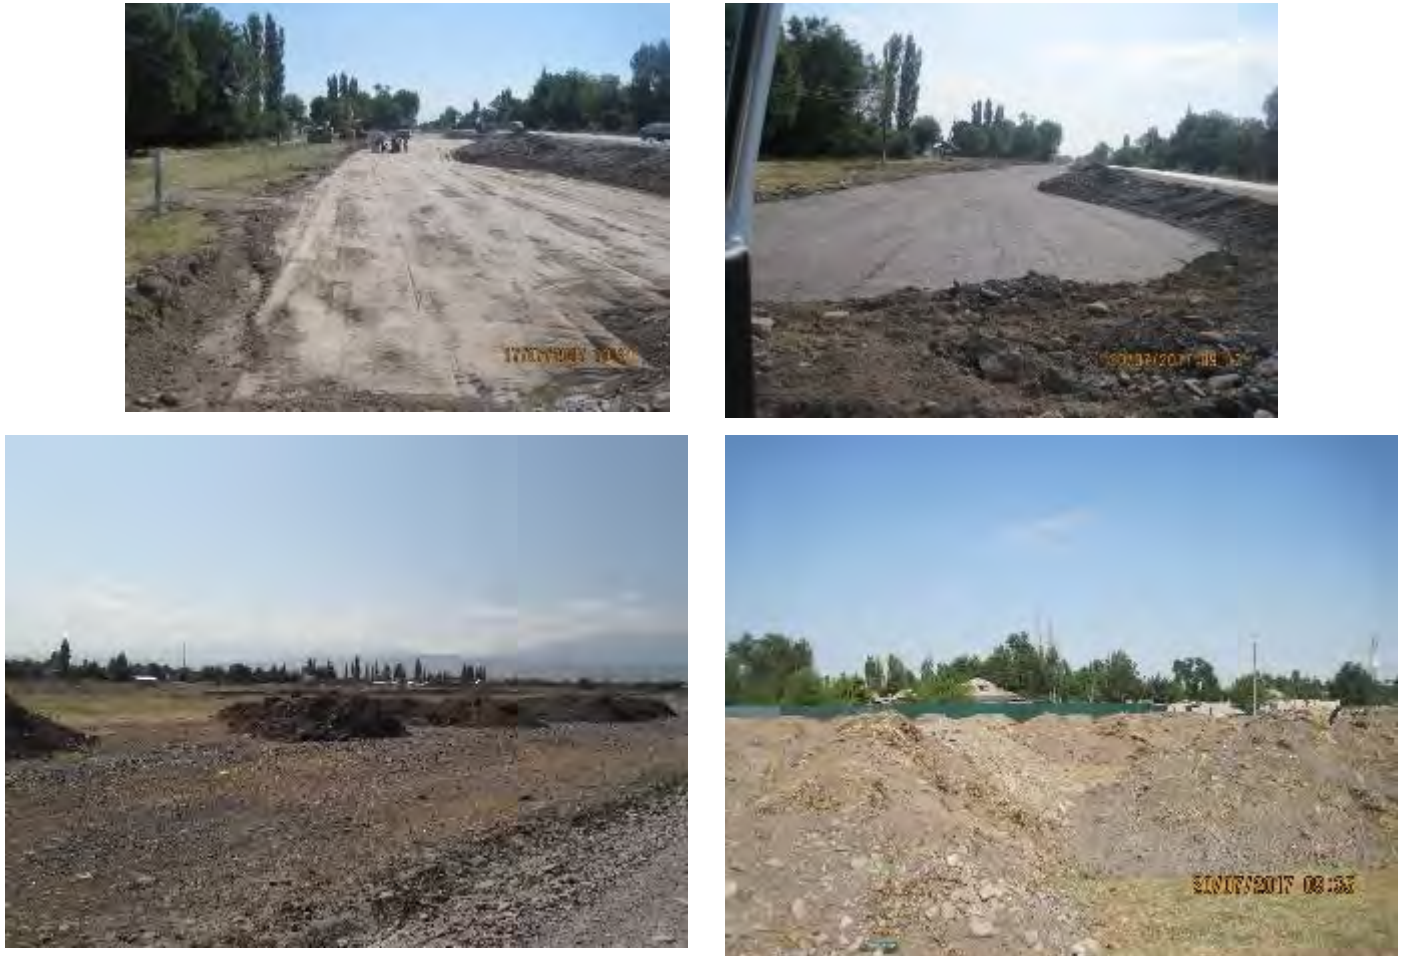
Figure 10. Subgrade preparation and topsoil storage Section 3.

104. Permits for the removal of topsoil in the construction corridor are not required. However the contractor has obtained permission to store up to 6,000 m<sup>3</sup> of topsoil at several sites along the Section 3 road alignment. Topsoil mounds are being kept to below 1.5m high and protected, as best as possible, from the elements; mainly wind during the dry construction season. CSC has instructed the contractor to seed the topsoil mounds with natural grass seeds in an effort to reduce erosion.

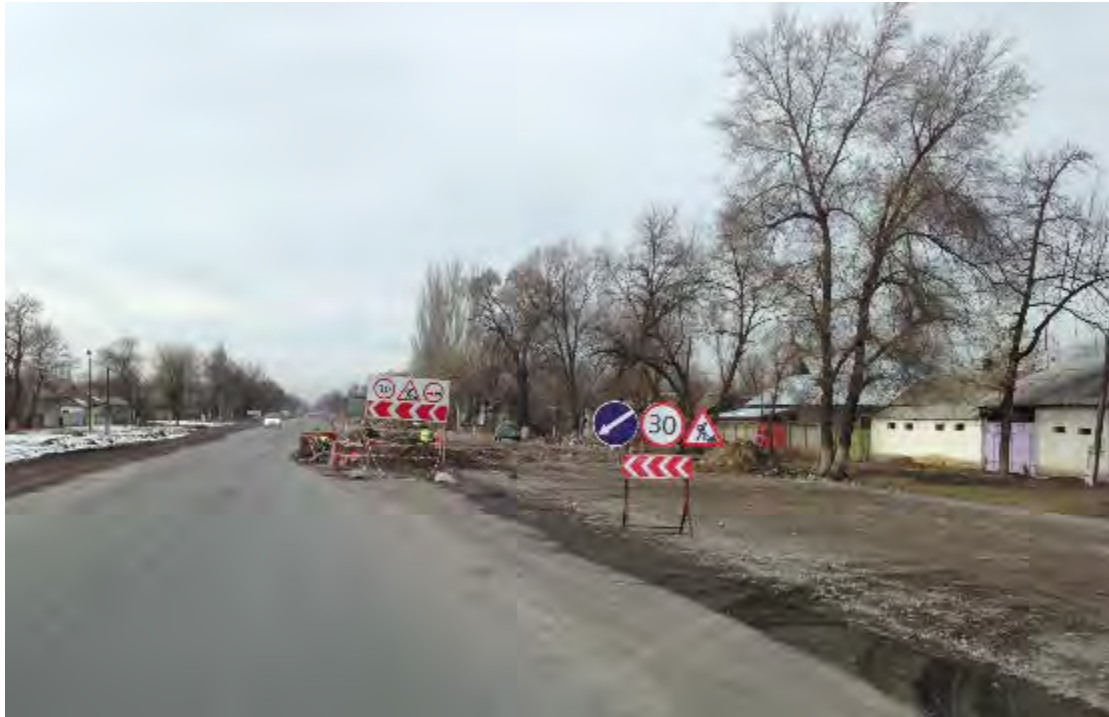
Figure 12. Culvert construction site in Section 3 showing standard diversion

111. The general method being applied is the maintain traffic flow by blocking 1/2 of the road and reconstructing the bridge or culvert then repeating the same process on the other lanes (Figure 12).

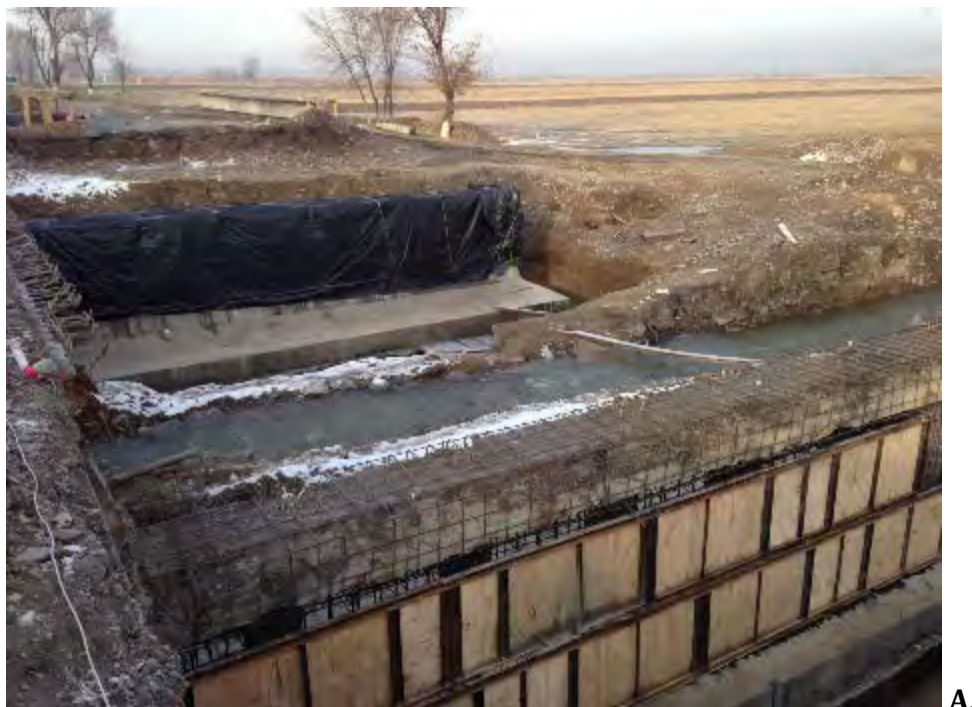
A.

***Non Compliance; CEMWP No. 2.4.2 and 2.4.2- and Annexes 7,8 and 12-These mitigative actions require that the contractor completed the majority of the work during the period when the river bed is dry (which is 8-3 months of the year) and refuelling and equipment washing to be done totally away from the river bank (Figure 13).***

Figure 13 Zhelhamish River: A-major work while river is active and B-concrete spill on the bank

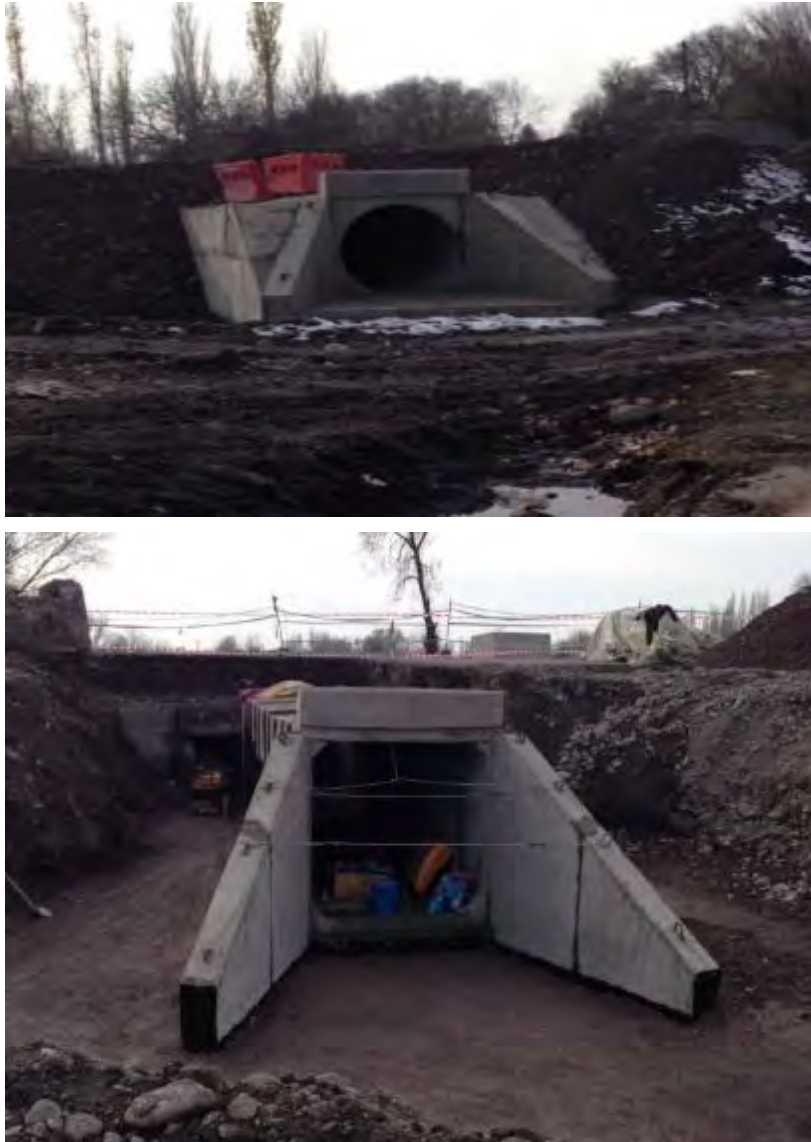
Figure 14. Two types of poured-in-place culverts under construction

113. After the inspection of 5 of these culvert three serious non-compliance issues were identified, namely a) Safety at the work site, especially after construction has stopped for any reason b) Confirmation that culvert sections left in the ground are unobstructed and that placement allows for ample slope for quick drainage c) adequate design of drainage channels downstream of the culvert discharge

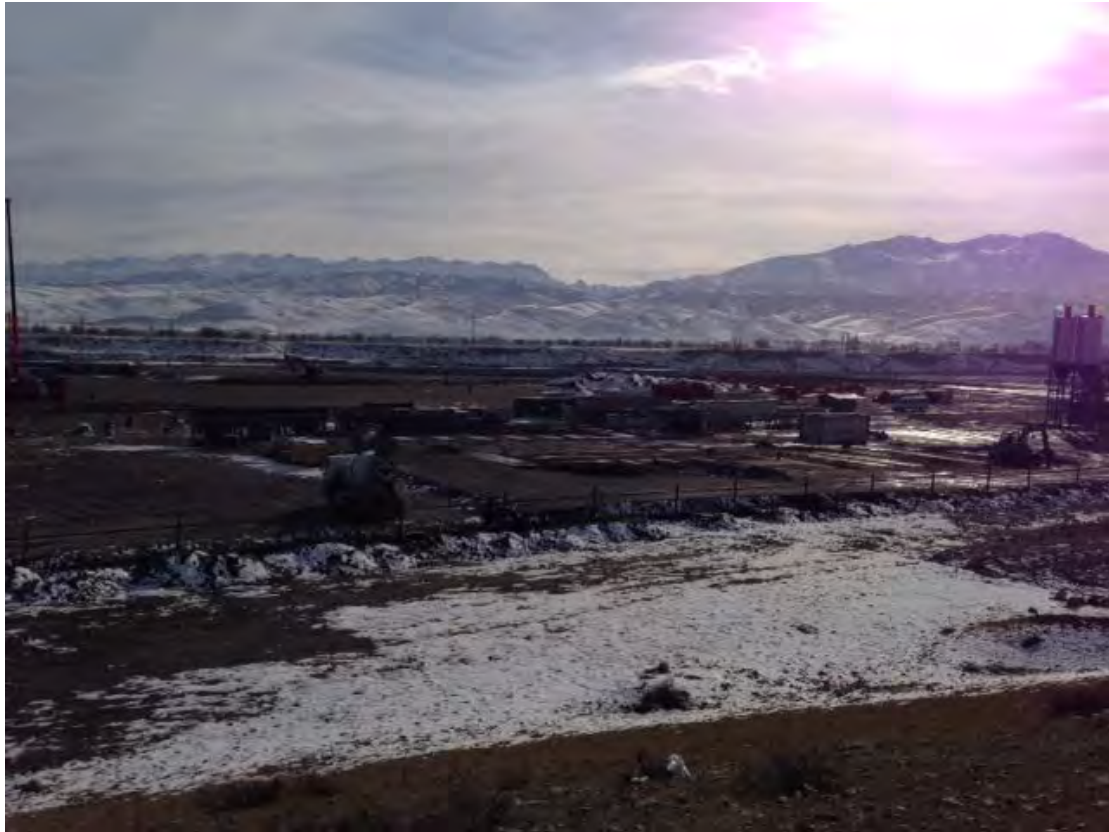
**CEMWP No. 2.7.1, 2.7.3 and Annexes 12,13 and 14-** The contractor has wisely decided to contain all materials processing activities in a large and remote (8 km) area of the Ak Suu 2 borrow site (Figure 16). That area will house the aggregate processing and crushing facility, the concrete batch plant as well as the asphalt production plant.

As a prerequisite to initiating the installation of any equipment the contractor must complete a special environmental assessment, known as an Ecological Passport, of these three facilities. This work has not been completed.

Figure 16 Ak Suu2 site for materials processing operation. Note start of fencing.

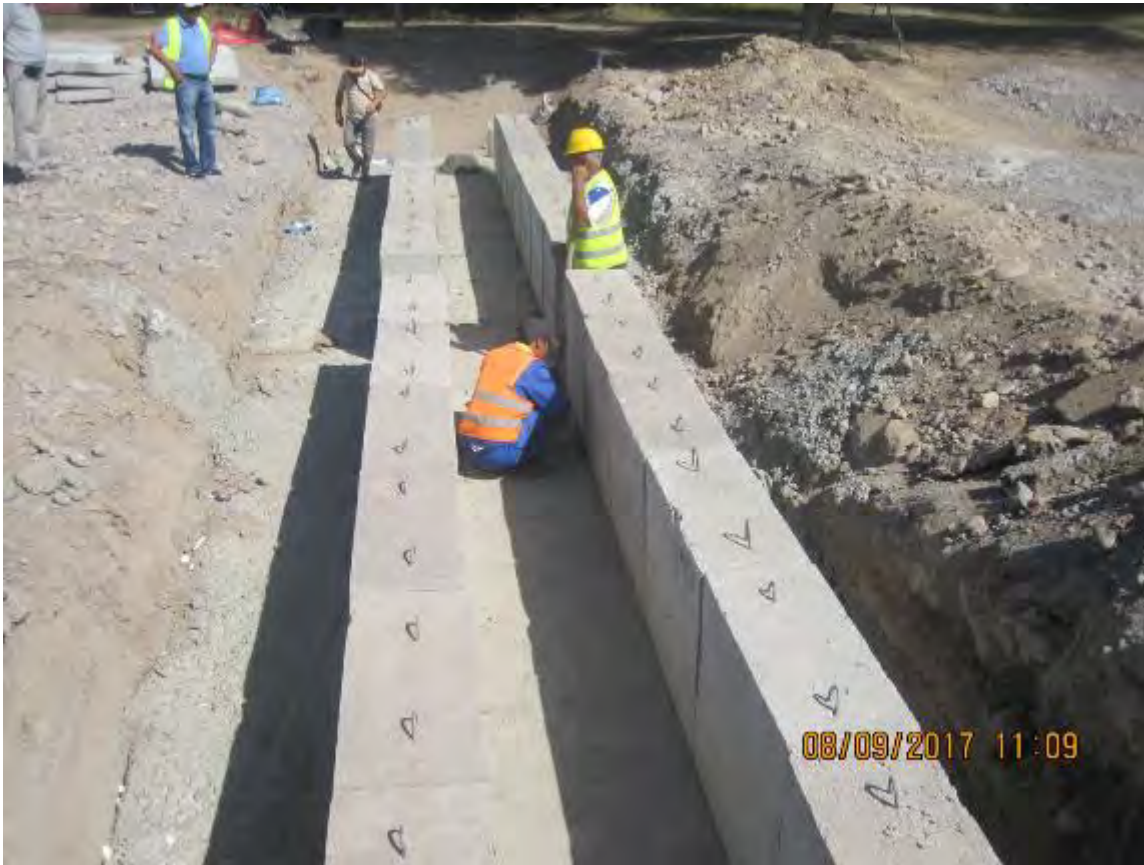
Driven out a wedge groundwater causes problem.

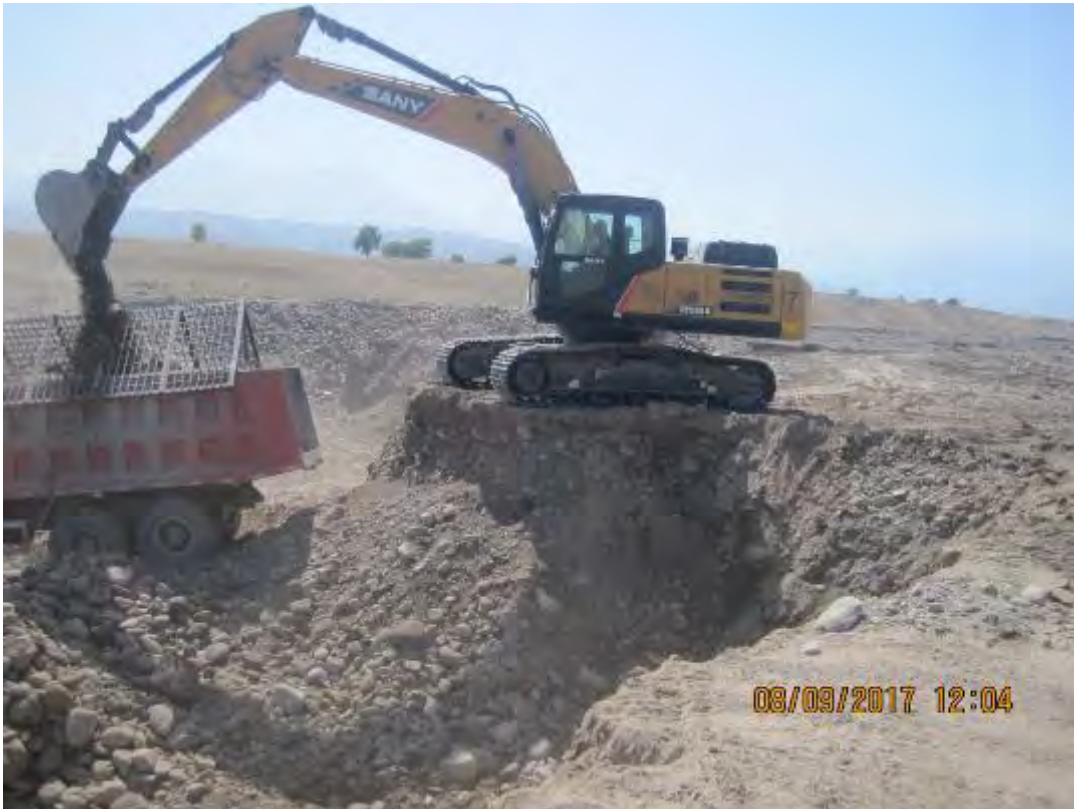
It was found that the excavator works in breach of safety regulations. Explanatory work was carried out with the excavator operator

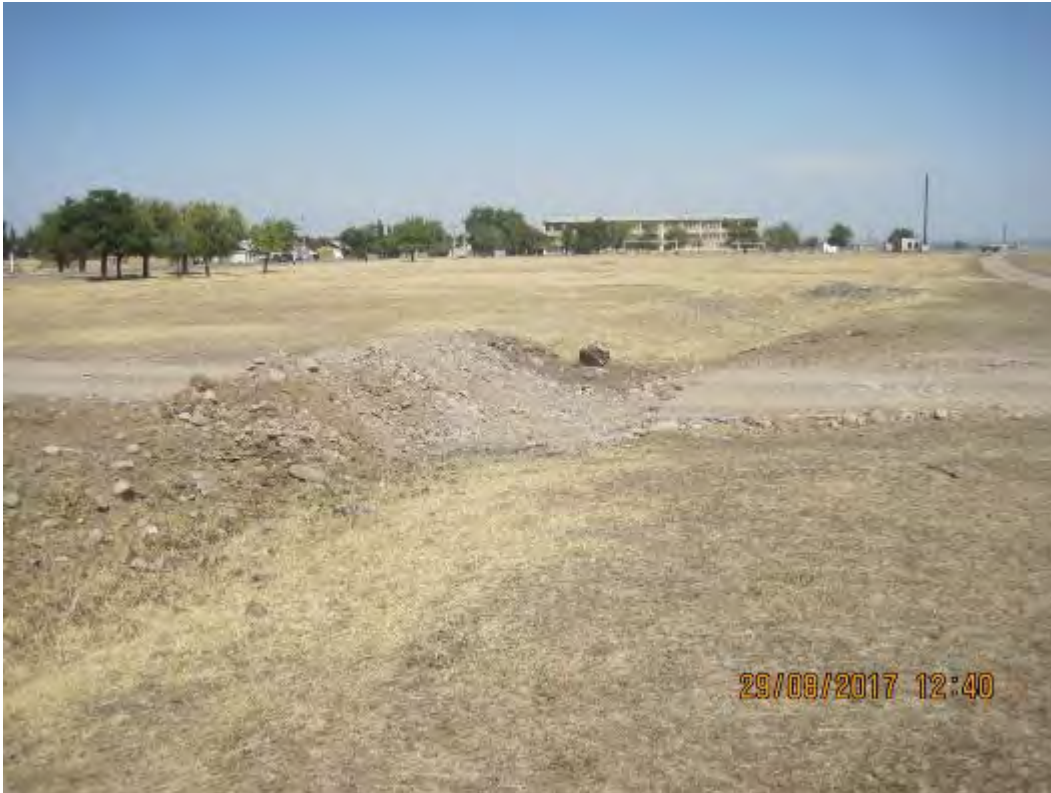
On the road from the Aksu 2 borrow pit, which leads to the village, a partitioning trench is made, so that no cars can cross it.

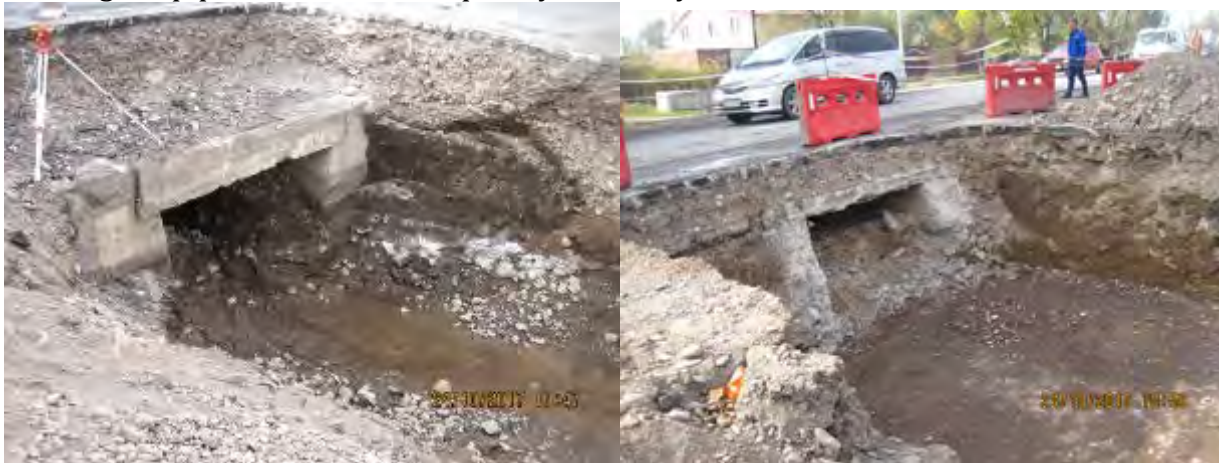
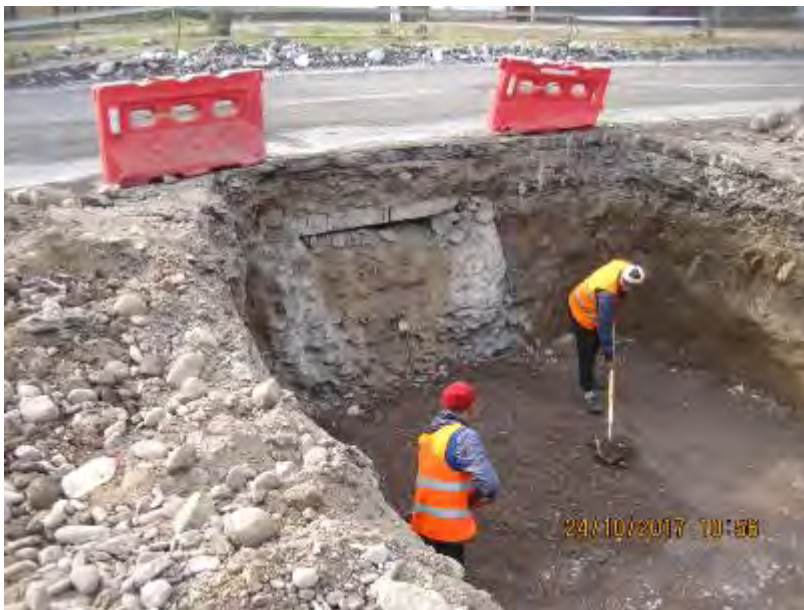
Existing old pipes are almost completely locked by soil.

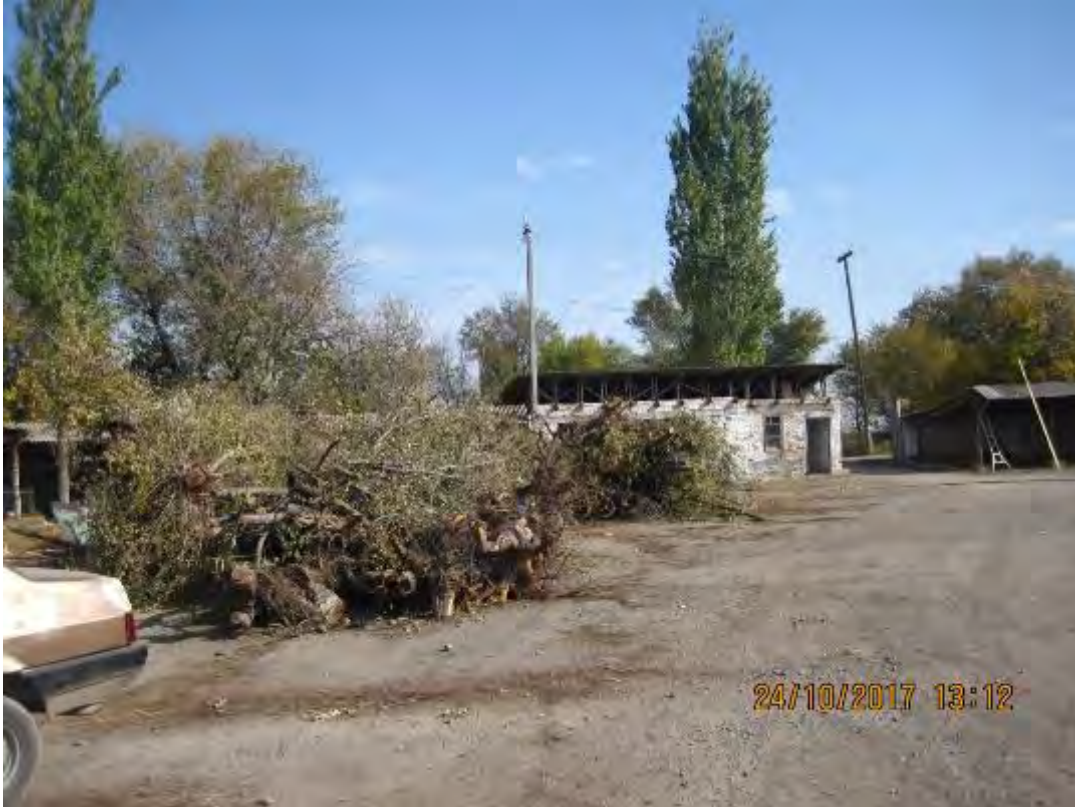
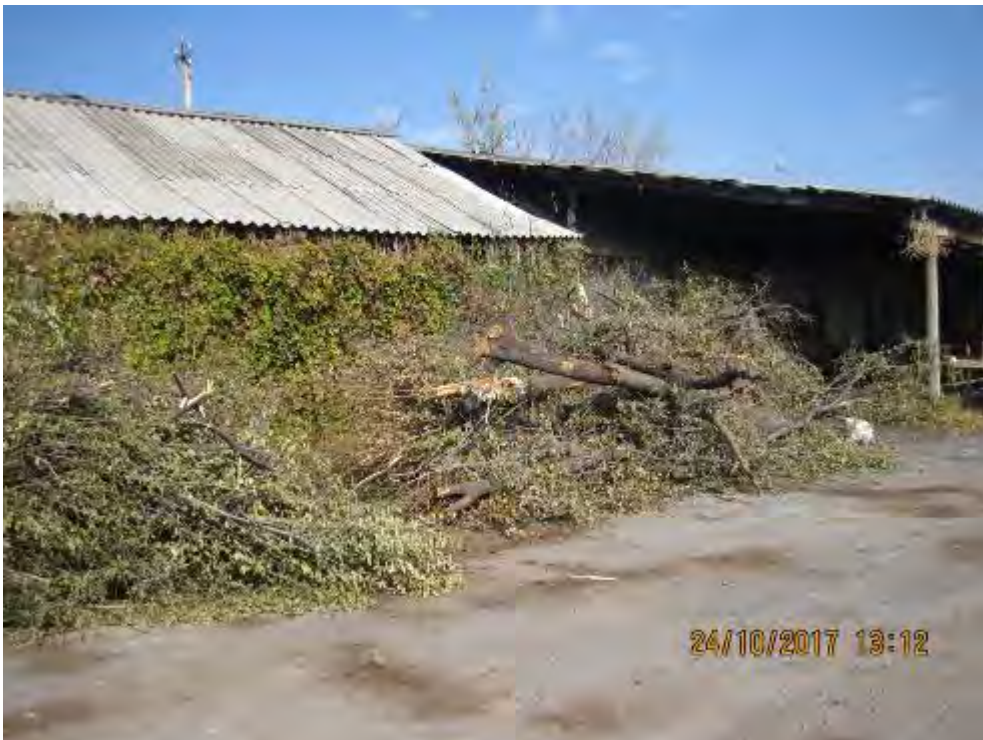
The branches and roots of trees are taken out immediately after cutting into specially designated areas by the local administration

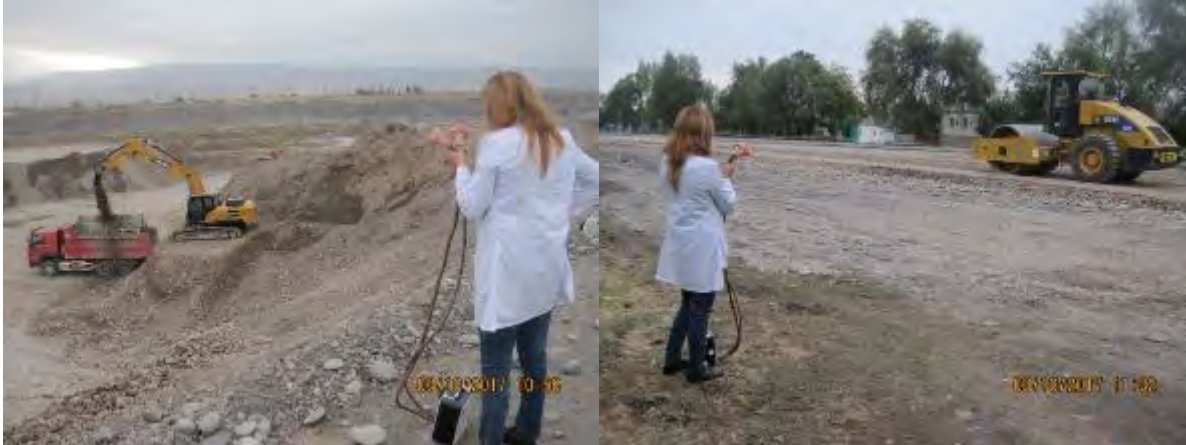
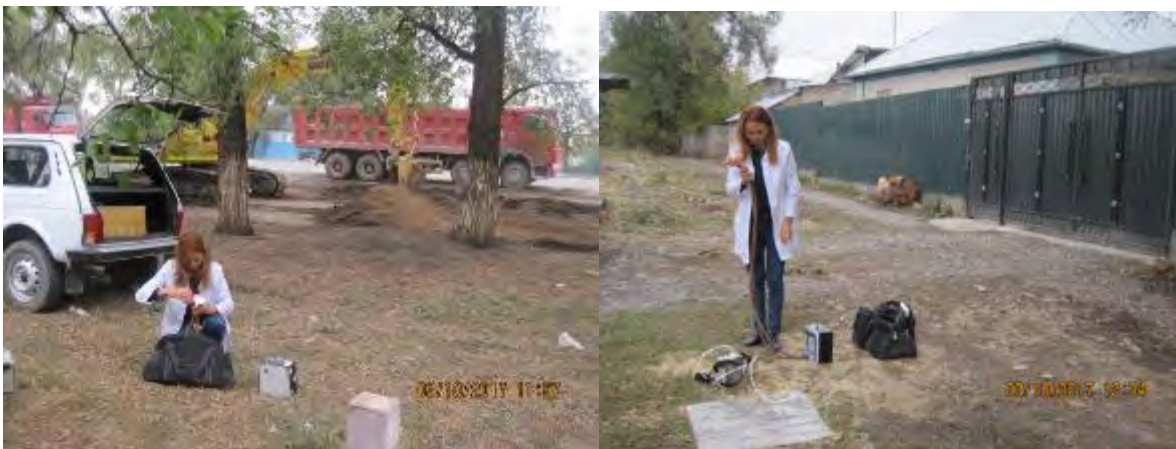
On October 3, samples of air were taken at the construction site near the houses on the places of work performance, as well as on a vulnerable site in the Petrovka village.

Air samples were examined for the content of nitrogen dioxide, sulfur dioxide, carbon monoxide, suspended materials. Based on the results of the analyzes, the excess of 1,1 MPC above nitrogen dioxide was noted at one point, and the 1.3 MPC exceeded on suspended materials at one point.

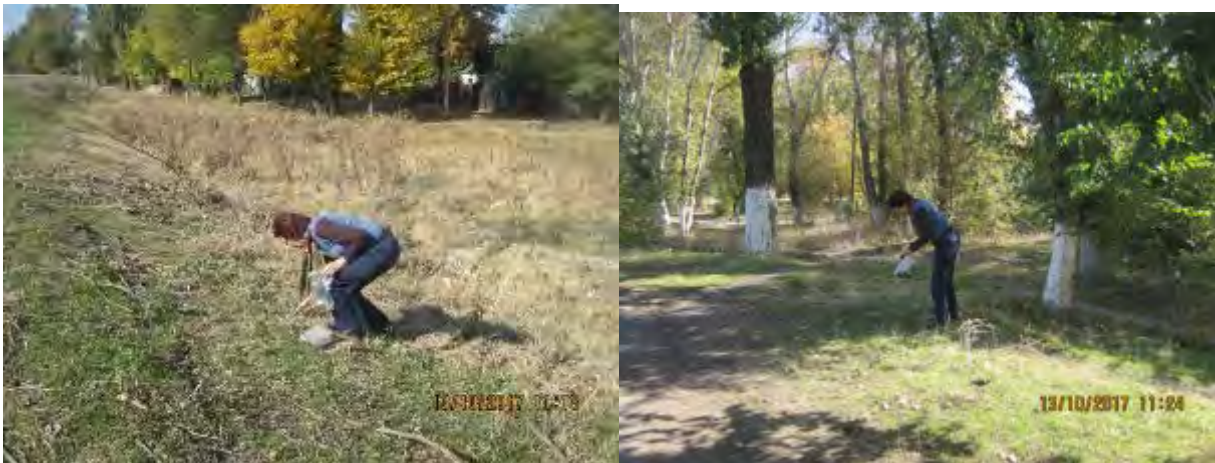
On October 13, soil samples were selected on sections of the road, the work on which is scheduled for 2017.

The soil samples were examined for lead and petroleum products. Based on the results of the analyzes, in almost all samples, the MPC was exceeded for lead and the high content of oil products.

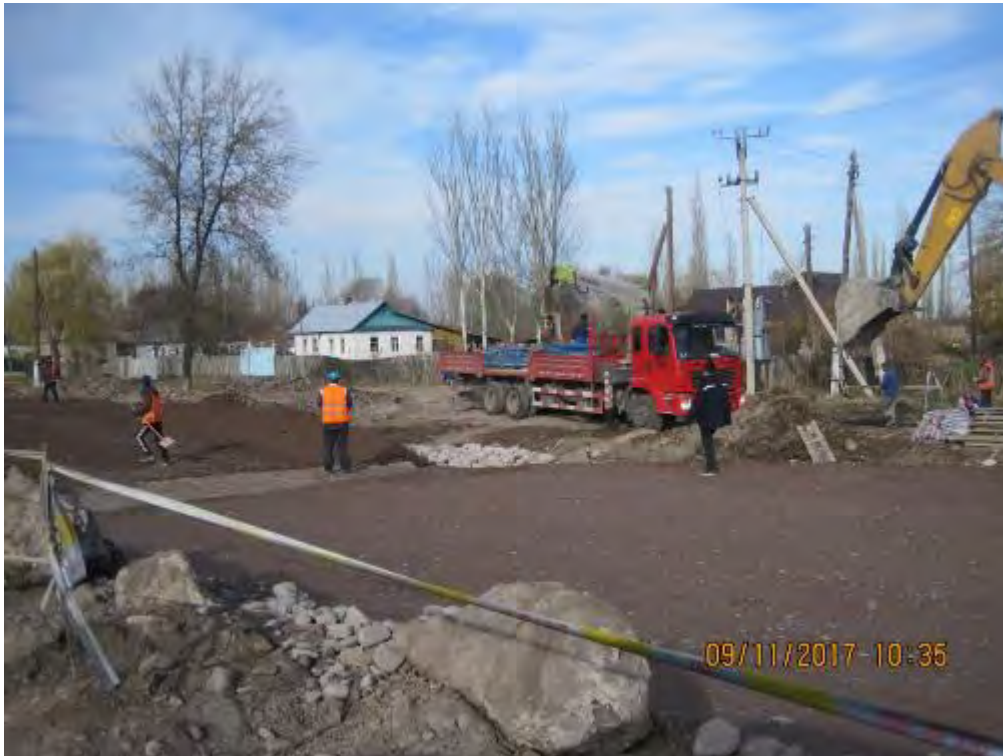
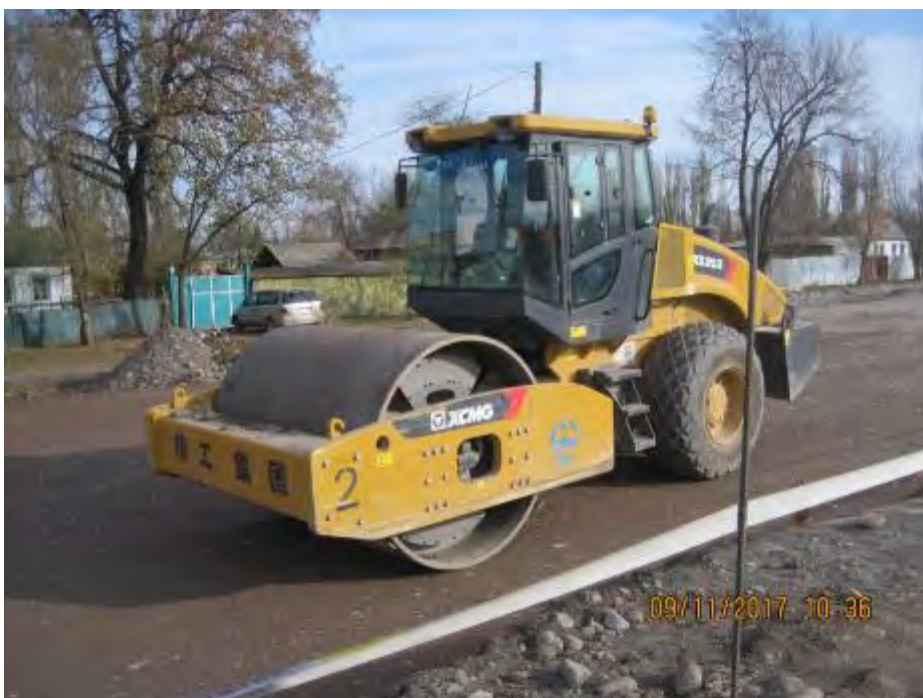
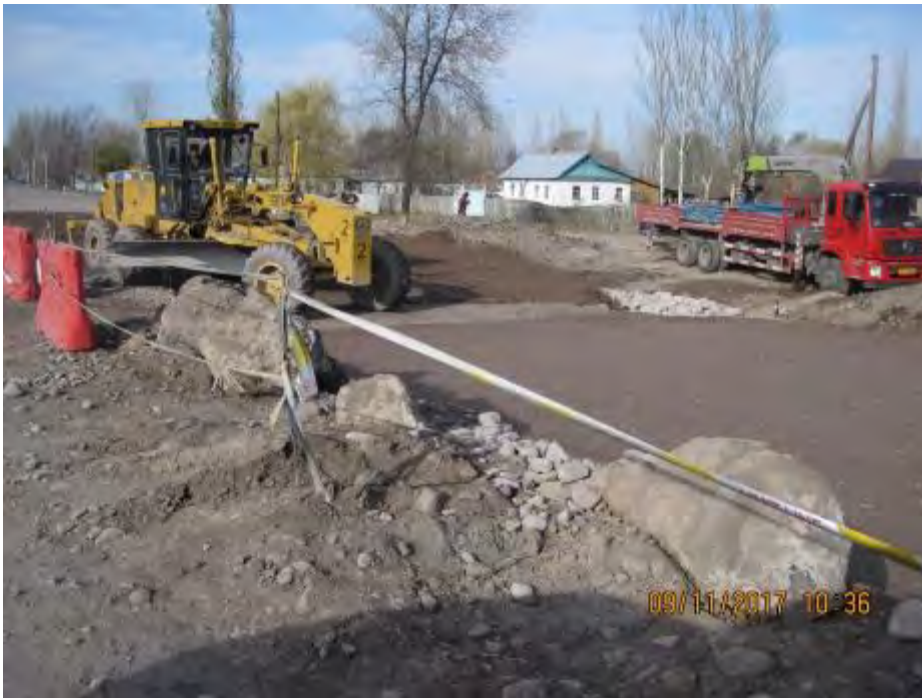
At present, earthworks are in progress on the 45.6 -51.6 km section of the road. (Section 3). Rolling and compaction of the side slopes of the north and south side of the road are being carried out.

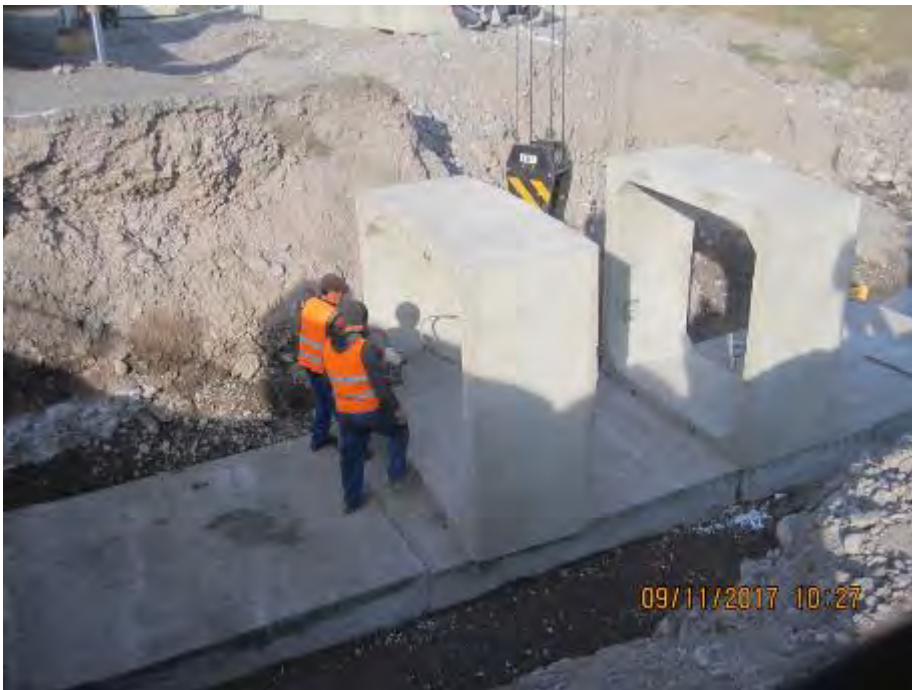
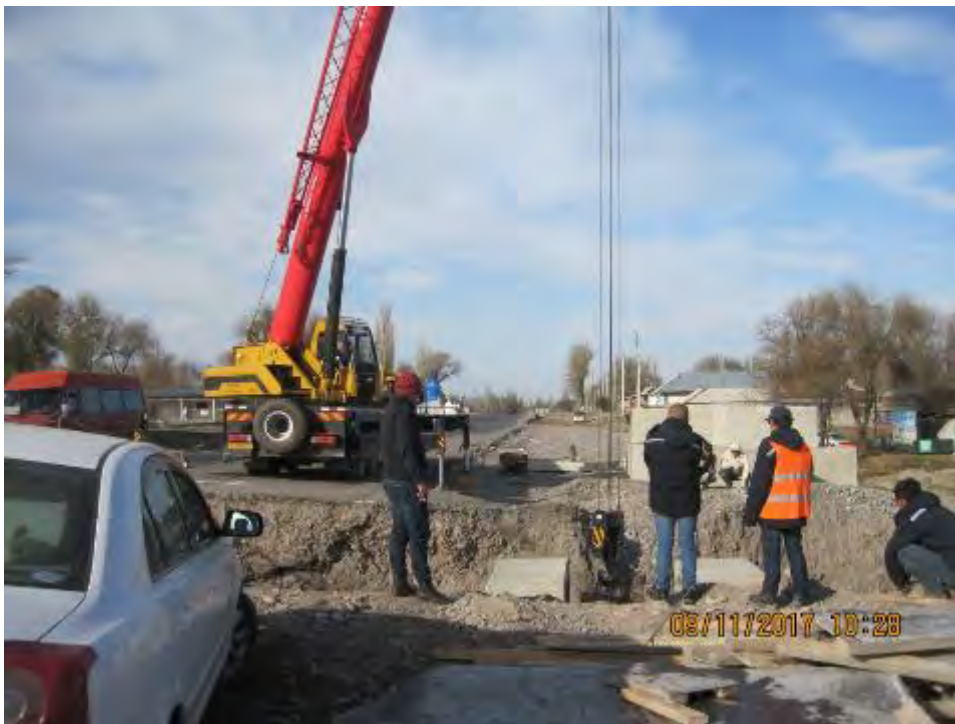
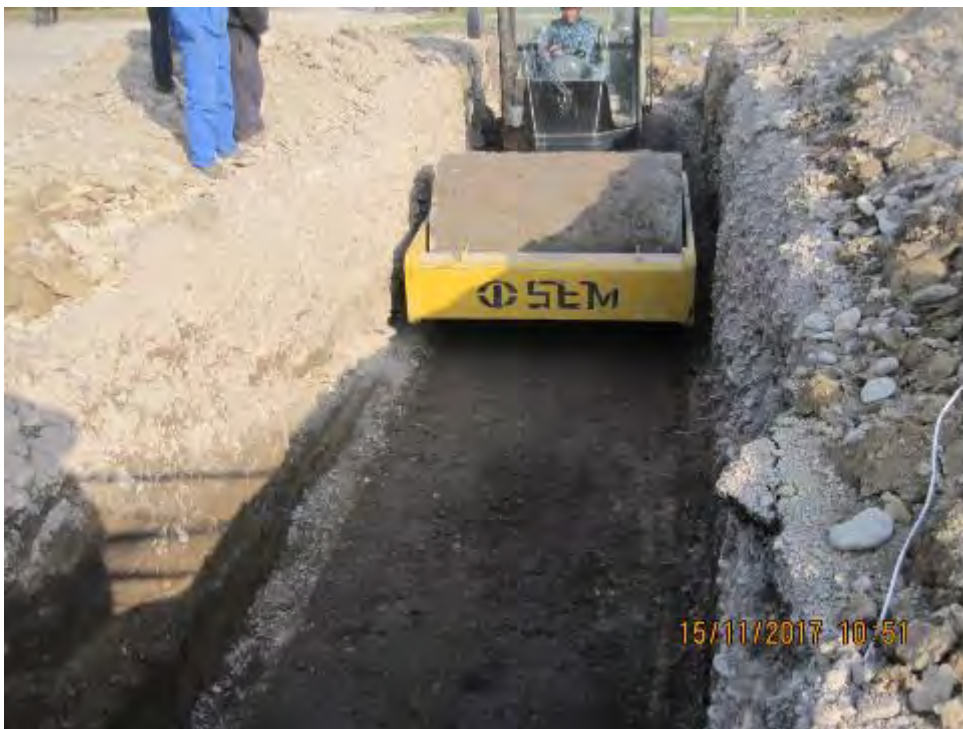
On the Section 3 in the Petrovka village, 45.6-51.6 km works on dismantling old and installing new culverts, transporting and installing new electric and telephone poles on the north side of the roadway were also being carried out.

The photo shows the ramming of the base under the culvert without vibration mode

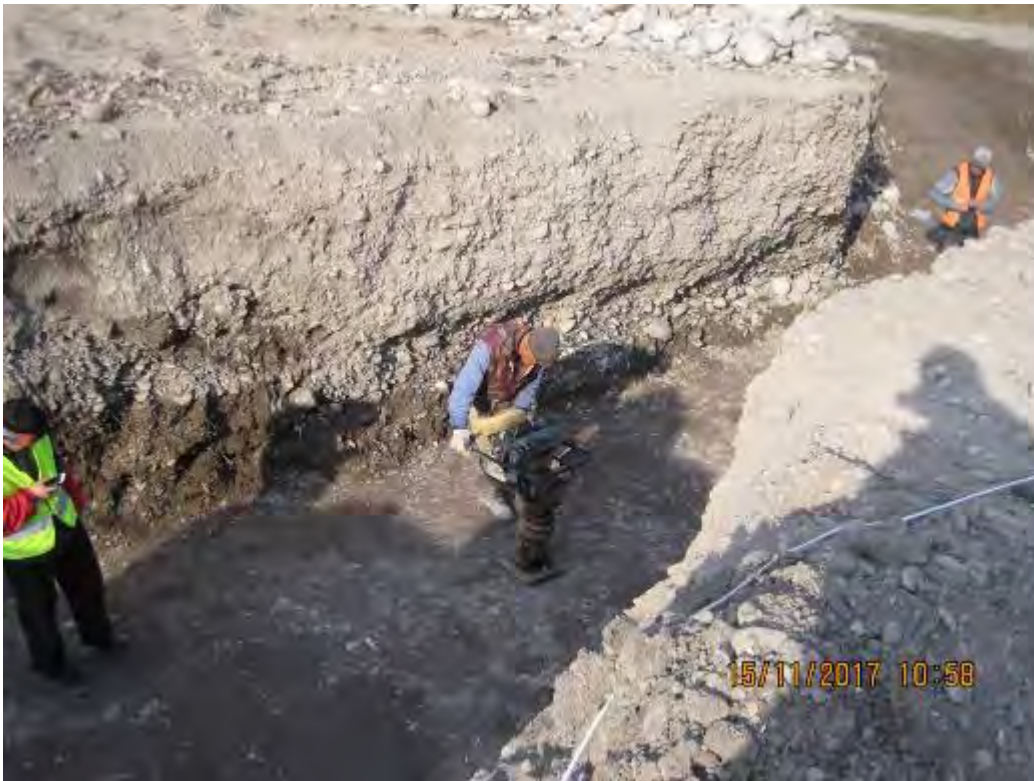
The photo shows the tamping of the base under the culvert

Driven out a wedge groundwater causes problem.

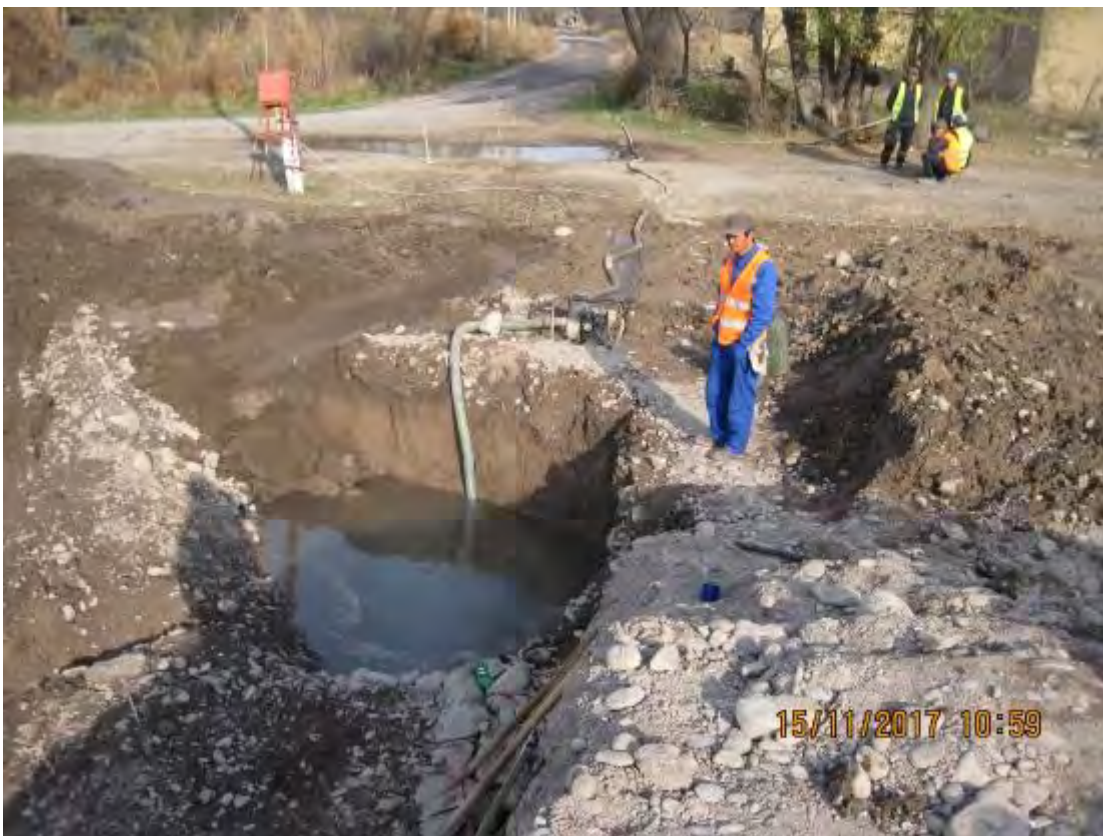
Existing old pipes are almost completely plugged with soil

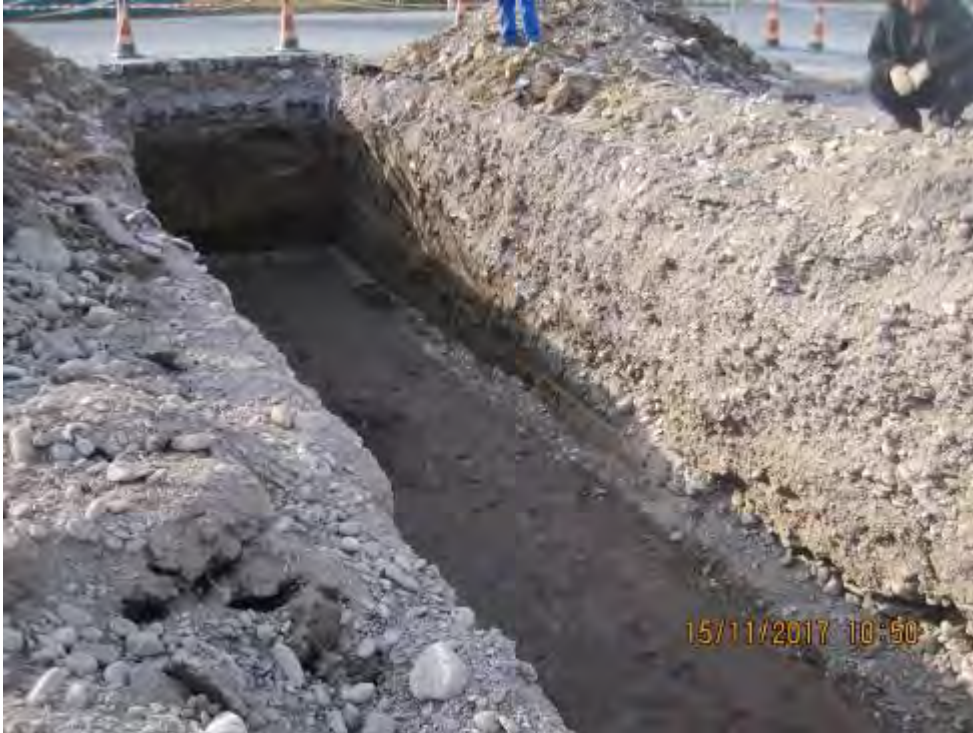
For the purposes of traffic safety, the site of work is fenced, barriers and signs of traffic safety are installed.

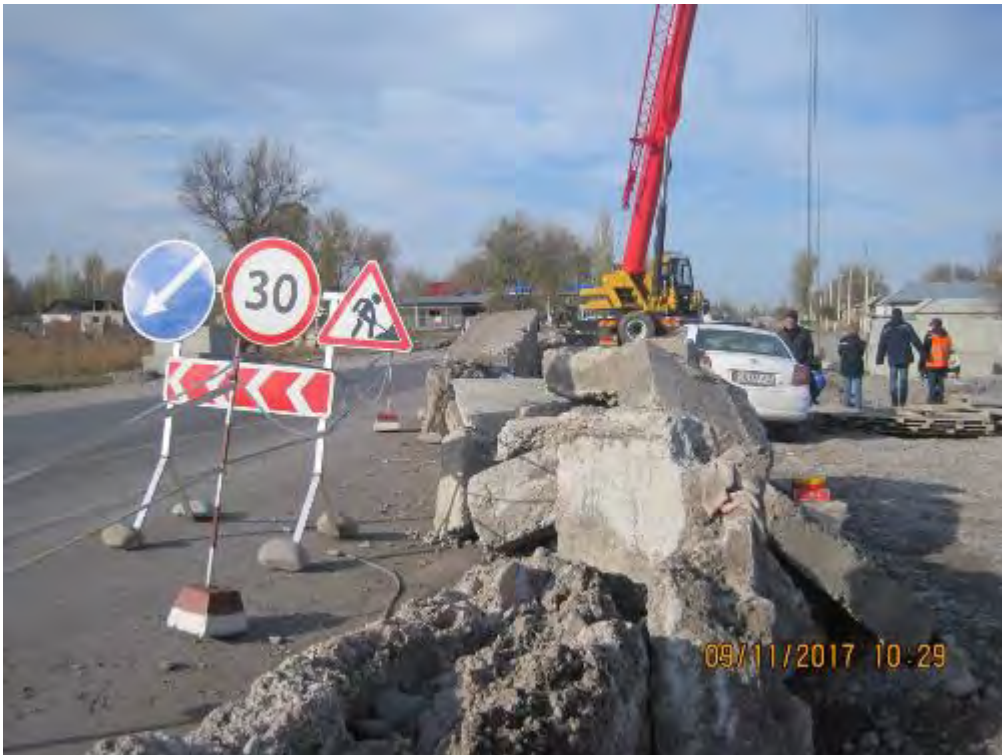
Night illumination with the help of lamps and LED strips is organized

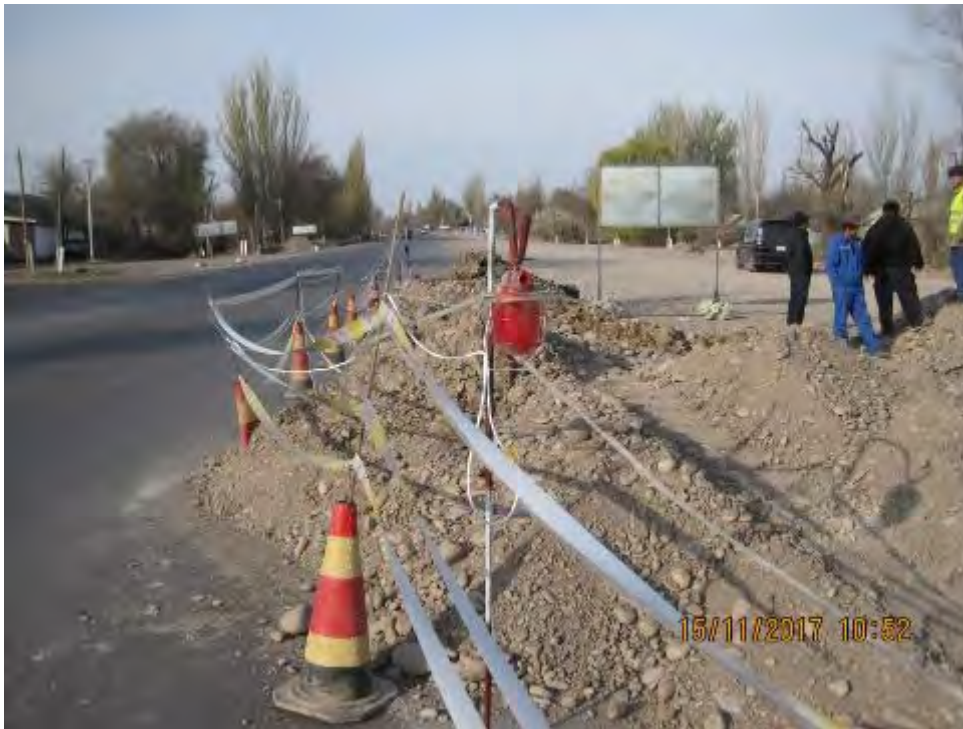
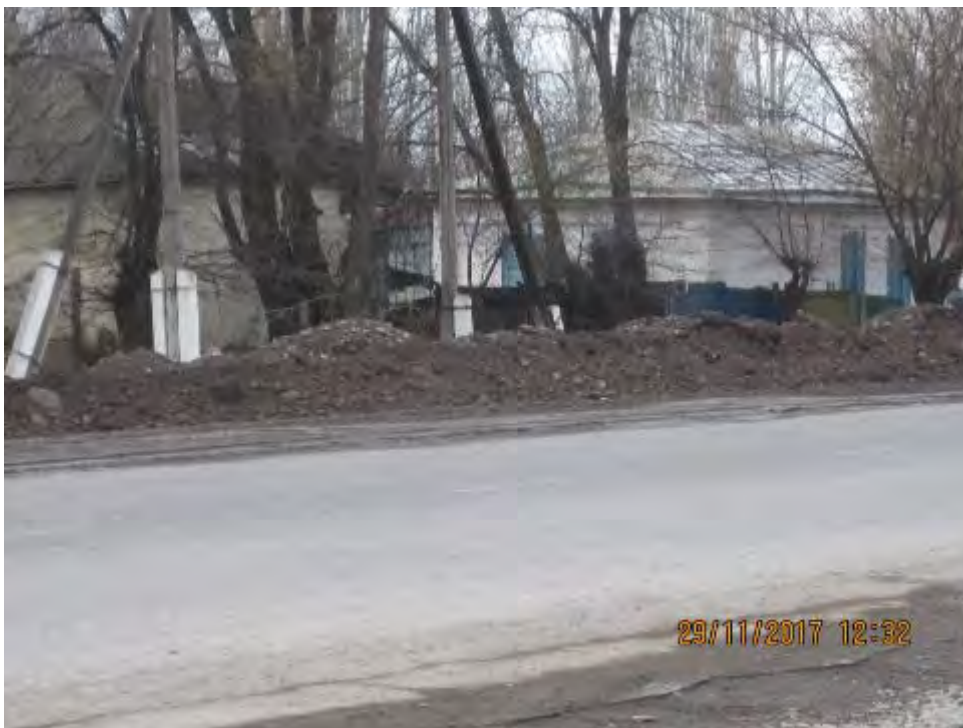
On Section 3 in the Petrovka village 45.6-51.6 km in order to ensure the safety of traffic in the winter in areas where had no time to make ramming of the side slopes, barriers are constructed from inert materials for the icy condition of roads.
