# **Semi-annual Environmental Monitoring Report**

Kyrgyz Republic:  
CAREC Transport Corridor 3 (Bishkek-Osh Road)  
Improvement Project, Phase 4

Prepared by Ministry of Transport and Road KR  
in consort with EPTISA Servicios De Ingeniería S.L.  
Eptisa Muhendislik and RAM Engineering

January 2018

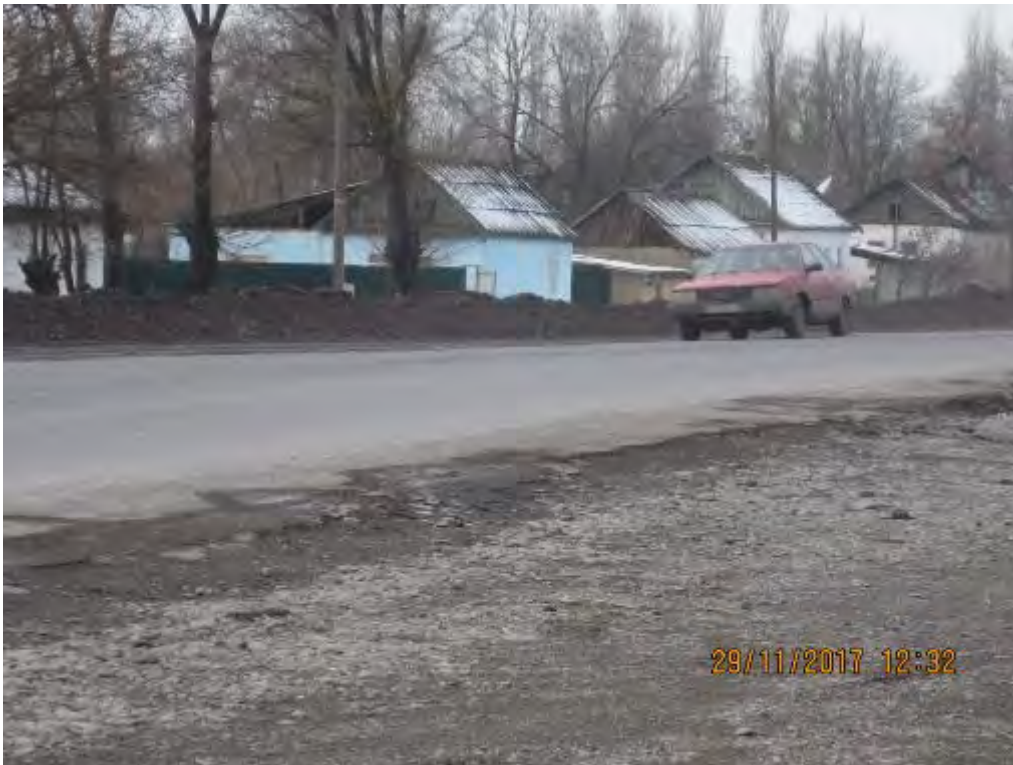
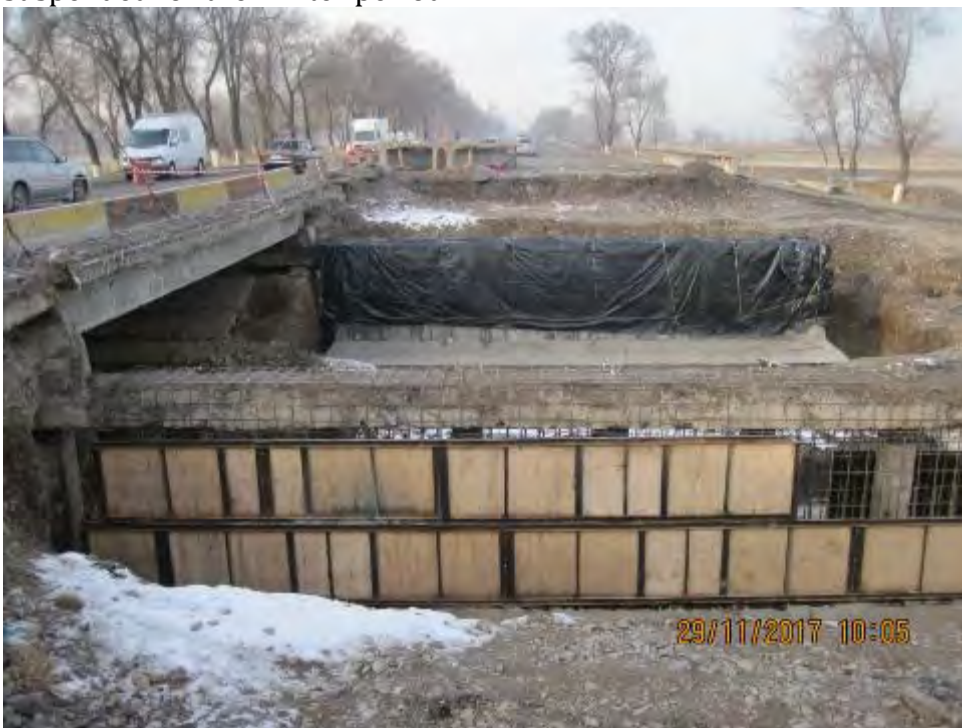
Construction work from the northern part of the bridge across the Jelamysh river is suspended for the winter period

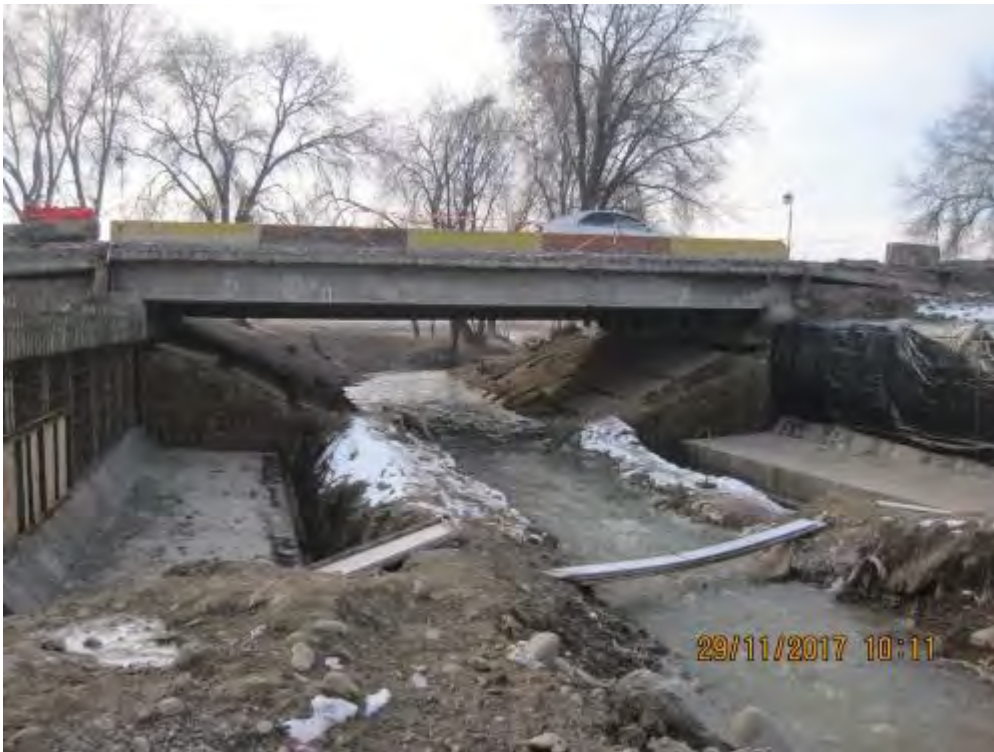
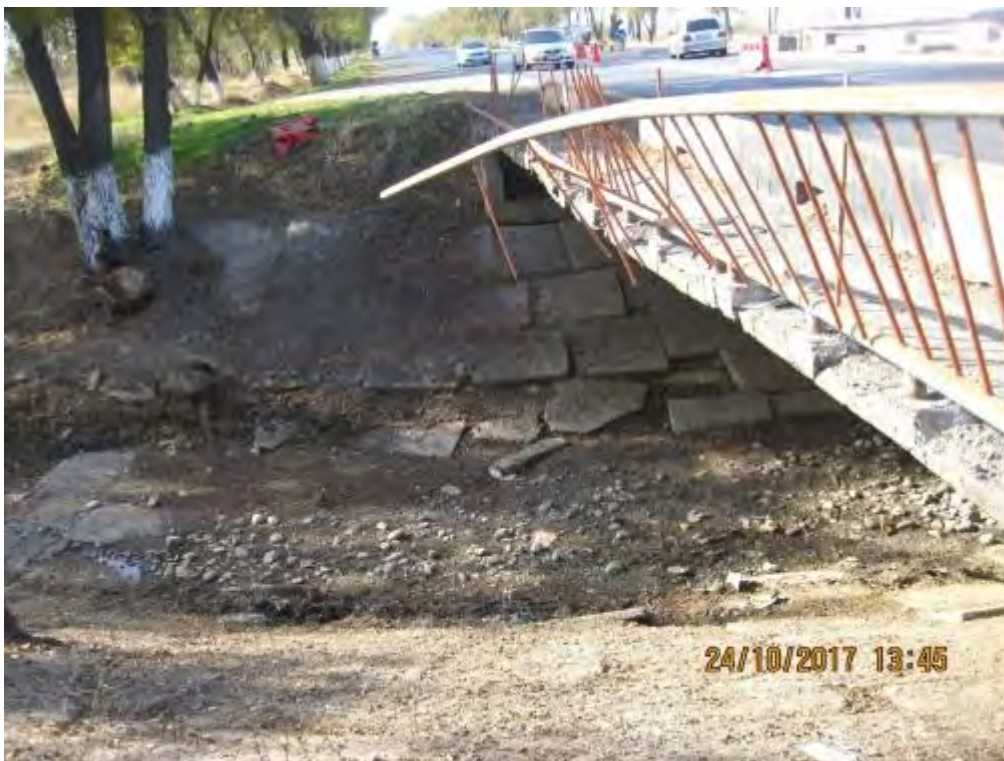
Water appeared in the Jelamysch river but suspended construction works currently do not have an impact on the water in the river.

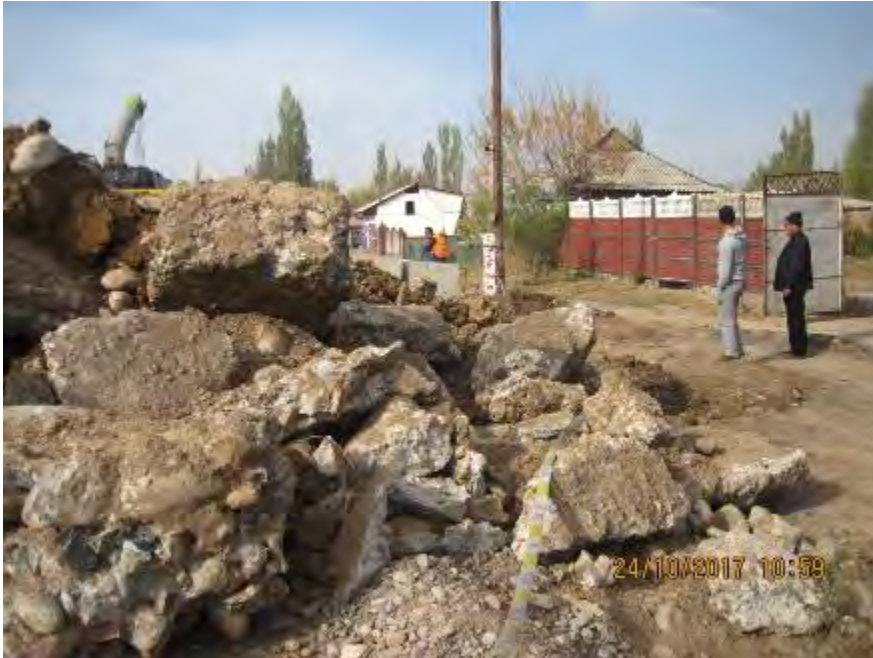
Reinforced concrete construction waste formed during the drilling of the road to install new pipes was removed to dedicated sites for storage of old concrete products.

Photo shows reinforced concrete wastes formed during the installation of culverts

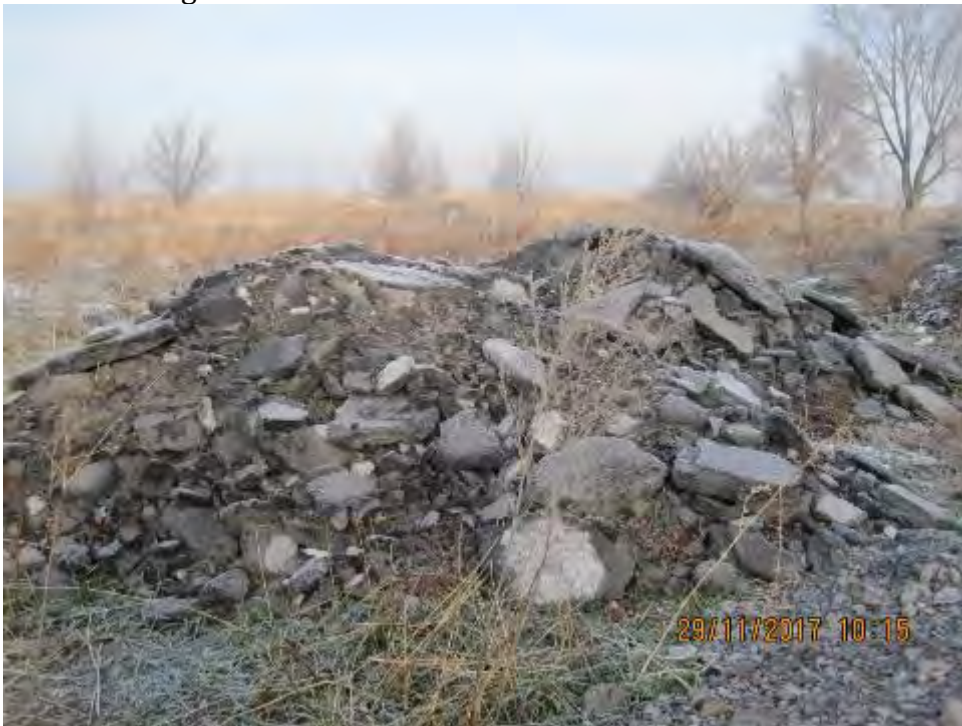
The old asphalt removed during the construction of the bridge was not used and stored near the bridge under the construction

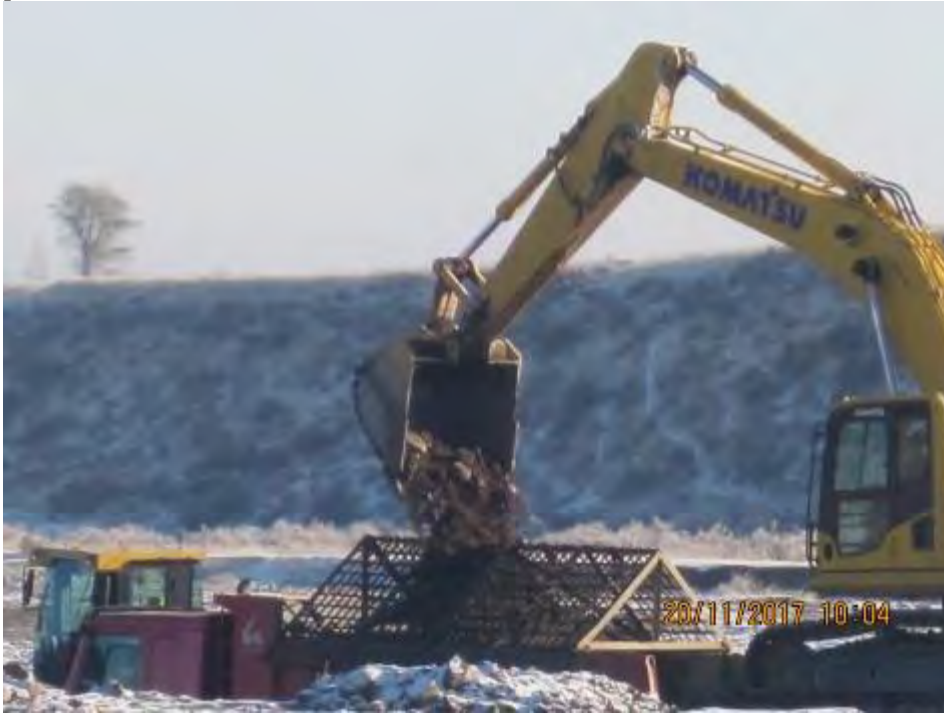
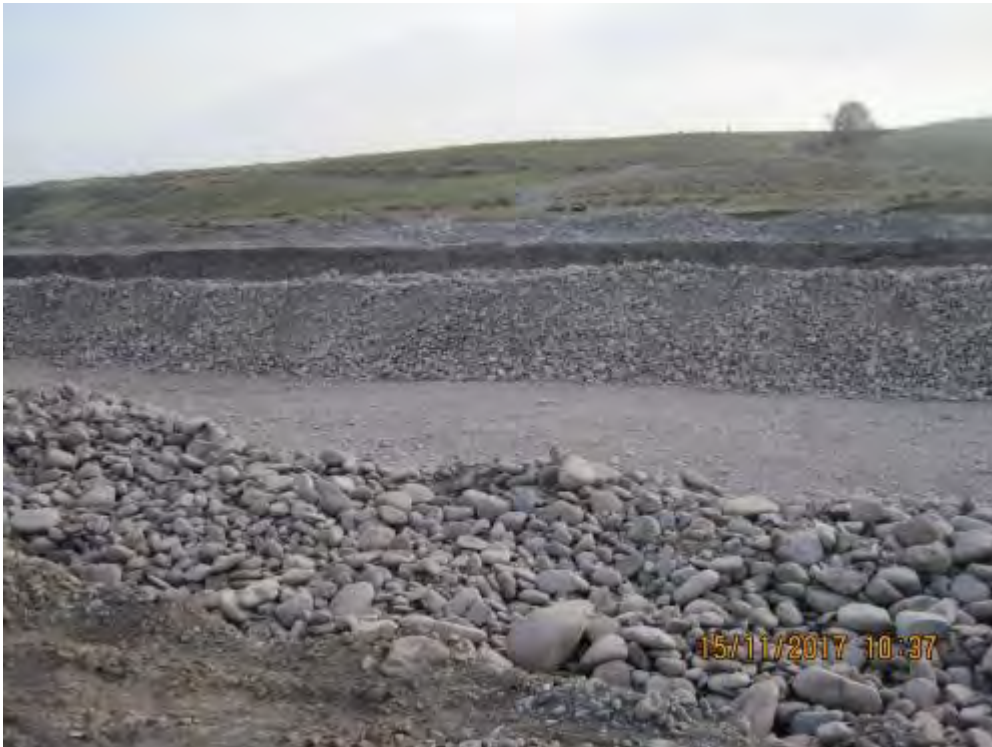
Work was carried out on excavating, sieving and stockpiling of materials on the Ak- 2 borrow pit.

Workplace dusting is minimal. This is seen on photos.

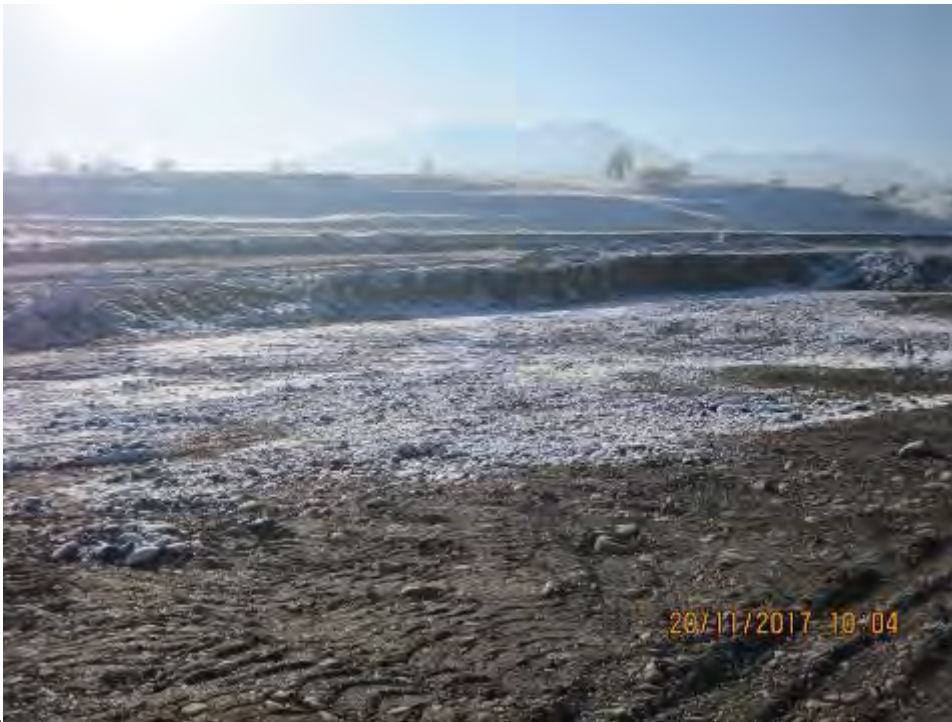
During the monitoring of the construction work, violations in the development of the Aksu 2 borrow pit were revealed, so with the allowed depth of development of 2.3 meters, the development is conducted to a depth of 4 or more meters. And the development is conducted in one small area, while the allocated and approved under the borrow pit area is very large.

In view of the foregoing, in order to avoid conflict with local authorities and penalties from State Inspectorate for Environmental and Technical Safety, an official warning was issued to the Contractor from Eptisa.

In the established timeframe, all the developments made deeper than the established depth, were filled.

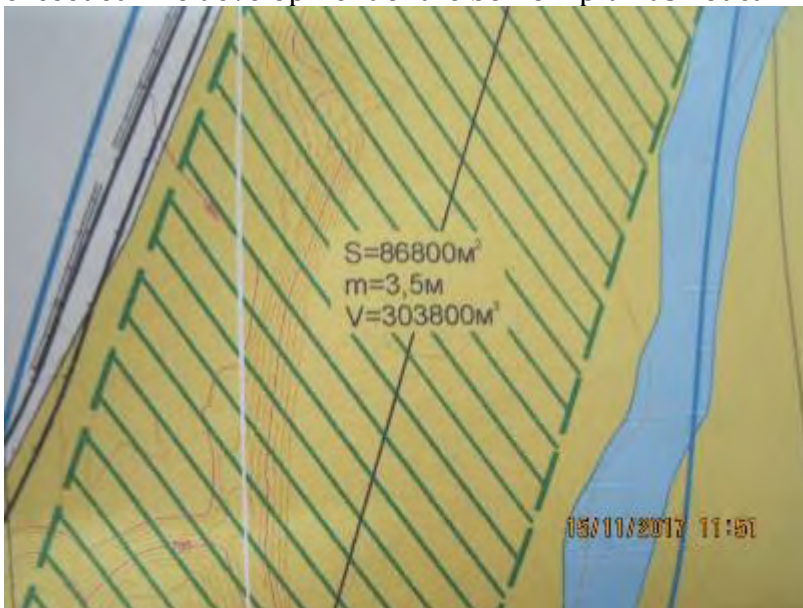
At the Aksu 1 borrow pit, the permitted depth of development of 3.5 meters is not exceeded. The development of the borrow pit was not carried out in November

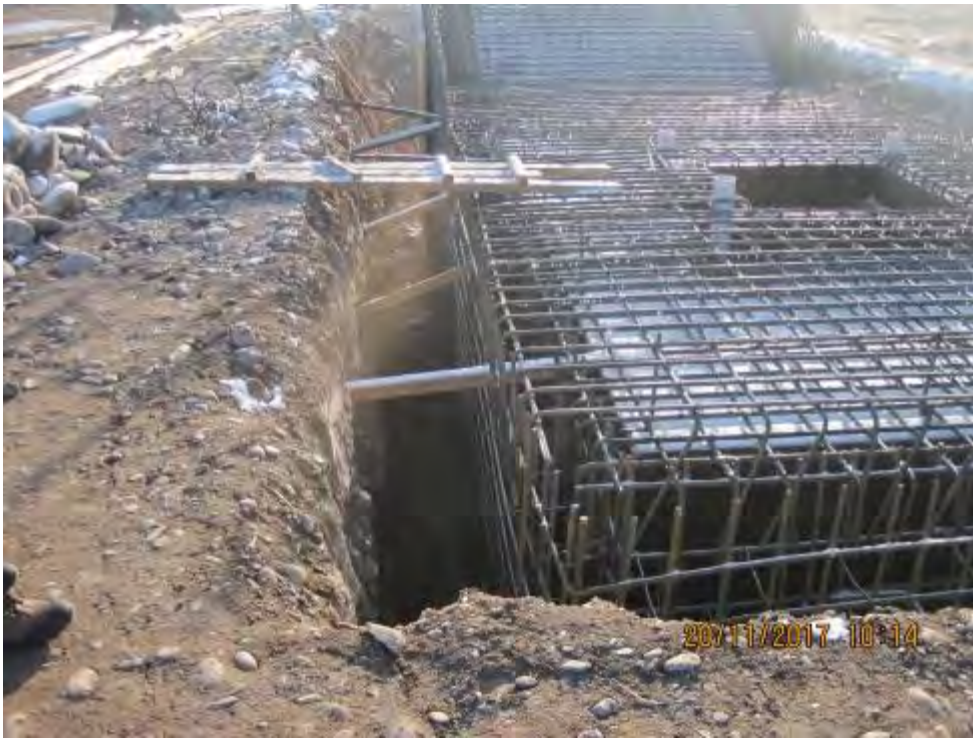
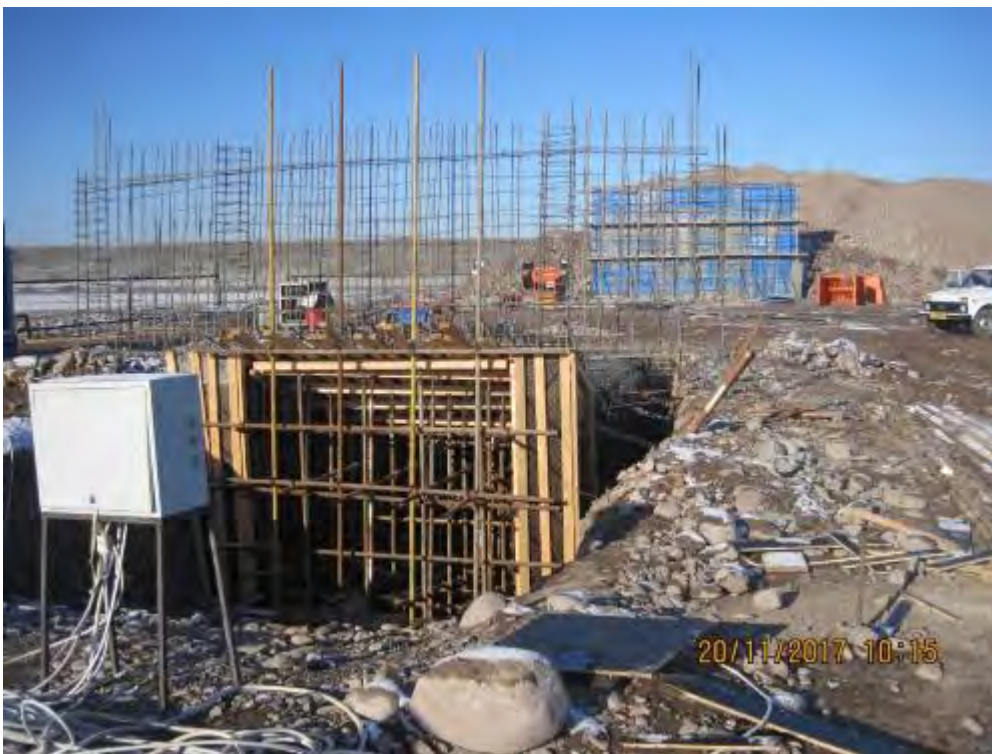
Photographs shows the construction of a foundation for a stone crusher

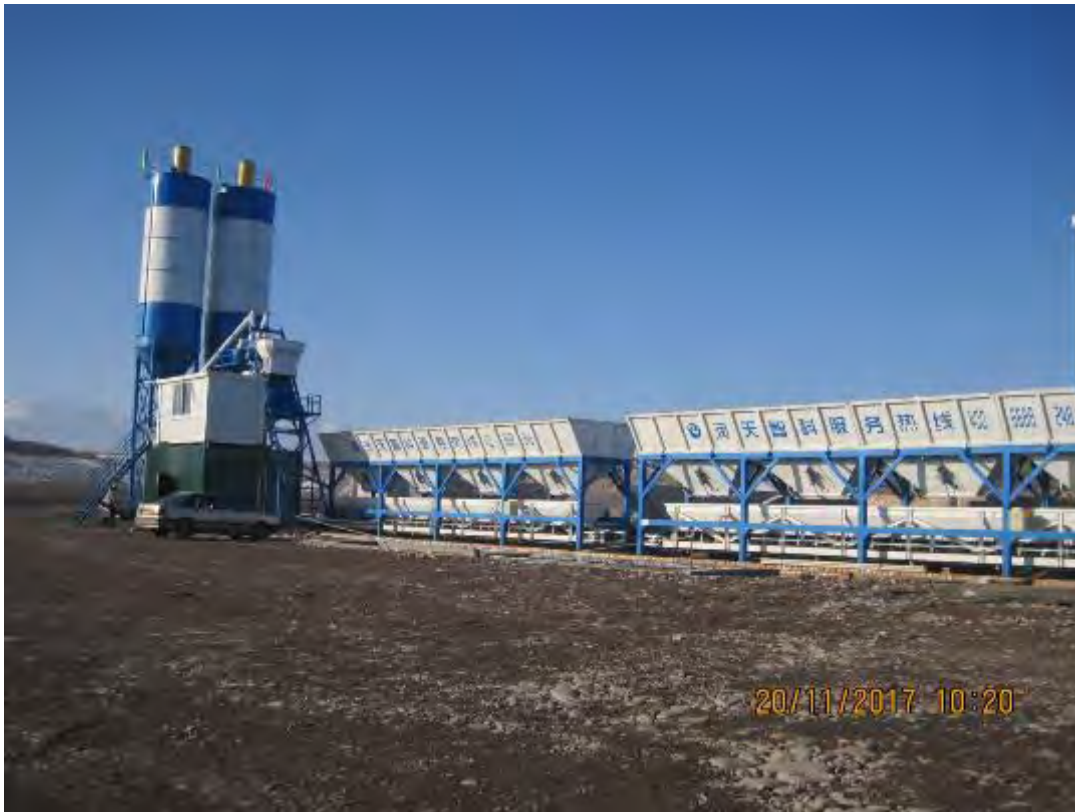
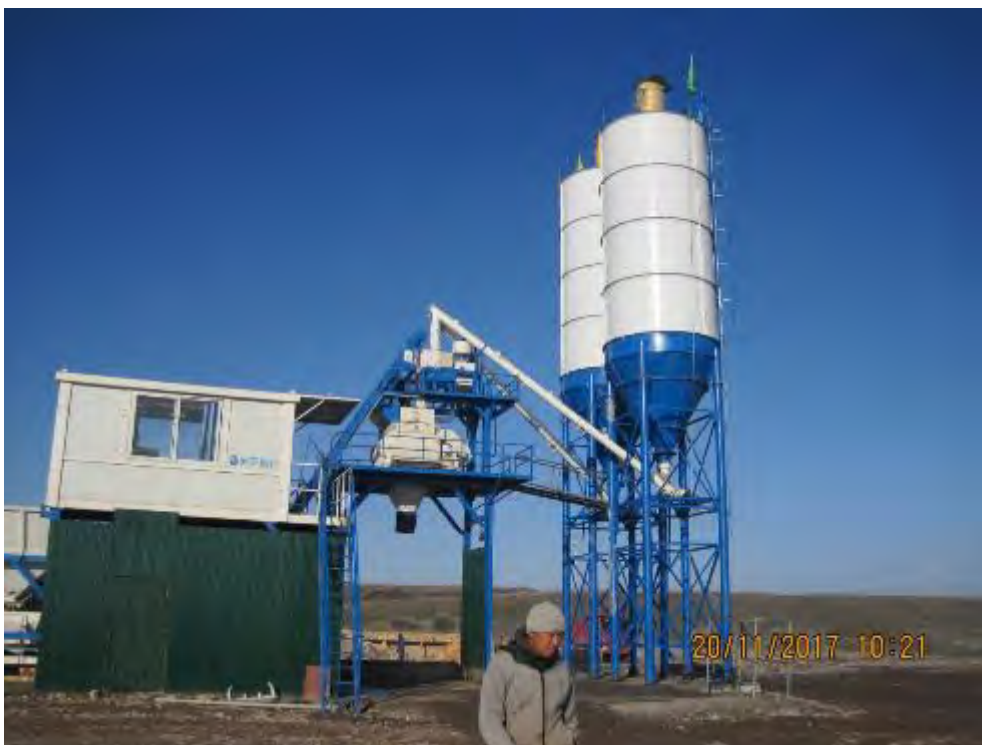
The construction of a concrete plant

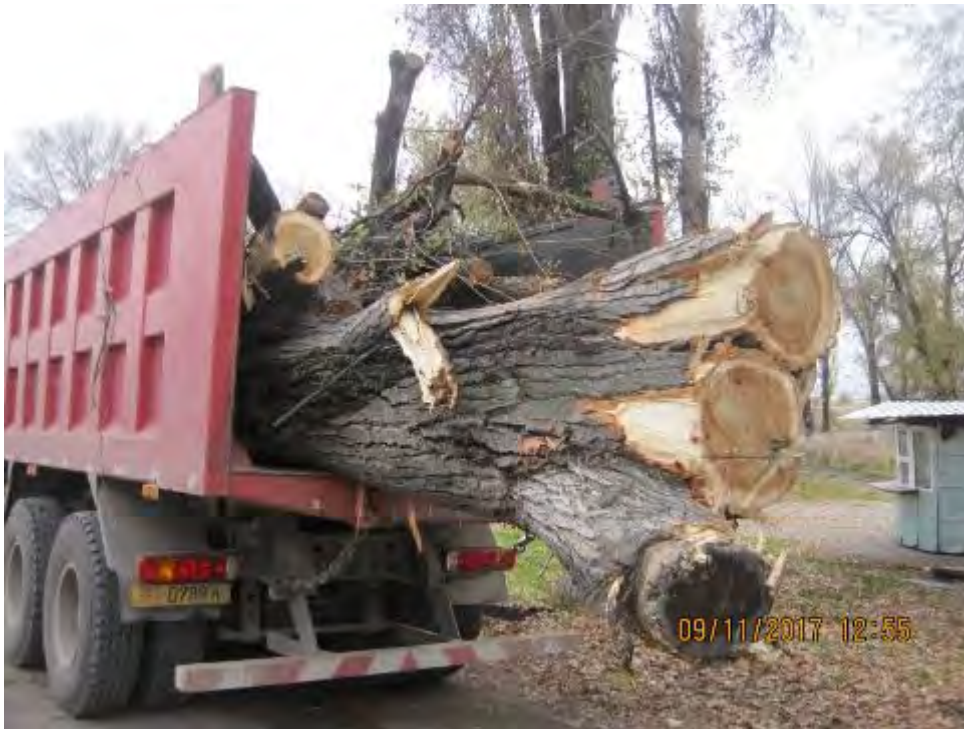
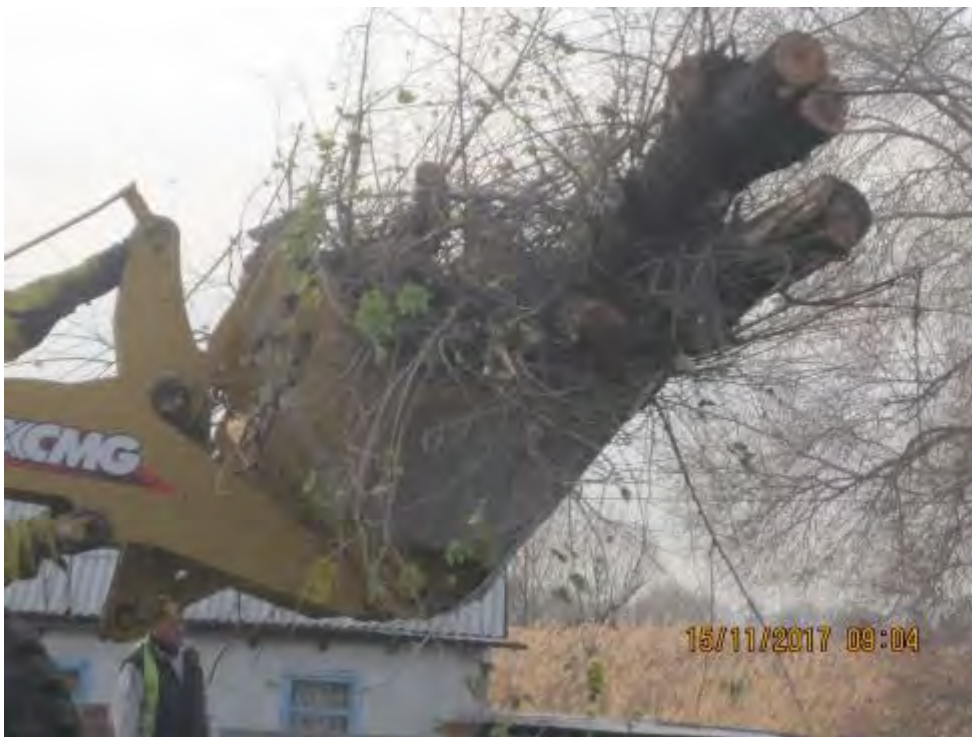
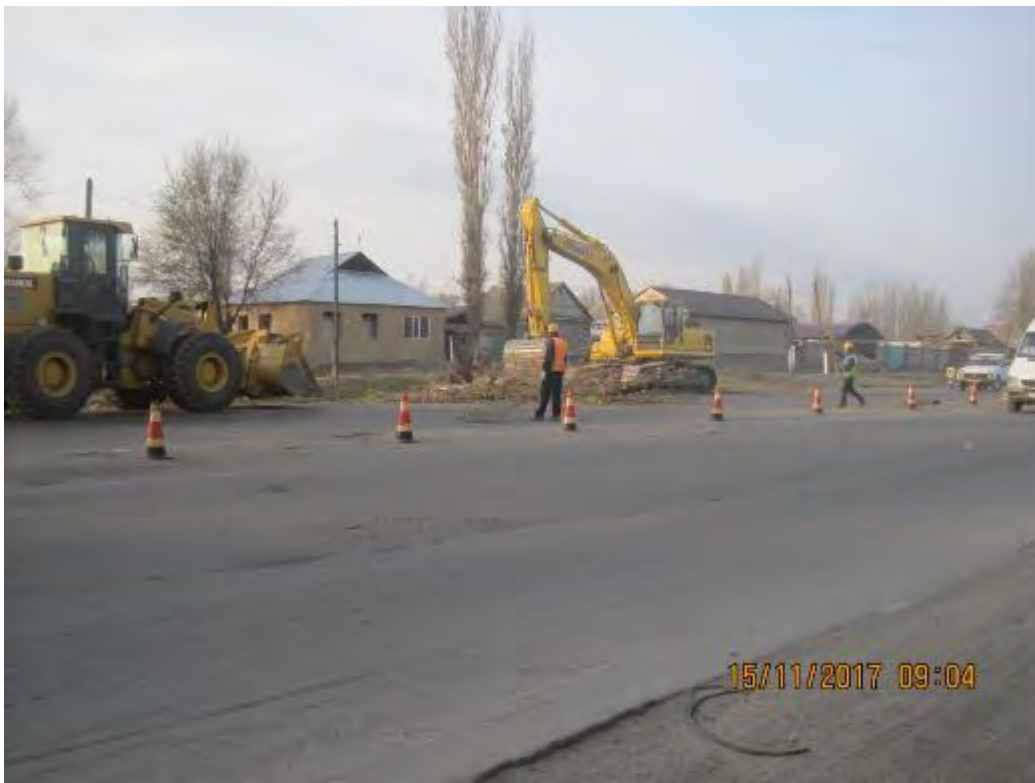
In November, work was carried out to cut trees on Section 1 of the PK 74 + 00 - 128 + 00 (15.9 - 21.3 km). The initial number of trees falling under the cutting was 762 pieces. After the sidewalk design was changed, a secondary survey was carried out, as a result of this 16 trees were preserved. As a result, the number of trees falling under the cutting in Section 1 is 746 pieces.

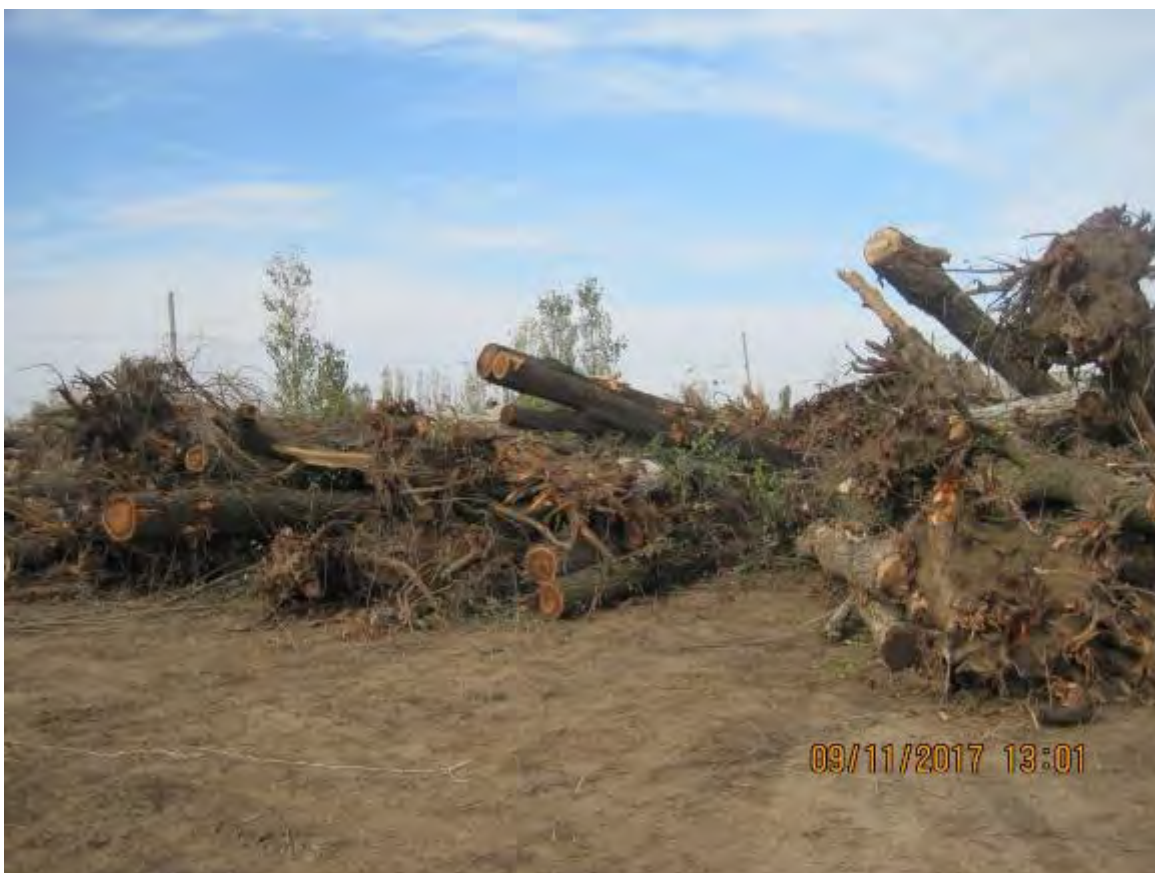
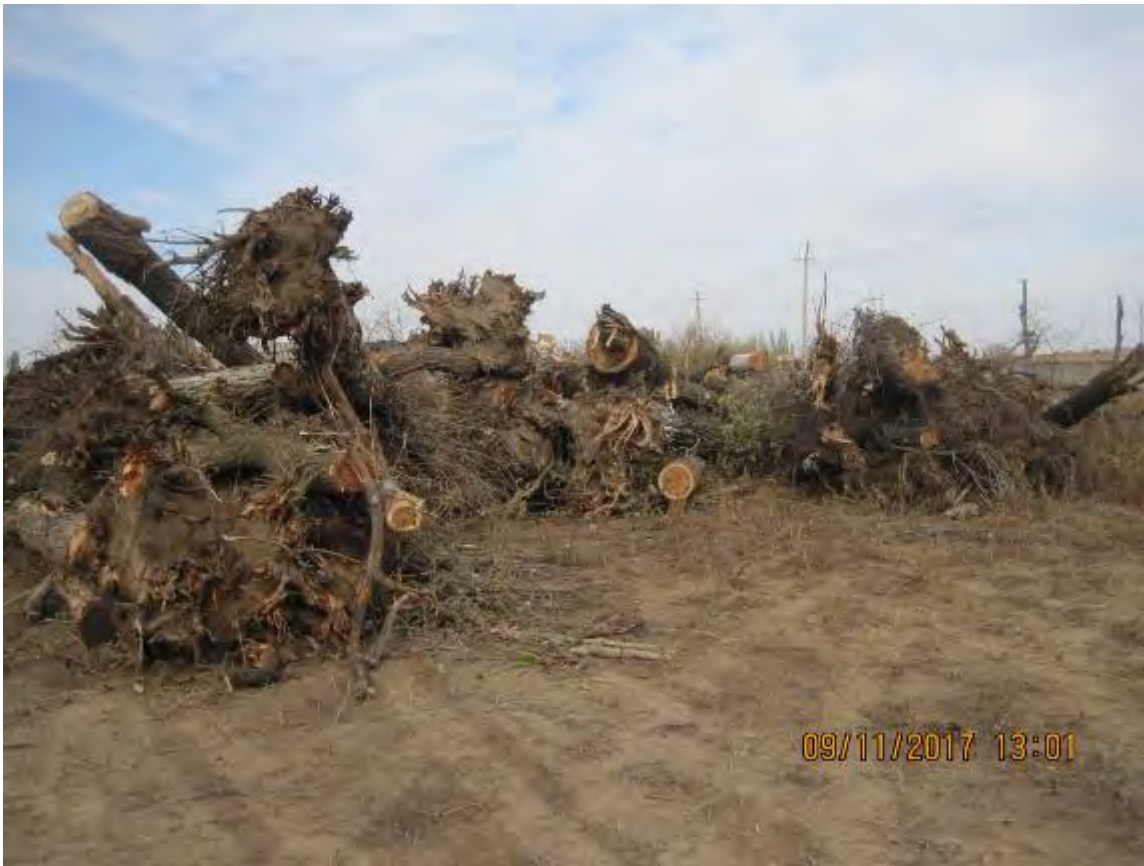
The branches and roots of trees are taken out immediately after cutting into specially designated areas by the local administration

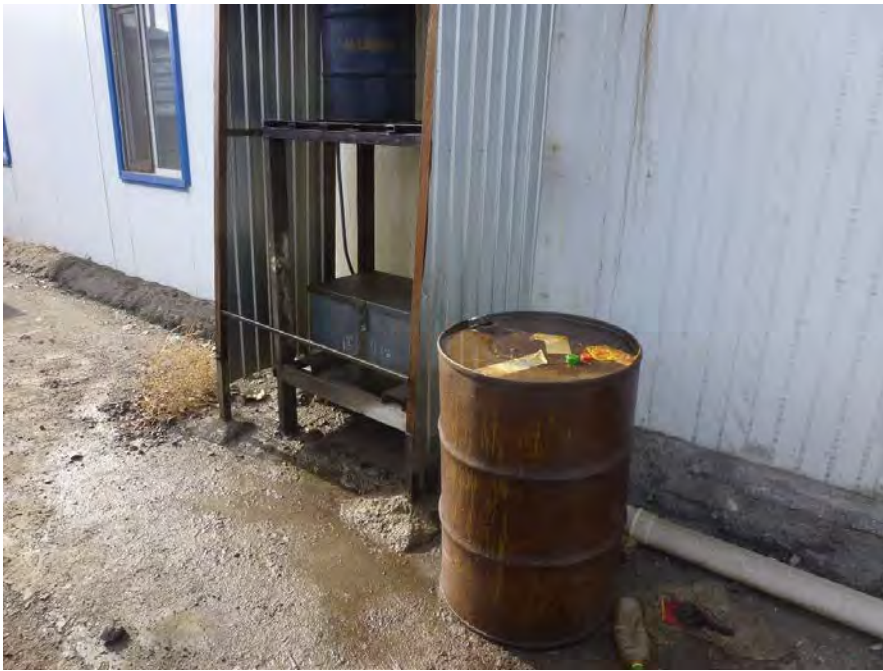
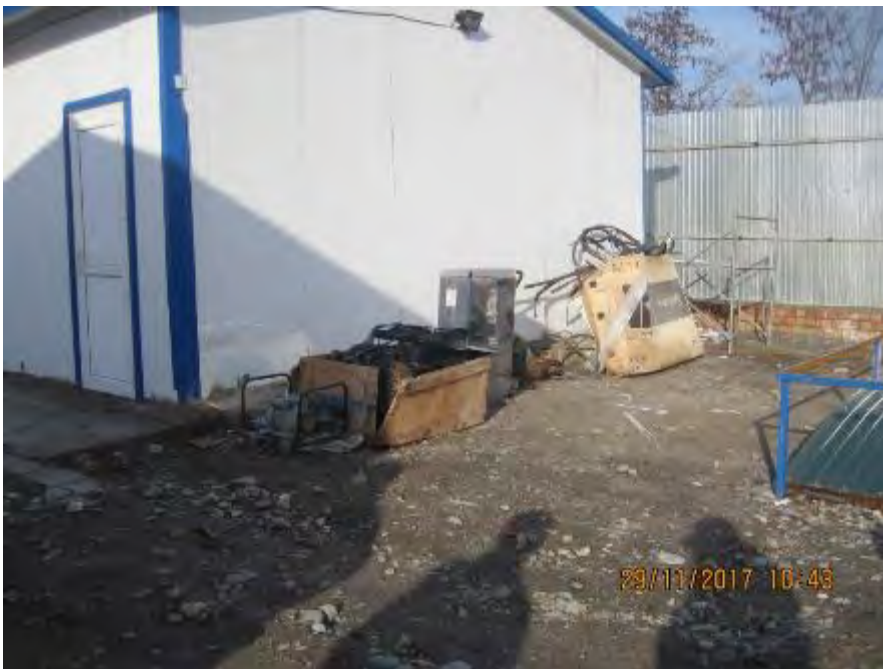
Barrels of oil and other wastes are not stored properly.

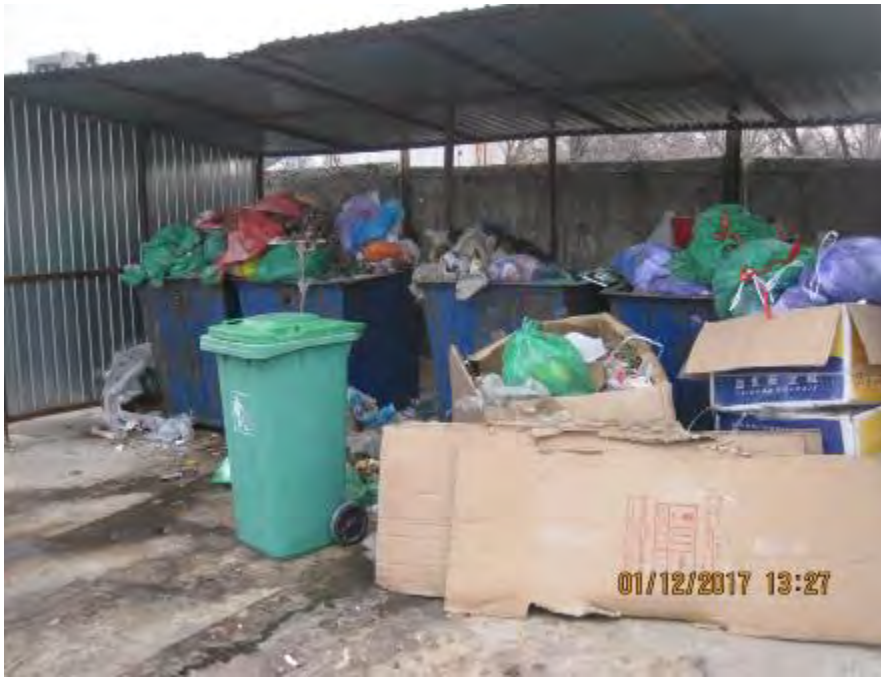
Household garbage is stored in containers, which are not disposed of in time. The reason is the lack of sufficient transport from the service company.
