Project Number: 45169-001  
Loan Number: ADB Loan 3056-KGZ (SF)  
Grant Number: 0366-KGZ (SF)

Semi-annual Environmental Report  
From July 1 to December 31 2018

CAREC Corridor 3 Improvement Project (Bishkek- Osh  
Road), Phase 4

**EPTISA Servicios De Ingeniería S.L. Eptisa Muhendislik and RAM Engineering**

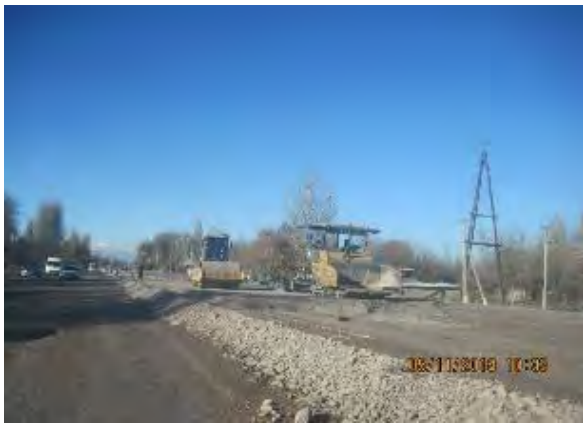
Figure 4 Roadbed compaction

- earthworks - laying, removal and taking out of excess unsuitable soil, rolling and tamping of road side slopes. According to the direction of ADB, works on soil compaction were carried out without vibration;
- works on pavement laying, laying of sub-base course, asphalt laying;
- arrangement of parapets and reinforced concrete chutes;
- construction of bridges and culverts

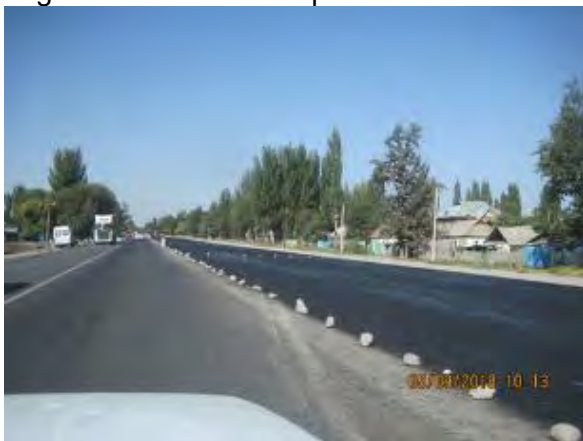
Figure 5 Laying of new asphalt

22. In July, production of asphalt at the asphalt plant and asphalt laying at sections 1-1 and 1-3 has been started. At these sections asphalt was laid, road was temporary marked and traffic was allowed.

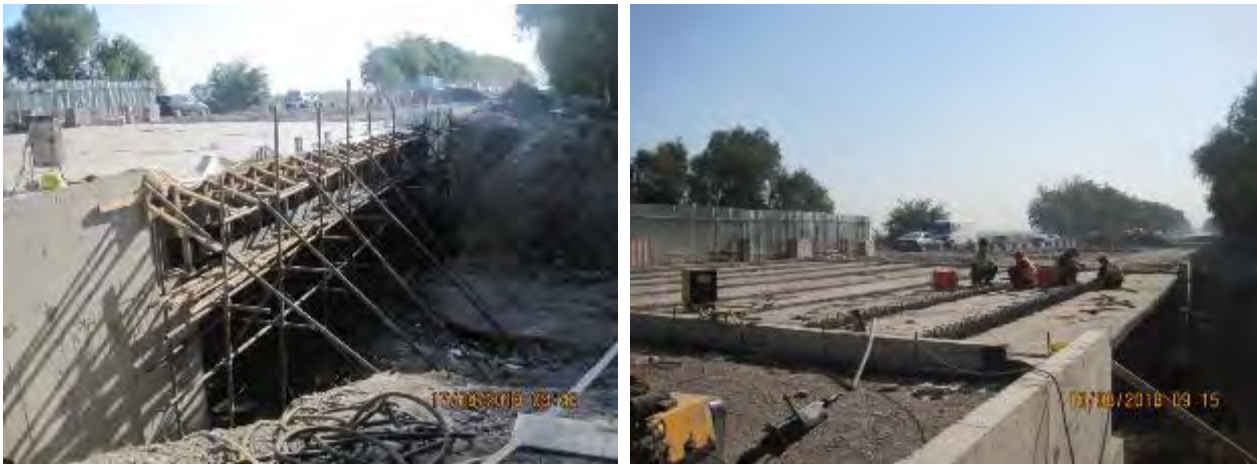
Figure 6 Construction of the bridge over Jelamysh river

23. During the construction of the bridge over Jelamysh river, bypass road was not built. The construction of the bridge did not affect the traffic. During the construction of the bridge, traffic is carried out on the main road. On the northern side of the bridge, construction was completed; the road is opened for traffic.

24. Construction of the bridge was carried out on the southern side of the road. In September, the construction of the bridge was completed. All construction waste, formed during the construction of the bridge, was removed.

25. There was no water in Jelamysh River during the construction period.

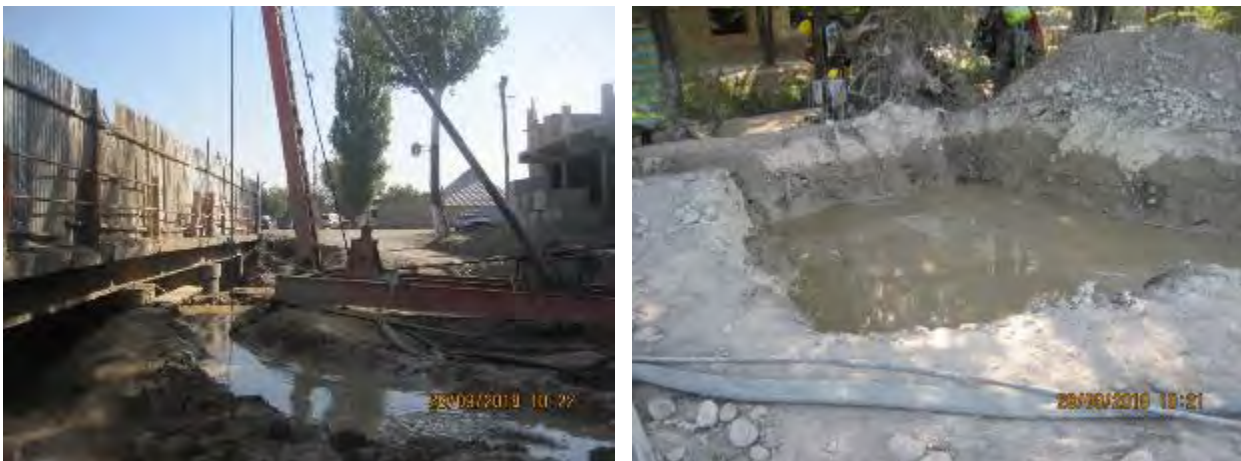
Figure 7 Construction of the bridge over Sokuluk River. Bentonite pit

26. During the construction of the bridge over Sokuluk river, bypass road was not built. The construction of the bridge did not affect the traffic. During the construction of the northern side of the bridge, traffic is carried out on the main road.

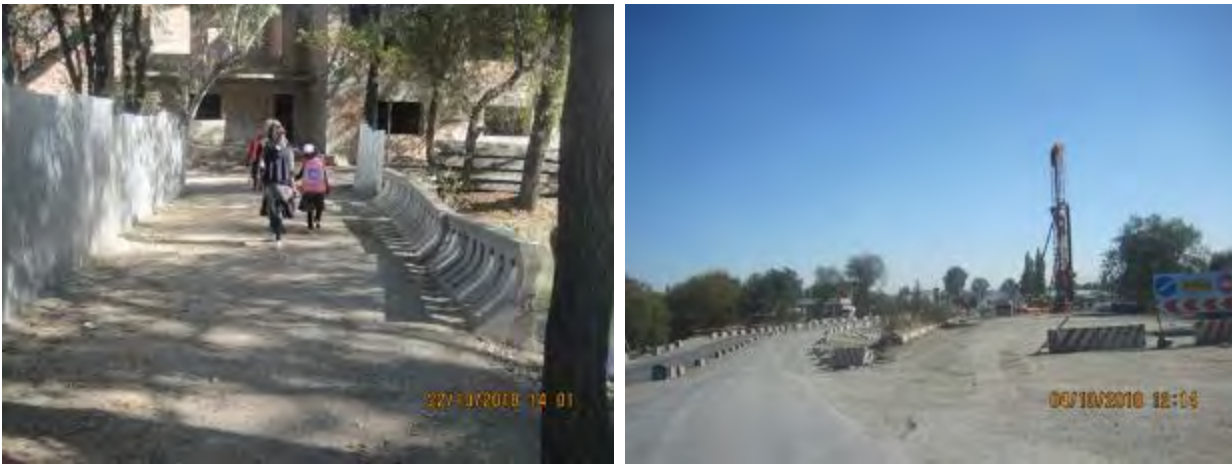
Figure 8 Pedestrian crossing over Sokuluk River. Road on the northern side of the bridge

27. In October, the construction of part of the bridge at the northern side of the road was completed. The northern part of the bridge is open for traffic. Works on construction of the southern part of the bridge is underway. Pedestrian crossing over the river is constructed at the southern side of the road.

- 28. On the photo: pedestrian crossing over Sokuluk river and road constructed on the northern side of the bridge, where traffic is carried out.
- 29. After the completion the construction of the northern side of the bridge, traffic was opened along it. Construction of the southern side of the bridge has begun. The bridge is constructed on bore hole piles. Bentonite is used as boring mud. The water solution with bentonite, remaining after use is taken into a special pit located in the river bed. It is necessary to remove the used clay from the riverbed after the completion of boring operations and after dewatering to take out from the construction site to place (pit) specially designated by local administration.

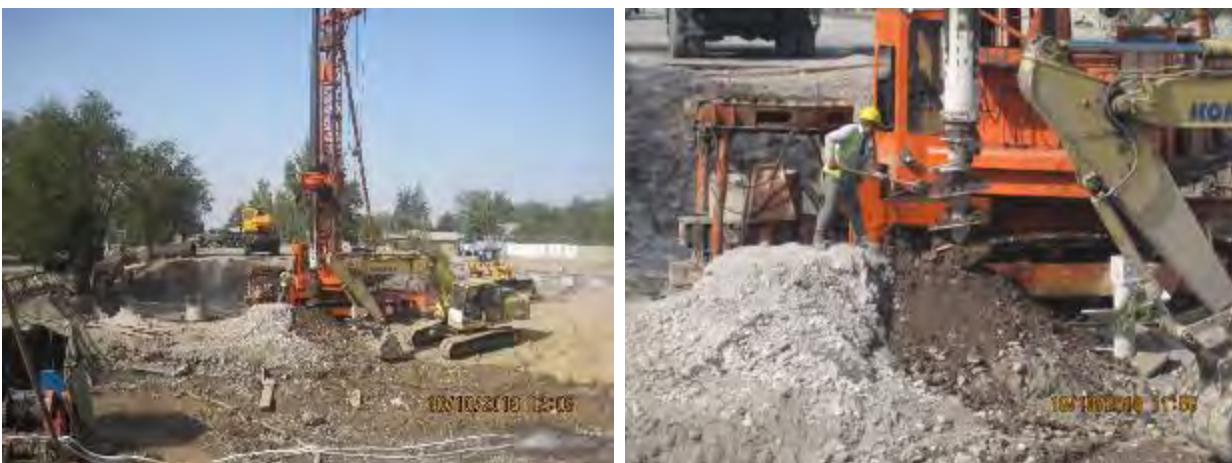
Figure 9 Construction of the bridge over Ak-Suu River on bore hole piles on the left bank

- 30. Subcontractor carries out the construction of the bridge at the left bank of the river. Method of construction - boring.

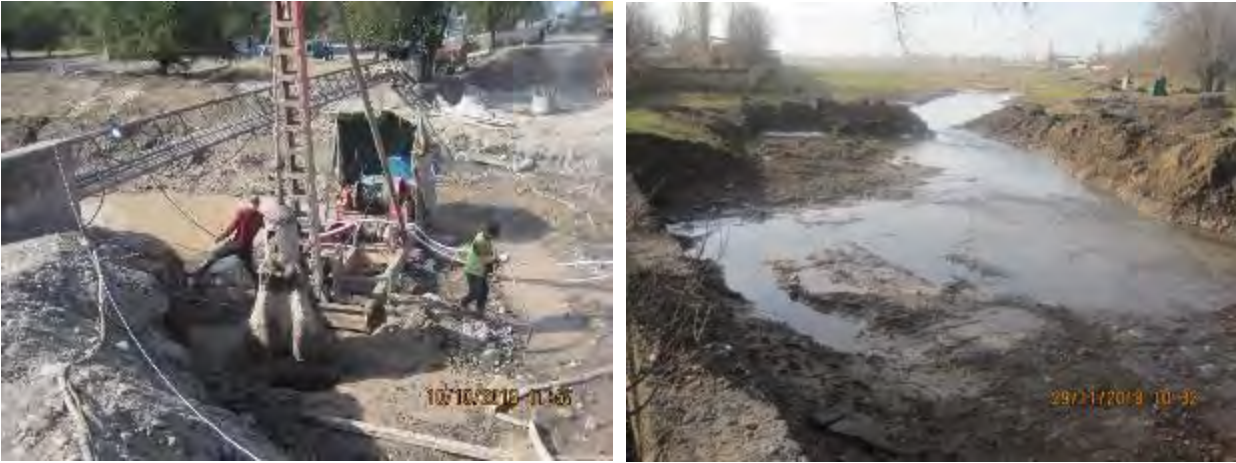
Figure 10 Construction of the bridge over Ak-Suu River on bore hole piles on the right bank

- 31. At the site, bypass road for traffic was constructed. Old bridge is dismantled. The Contractor carried out works at the right bank of the river. The bridge is constructed on bore hole piles. Bentonite is used as boring mud. The riverbed is blocked. Water diverted from the site where the construction works are underway. The bentonite pit is located directly in the river bed.

91. Currently, the river bed is blocked by an earthen dam. The water flow goes along the right bank and wash out the clay from the pit located in the riverbed with used clay, which causes river pollution. The Contractor was warned on need of urgent cleaning of the riverbed, but until now, the situation remains unchanged.

32. At the end of October, part of the Contractor's equipment was taken out, the clay pit waste in the riverbed cleared.

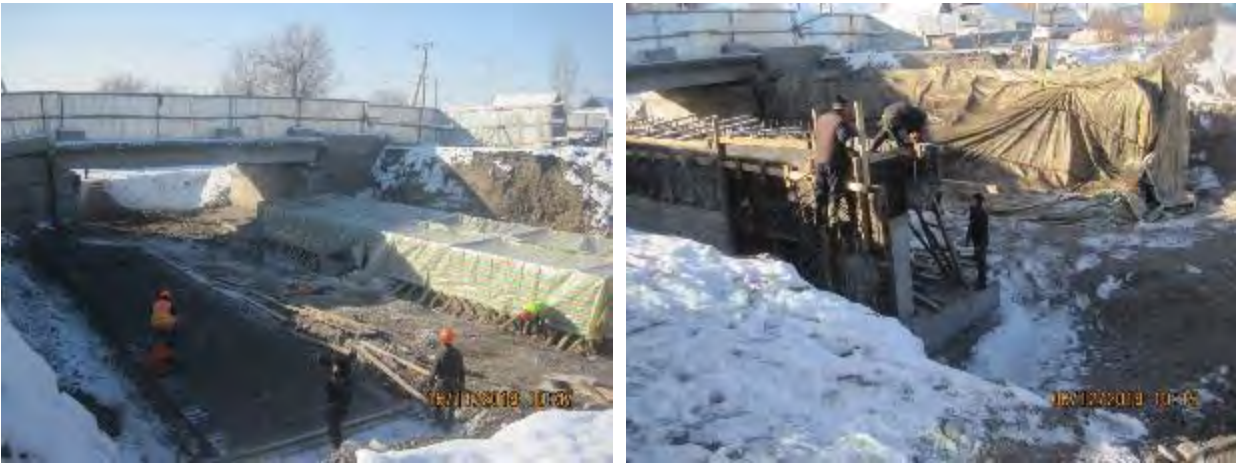
Figure 11 Construction of the bridge at KM 44+641

33. Construction of bridge at the south side of the road is finished. At this side of the bridge, traffic is open. Construction works are underway at the north side of the bridge. Currently, construction is suspended for the winter period.

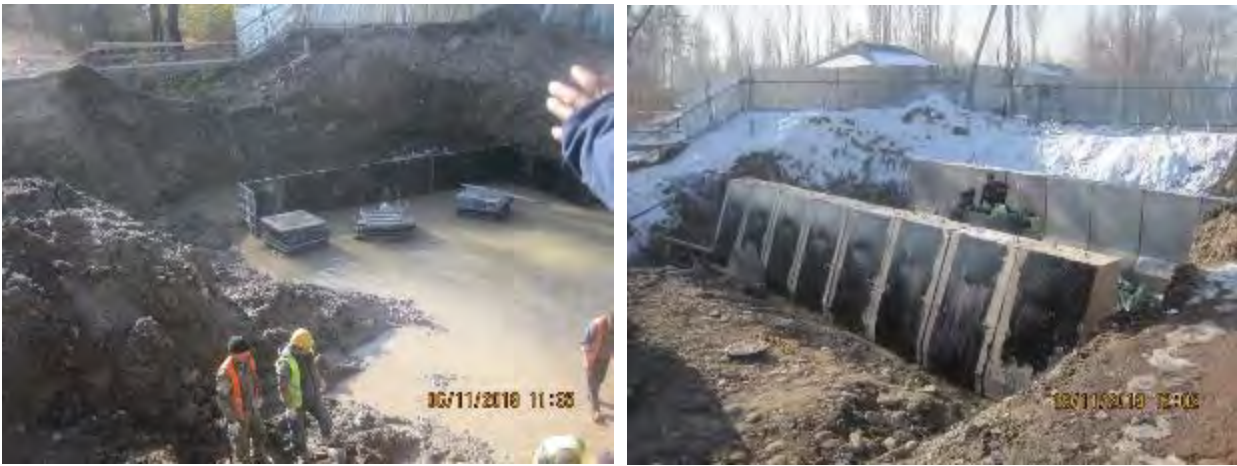
Figure 12 Construction of the bridge over Jantay canal

34. In October, construction of the bridge over Jantay canal was started. The bridge will be constructed in a rectangular tube, 6x2 meters in size.

35. The construction of the bridge was complicated by increased level of ground water.

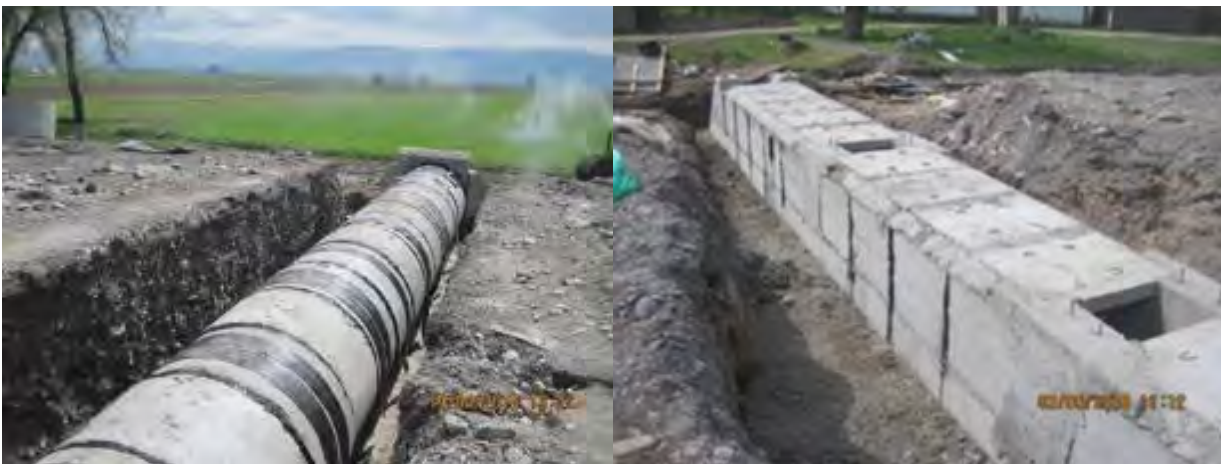
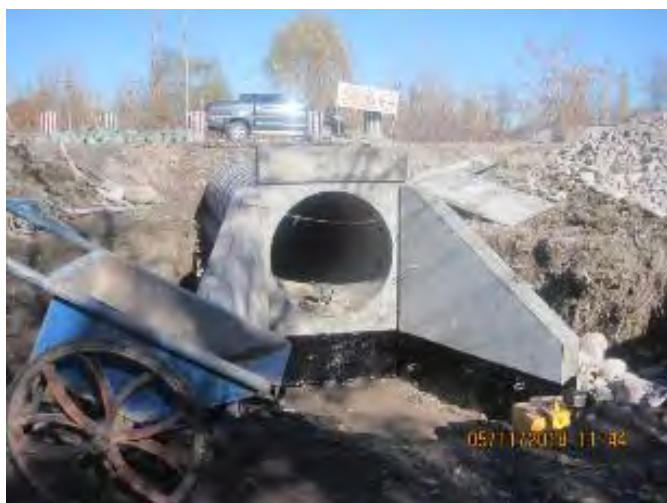
Figure 13 Construction of culverts

36. Works on dismantling of old and installation of new culverts were carried out at all road sections. Construction of culverts is finished at sections 1-1, 1-3. Construction works are underway in other road sections.

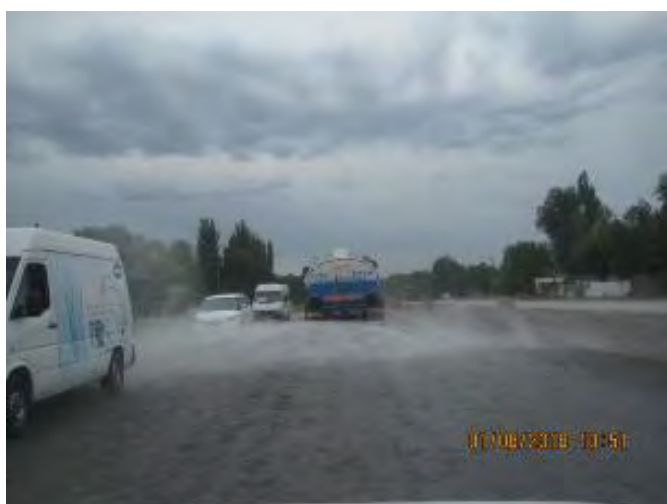
Figure 14 Water sprinkling at work sites

37. Watering machines were constantly presence at sites; water sprinkling of construction sites was regularly carried out.

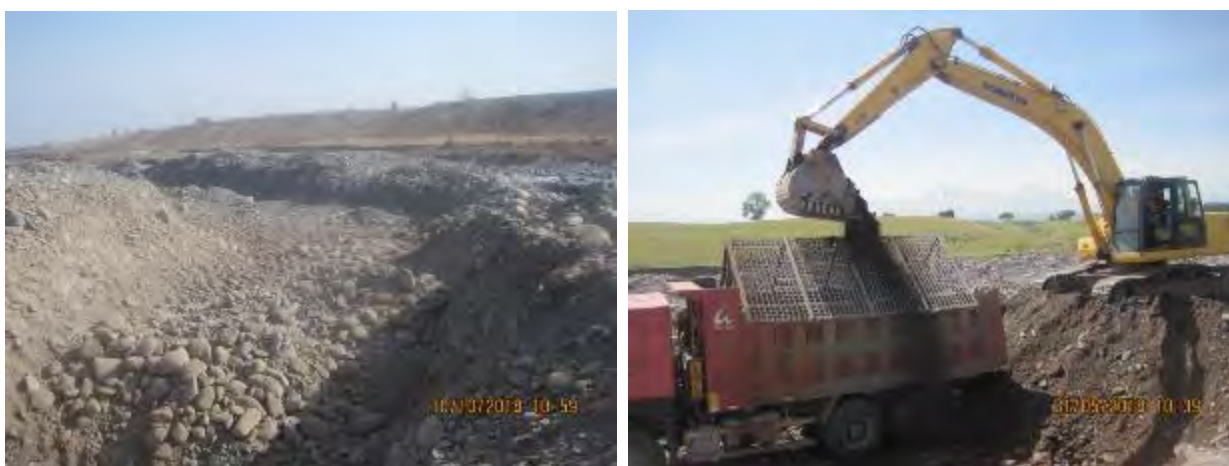
Figure 15 Development of Ak-Suu 2 borrow-pit

41. At section 1-4 works on leveling and preparation of new sites for production of sand and gravel mix were performed, also as necessary, the shipment of raw materials for the work of crushing plant and for stockpiling, was carried out. In November, the development of the borrow-pit at the right side of Ak-Suu River has been started.

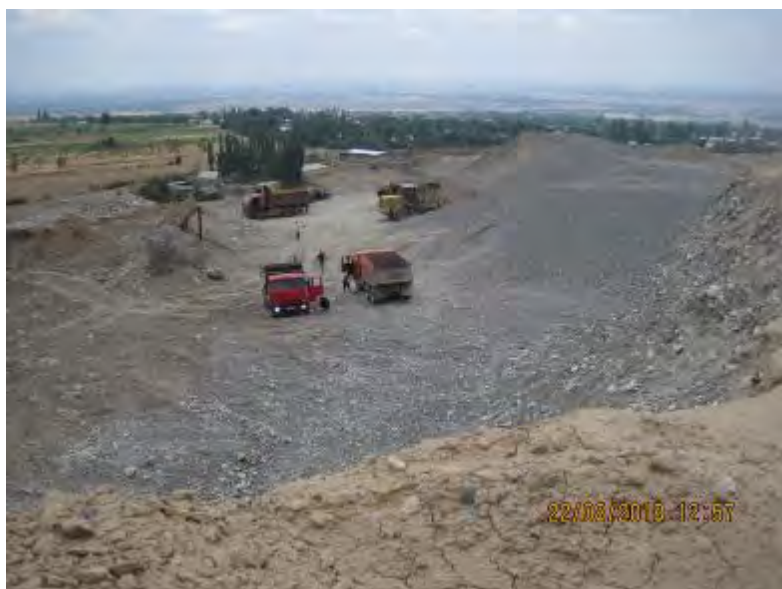
Figure 16 Development of Jelamysh borrow-pit

42. From July to November, works on excavating, sifting and taking out of material from the spoil areas were carried out.

43. In November due to the completion of works on development of Jelamysh borrow-pit, a letter was sent to the Contractor, stating that the Contractor should draw-up a reclamation design for disturbed lands of the borrow-pit. After receiving all necessary approvals, it is necessary to perform reclamation works at borrow-pit, according to the design.

98. During the reporting period no violations in works on development of borrow-pit were revealed. Currently, the works in the borrow-pit are completed. In 2019, it is necessary to carry out reclamation of the borrow-pit.

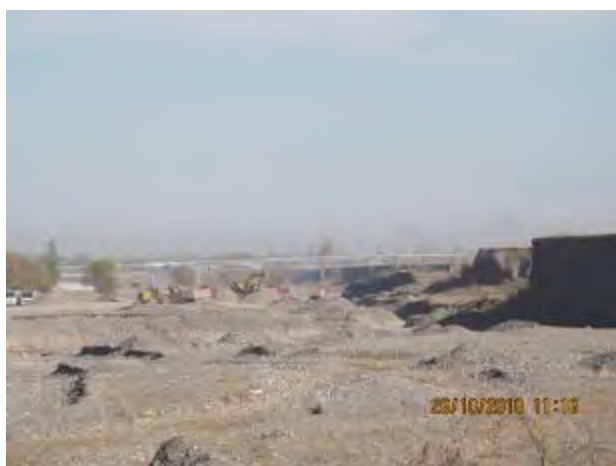
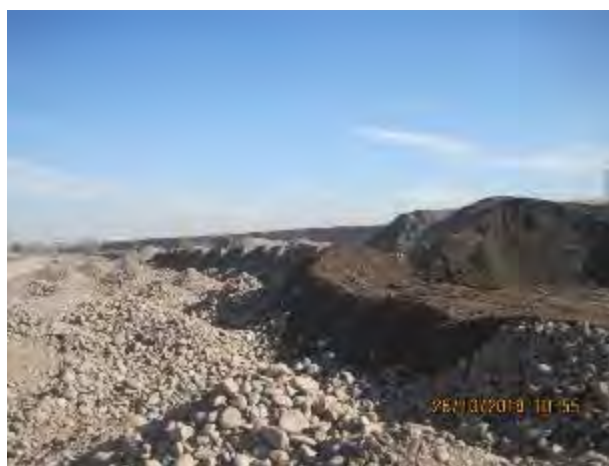
Figure 17 Development of Kara-Balta borrow-pit

44. The development of Kara-Balta borrow-pit has been started in September. Works on excavation, sifting and stockpiling of material were carried out in spoil areas. The works were suspended in the end of November.

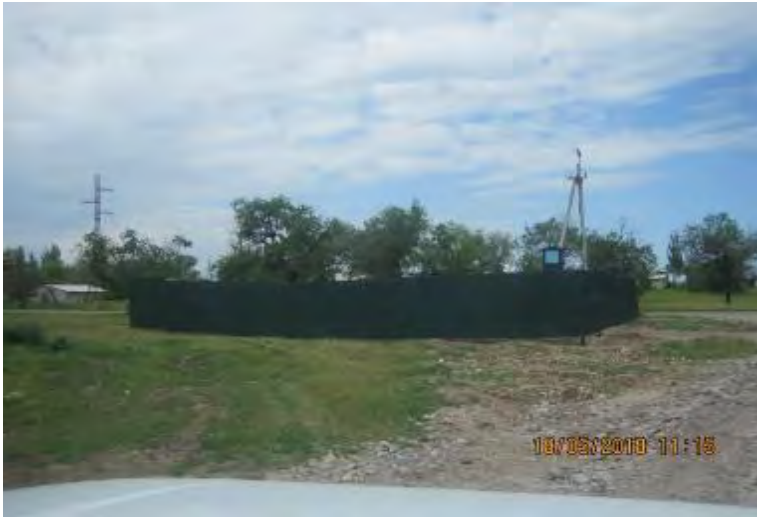
Figure 25 Restored well for water supply to the plant

59. In the territory of the plant water is supplied from an existing well based on the Contract No. 38 dd October 10, 2017 “On the provision of a well for temporary use”. The well was restored by the Contractor and pipeline was laid to the plant in order to provide water to the plant. Currently, there are no problems with water at the plant. On the photo: the fenced area of the well.

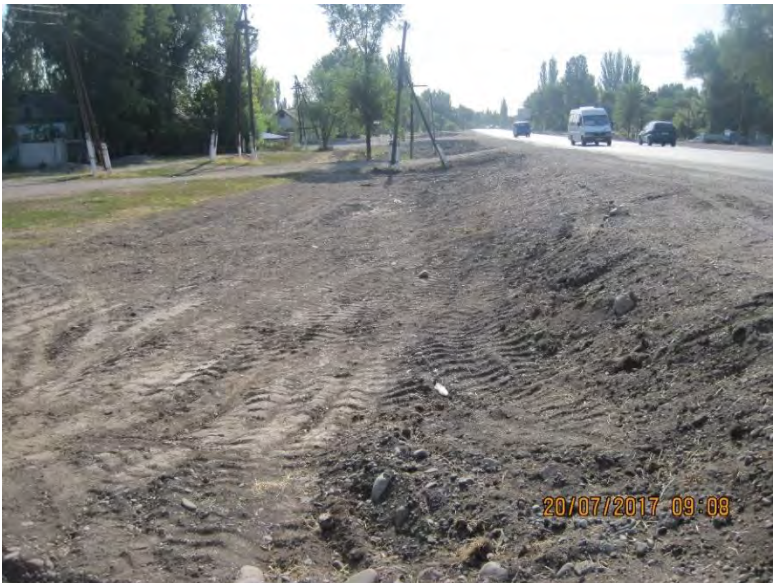
Figure 26 Road section with the removed topsoil

61. Obtaining permission to remove topsoil in the construction corridor from the environmental authorities is not required. The contractor has obtained permission from local authorities to store topsoil in several sections. Embankments of topsoil are kept at a height not exceeding 1.5 m and maximally protected from the impact of elements, mainly, from a wind during the dry construction season. International Environmental specialist of EPTISA instructed the Contractor to plant embankment of topsoil with a seed of natural grasses to reduce erosion. But given the long dry period in the road construction area, this is not possible to carry out. Currently, topsoil is removed on an area of 15 hectares. The total volume of removed soil is 30 000 m<sup>3</sup>.

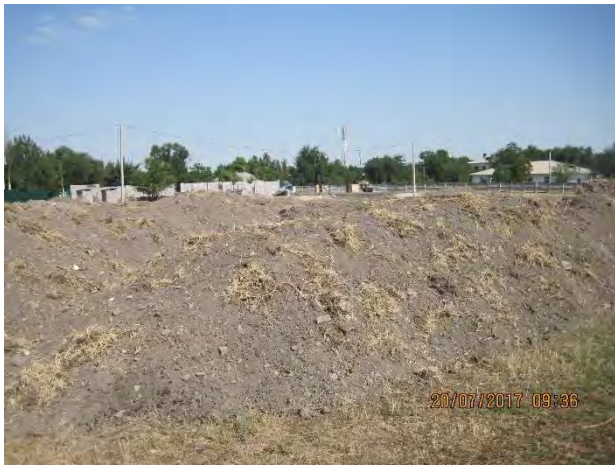
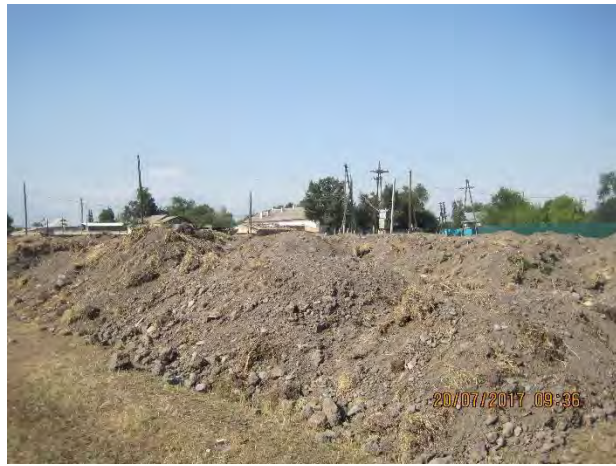
Figure 27 The stored topsoil

60. Topsoil is removed and stored in special areas allocated by the local administration. After completion of the construction work, it can be used for backfilling slopes. (Figure 27).

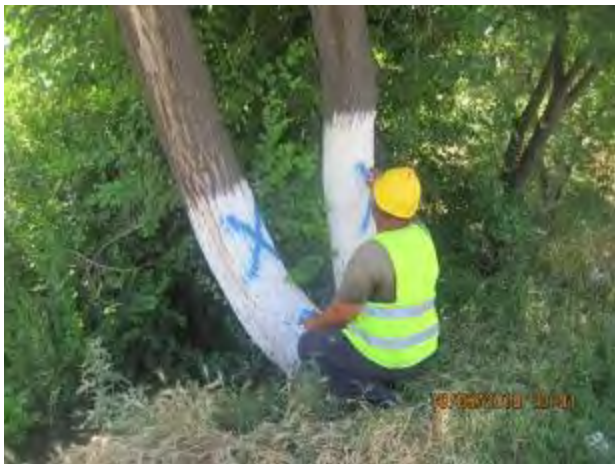
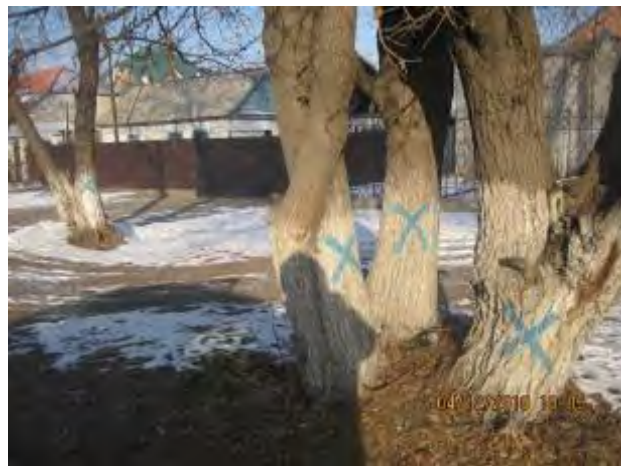
Figure 28 Marking of trees for cutting down

62. At sections 2-1, 2-3 and 2-4 trees were marked, all documentation was prepared, Tree Planting Plans were drawn up and agreed by ADB. Permission for tree cutting was obtained. In September, at sections 2-3 and 2-4 trees were cut down completely. Stems of the cut down trees were stored in specially designated areas. For section 2-1 permission for cutting was obtained in December, after that trees were cut down.

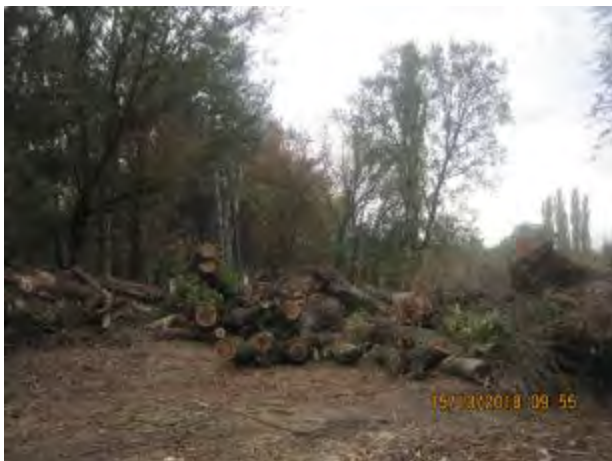
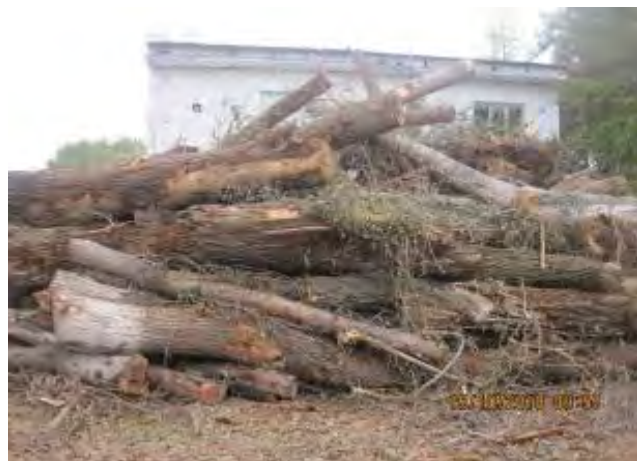
Figure 29 The stored stems of cut down trees

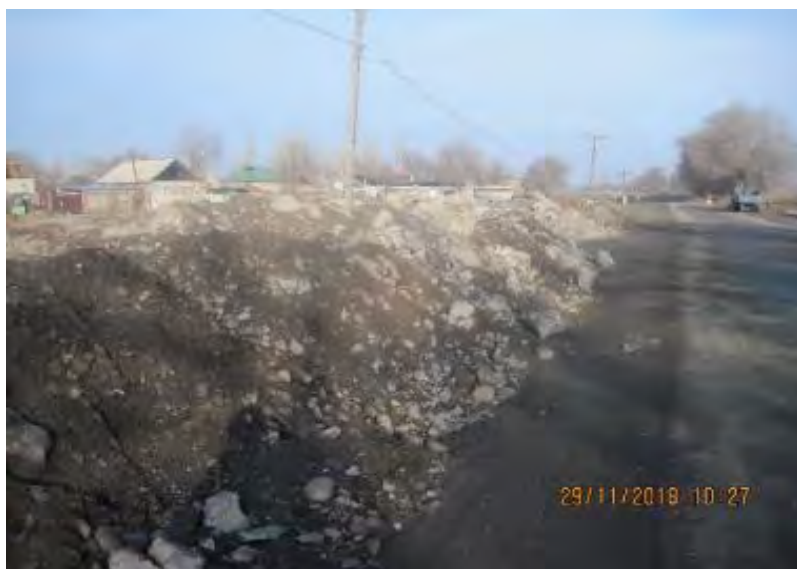
92. A large amount of construction waste is stockpiled at the northern side of the bridge under construction. A letter was sent to the Contractor on the need to take out the formed concrete waste to the designated places.

Figure 35 Construction waste at the northern side of the bridge under construction

93. The Contractor replied that the soil stockpiled at the northern side of the bridge would be almost entirely used for filling of the voids formed during the construction of the main bridge support structure. After completion of works on filling and compacting of the voids, the remaining soil and old concrete waste will be removed and disposed. Completion of construction of this bridge is planned for the construction season in 2019.

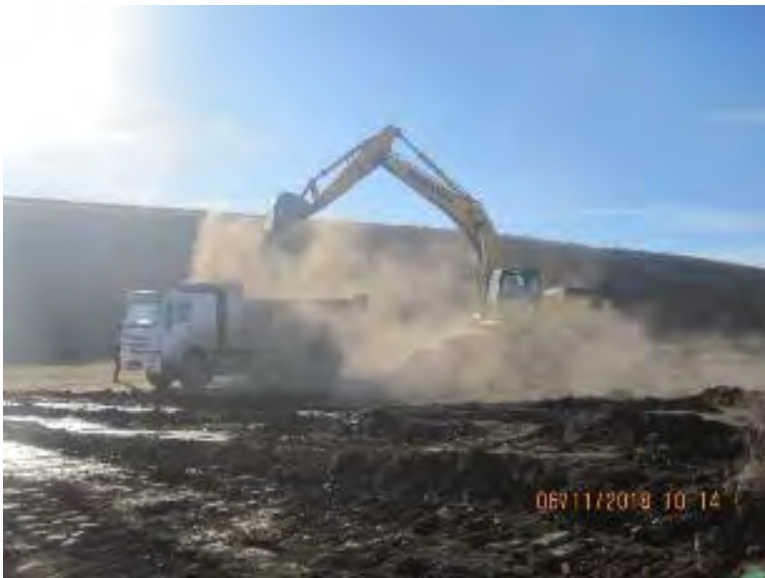
97. It is also identified, that the water sprinkling is not constantly carried out during the execution of works in borrow-pit, what leads to dust formation. In March and April 2019, the Consultant will hold additional discussions on the issue of dust suppression measures, in order to improve the situation, and also raise the issue of increasing the number of water transport vehicles.

Figure 38 Dust formation during carrying out of works at the borrow-pit

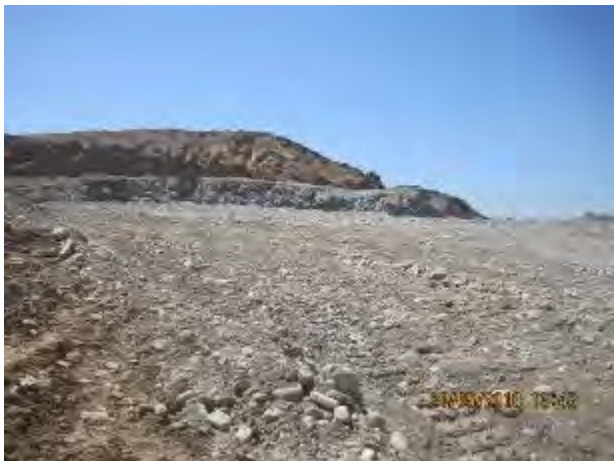
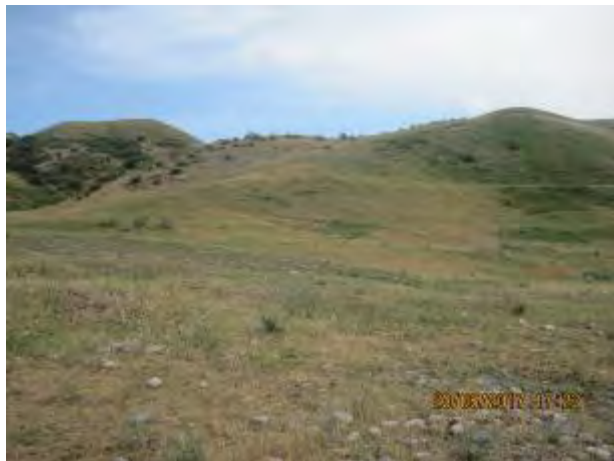
Figure 39 Jelamysh borrow-pit before development

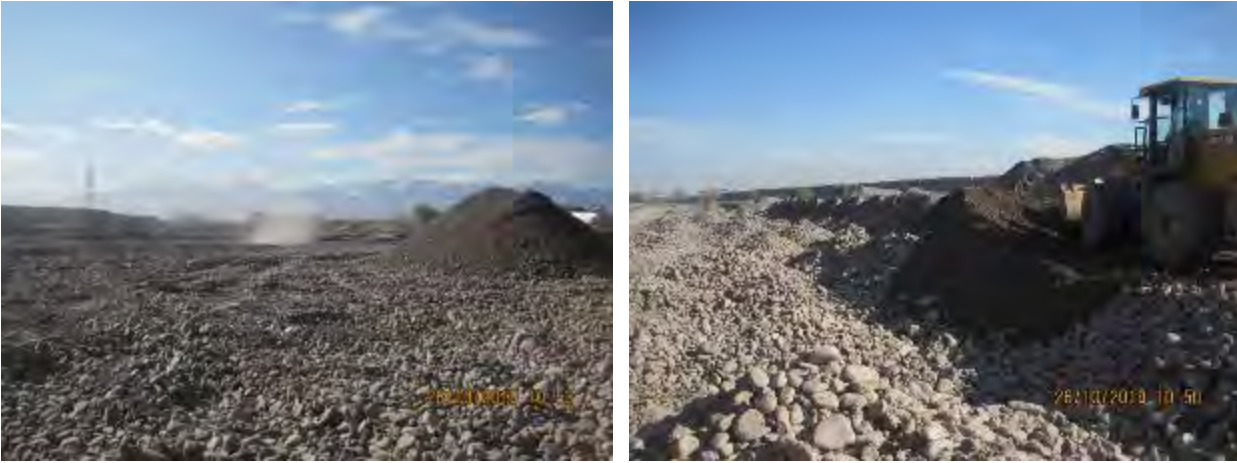
99. Development of Kara-Balta borrow-pit has been started in September. Works on excavating, sifting and stockpiling of material in the spoil areas were carried out.

Figure 40 Development of Kara-Balta borrow-pit

100. In the end of November, the works were suspended. The materials from the borrow-pit were transported along the asphalt road passing next to the administrative buildings of the refinery. Given the condition of the road, there is a high probability of asphalt damage. In this regard, in 2019 it is necessary to find new ways of transporting material from the borrow-pit.

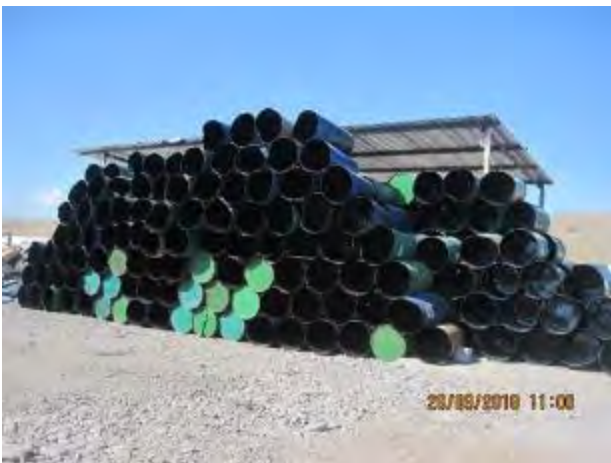
Figure 43 Empty barrels from used bitumen

102. At the end of September all bitumen located at the asphalt plant was used up. All leakages were collected and stacked in barrels. A concrete platform for bitumen storage has been prepared. Empty barrels of bitumen are stored in the asphalt plant and are used as road barriers

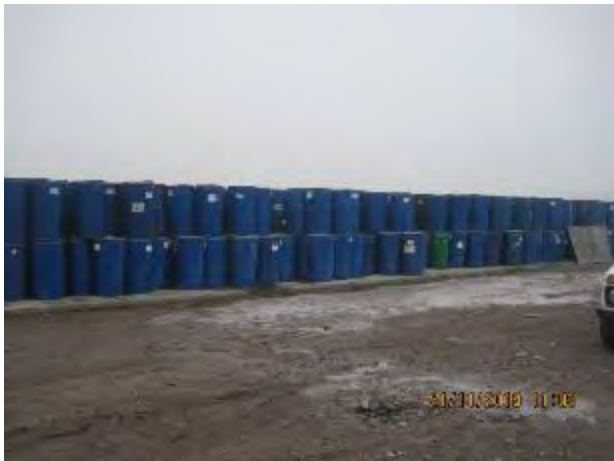
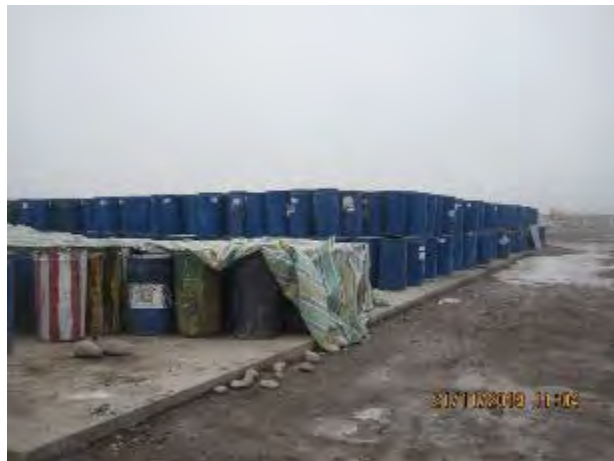
103. For production of asphalt, bitumen pits were rented and bitumen carriers deliver bitumen to the territory of the plant. In November, bitumen was delivered to the territory of asphalt plant on metal barrels, and was stored in prepared platform.

Figure 44 Bitumen in metal barrels stored in the prepared platform

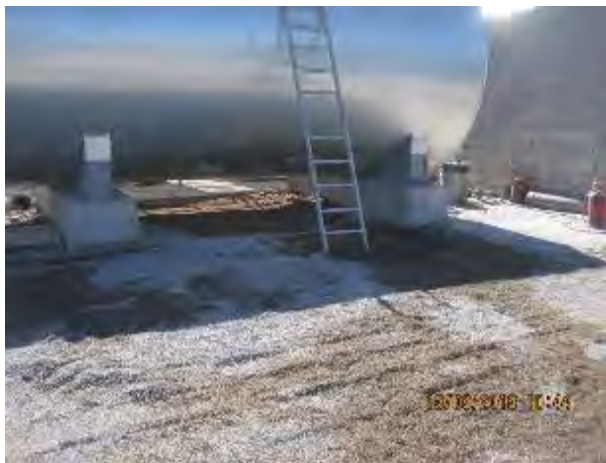
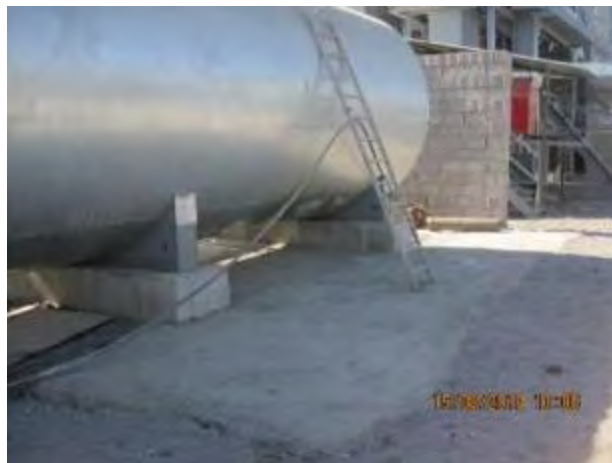
104. During the operation of the plant, all soil around the tanks with chemicals must be protected from leaks and spills of hazardous materials with an impermeable protective coating.

Figure 45 Impermeable protective coating around the tanks with chemicals

105. The Contractor was recommended to protect the soil around the tanks with chemicals from leaks and spills of hazardous materials with an impermeable protective coating. These recommendations were considered and performed by the Contractor.

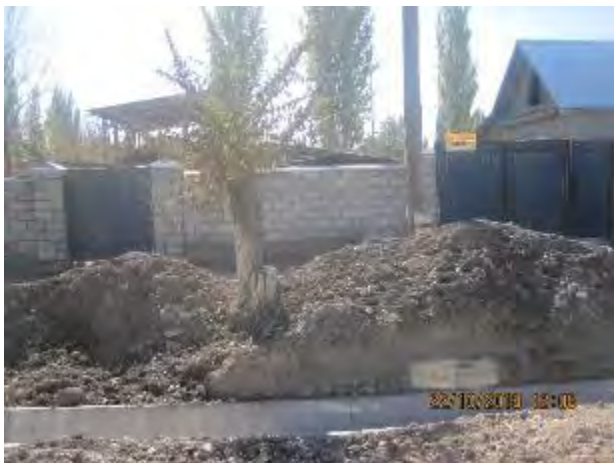
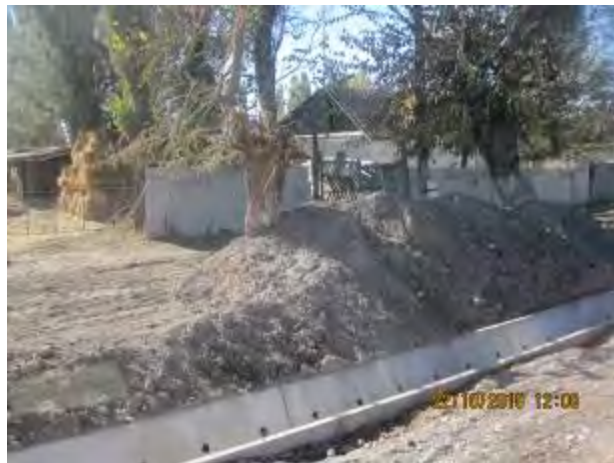
108. At section 1-3, starting from KM 51, during the installation of reinforced concrete chutes, tree stems were covered with excess soil. The Contractor promised to remove unsuitable soil and clear tree stems. In due time the soil was removed.

Figure 47 Stems of trees during installation of concrete culvert chutes before and after clearing of stems from the soil

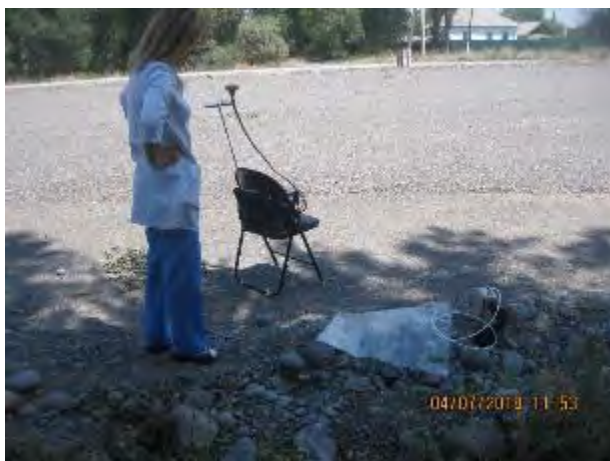
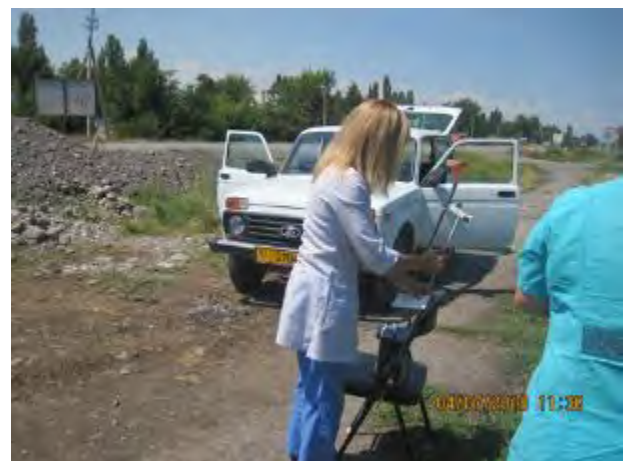
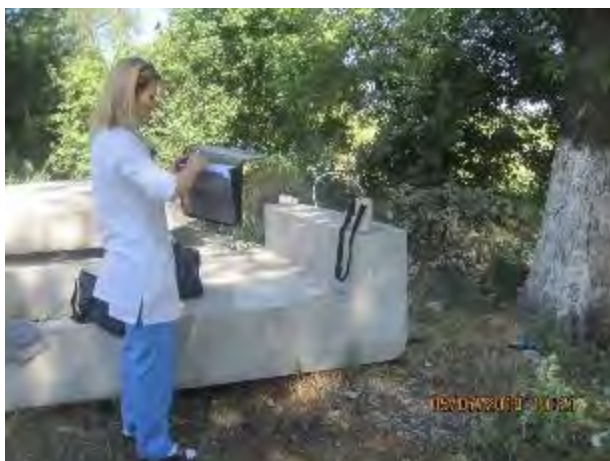
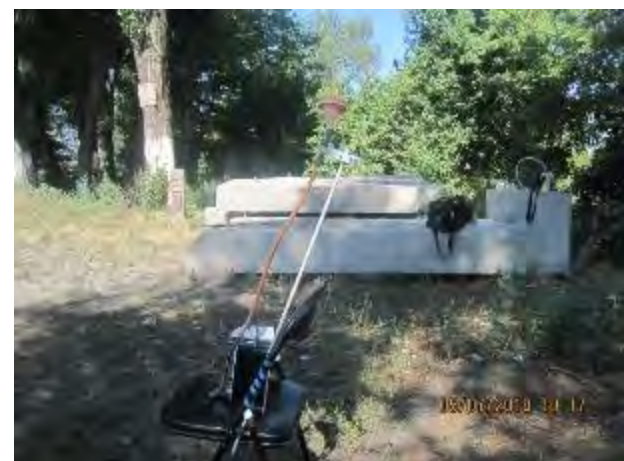
Figure 49 Air quality monitoring

116. According to the results of the air quality monitoring, dust content was exceeded in almost all samples.
117. The Contractor was informed that more effective measures should be taken to control dust generation.
118. It should be noted, that the excess dust content in the air was also noted in 2013 -2017 before the start of road construction works, in this regard, it could not be argued that the reason for this excess is only construction work.

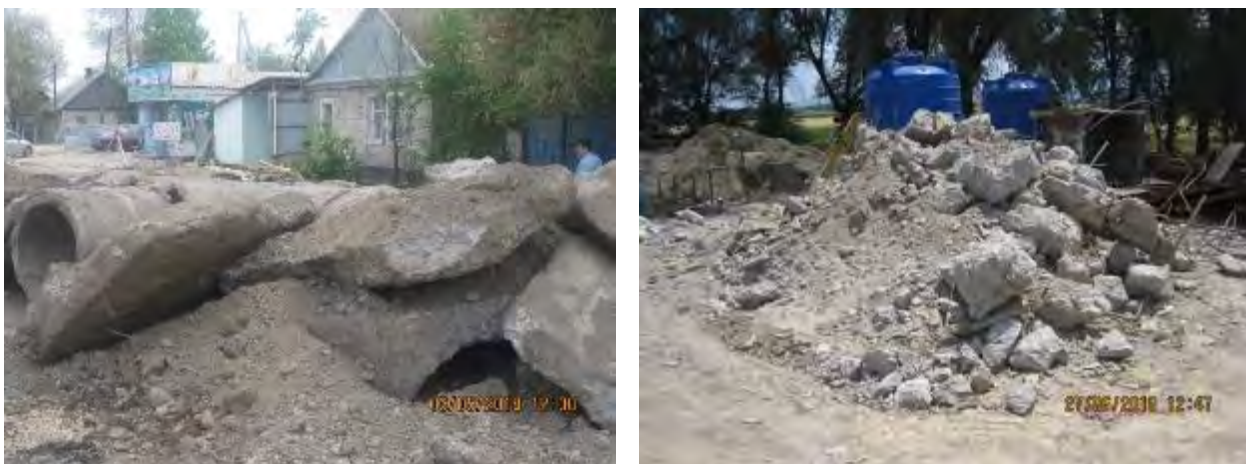
138. Construction reinforced-concrete waste is generated during the dismantling of bridges and culverts. Since the beginning of construction work in 2017, almost 3,000.0 m<sup>3</sup> of reinforced concrete waste has been generated.

Figure 60 Construction reinforced concrete waste

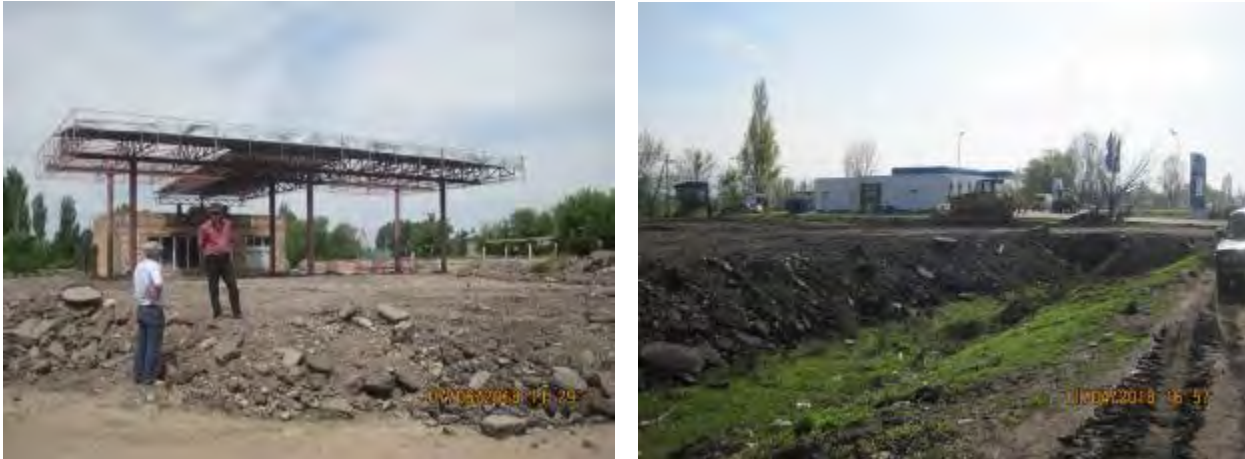
140. With the beginning of the road works in areas 1-1 and 1-3, there was a problem with the disposal of old asphalt. The problem of crushing the old asphalt remains unresolved on the Contractor's side the demands of crushing the old asphalt to pieces of size 20x20 are not

met. This issue is constantly discussed with the contractor. When sprinkling old asphalt onto rural roads, the contractor re-supplies the equipment to the backfill site and conducts the rolling and crushing of large pieces in place, which leads to incomplete crushing of large pieces of old asphalt. At the request of local residents (landlords), the old asphalt is partially removed to fill the existing holes in their private land. These sites are usually located along the road and are used for commercial purposes (construction of shops, gas stations, etc.). In this case, the site owners leveled the asphalt on their own. A letter has been received from ADB stating that in order to avoid harming the health of local residents; it is prohibited to transfer old asphalt to local residents for their own use. This requirement has been met and will be monitored in the current construction season. Asphalt was not removed to the wetlands.

Figure 61 Taking out of old asphalt for backfilling of private areas at the request of the residents

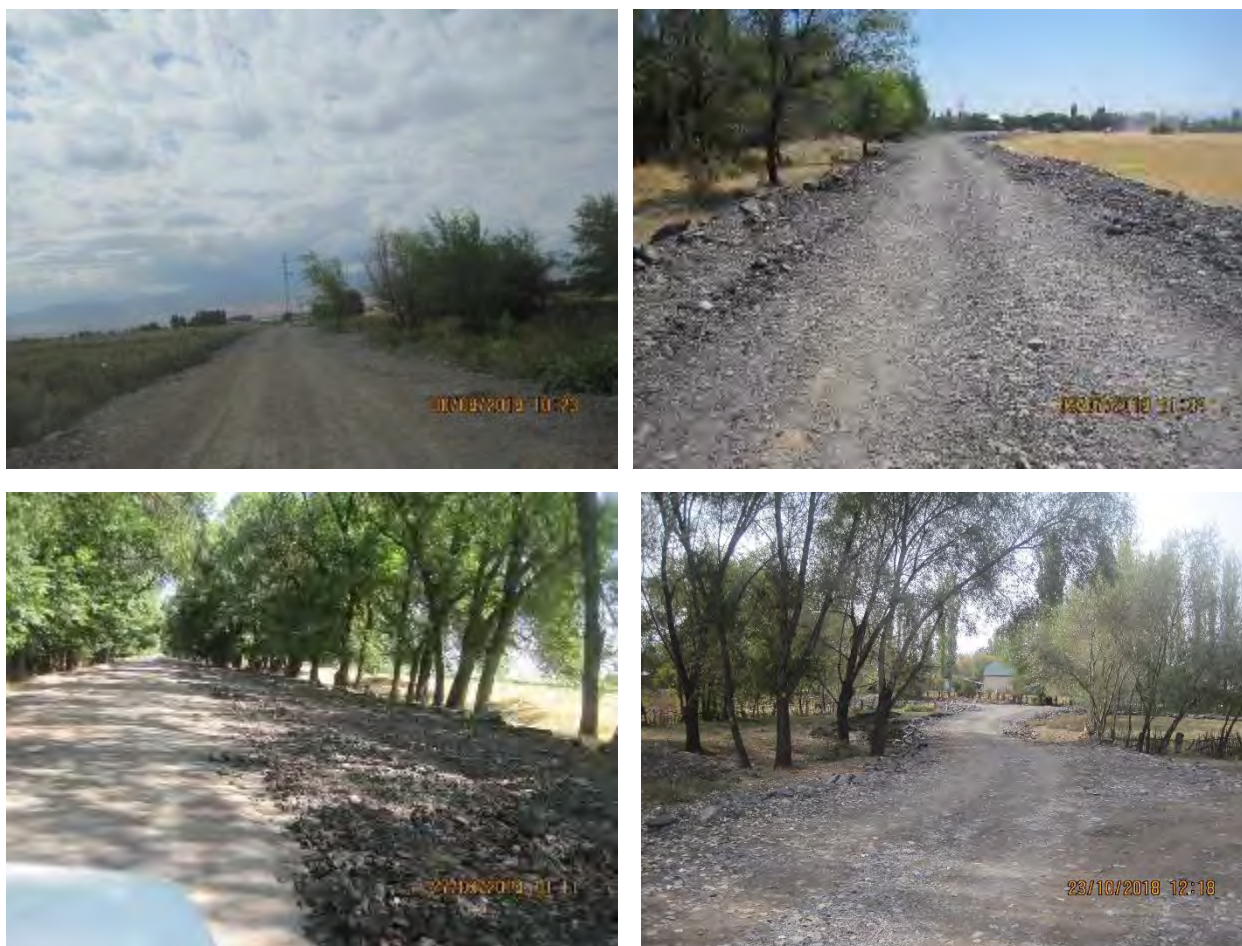
- Section 4-1 - 6010 m<sup>3</sup>.
- 144. The Contractor’s specialist, Mirbek Abirchoroyev, deals with the disposal of old asphalt.
- 145. The problem of old asphalt crushing remains unresolved. Currently, the old asphalt is taking out for backfilling of village streets. As in villages, there is no equipment for leveling of large pieces of old asphalt, the Contractor leveling asphalt by his own equipment. On the contractor’s side, the requirements for crushing old asphalt to small sizes are not complied with in accordance with the technical specifications of the contract. This issue will be further discussed with the contractor at the beginning of the next construction season.

Figure 62 Taking out of old asphalt for backfilling of rural streets

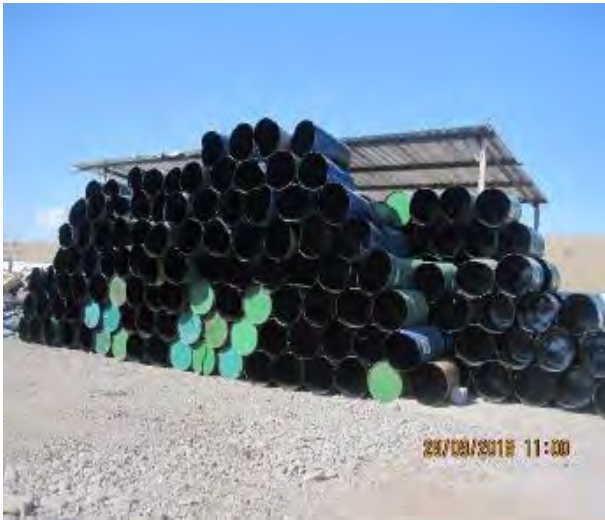
149. Empty barrels from used bitumen are also stored at the asphalt plant and are gradually used during the execution of construction works on the road.

Figure 64 Empty barrels from the used bitumen

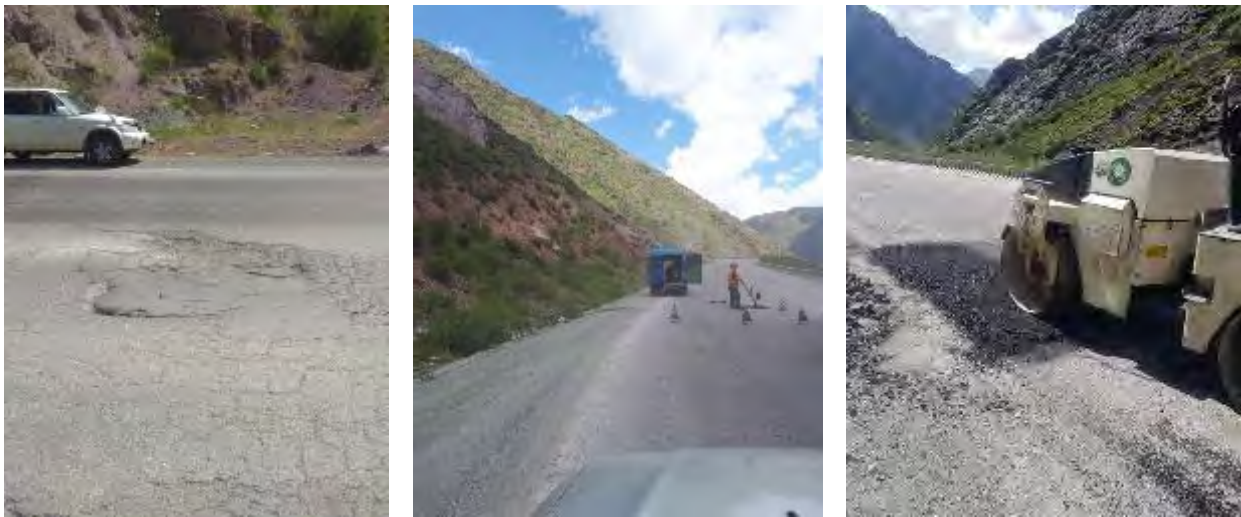
Figure 2 Current repair of the roadbed

23. Road maintenance works throughout the road section include the following:
- road maintenance 63 km -123 km (patching, pouring cracks, cleaning.
