Project Number: 45169-001  
Loan Number: ADB Loan 3056-KGZ (SF)  
Grant Number: 0366-KGZ (SF)

Semi-annual Environmental Report  
From July 1 to December 31 2018

CAREC Corridor 3 Improvement Project (Bishkek- Osh  
Road), Phase 4

**EPTISA Servicios De Ingeniería S.L. Eptisa Muhendislik and RAM Engineering**

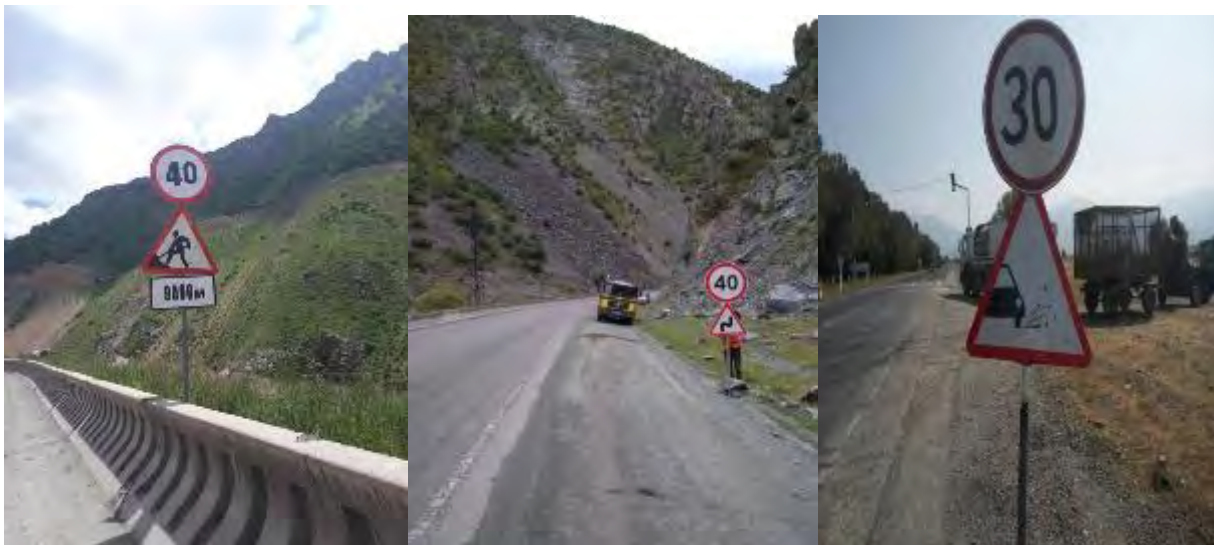
Figure 3 Installation of road signs

Installation of road signs at 121 km - 129 km

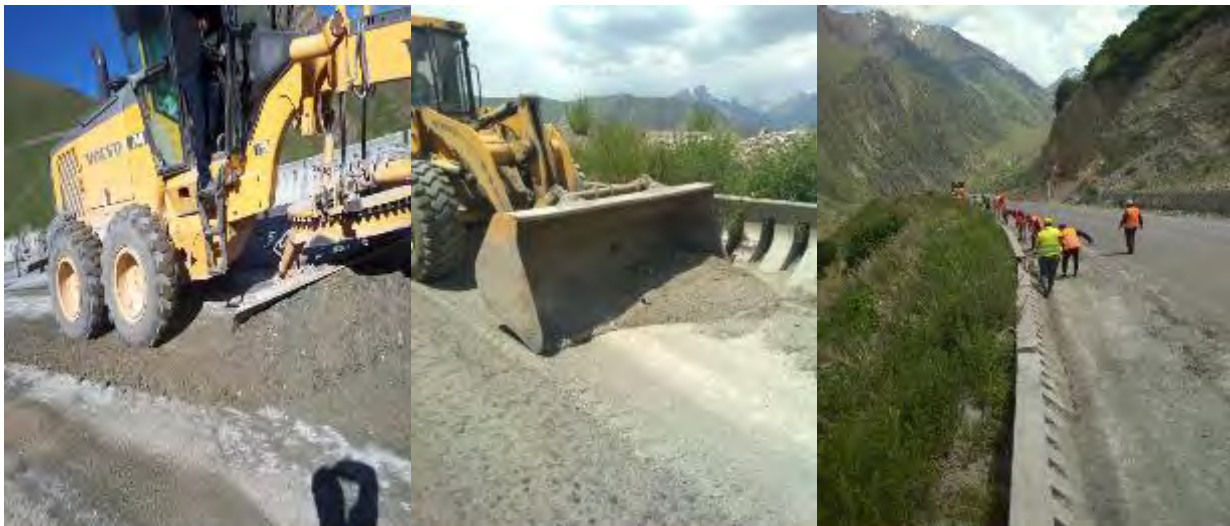
Figure 4 Works along the parapets

-cleaning and repair of drainage structures: grader and levelling of earth ditches for ensuring free flow of water; Cleaning work along the parapets and drainage channels at 81-129km.

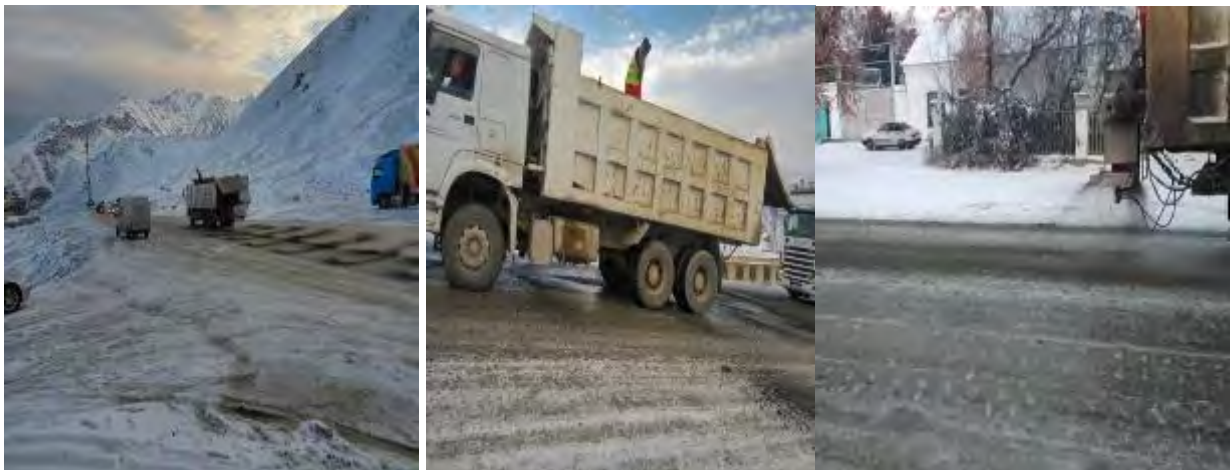
- cleaning the road surface in winter, including sanding and a limited amount of salt. (Section 61 km-129 km)

Figure 5 Clearing of road surface during the winter period  
- minor repair of pipes.

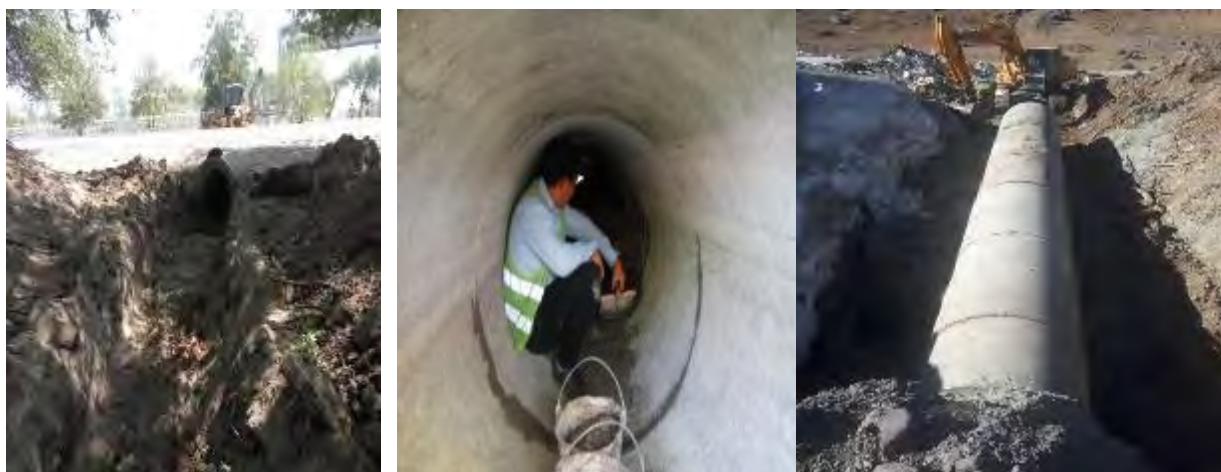
Figure 6 Clearing of culvert pipes

24. Cleaning and repair drainage structures – In total, there are 69 culverts, which contribute to runoff and water drainage from one side to another, in the slope. In summer, these structures are free from water and there was construction without affecting the seasonal water flow. Pipes are precast concrete pipes that are manually cleaned. For the repair work of each construction requires a small amount of material (about 20-50 kg), which is mixed manually or using a small mixer, applied and finished completely by hand. All the pipes are in the ground/soil ditches. The work consists of removal of dirt and debris to ensure unobstructed flow of water. Cleaning of culverts 61-129 km (82 PCs)

Cleaning of culvert pipes		
Section		Amount
61+00km 129+00	Waste removal. Partly is completely clogged.	82PCs

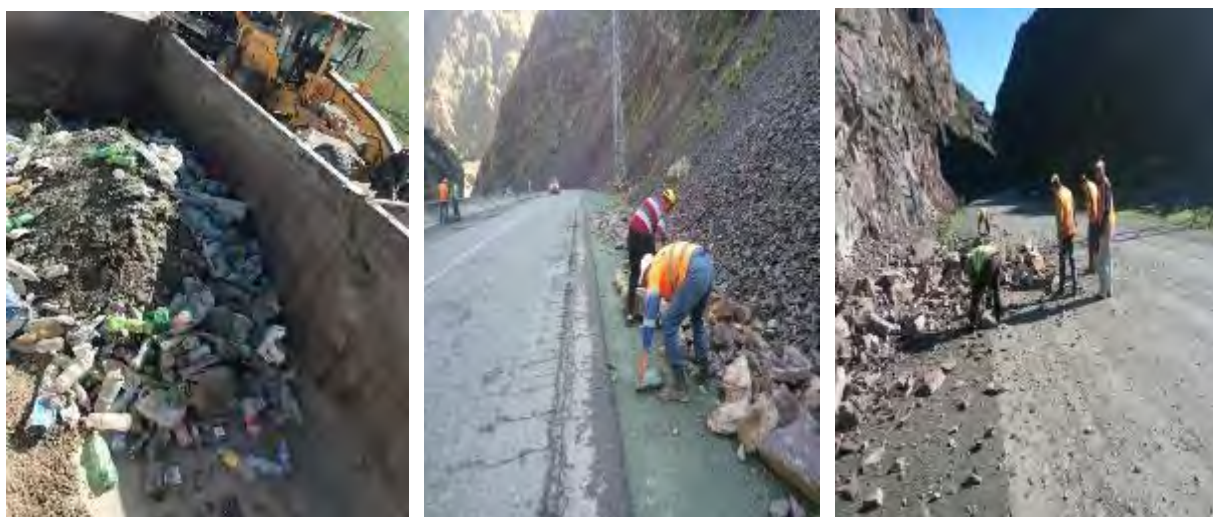
Figure 7 Waste collection along the road

- cleaning and minor repair of structures; Clearing of waste 61-129,5 km.
