Semi-annual environmental monitoring report

January - June 2023

Central Asian Regional Economic Cooperation Corridor 3 Improvement Project (Bishkek-Osh Road), Phase 4, Bishkek-Kara-Balta section (km 8.5 - km 61).

Prepared by: Joint Venture Temelsu International Engineering Services Inc., E. Gen Consultants Ltd., and Desh Upodesh Ltd. in association with Kyrgyz TREC International, Ltd. for the Ministry of Transport and Communications of the Kyrgyz Republic and the Asian Development Bank.

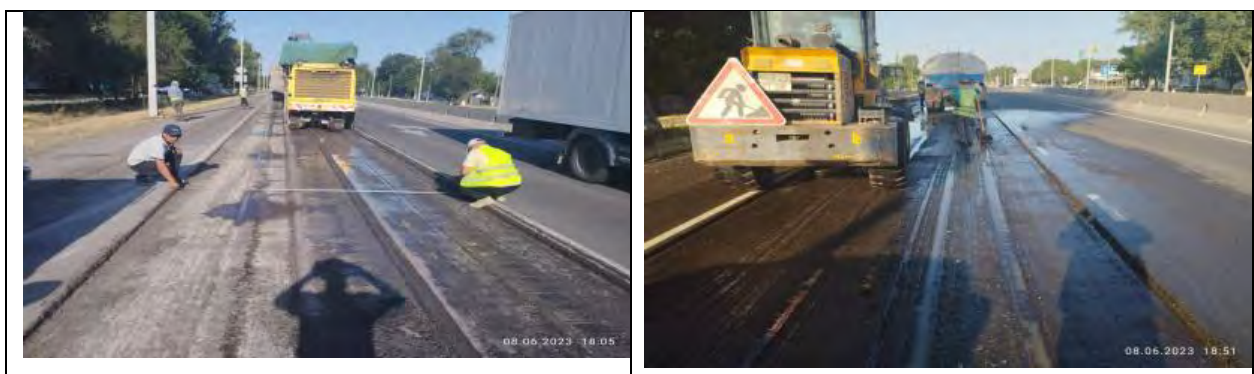
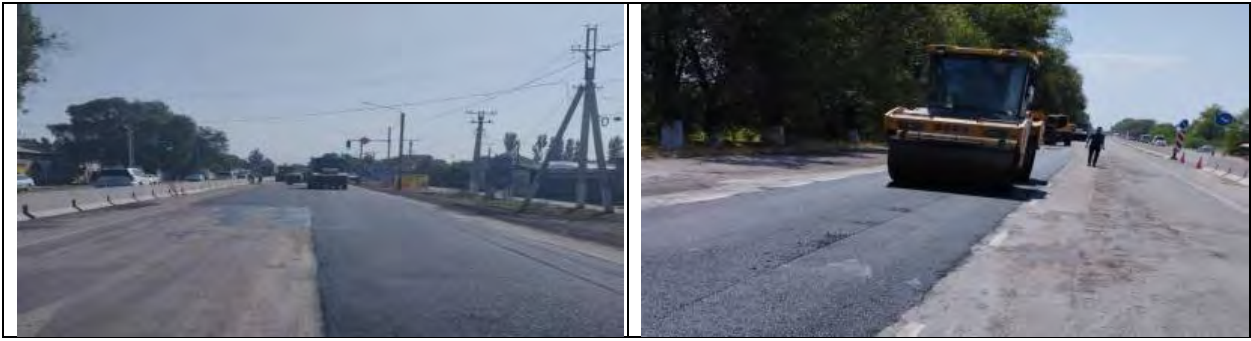
Figure 3 Milling and laying wearing course, removing ruts on the road

30. Deformed asphalt where rutting was developed was removed and the new asphalt was laid.

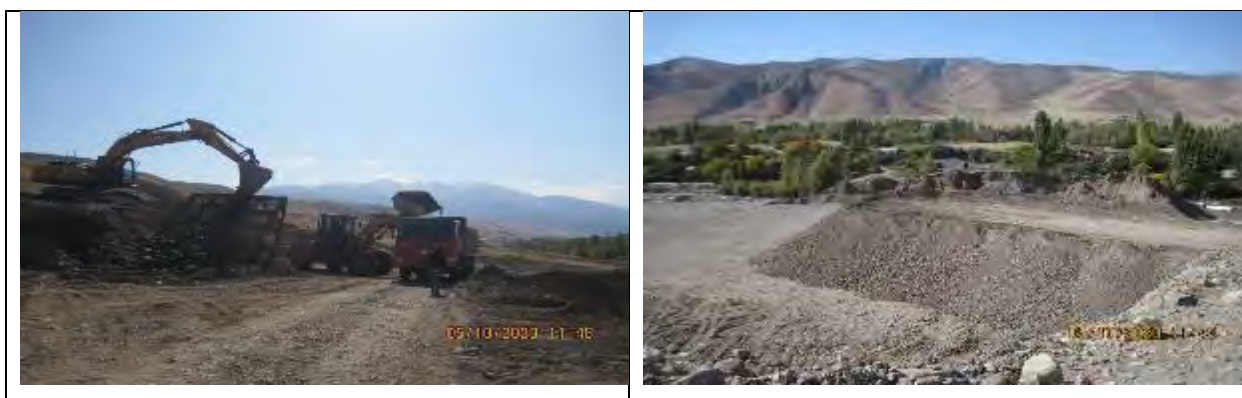
Figure 18 Development of Saz borrow pit

55. In May 2023, the borrow pit was reclaimed, and on June 9, 2023, the reclaimed Saz borrow pit was handed over to the Reclamation Commission.

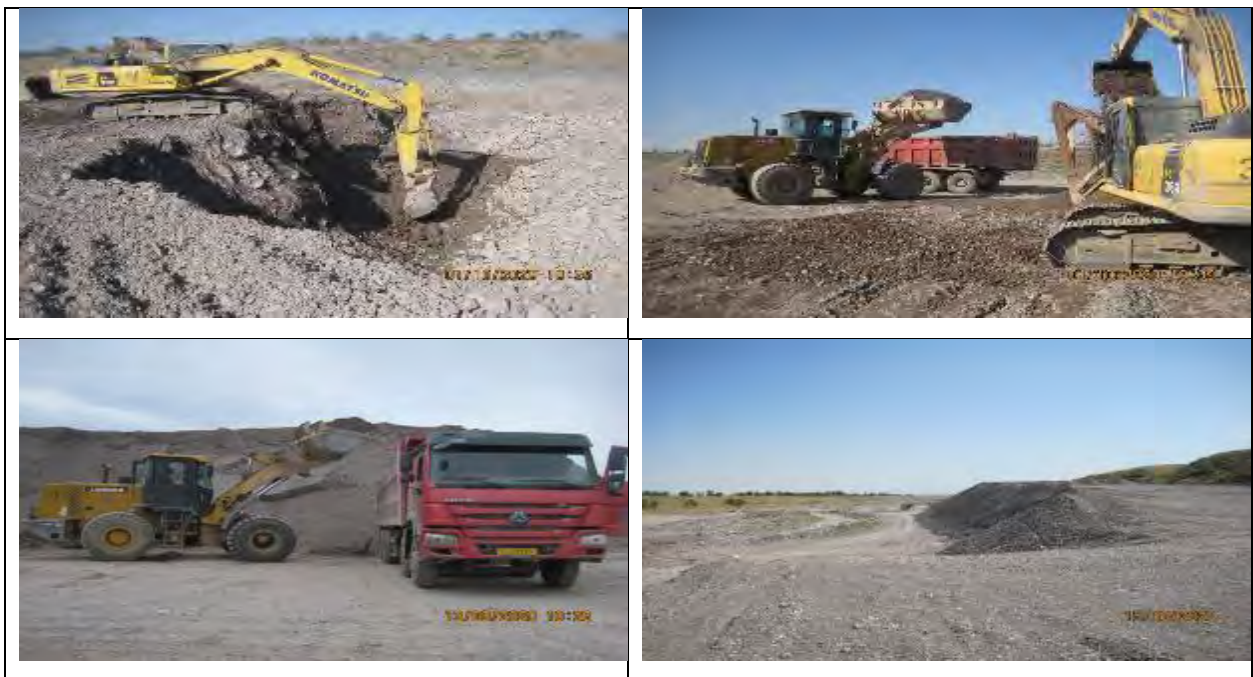
Figure 20 Development of the Ak-Suu 2 borrow pit on moistened material

57. At the beginning of borrow pit development, dusting was observed both on the territory of the borrow pit area and on the road leading to the it. After written warnings, the Contractor allocated 2 watering machines for regular water sprinkling at the borrow pit area, and on the road leading to it. In the reporting period, dusting was not observed during work at the borrow pit.

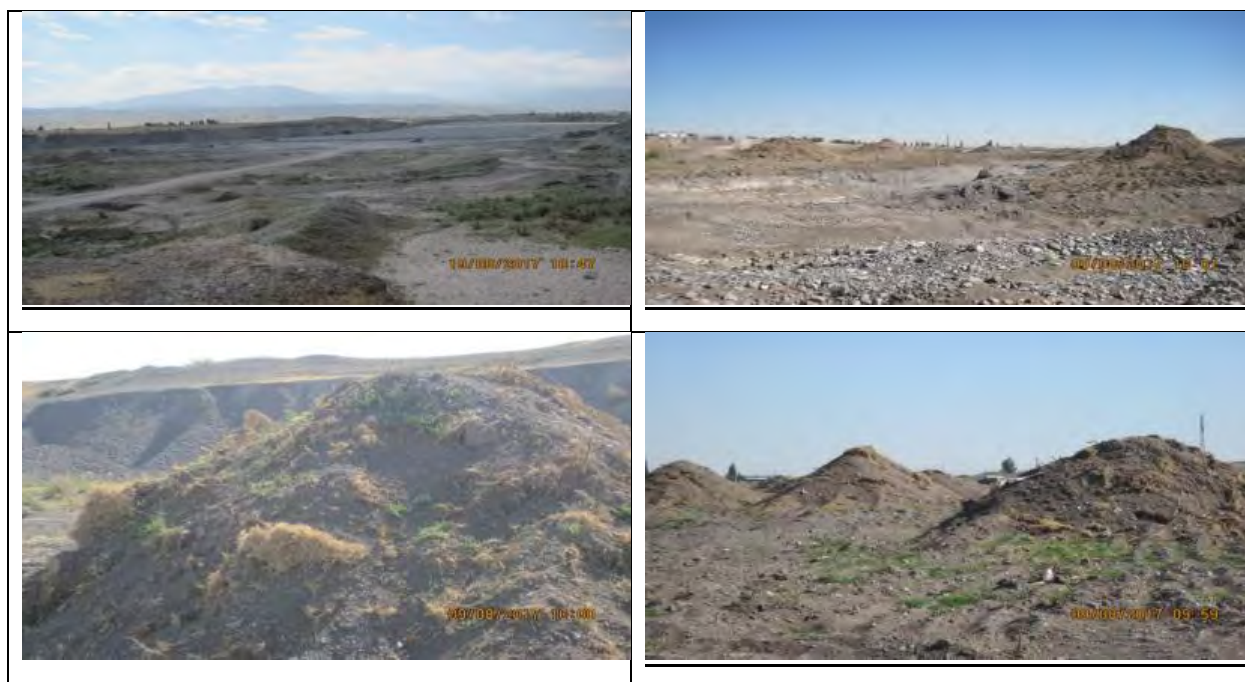
Figure 22 Ak-Suu1 borrow pit. Further, the removed soil layer was used for reclamation

59. **Ak-Suu 1 borrow pit.** The borrow pit was used for the collection and taking out of inert materials for the construction of road in the Moskovskiy district. To date, the borrow pit has been reclaimed and is ready to be handed over to the Reclamation Commission.

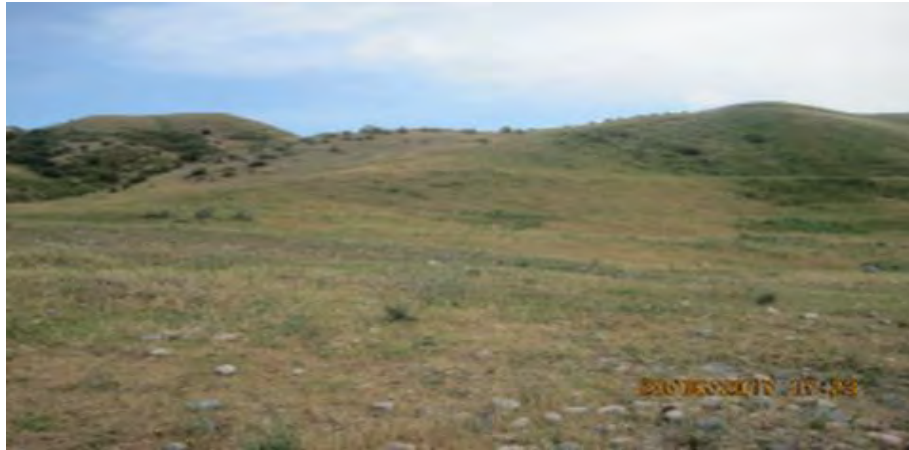
Figure 23 Jelamysh borrow pit before development

62. To develop the borrow pit, it was necessary to repair the technological road of more than 10 km long - its condition was unsatisfactory. In addition, it was necessary to replace with a new one or repair the old bridge, with a carrying capacity of 25 tons (for the passage of loaded dump trucks). Access road and bridge were repaired before development of borrow pit.

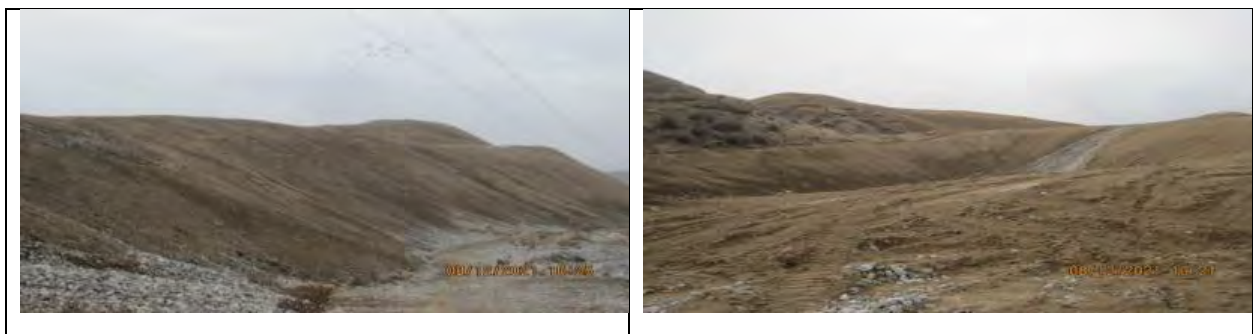
Figure 24 Jelamysh borrow pit after reclamation

63. After the completion of the borrow pit development, a Borrow pit reclamation plan was prepared, according to which it was reclaimed.
64. The reclaimed borrow pit was handed over to the commission in December 2021.

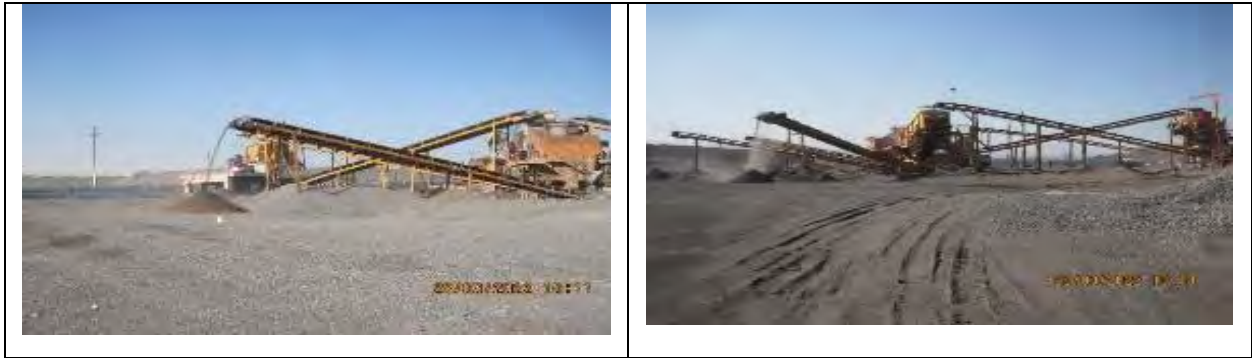
Figure 30 Stone crushing plant

76. During the reporting period, the stone crushing plant operated on moistened raw materials without dusting. Moistening of inert material before crushing is sufficient for dust suppression. The nearest villages are located at a big distance from the production site. There is no impact on the population of villages because of the plant operation.

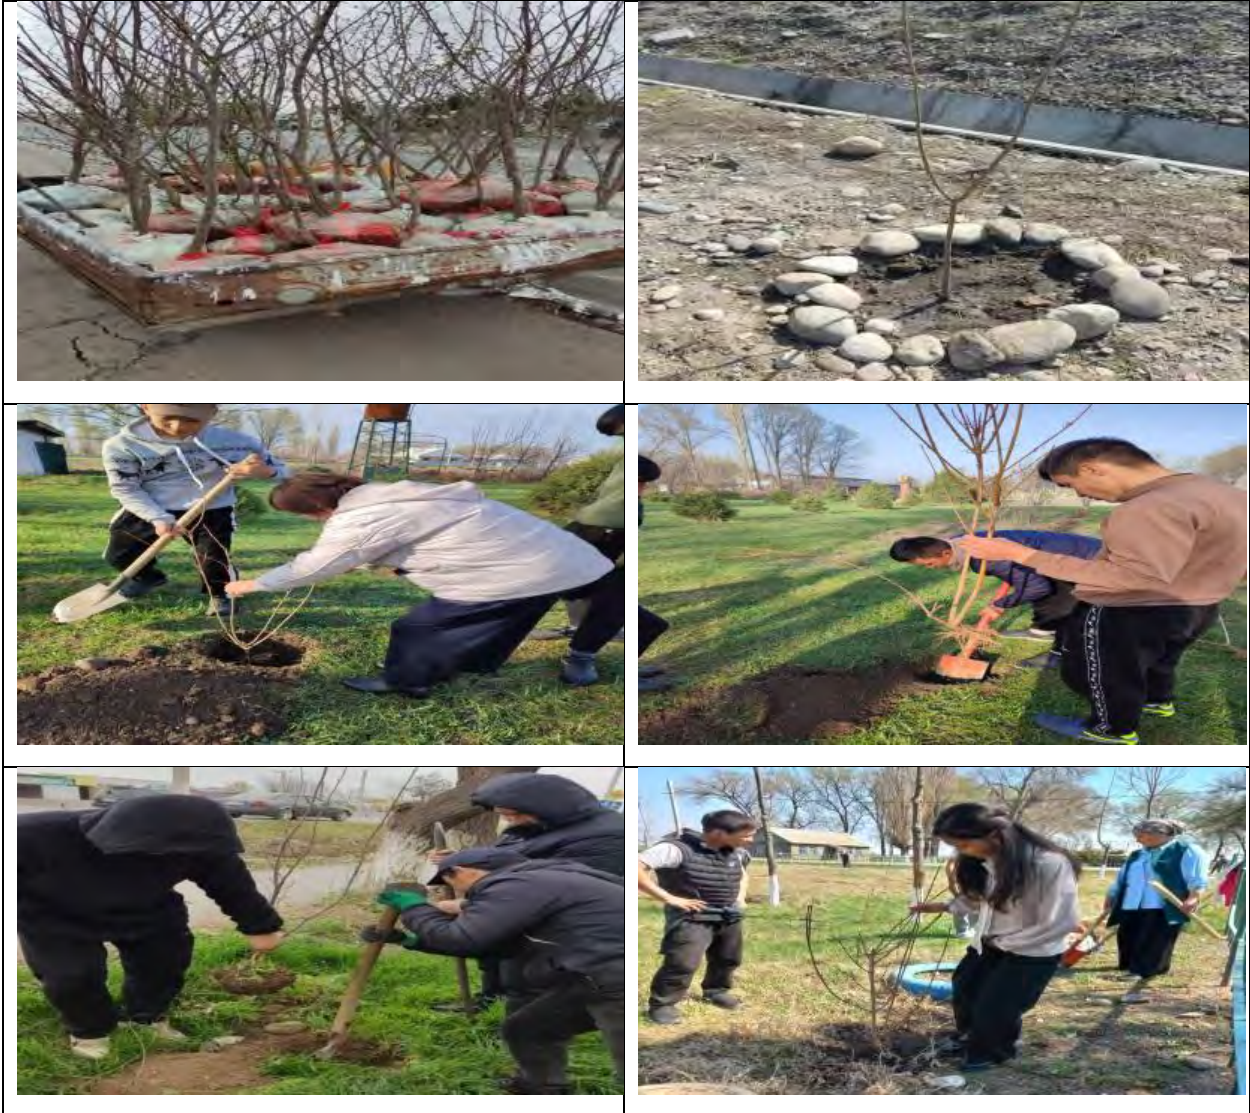
Figure 35 Planting of seedlings in spring 2023

94. As a result of a site visit by the ADB Environmental Consultant and the Environment Specialist of the MOTC PIU, it was found that a significant number of planted seedlings were dried, burned, or subjected to vandalism. According to the inventory of seedlings planted on the project road, about 700 seedlings died due to the fault of the contractor to water the seedlings in a timely manner.

95. It has also been found that, to date, the Contractor has not watered the seedlings, as specified in letter No.0541BOC3 55/3350-00592 dd 24.04.2023.

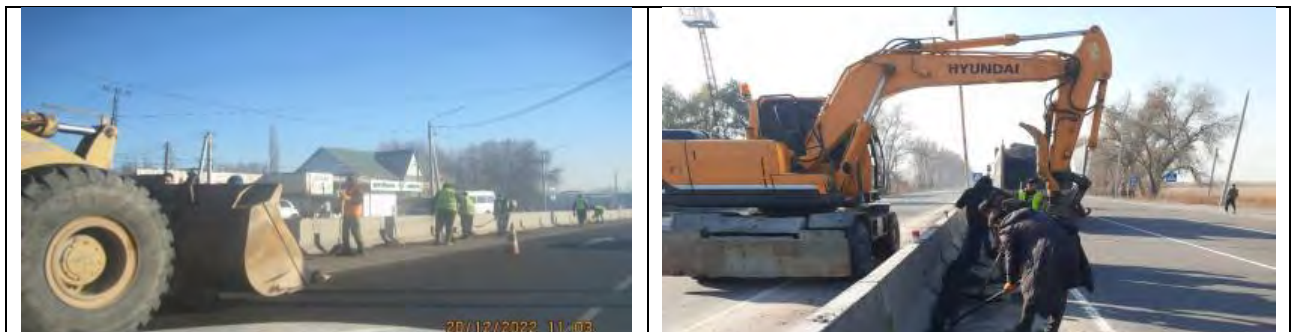
Figure 37 Cleaning parapets from soil waste and removal of waste from the road

129. During the monitoring, it was found that on the road shoulders, where the work was carried out to strengthen the parapets, there were not removed soil waste which was stored in small piles.

The contractor was warned with an indication of timing to fix this violation. In due time, soil waste was collected on the shoulders and taken out. In the future, the soil accumulated near the parapets was cleaned and removed in a timely manner.

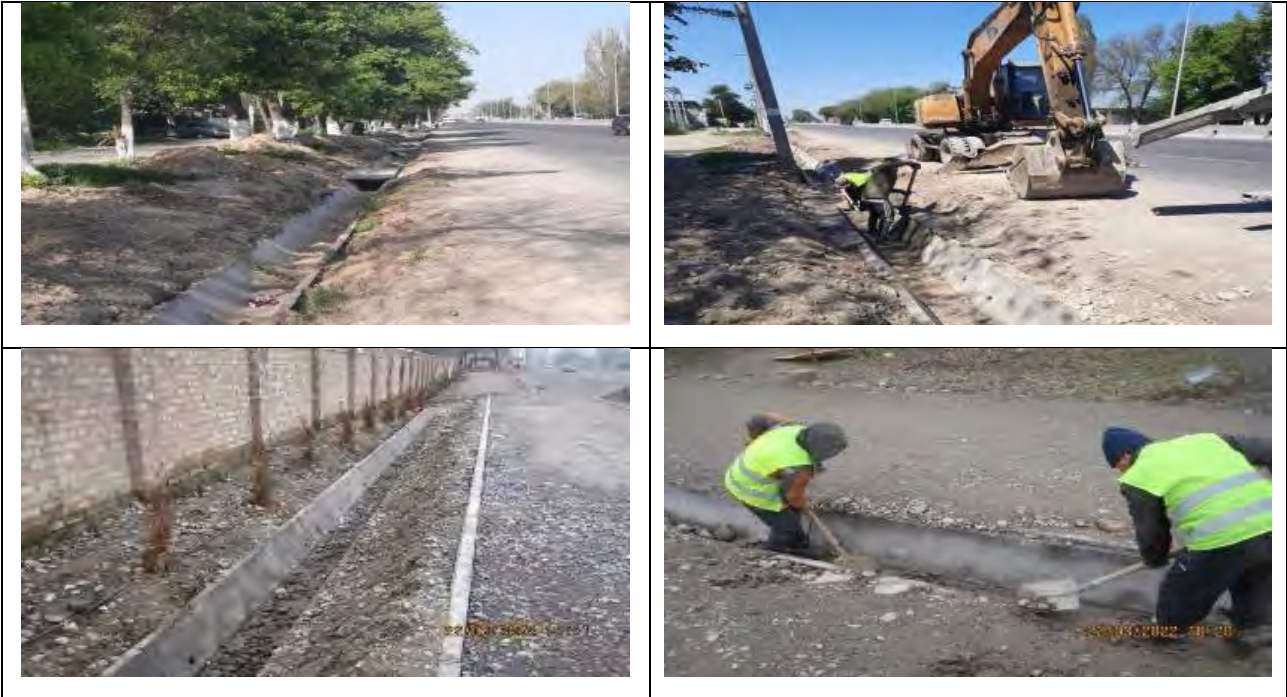
130. During the reporting period, new drainage ditches were installed and previously installed ones were cleaned from stones and debris.

Figure 38 Cleaning drainage ditches

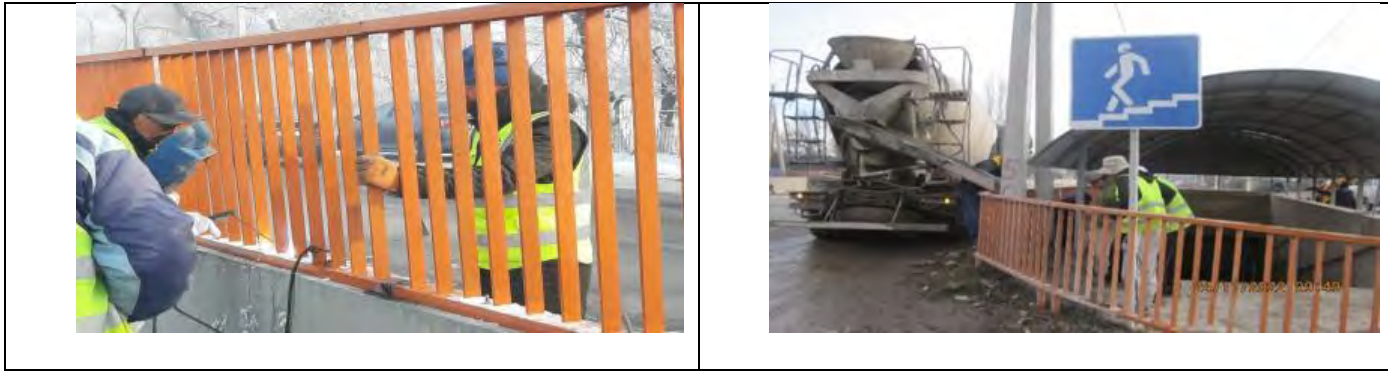
135. The violations were eliminated. A reinforced concrete pavement perimeter was constructed around the crossing, and the roof of the ceiling was built up. Metal gratings were installed on the road near the crossing.

Figure 42 Installation of a metal grating near underpasses

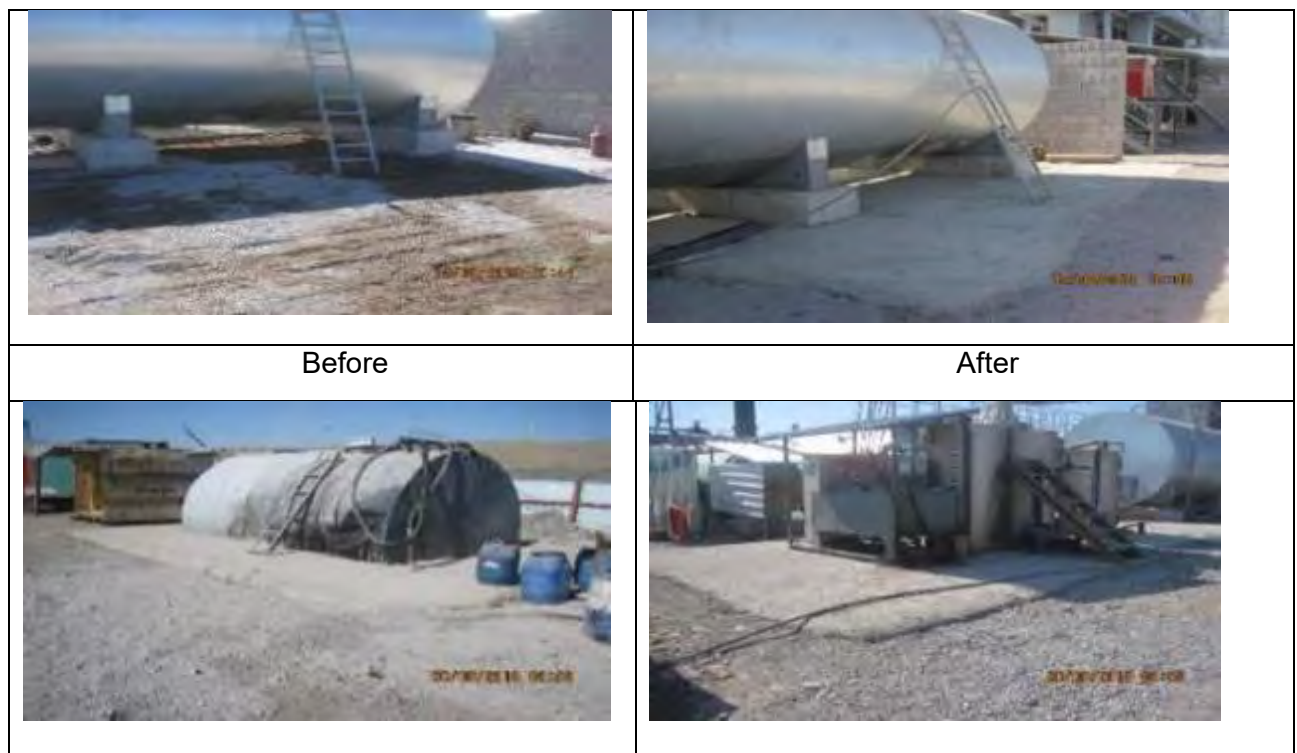
159. During the operation of the plant, all soil around the containers with chemicals must be protected from runoff and spills of hazardous materials by an impenetrable protective cover.

Figure 51 Impenetrable protective coating around chemical containers

160. The Contractor was recommended to protect the soil around the containers with chemicals from runoff and spills of hazardous materials with an impenetrable protective coating. These recommendations were taken into account and implemented by the Contractor.

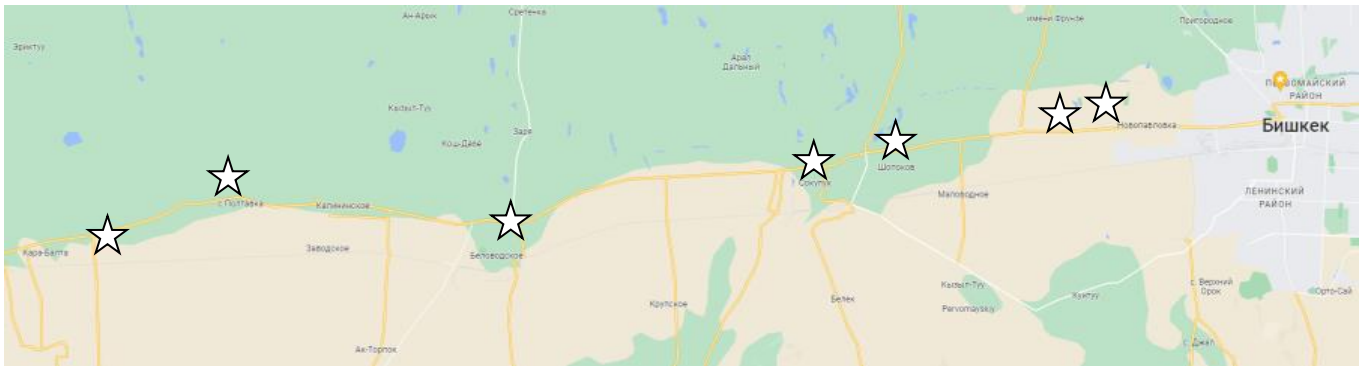
Figure 59 Noise measurement points

199. **Conclusion on the results of measurements of background noise level:** at the time of the measurements, the background noise level at the measured points when vehicles were passing along the road was from 61 dBa to 76 dBa. There was a single excess of the background noise level at the measurement point in the village of Novonikolaevka at 16:00 - 76 dBa (while maximum permissible level is 75 dBa). These indicators were short-term.

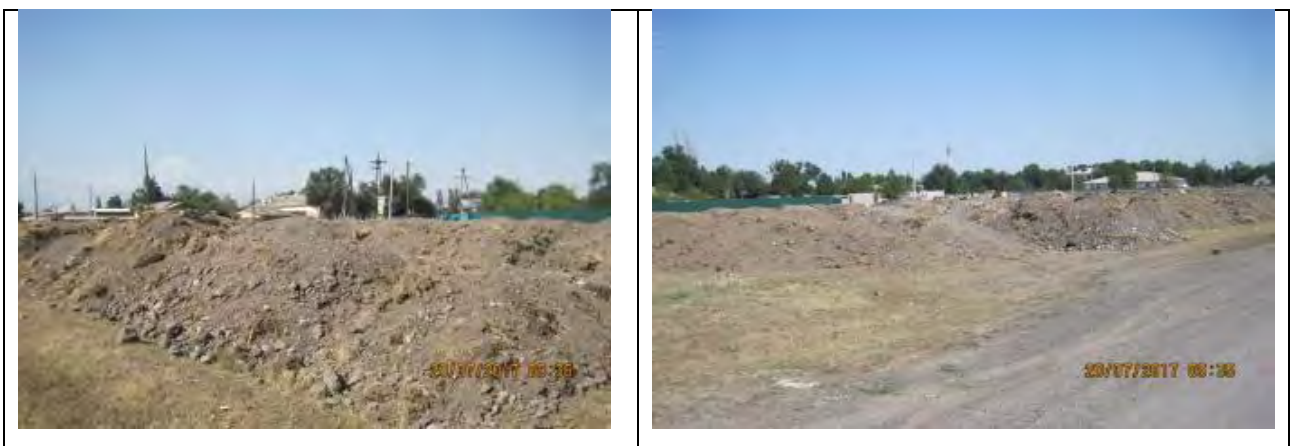
Figure 15 Dumps with removed and disposed soil

73. Unsuitable soil in large volumes was subsequently taken out to the sites intended for storage of the removed soil in the village of Petrovka. Upon completion of the main construction works, the Contractor had to taking out all the soil.

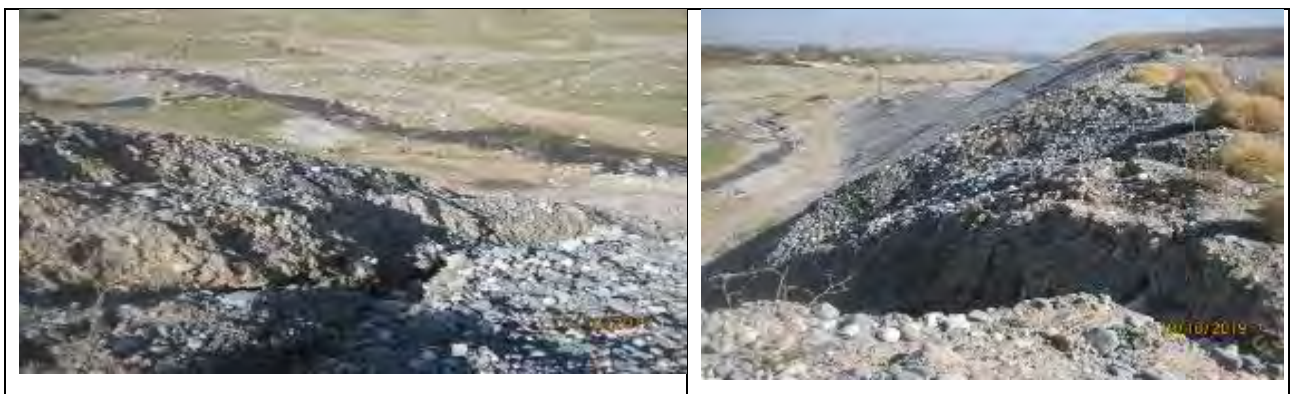
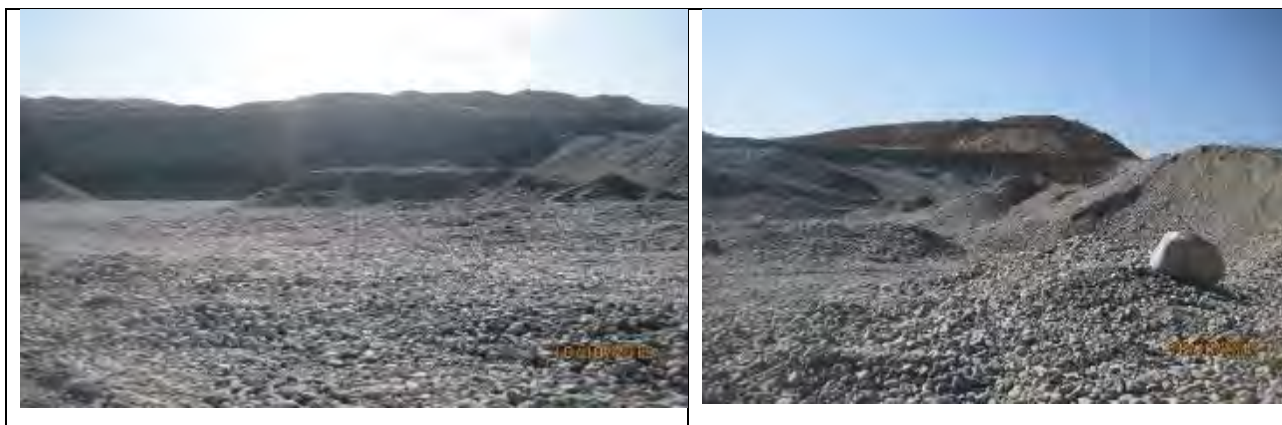
Figure 24 Jelamysh borrow pit after completion of development work

94. Development of the borrow pit from the very beginning was carried out in violation of the design, about what the Contractor was repeatedly warned in writing. Considering that the borrow pit's field is located on a slope, the development of deposit had to be carried out in layers with ledges of 5 m, starting from the upper part. In fact, the development of inert materials in the borrow pit was carried out from the bottom part with a ledge height of more than 10 m in violation of design solutions and safety precautions.

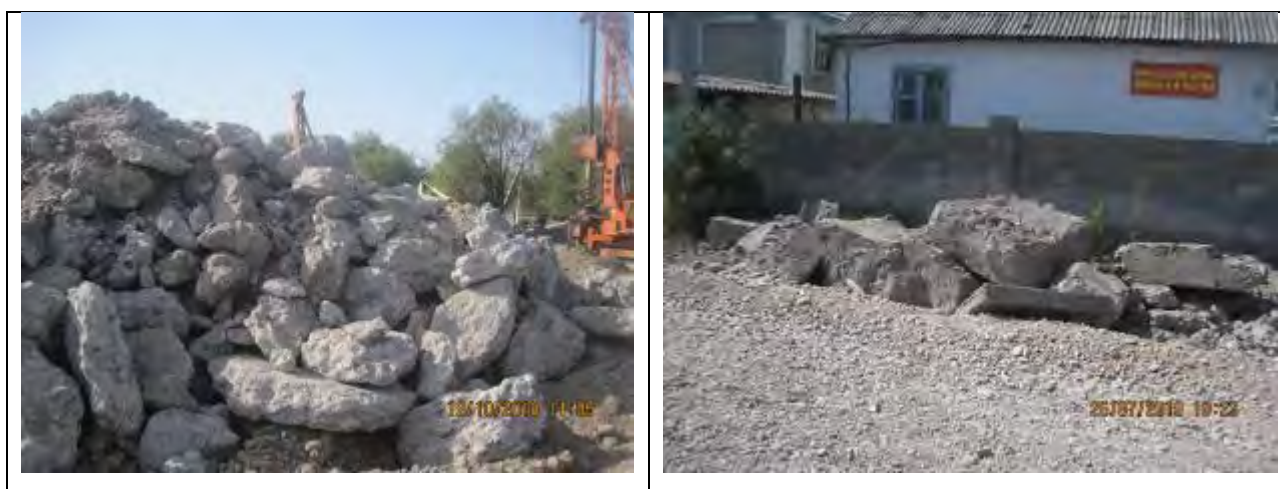
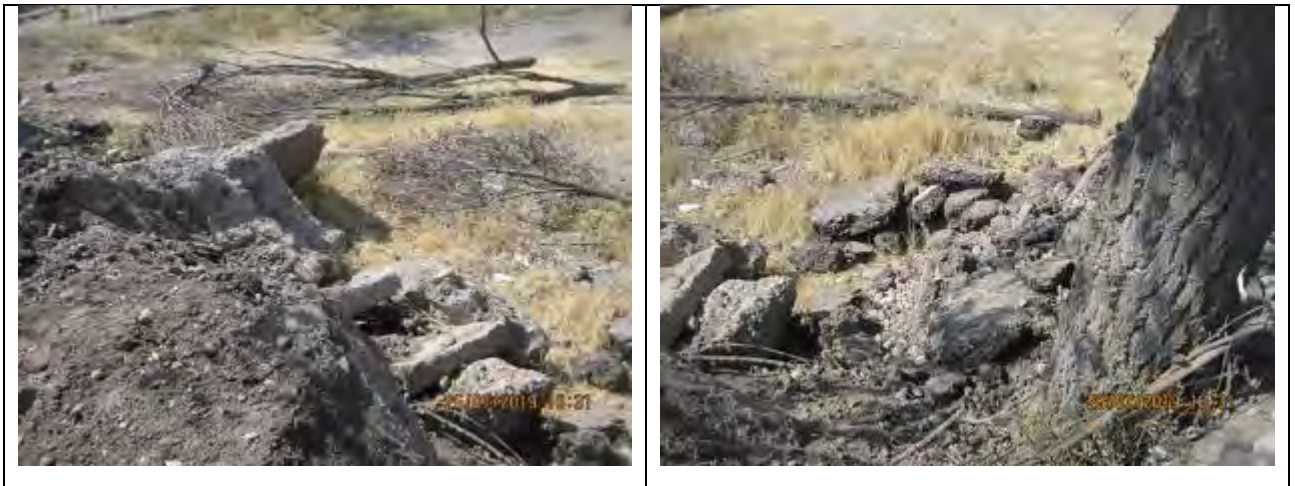
Figure 26 Construction reinforced concrete waste

99. Construction reinforced concrete waste was accumulated during the dismantling of bridges and culvert pipes.

100. Initially, construction waste was promptly removed to the allocated by DEP-9 (Road maintenance unit) places for the storage of old reinforced concrete products. With the increase of construction work, the allocated places could not accommodate all the waste, and a problem arose with determining the storage places for reinforced concrete waste. In the spring of 2019, together with the local authorities, places were allocated for the storage of old reinforced concrete products. Basically, these were areas where there were pits and which the local authorities planned to use for commercial purposes. Removed unsuitable soil was also taking out to these places.

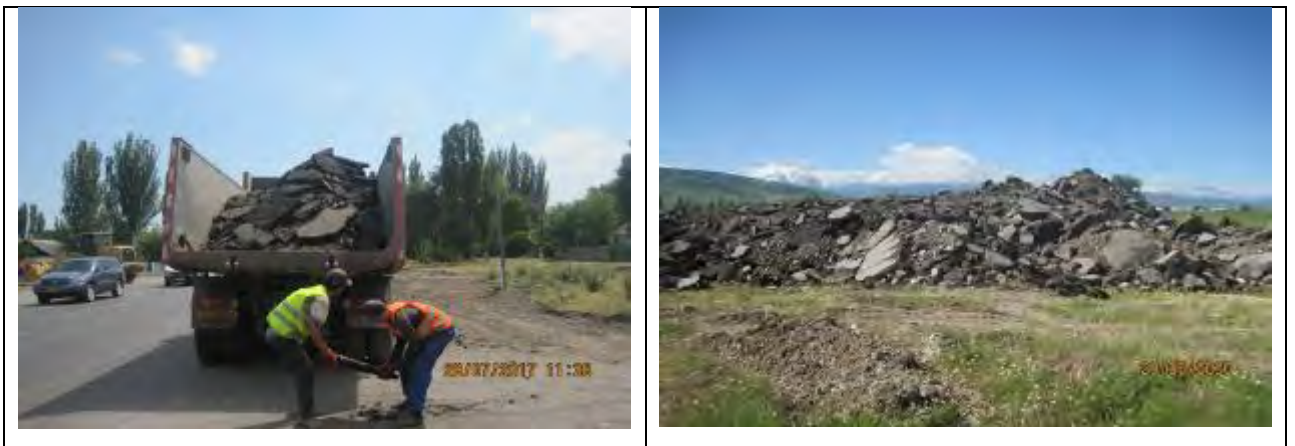
Figure 27 Old asphalt removed from the roadbed

101. In the process of excavating the old asphalt concrete pavement, the problem of crushing the old asphalt to a size of 20x20 remained unresolved. Therefore, the problem of disposal arose. Given that the villages do not have equipment for leveling large pieces of old asphalt, the problem arose to take out uncrushed old asphalt for backfilling rural streets proposed by local authorities. Partially at the request of residents, the removed asphalt was taken out to make embankments on private sites. The levelling of private land plots was carried out by the owners themselves. Asphalt was not taken out to wetlands.

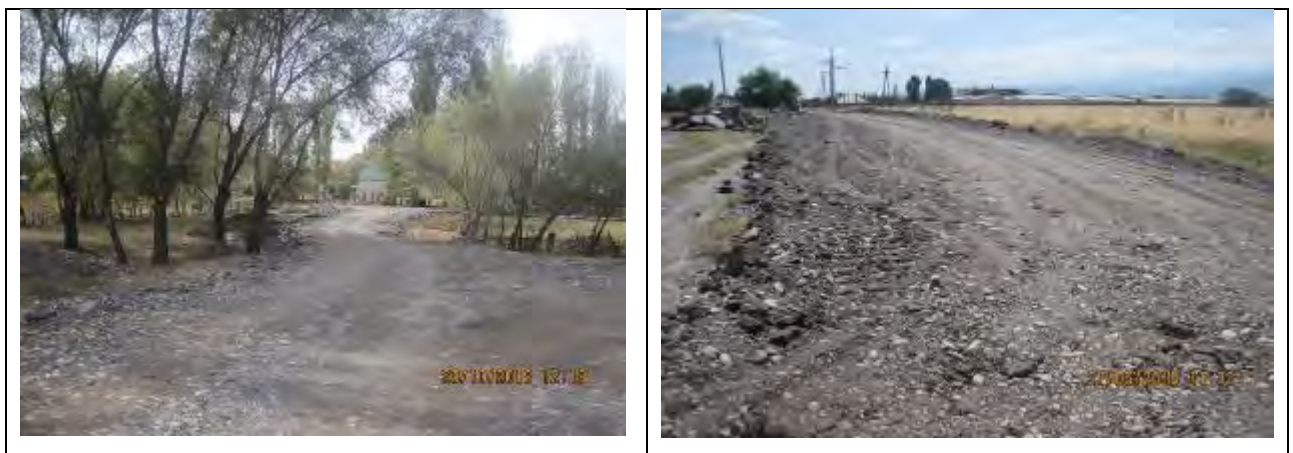
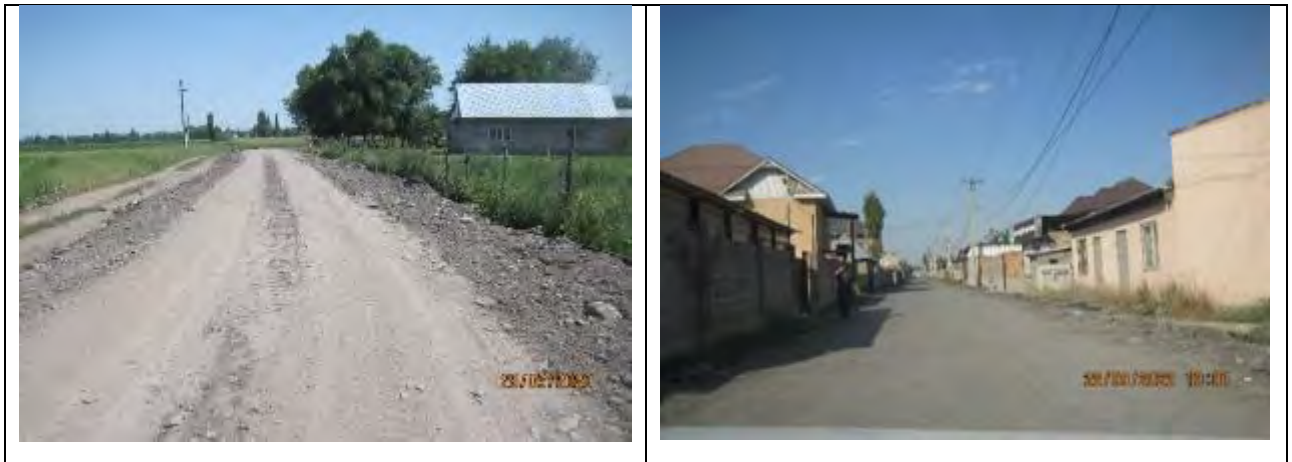
Figure 29 Streets backfilled with old asphalt

102. Later, by agreement with the local authorities, it was decided to take out the old asphalt to the streets proposed by the local administration. The problem was that large pieces of uncrushed asphalt remained on the sides of the backfilled roads. Considering this fact, the Contractor leveled the old asphalt with its own equipment. Separate places were noted where, after the backfilling and levelling works, uncrushed pieces of asphalt remain on the roadsides. The contractor was given instructions to correct and bring to the proper condition the found shortcomings.

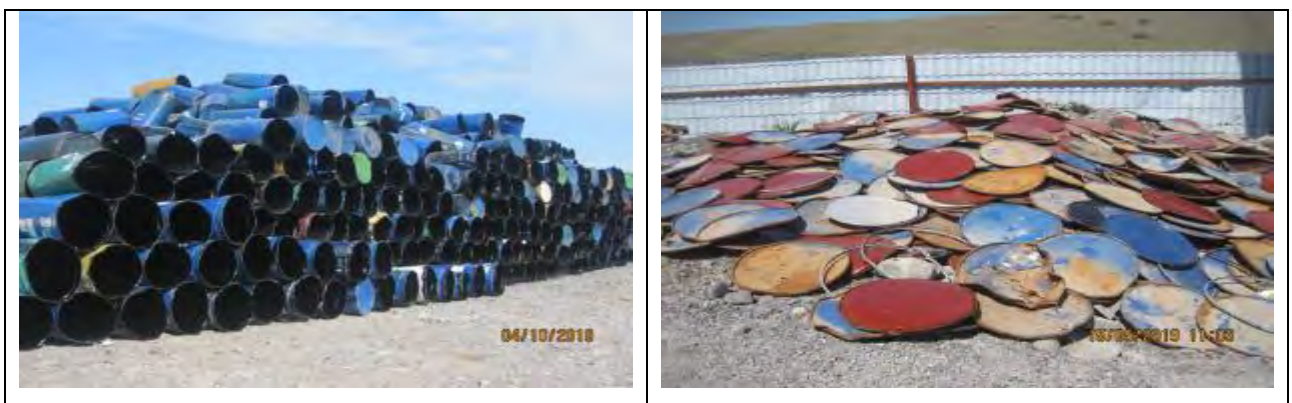
Figure 31 Waste on the territory of the asphalt plant. Waste barrels and metal drum lids

106. On the territory of the asphalt plant, waste was accumulated during the production of asphalt. Basically, these were empty barrels from used bitumen. The barrels were partly used for construction work on the road, most of them were sold for scrap.

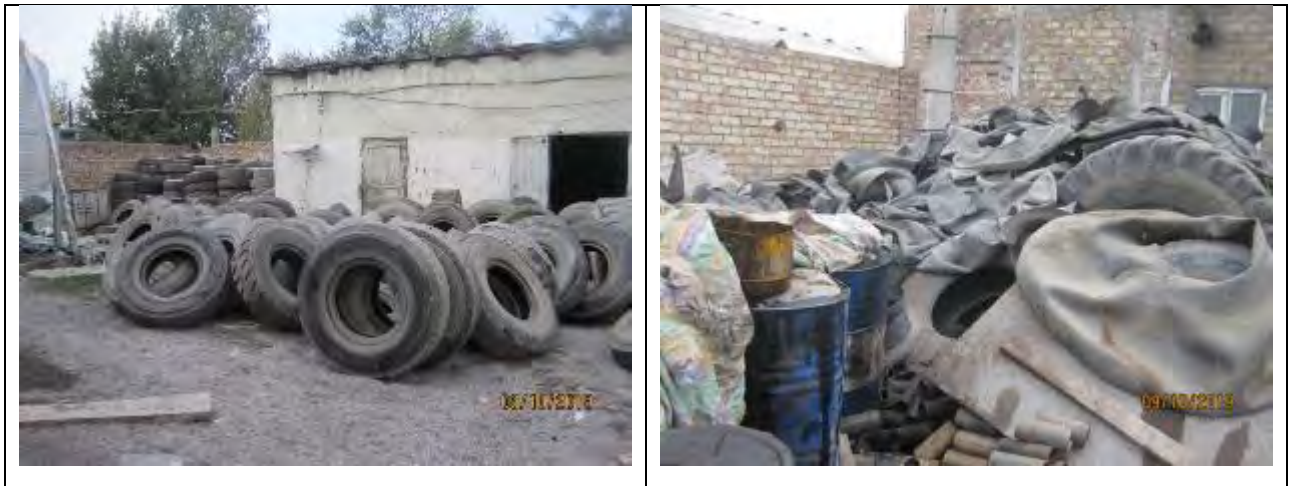
107. Production waste also included old car tires and scrap metal waste, which were removed and disposed of under an agreement with specialized companies.

Figure 32 Old car tires to be recycled

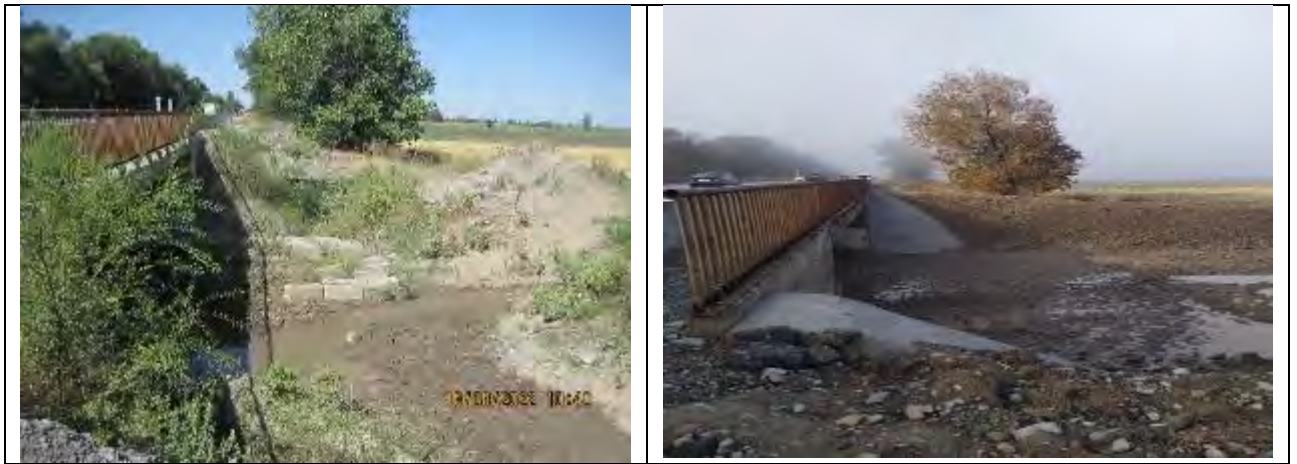
128. After the completion of construction works, a large amount of soil, construction waste, and reinforced concrete structures remained in the riverbed of the Jelamysh River.

Figure 38 Riverbed of Jelamysh River before and after waste disposal

129. A letter was sent to the contractor, to remove all construction waste from the riverbed as soon as possible.

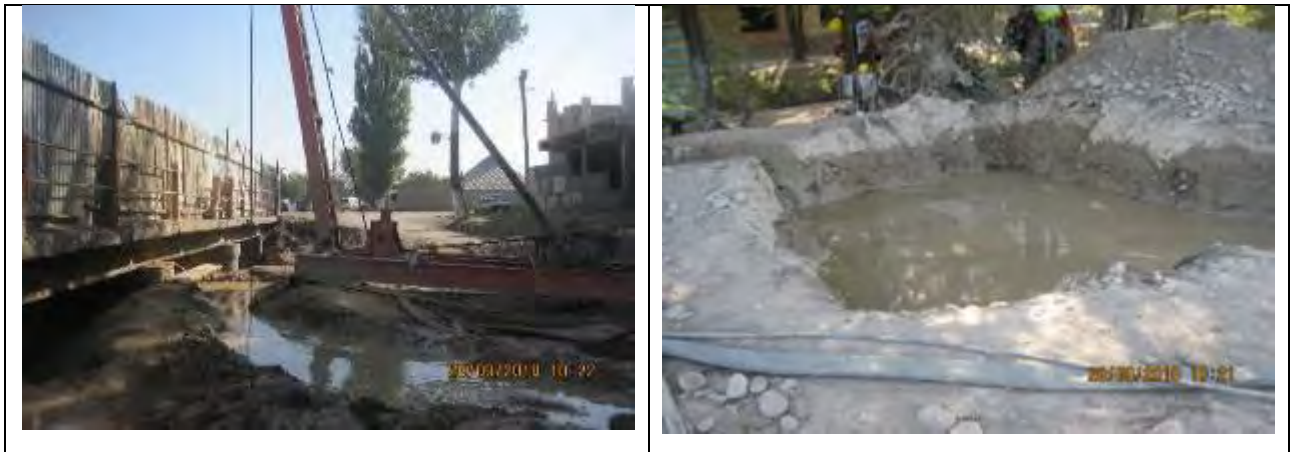
130. This bridge structure across the Sokuluk river is located in the center of the Sokuluk village. The method of bridge construction is bore piling. Bentonite was used as the drilling fluid. The aqueous solution with bentonite remained after use was discharged into a special pit and, after dehydration, was taken out from the construction site to a place (pit) specially allocated by the local administration.

Figure 39 Construction of a bridge across the Sokuluk river. Bentonite pit

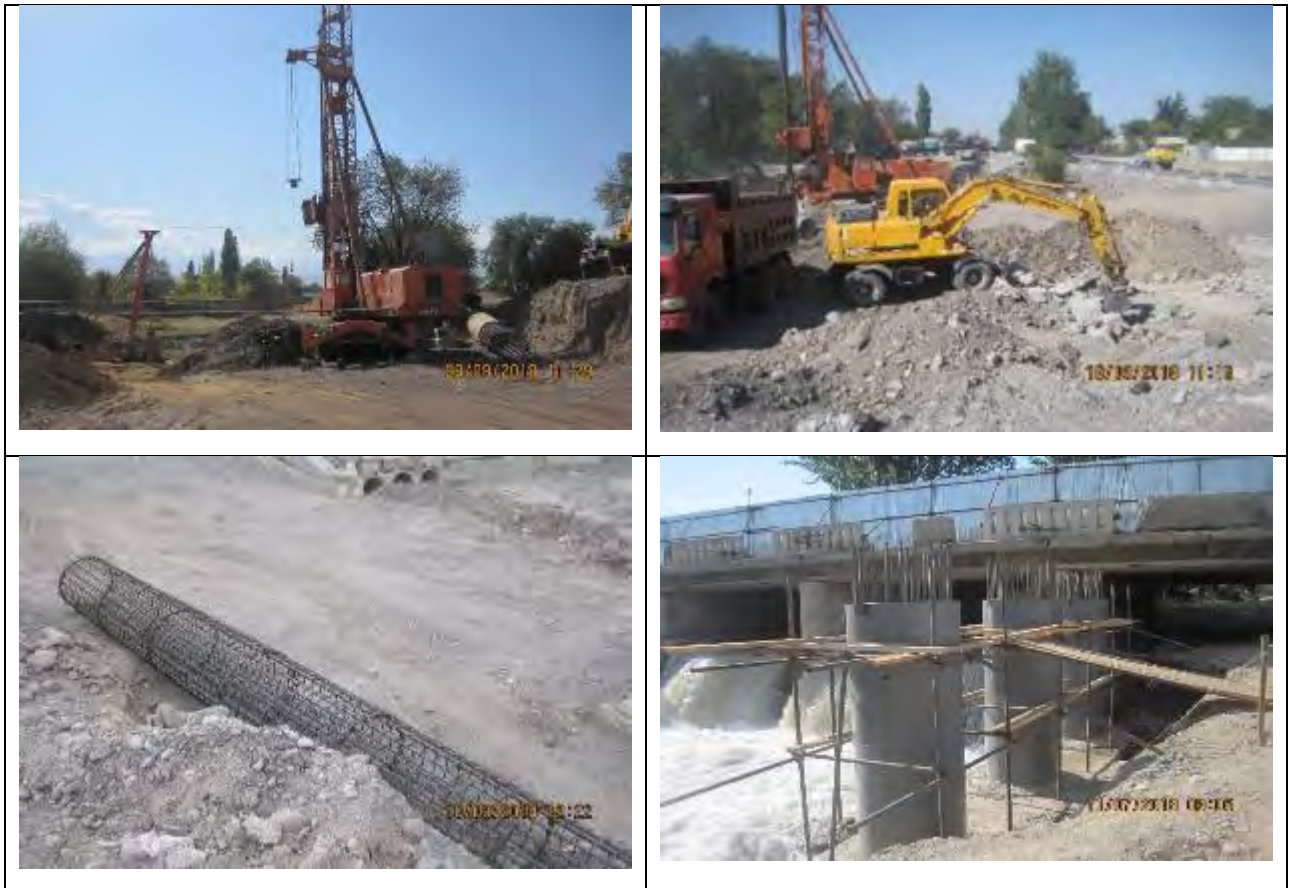
141. On the right bank of the river, the work was carried out by the Contractor using the bore piling method. Bentonite is used as drilling fluid. The riverbed was blocked. Water has been diverted from the site where construction work was underway. The bentonite pit was located directly in the riverbed.

Figure 42 Construction of bridge across the Aksuu river

- 142. After removal of equipment, the clay pit in the riverbed remained uncleaned.
- 143. The flow of water eroded a pit with used clay located in the riverbed, which caused pollution of the river. The contractor was given several warnings about the urgent need to clean up the riverbed.
- 144. The riverbed was cleared of bentonite clay only in the spring of 2019.

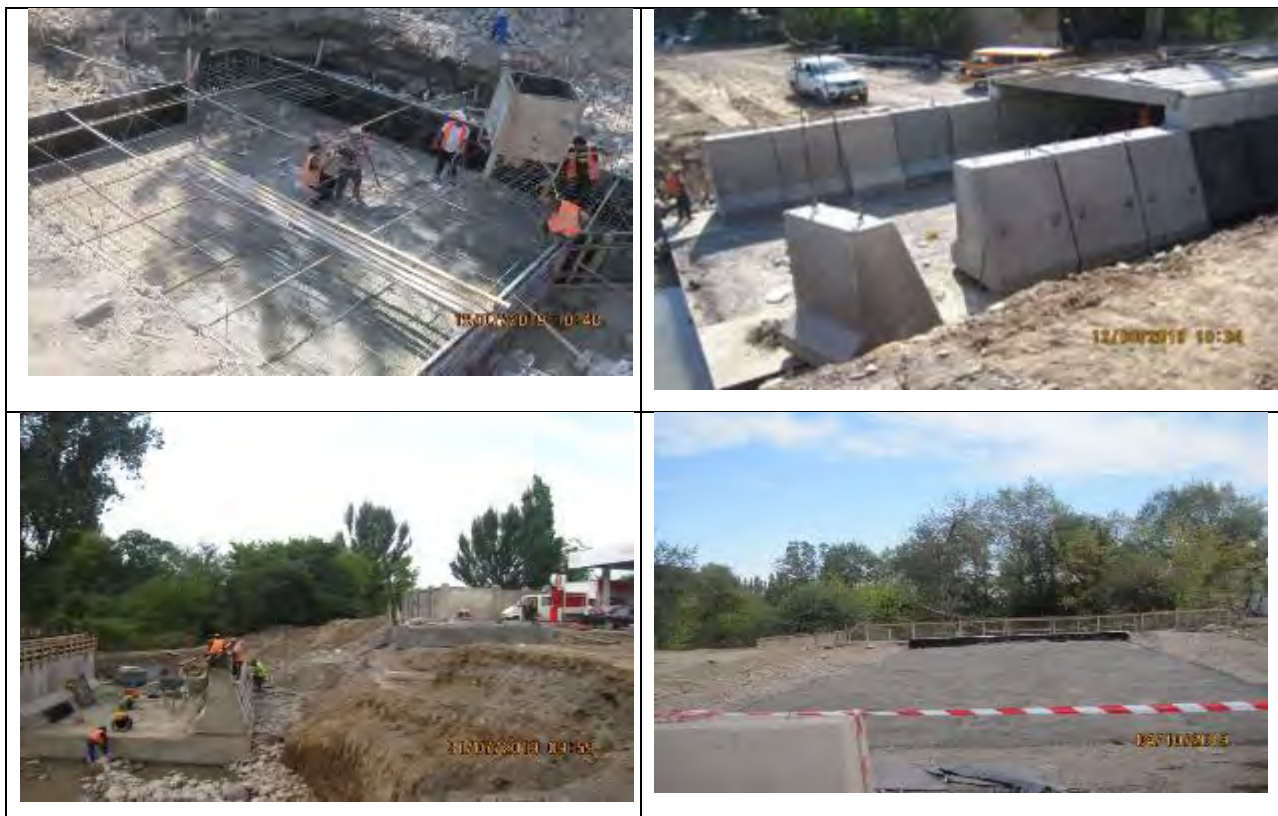
Figure 46 Construction of bridge on the Krepstnoy canal

157. Construction of the bridge was carried out with gross violations of safety precautions. There were no special means for working at height, ladders and equipped scaffolds. The area around the bridge was littered.

158. A letter was sent to the contractor with instructions to take measures to eliminate the found violations. Within the specified timeline, the violations were eliminated. Garbage removed; ladder made for work at height.

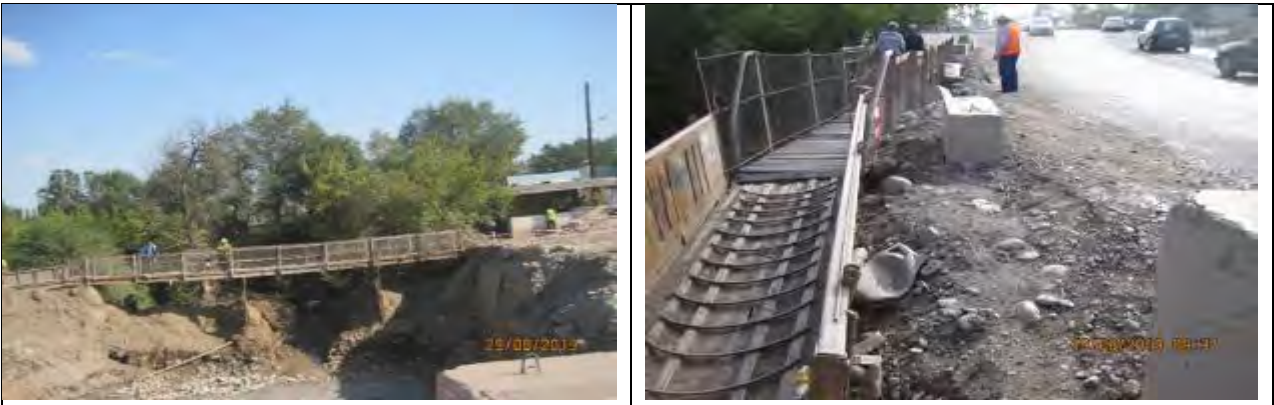
159. The pedestrian bridge on the Krepostnoy Canal was in an unsatisfactory condition prior to construction. A letter was sent to the contractor to strengthen the existing bridge before the construction of the new bridge.

Figure 48 Pedestrian bridge on the Krepostnoy canal before the construction of a new bridge

160. Within the specified timeline, the bridge structure was strengthened. The bridge was covered with a concrete layer.
