Semi-annual environmental monitoring report

January - June 2023

Central Asian Regional Economic Cooperation Corridor 3 Improvement Project (Bishkek-Osh Road), Phase 4, Bishkek-Kara-Balta section (km 8.5 - km 61).

Prepared by: Joint Venture Temelsu International Engineering Services Inc., E. Gen Consultants Ltd., and Desh Upodesh Ltd. in association with Kyrgyz TREC International, Ltd. for the Ministry of Transport and Communications of the Kyrgyz Republic and the Asian Development Bank.

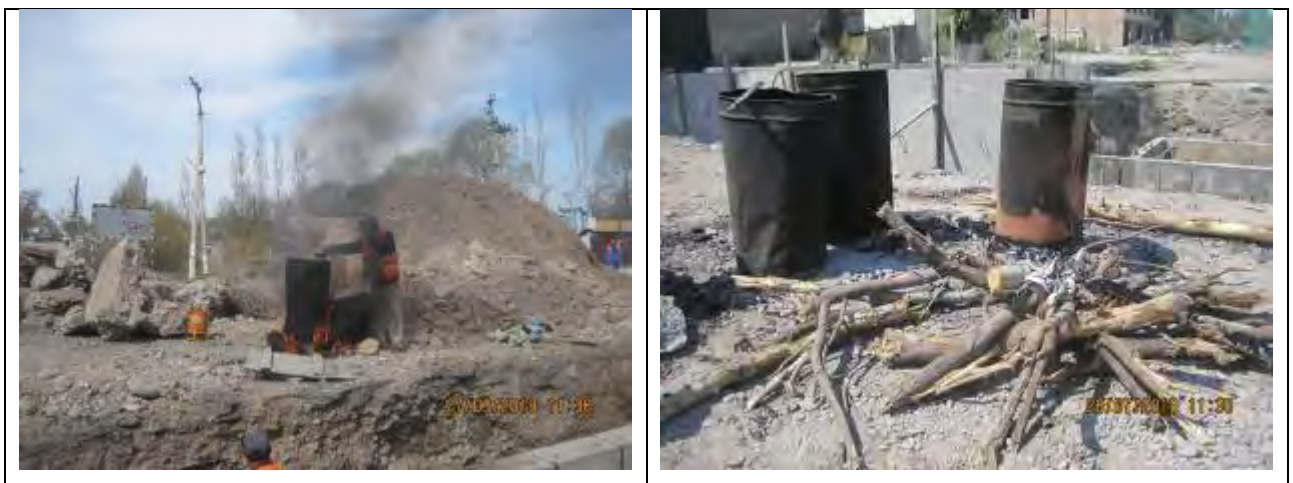
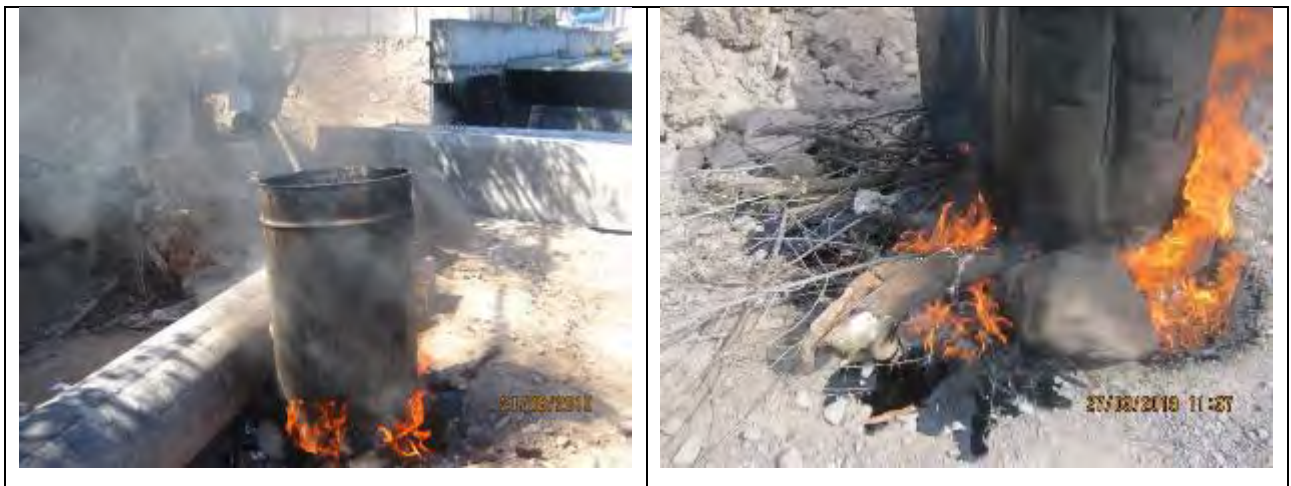
168. Bitumen for waterproofing pipes was melted on the spot. Taking into account that the Contractor does not allocate dry firewood for these purposes, the workers were forced to burn bitumen. The poisonous black smoke emitted at the same time adversely affected the health of workers and villagers. Repeated letter was sent to the contractor specifying the violation.

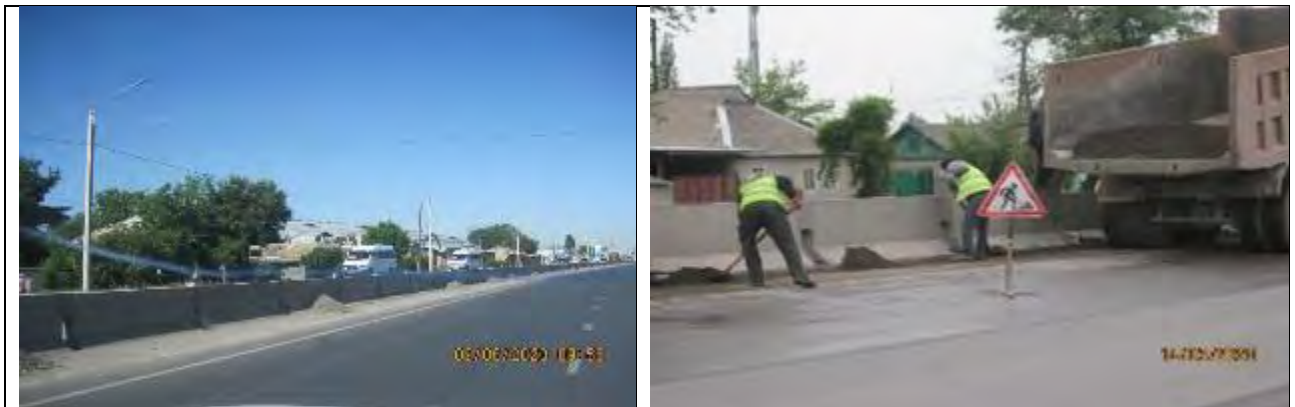
175. During the monitoring, it was found that on the road shoulders, where parapets strengthened, there were soil wastes that were not removed, and stored in small piles. The contractor was warned with an indication of timing for the elimination of this violation. In due time, soil waste was collected from the road shoulder and taken out. In the future, the soil accumulated near the parapets was cleaned and removed in a timely manner.

Figure 57 Cleaning of parapets from soil waste and removal of waste from the road

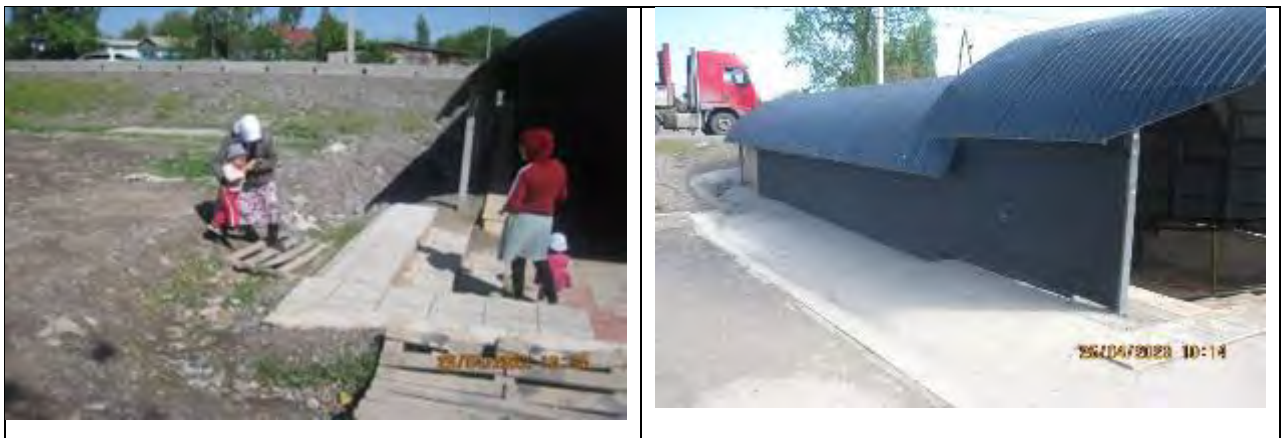
182. The area around the underpass near the school in the Novonikolaevka village (km 59+640) was in an unsatisfactory condition. It was difficult for schoolchildren to go down to this underpass, especially in icy conditions, which could cause falls and injuries. A letter was sent to the contractor to eliminate these violations.

Figure 60 Violations near the underpass in front of the school in the Novonikolaevka village

183. In December 2022, the violations were eliminated. A reinforced concrete platform was constructed around the underpass, and roof installed. Metal gratings are installed on the road near the underpass.

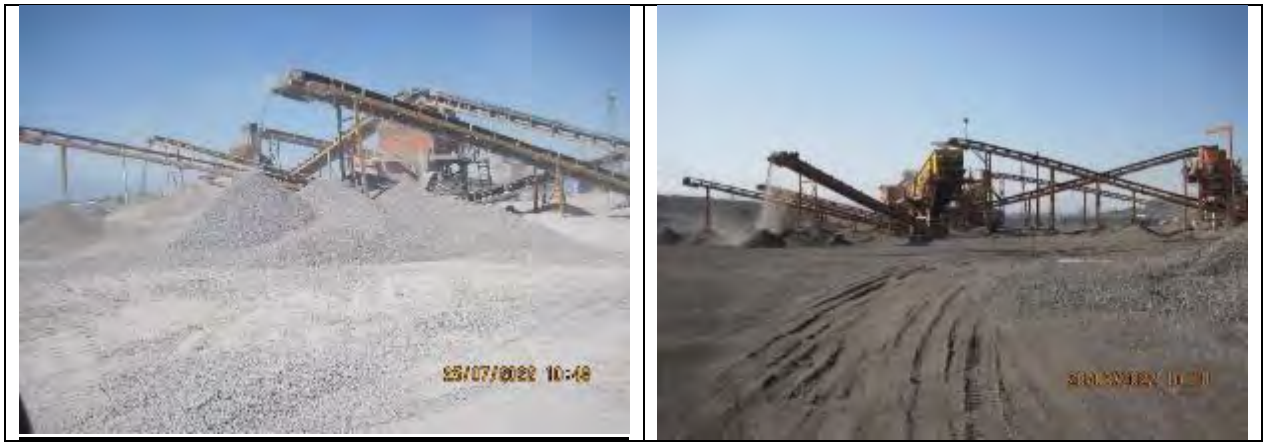
Figure 64 Operation of a stone crushing plant on moistened raw materials

190. *Problems with the stone crusher.* It has been repeatedly found that the stone crushing plant operates without water sprinkling, thus polluting the territory of the plant and the territory adjacent to the plant, causing harm to health and the environment. Several letters of non-compliance were sent to the contractor, but the violation continued. All warnings from Eptisa were ignored. The contractor explained the current situation by breakdowns in pipelines.

191. At the same time, the requirements of the general conditions of the Contract-Technical Specifications, paragraph 1.2.10 (j), were violated: “Crushing plants should only work with dust control devices”.

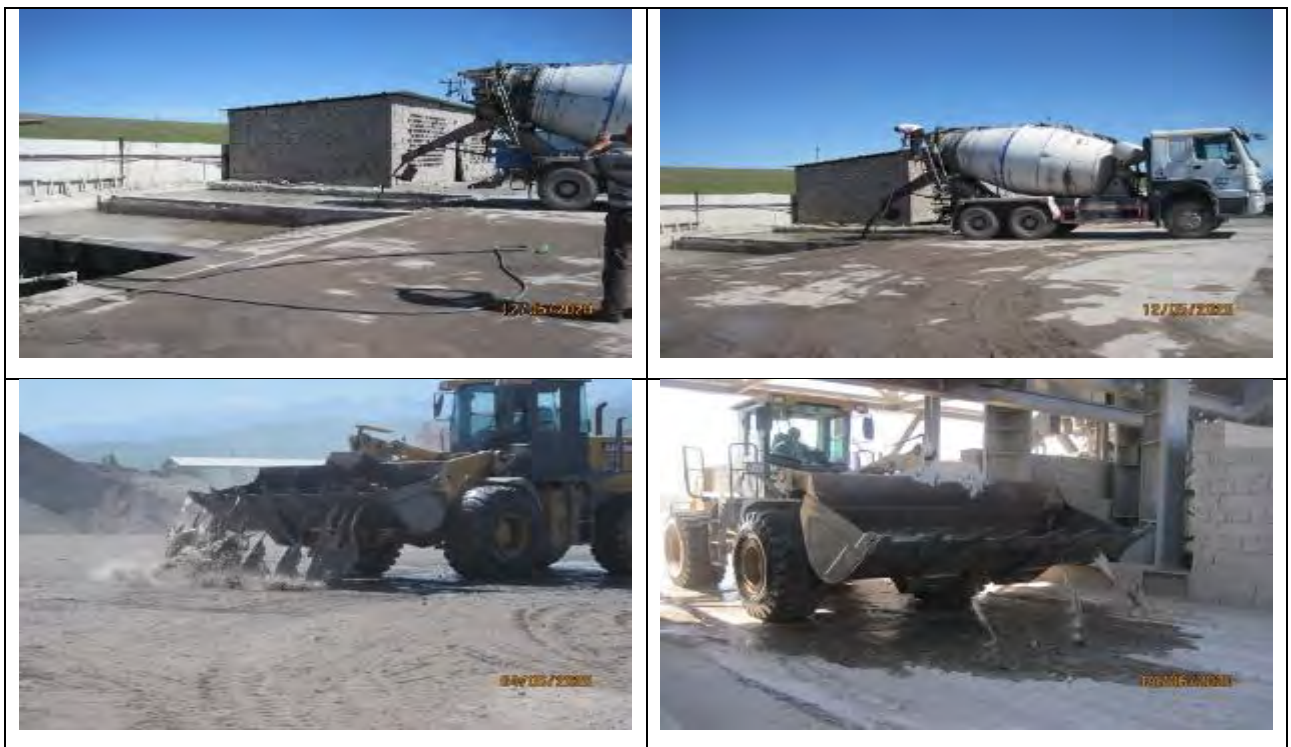
194. Washing of concrete mixers is carried out on a specially designated site. Wash water is discharged into a special three-section sump. Further, washing water, after settling, is used to sprinkle it on the territory of the production site.

Figure 67 Washing of concrete mixers

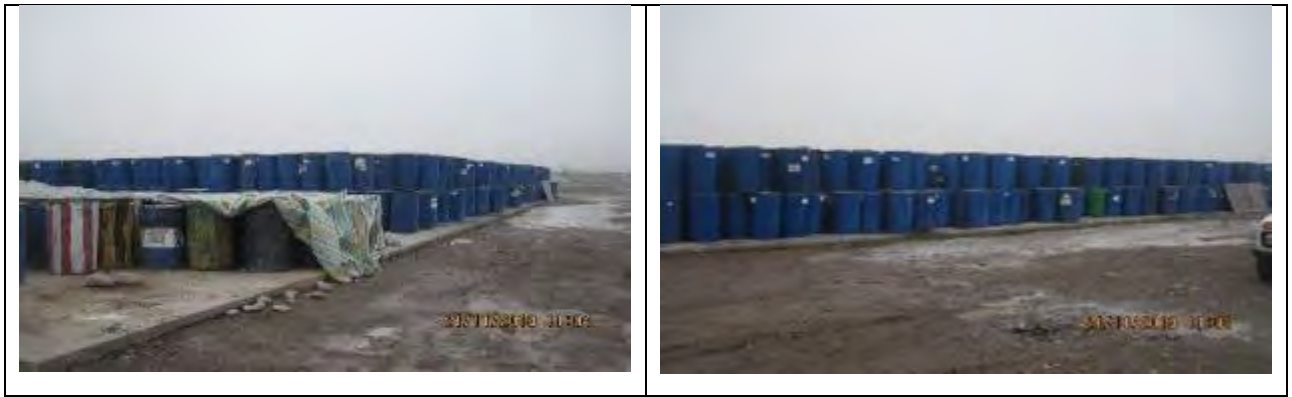
199. The next batch of bitumen was delivered in metal barrels. The barrels were installed on a specially prepared concrete platform. Partially the barrels were installed on a dense polyethylene film.

Figure 70 Bitumen in metal barrels stored on a prepared site

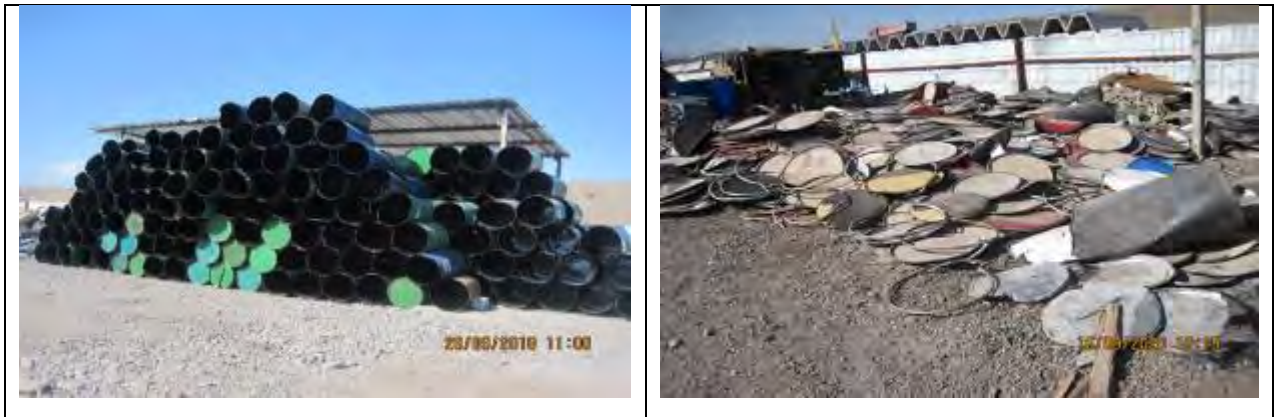
200. The problem was in the disposal of empty barrels and caps. Empty barrels from bitumen were stored on the territory of the asphalt plant and the Contractor had to constantly be reminded on the need for its disposal.

Figure 71 Empty barrels from used bitumen

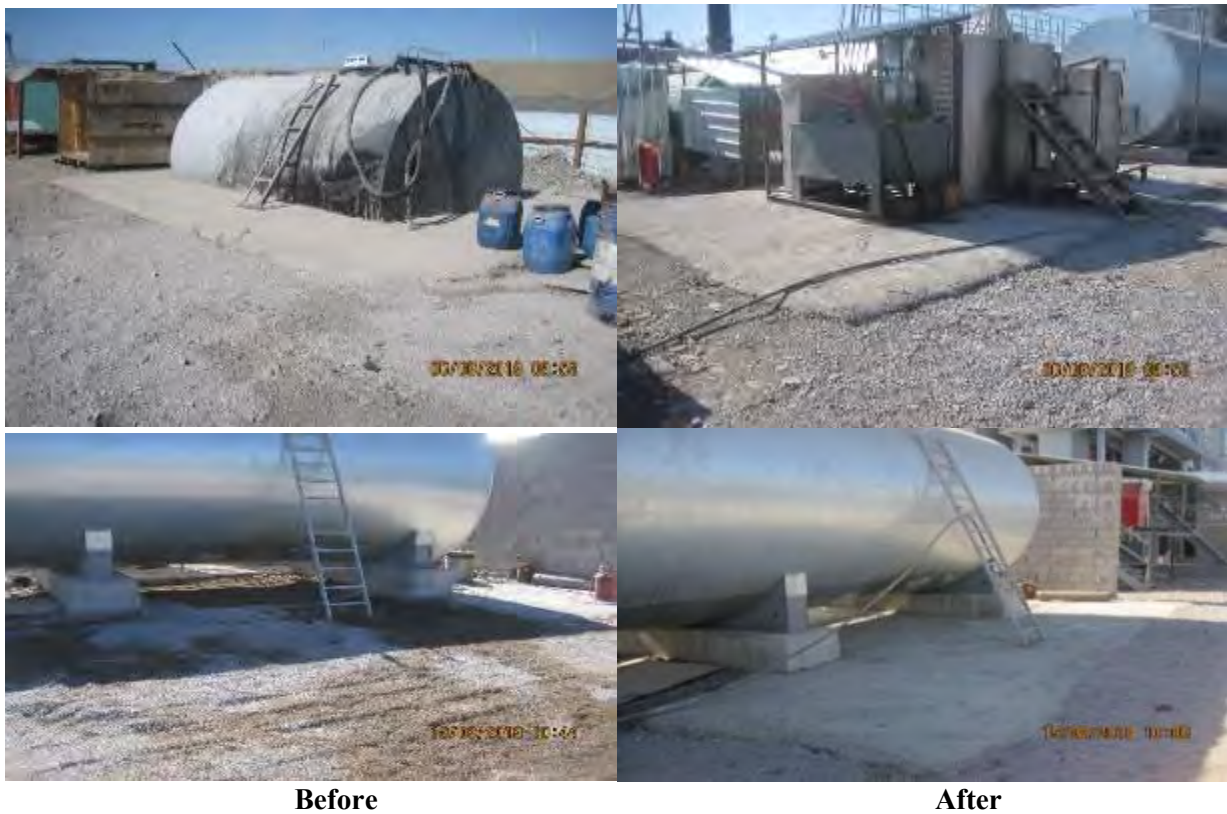
202. During the operation of the plant, all soil around the containers with chemicals must be protected from runoff and spills of hazardous materials by an impenetrable protective cover.

Figure 72 Impenetrable protective coating around chemical containers

203. The Contractor was recommended to protect the soil around the containers with chemicals from runoff and spills of hazardous materials with an impenetrable protective coating. These recommendations were taken into account and implemented by the Contractor.

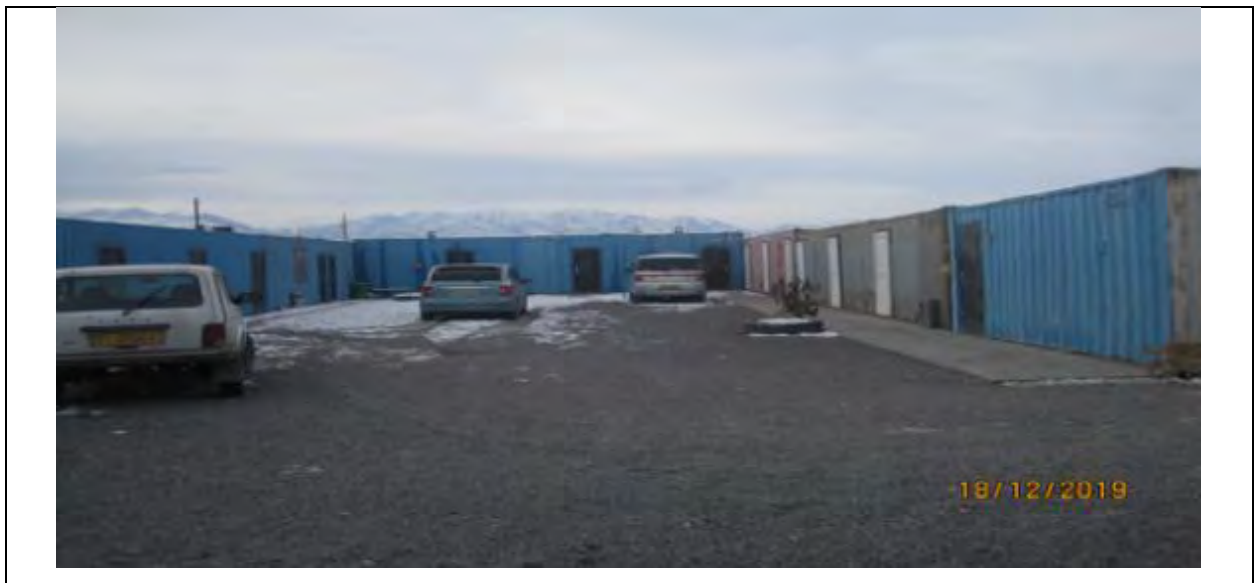
204. Due to the proximity to the main gas pipeline, in 2018 the relevant services have repeatedly issued orders to relocate the residential sector outside the sanitary protection zone. Once the land plot owner's (Emergency Control Ministry) permission was obtained, in 2019 the residential area was relocated to a safe distance and placed on the east side of the industrial zone in accordance with safety requirements and hygiene standards.

Figure 73 Workers' accommodation camp on the territory of the production site

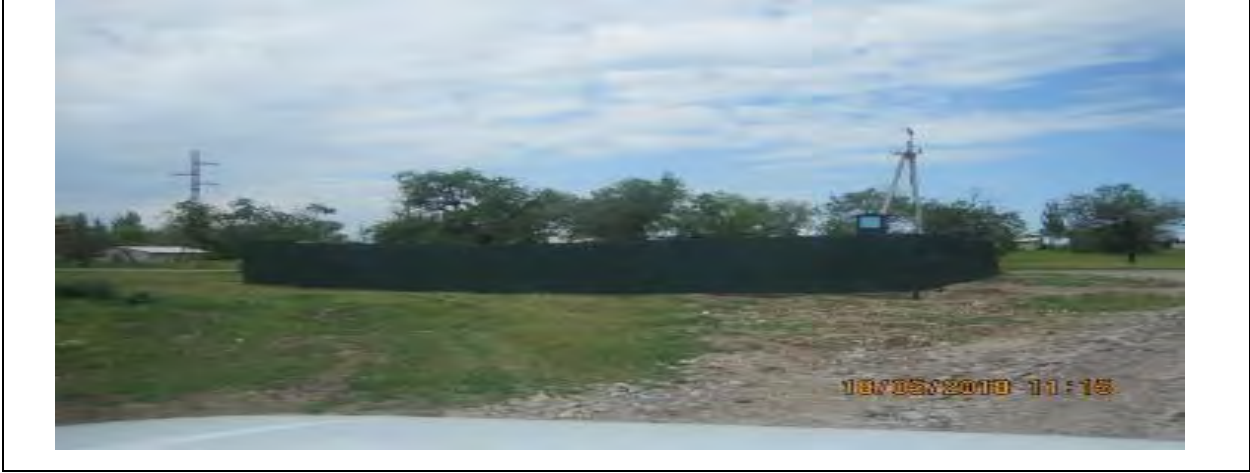
207. Water on the territory of the production site is supplied from an existing well on the basis of Agreement No. 38 “On the provision of a well for temporary use” dated October 10, 2017. The well was restored by the Contractor, a pipeline was laid to the plant. Currently, there are no problems with water at the plant. The figure below shows the fenced area of the well.

Figure 74 Restored well to supply the plant with water

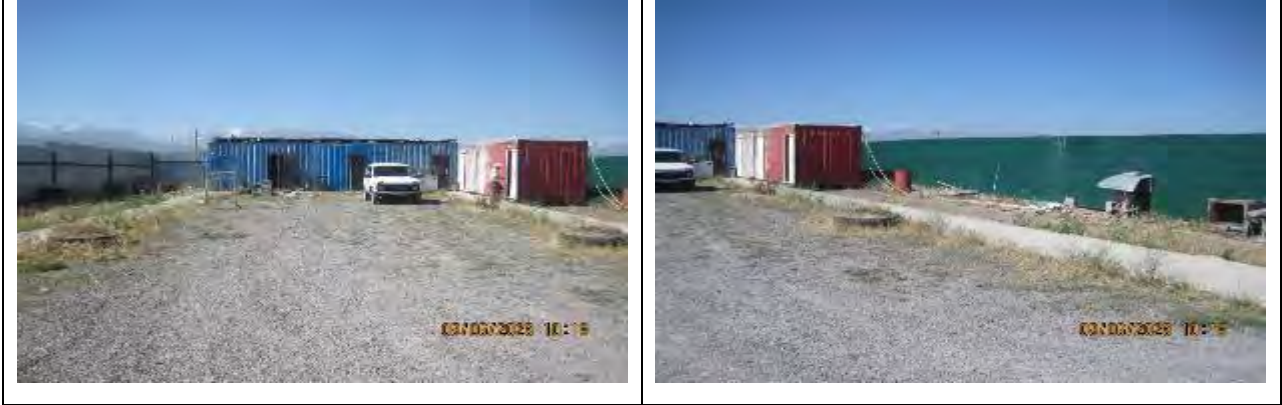
209. The workers' camp is currently being dismantled. Only a few containers left for specialists.

Figure 75 Dismantled camp for workers on the territory of the production site

208. After the completion of the project, the Contractor within six months, starting from February 2024, will remove equipment, level the territory, probably only washing pits for concrete mixers will remain, as well as earth-deposits that served to load the material into the crusher.

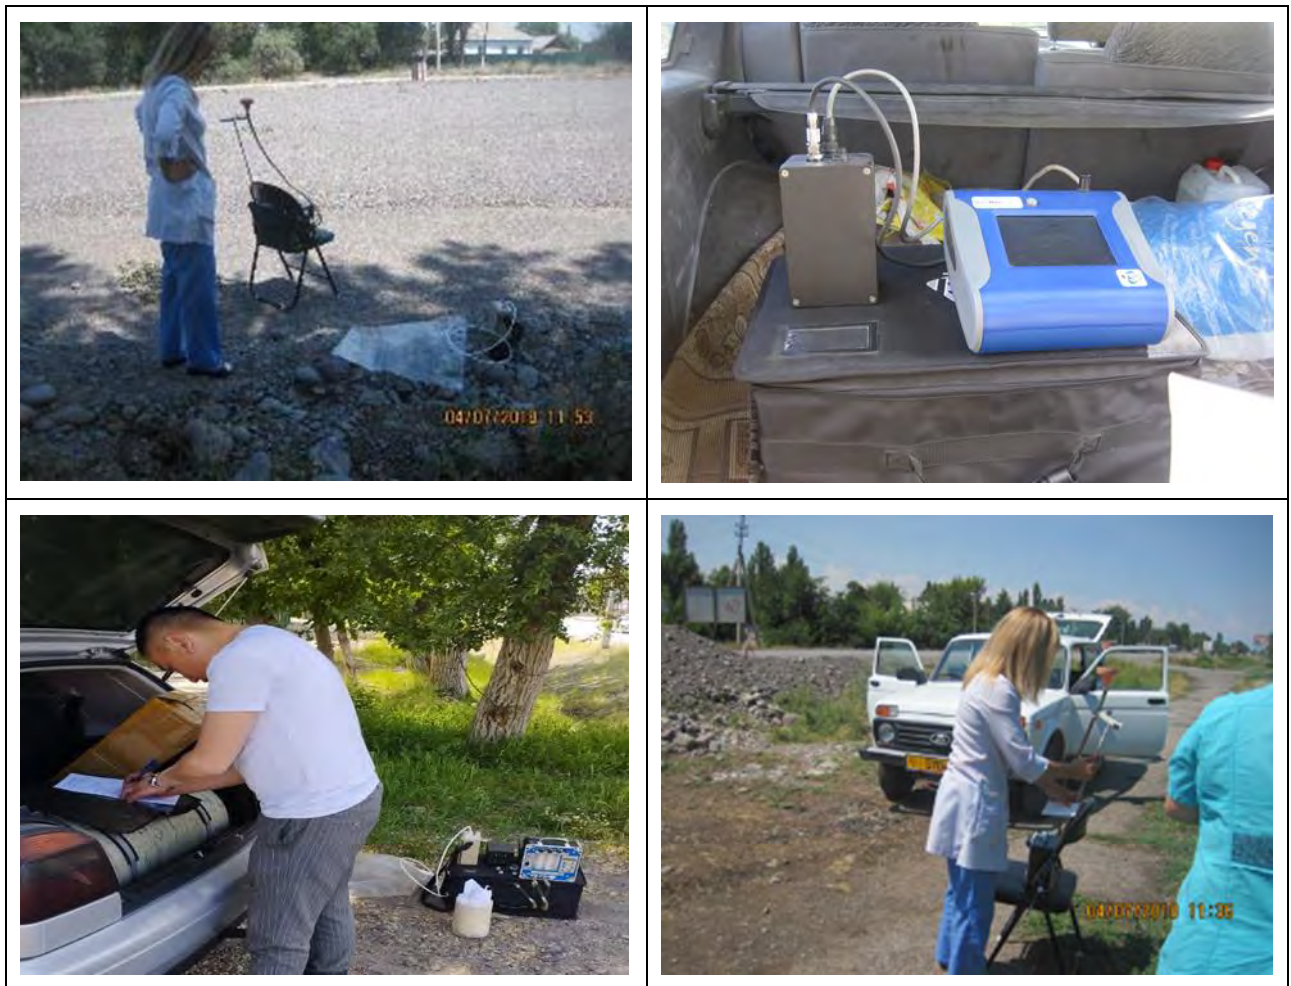
Figure 76 Air quality monitoring

221. *Conclusion based on the results of air quality measurements*: according to the results of air quality tests, the maximum permissible concentration (MPC) was exceeded for nitrogen dioxide up to 2.5 MPC. This

excess was observed regularly from the very beginning of the monitoring on the project road, starting in 2013, even before the start of construction.

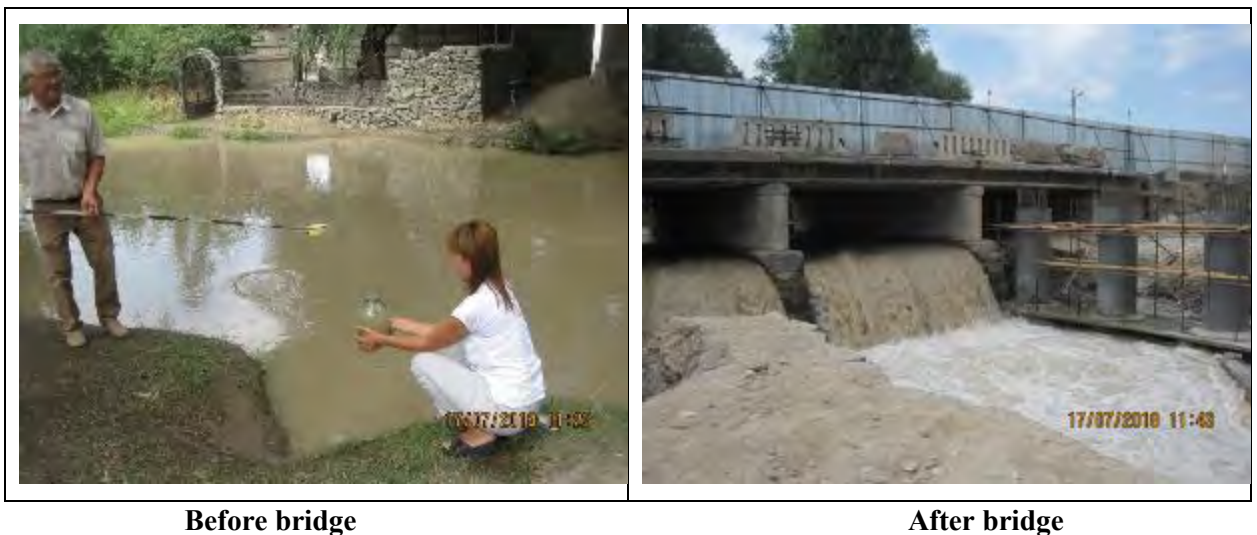
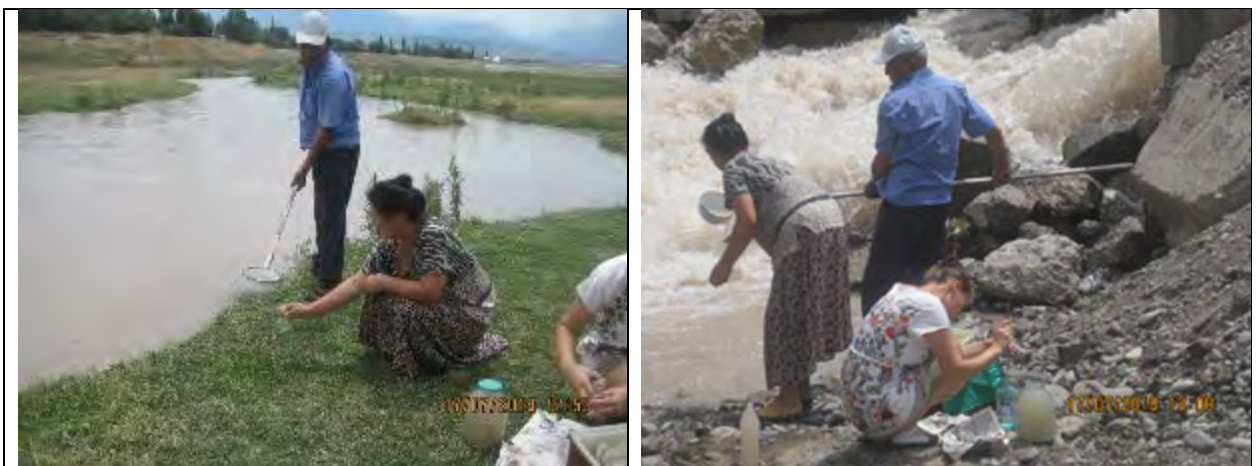
226. The results of the monitoring showed that on both rivers there was no impact of construction work in the samples behind the bridge along the Sokuluk and Ak Suu rivers. Subsequently, in 2019 and later, water did not enter the rivers and was taken apart for irrigation.

Figure 77 Water sampling on the Sokuluk river

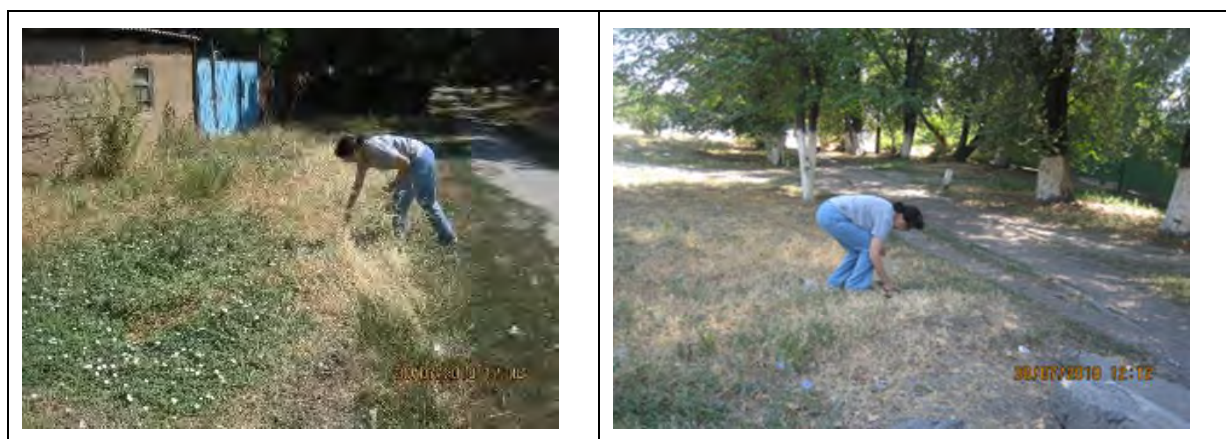
Figure 79 Topsoil sampling

228. Soil was monitored in order to determine the possibility of its further use. Samples were taken from the top layer of soil from a depth of no more than 10 cm. Background samples were taken in areas remote from the road. According to the results of the monitoring, there was excess lead content and a high content of oil products. In the future, this soil can be used for backfilling slopes, if necessary. When such soil is used for lawn purposes or as soil for planting trees, it is necessary to mix the contaminated top layer with uncontaminated soil.

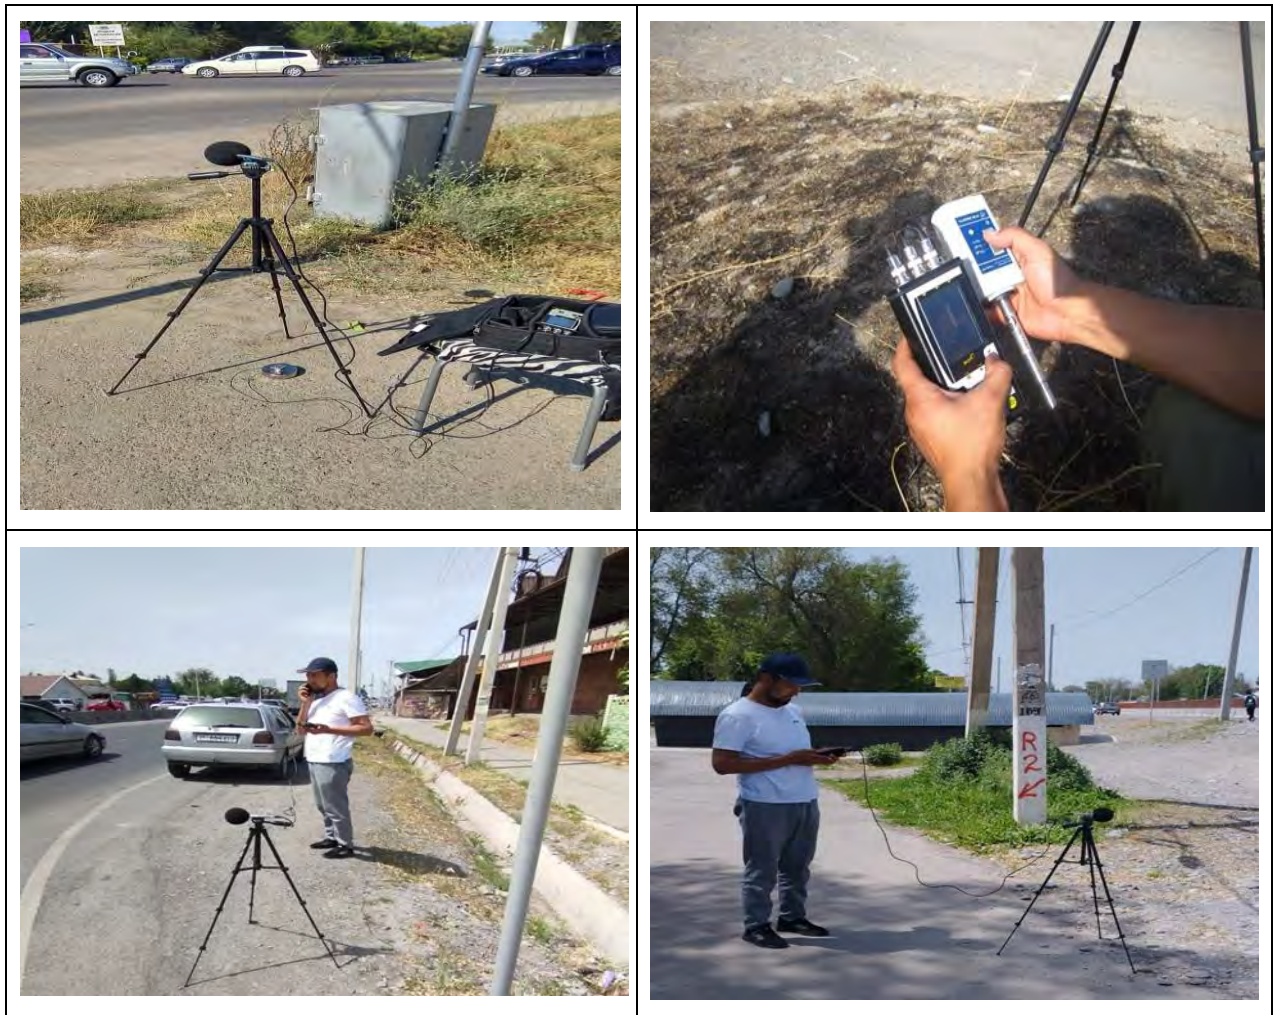
231. Also on June 8, 2018, noise and vibration monitoring was conducted in the Sokuluk bridge construction area, where pile driving was carried out, which could cause vibration in nearby houses. The laboratory measured noise and vibration in a nearby house, as well as in the surrounding area. The noise level measured in the bedroom of the house at 231 Frunze Street during the operation of the equipment did not exceed the sanitary standard.

Figure 80 Noise and vibration monitoring

232. *Conclusion based on the results of measurements of background noise and vibration level:* at the time of the measurements, the background noise level at the measurement points at a distance of 5–41 m from the edge of the road when vehicles were passing was 61–83 dBa while maximum permissible level is 75 dBa. When the construction equipment was operated, the excess of the sanitary norm was from 5 to 10 dBa, and when the construction equipment was turned off, the noise level exceeded the sanitary norm by up to 2 dBa. These indicators were short-term.

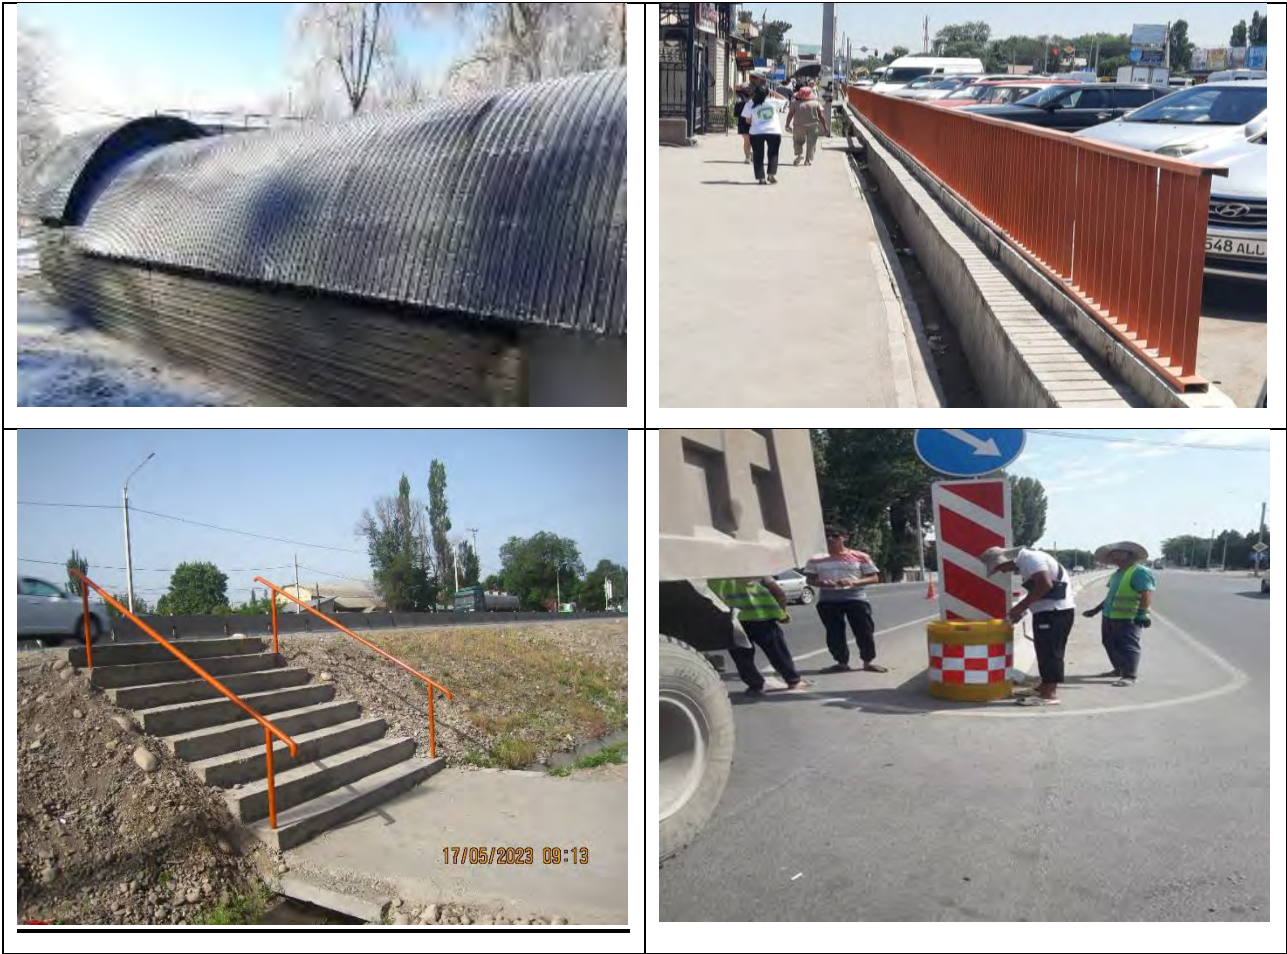
245. The buffers are filled with sand, have a height of 80 cm, a diameter of 55 cm and a weight of 200 kg. The buffers were installed next to the parapet on the road, have a reflective film and are therefore visible from afar at night.

246. In the case of an accident, buffers can withstand hits and deformations, reducing damage to vehicles and ensuring the safety of passengers.

Figure 81 Examples of good practices
