Semi-annual environmental monitoring report

July - December 2023

Central Asian Regional Economic Cooperation Corridor 3 Improvement Project (Bishkek-Osh Road), Phase 4, Bishkek-Kara-Balta section (km 8.5 - km 61).

Prepared by: Joint Venture Temelsu International Engineering Services Inc., E. Gen Consultants Ltd., and Desh Upodesh Ltd. in association with Kyrgyz TREC International, Ltd. for the Ministry of Transport and Communications of the Kyrgyz Republic and the Asian Development Bank.

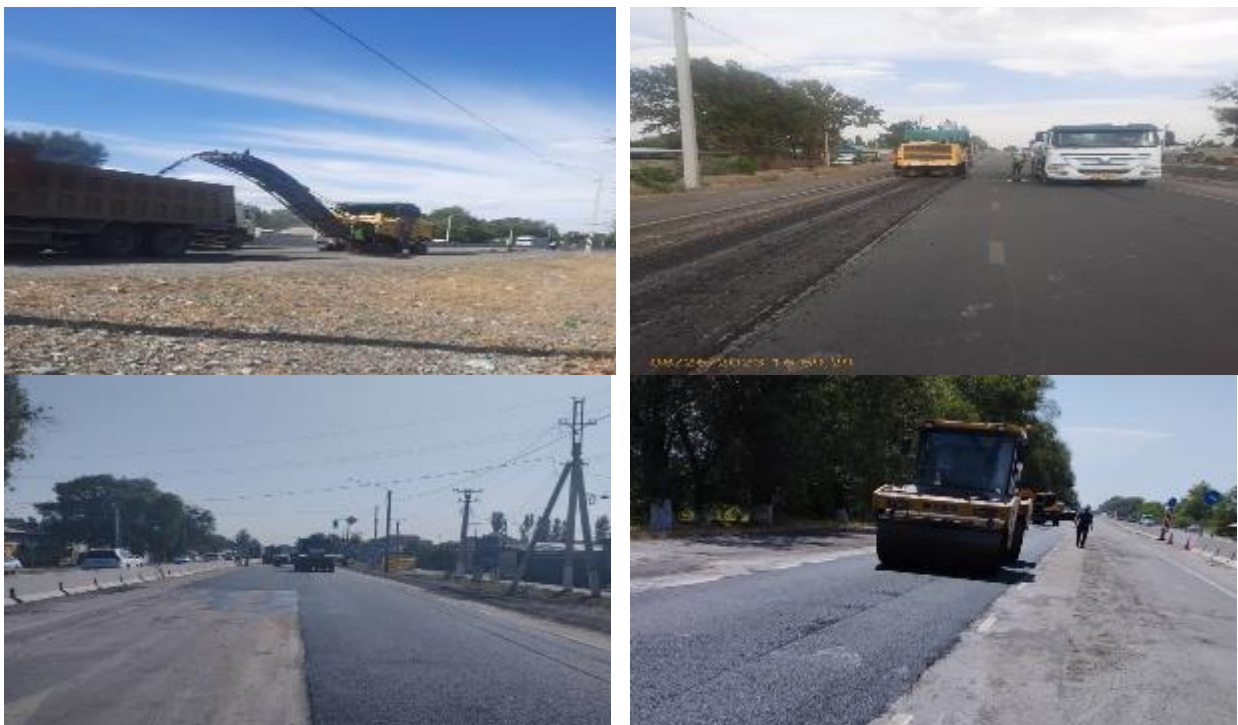
33. Work was carried out to remove deformed asphalt and lay new asphalt where rutting was developed.

Figure 3 Milling and laying wearing course, removing rutting

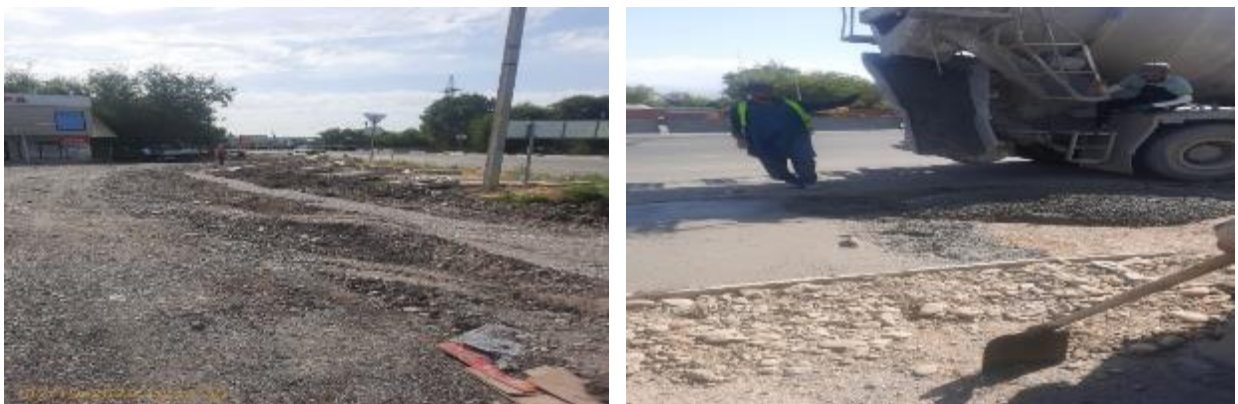
Figure 4 Construction of sidewalks

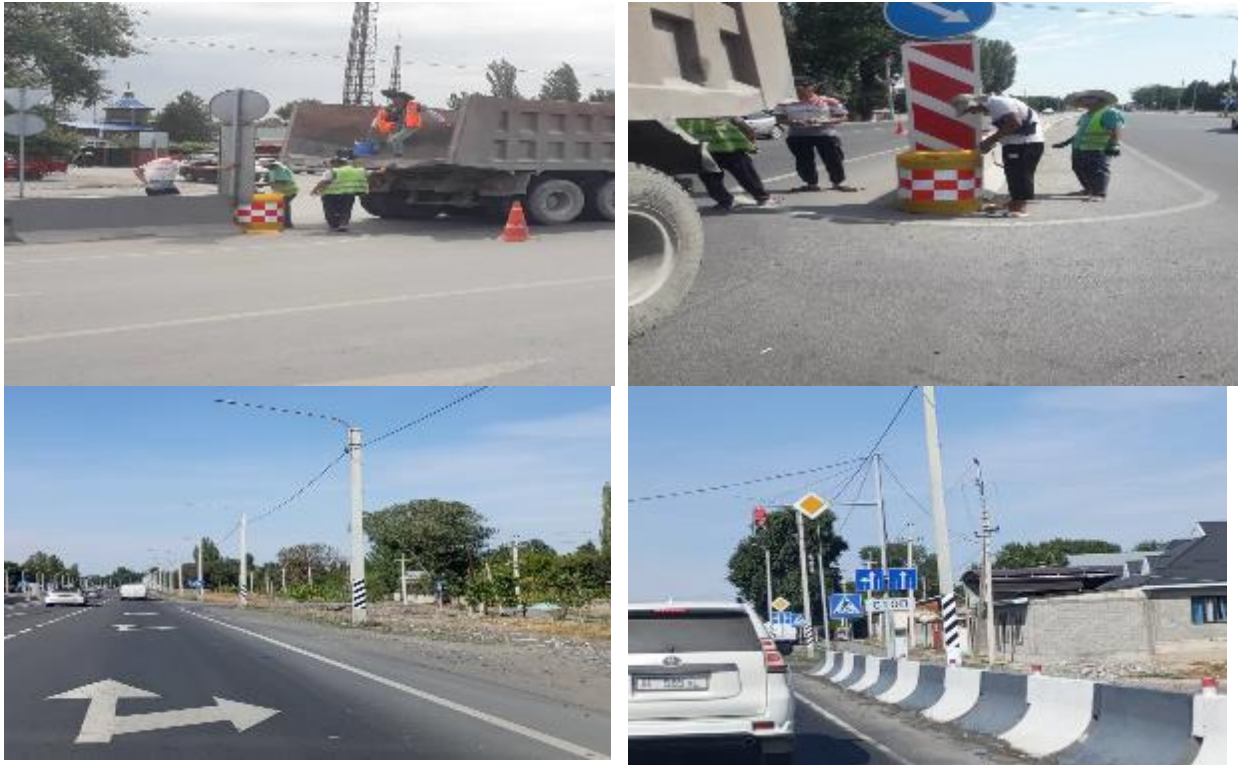
38. Anti shock buffers were installed on the carriageway to prevent traffic accidents and prevent loss of life. 50 buffers had been installed.

Figure 11 Installation of anti shock buffers. Application of road marking

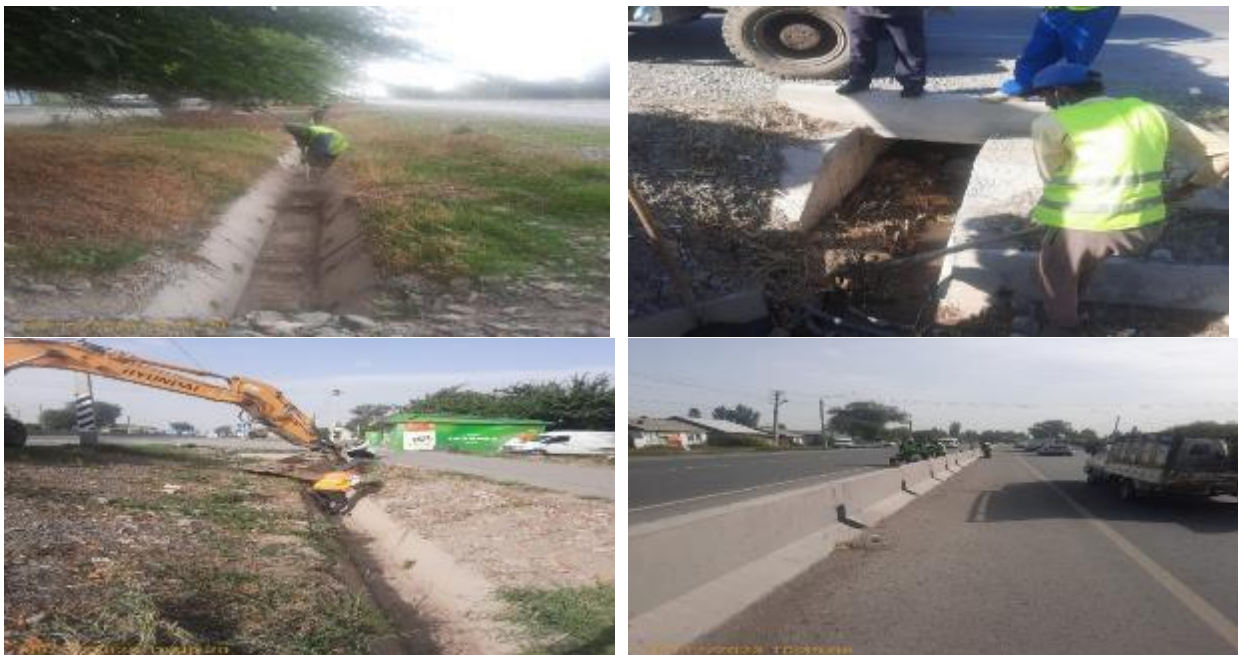
41. In the autumn period, debris, stones, and grass were cleared near parapets and on drainage ditches.

Figure 12 Removing debris on drainage ditches and parapets

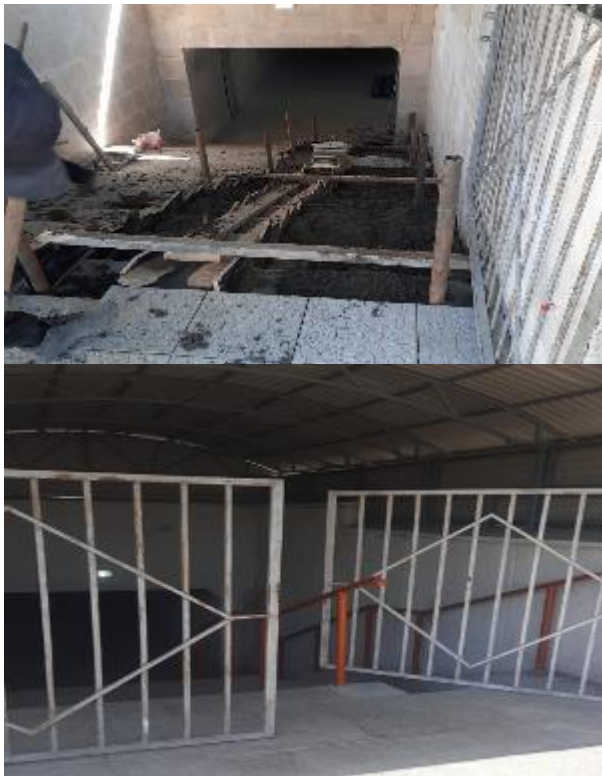
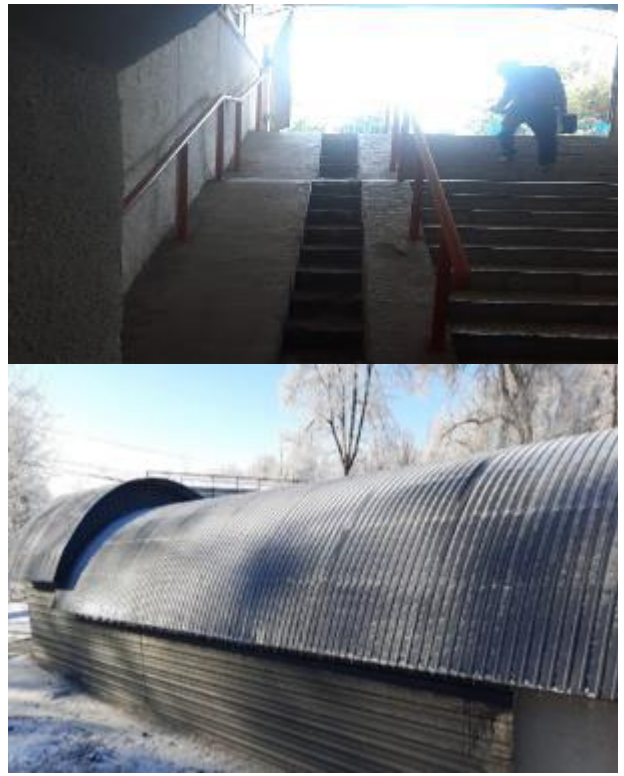
43. Work continued on underpasses. Roofings were built up, walls and steps were finished, and concrete pavement perimeter was constructed.

Figure 17 Work on underpasses

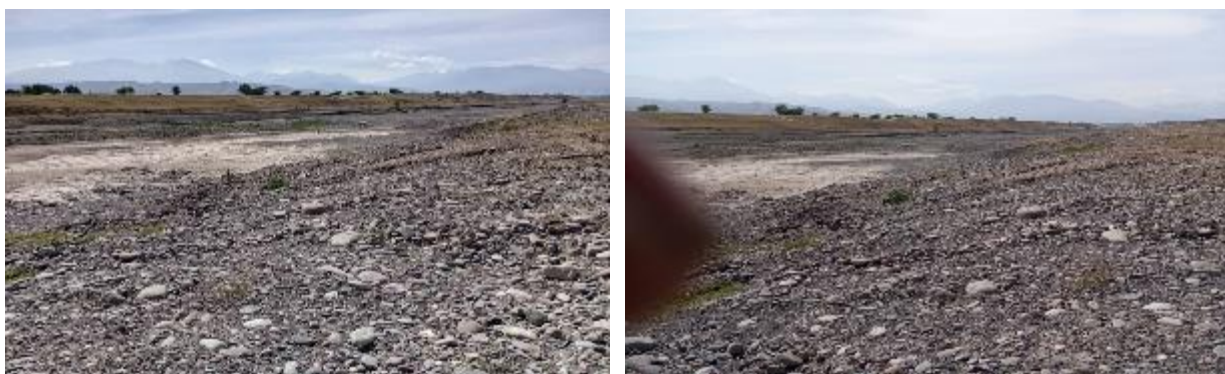
50. During the reporting period, no work on the extraction of inert materials was carried out at the borrow pit. Reclamation works were carried out at the borrow pit.

Figure 22 Ak Suu2 borrow pit after reclamation

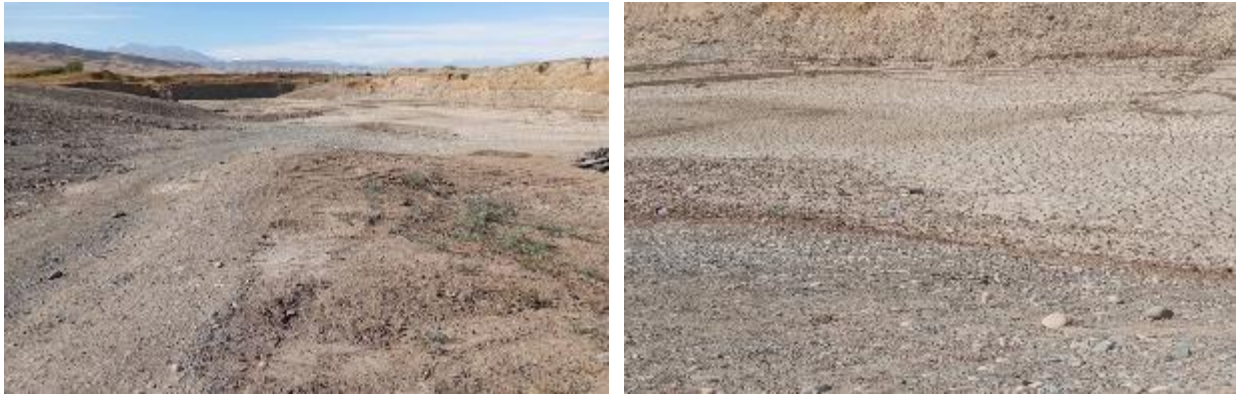
52. During the reporting period, no work on the extraction of inert materials was carried out at the borrow pit. Reclamation work was carried out at the borrow pit.

Figure 23 Belek borrow pit after reclamation

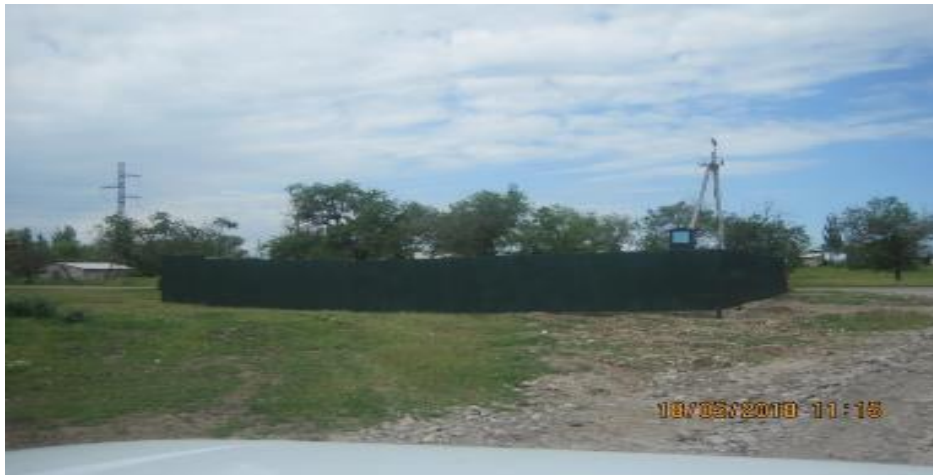
55. Water on the territory of the production site is supplied from an existing well on the basis of Agreement No. 38 "On the provision of a well for temporary use" dated October 10, 2017. The well was restored by the Contractor, and a pipeline was laid to the plant. The well area is fenced. There were no problems with water during the operation of the plant.

Figure 25 Restored well to supply the plant with water

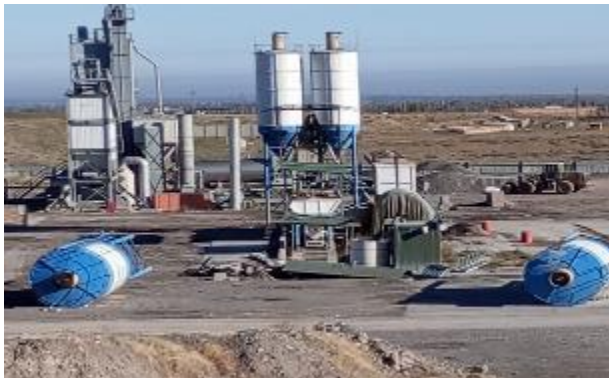
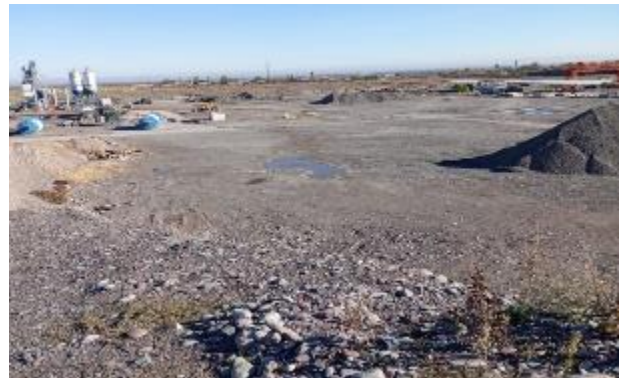
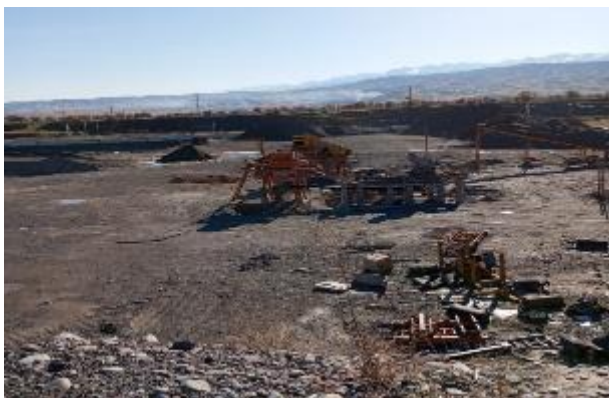
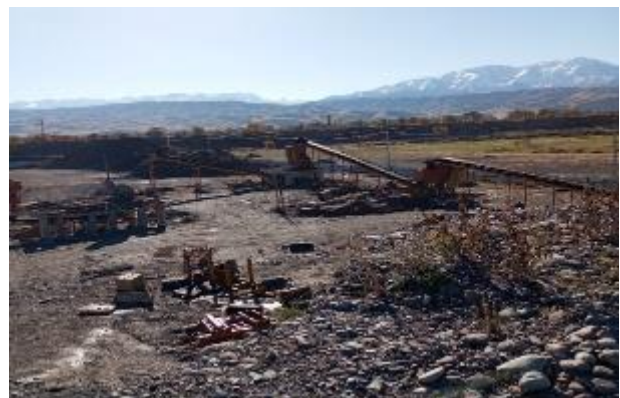
- 56. During the reporting period, asphalt and concrete mixture were produced at the production site, which were used mainly on the construction sites.
- 57. Currently, structures at the plant are being dismantled.
- 58. After completion of the project, the Contractor will remove the equipment within six months, starting in February 2024, and will level the territory; probably only washing pits for concrete mixers will remain, as well as an earthen embankment which was used to load material into the crusher.

Figure 26 Dismantling of equipment on the production site

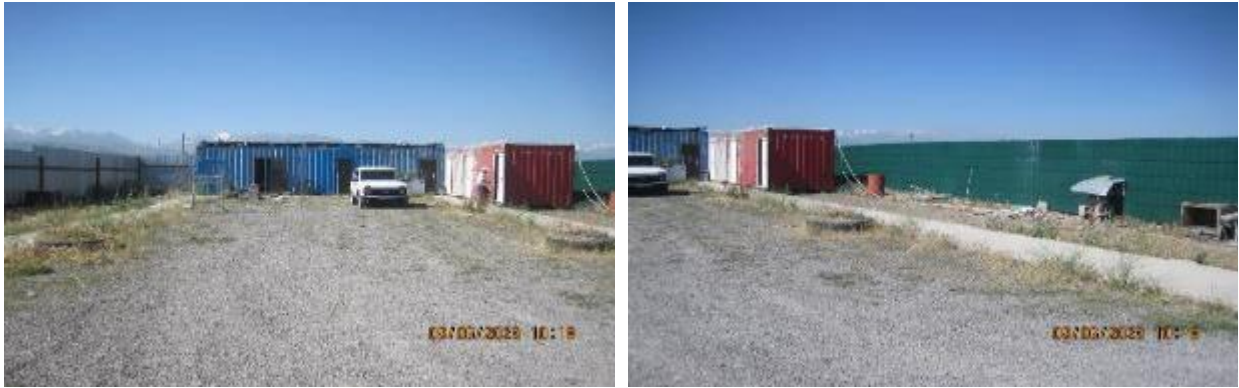
- 59. The workers' camp is also being dismantled. There are a few containers left for specialists.

Figure 27 Dismantled camp for workers on the territory of the production site

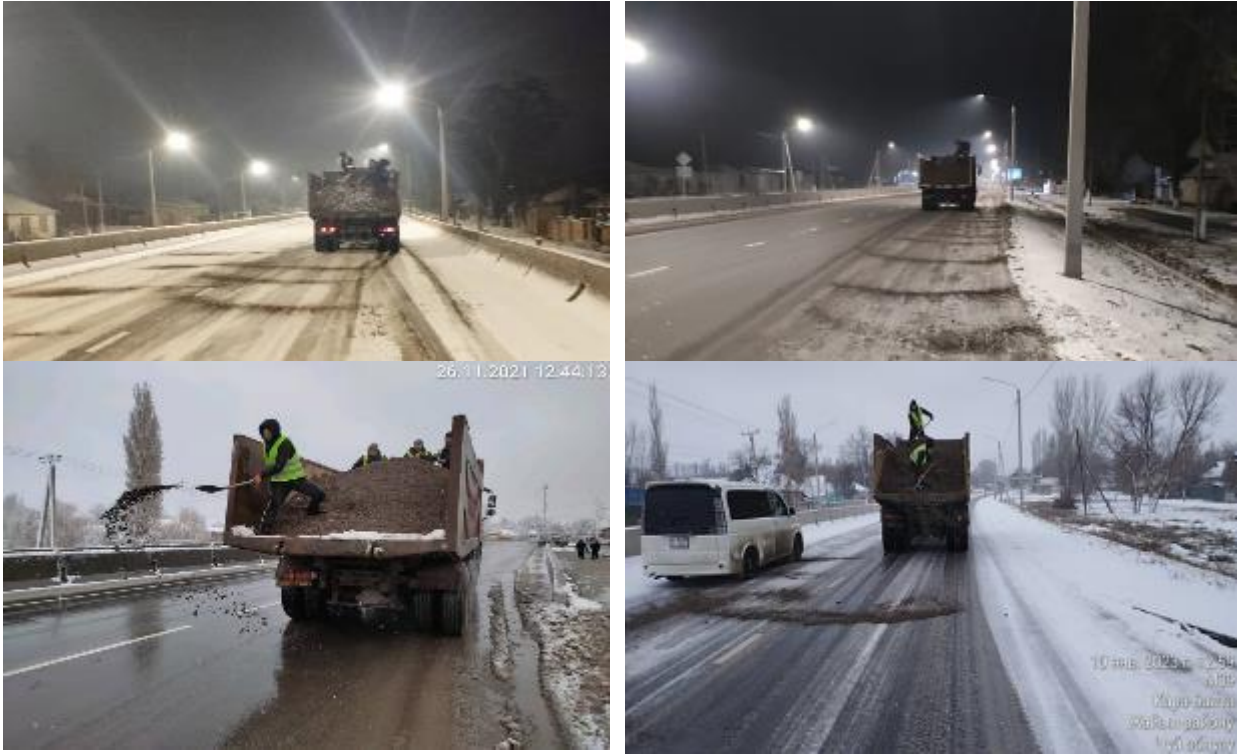
Figure 28 Sand sprinkling on the road. Control of ice

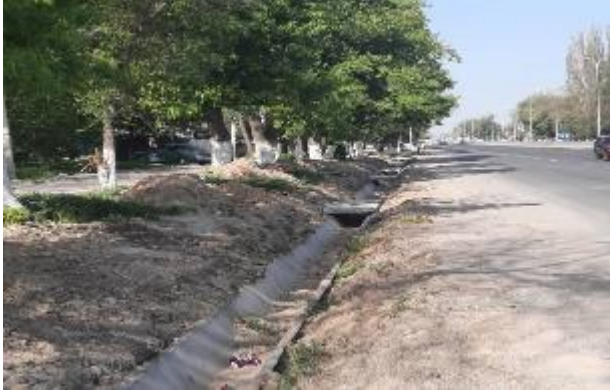
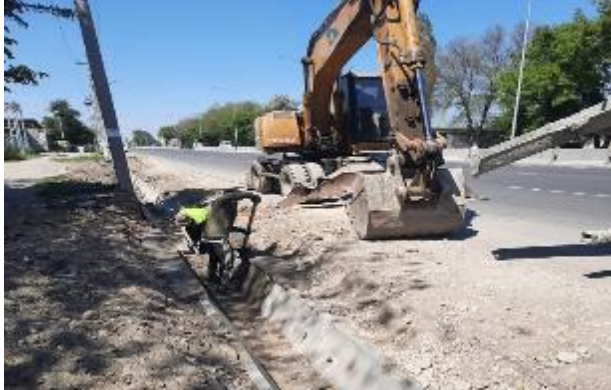
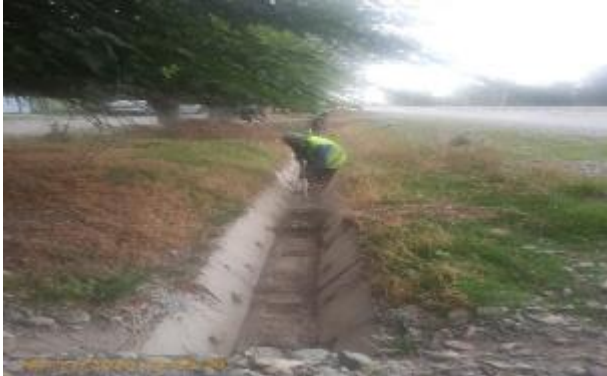
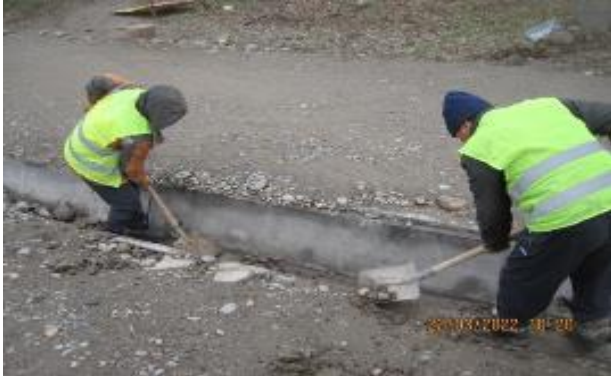
100. In July, new drainage ditches were installed and on the previously installed ones' stones and debris were removed.

Figure 30 Cleaning drainage ditches

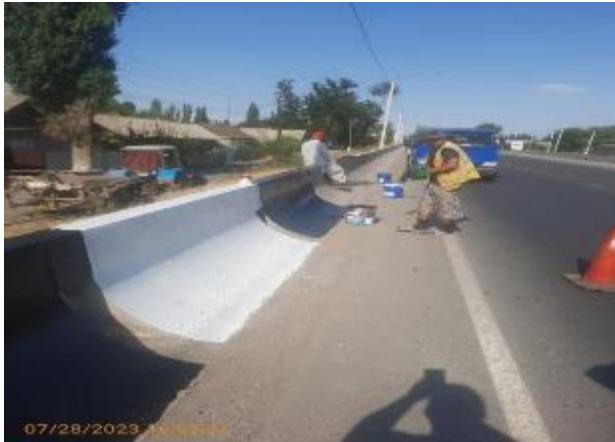
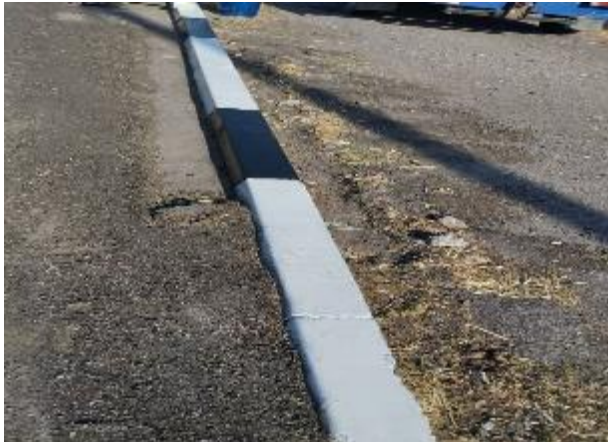
102. Parapets and curbstones were painted.

Figure 31 Painting parapets and curbstones

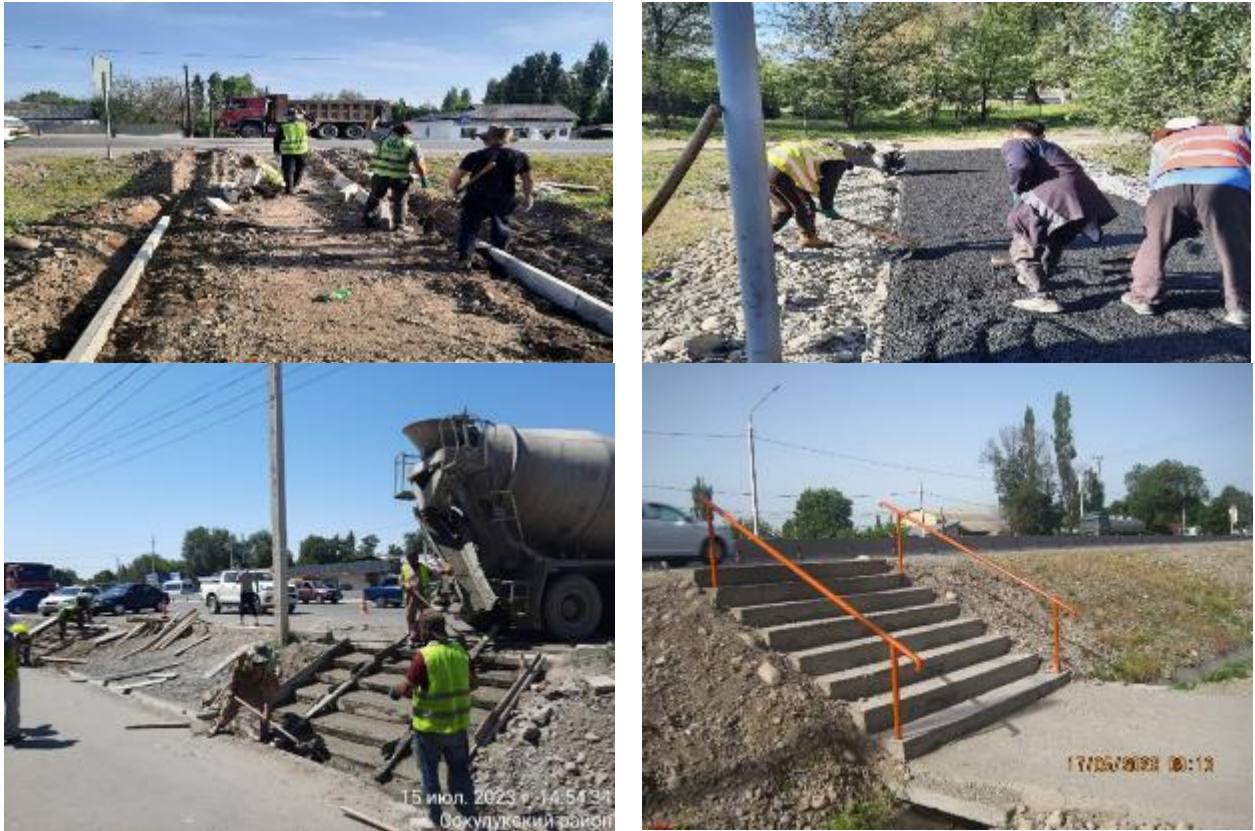
103. Steps were constructed on jointing walkways with large slopes.

Figure 32 Construction of jointing walkways

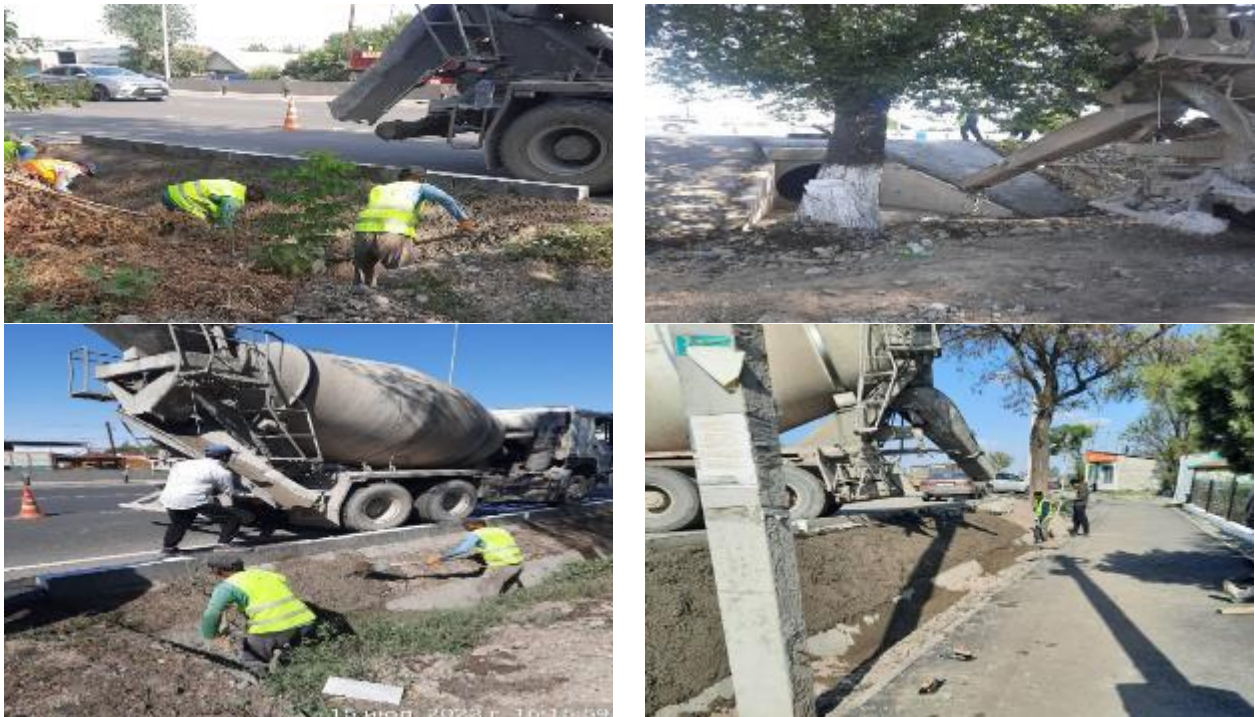
104. During the reporting period, road shoulders were cleaned and strengthened.

Figure 33 Cleaning and strengthening shoulders

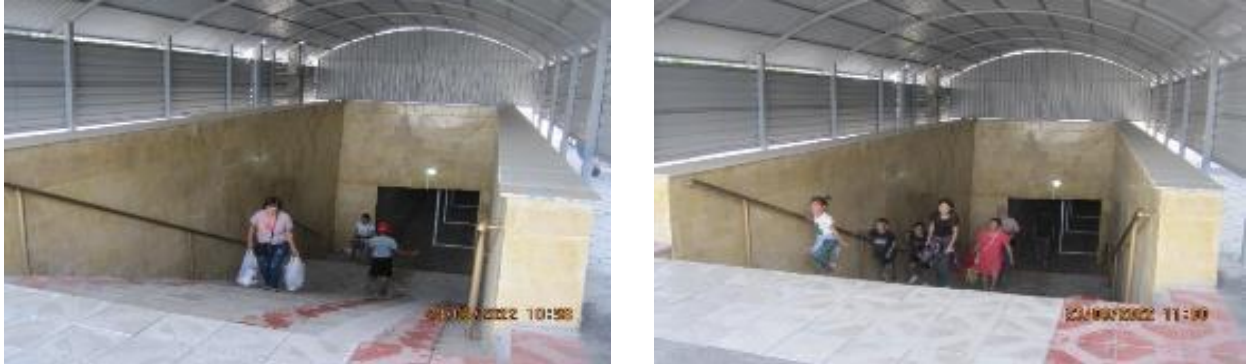
105. During the reporting period, completing works were carried out on underpasses. Walls and steps were covered with finishing tiles. The walls were finished, a concrete pavement perimeter was constructed, and a roof was extended on underpasses to prevent icing on steps.

106. Adults and children are currently crossing the road using underpasses. Lighting connected in all underpasses.

Figure 34 Underpass in the Sokuluk village

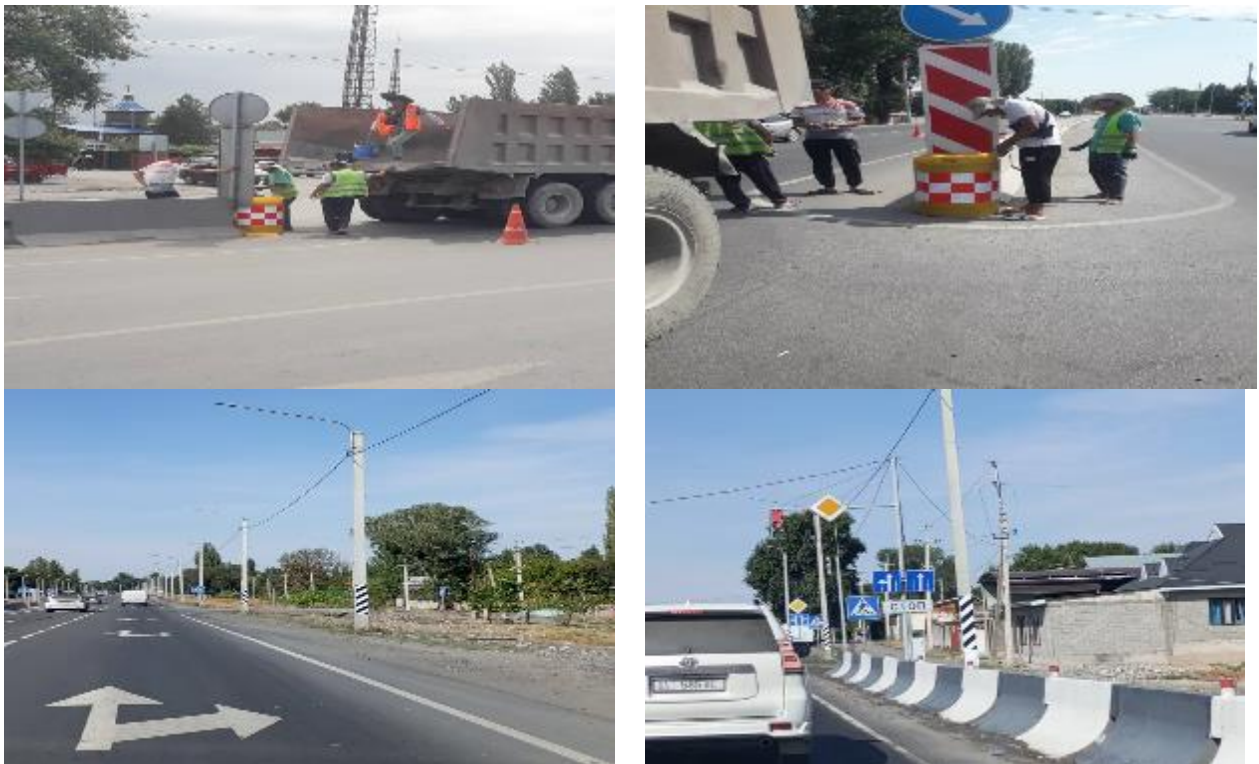
107. Anti shock buffers on the carriageway were installed to prevent traffic accidents and prevent loss of life. 50 buffers were installed at 45.1 km section and 7 buffers at 7.4 km section.

Figure 35 Installation of anti shock buffers. Application of road marking

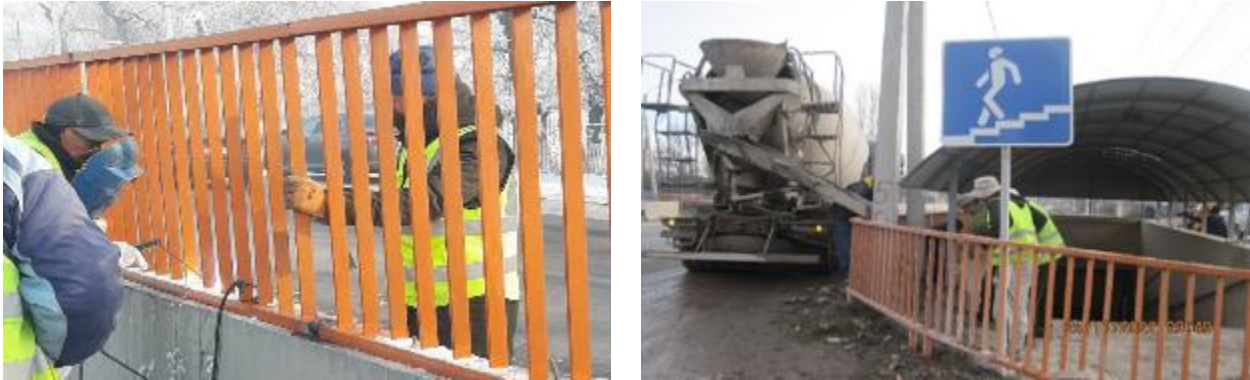
108. Metal guardrails were installed on the top of the parapets near underpasses, in crowded places, and near schools, markets and supermarkets. This was done to prevent road accidents and

prevent deaths in especially dangerous places, and to prevent people from jumping over the parapets creating an emergency situation.

Figure 36 Installation of metal guardrails near underpasses and in crowded places

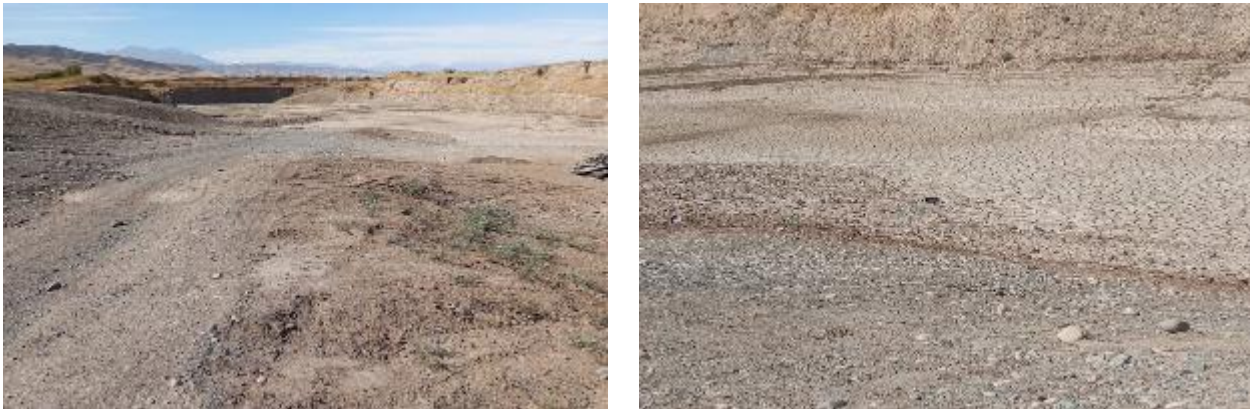
110. **Belek borrow pit.** During the reporting period, no work on extraction of inert materials was carried out at the borrow pit. Reclamation has been done. The borrow pit is prepared for handing over to Reclamation commission. The borrow pit should be handed over to the Reclamation Commission by February 2024.

Figure 37 Belek borrow pit after reclamation

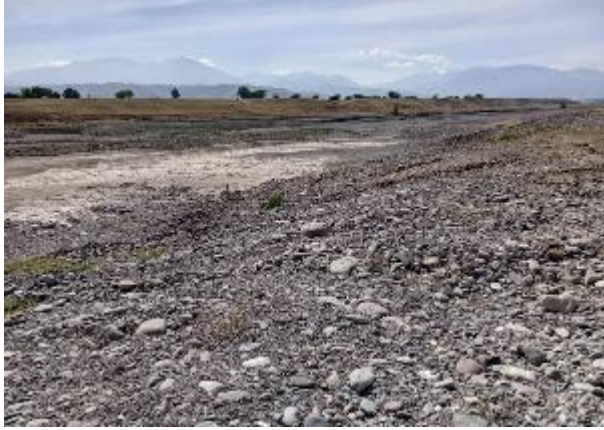
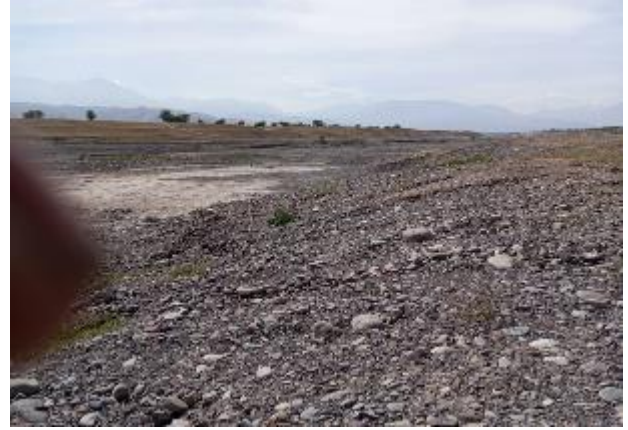
111. **Ak Suu 2 borrow pit.** During the reporting period, no work on extraction of inert materials was carried out at the borrow pit. Reclamation work was done. The borrow pit is prepared for handing over to Reclamation commission. The borrow pit should be handed over to the Reclamation Commission by February 2024.

Figure 38 Ak Suu 2 borrow pit after reclamation

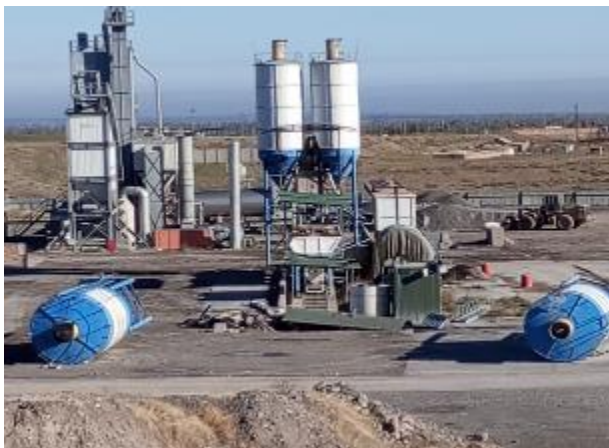
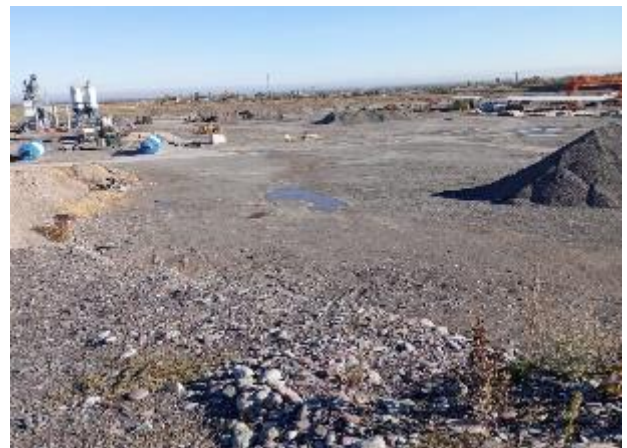
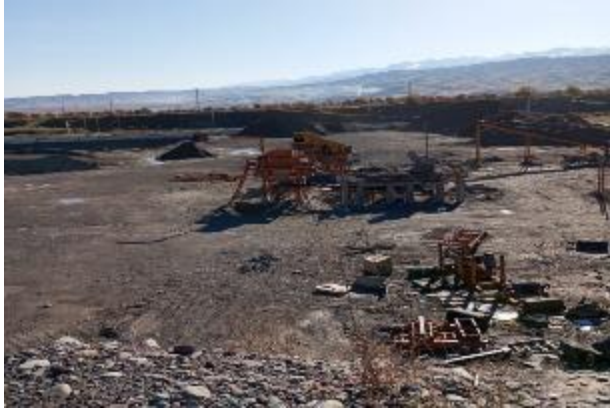
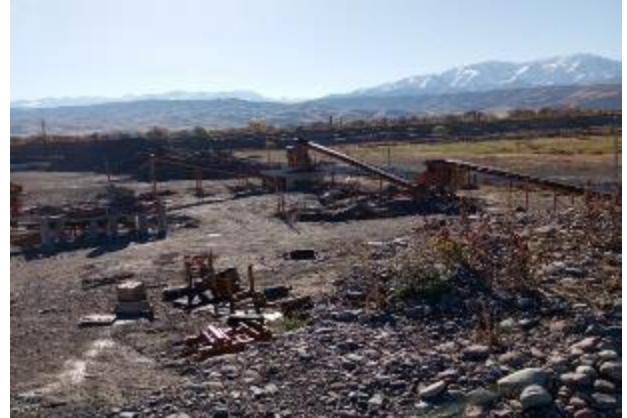
115. Currently, partial dismantling of structures at the plant is being carried out.

Figure 39 Dismantling of equipment on the production site

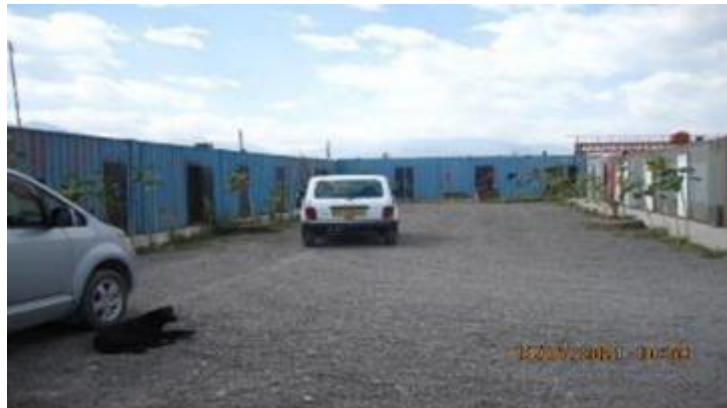
116. *Camp for the residence of workers at the territory of production site.* Initially, the workers' camp was designed for 50 places. There are kitchen room, equipped place for eating, shower rooms, washbasins, toilets at the camp. 2 fire shields were installed on the territory of the camp.

Figure 40 Workers' accommodation camp on the territory of the production site

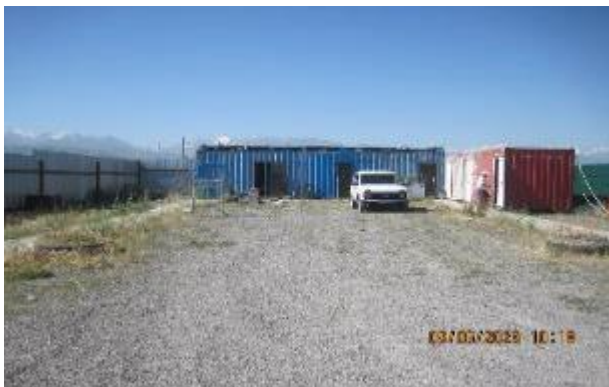
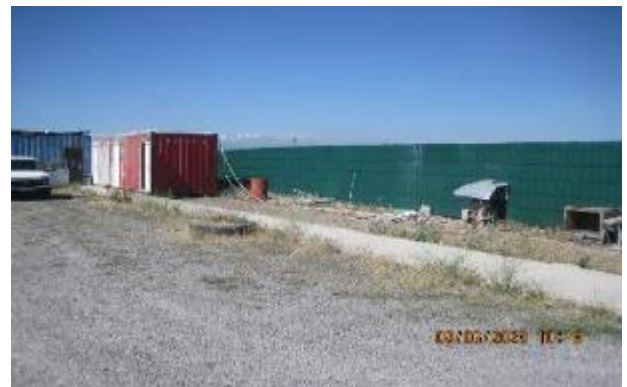
117. Currently, most of the residential containers have been removed. The camp is being dismantled. There are a few containers left for specialists.

Figure 41 Dismantled camp for workers on the territory of the production site

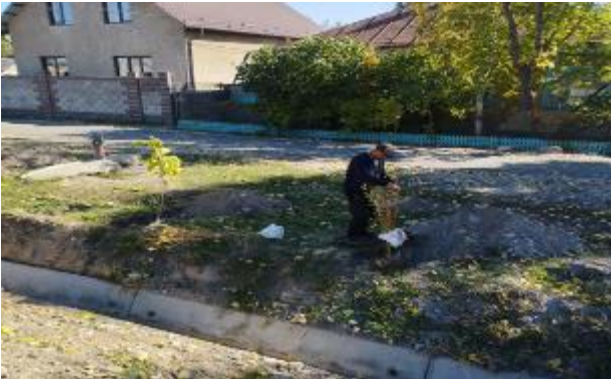
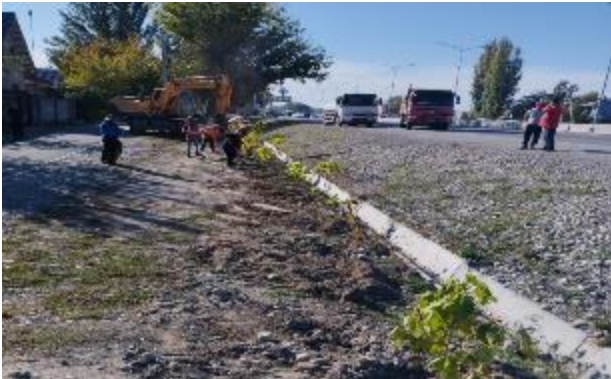
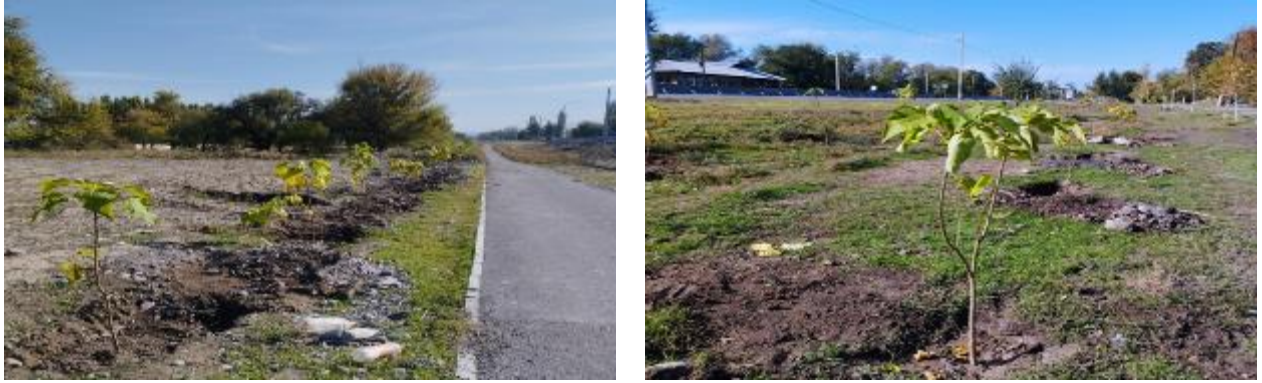
127. Starting in the spring of 2023, the China Railway No. 5 contracting company has started a phased planting of tree seedlings on km 8.5 to km 15.9 section in separate areas, where there were places free from growing trees.

Figure 42 Planting seedlings in autumn 2023

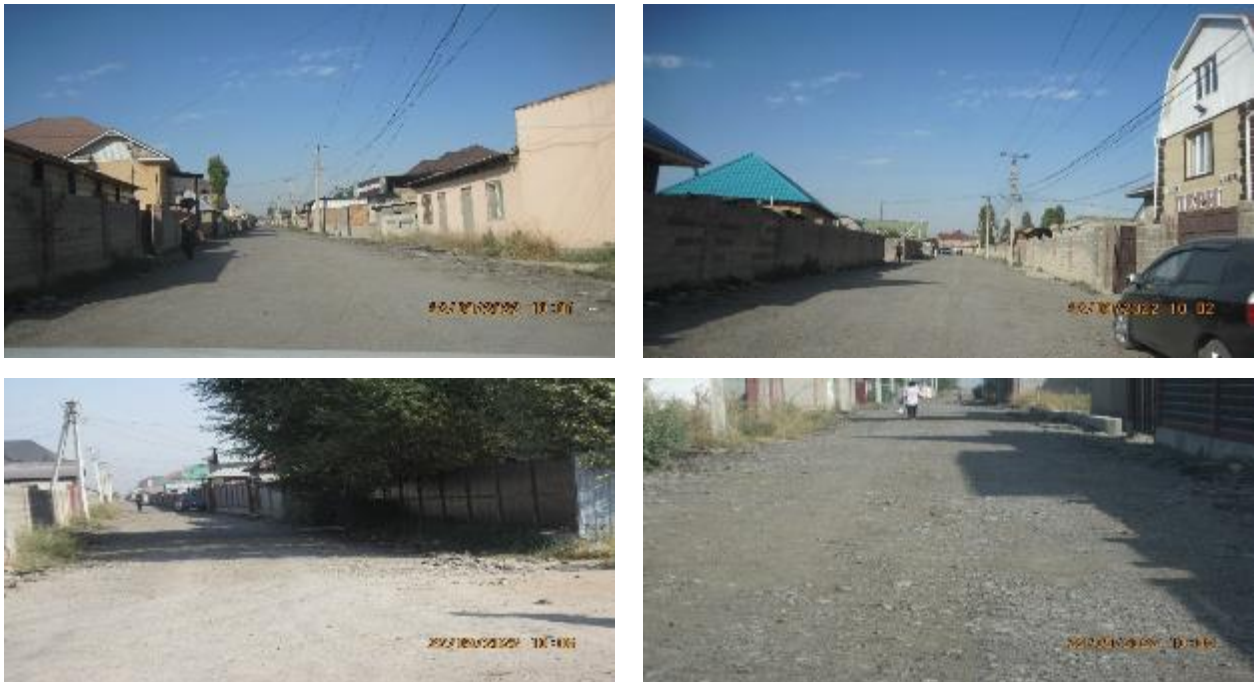
165. Asphalt wasn't transported to wetlands. A letter received from the ADB stating that in order to avoid harm to the health of local residents, it is prohibited to give old asphalt to local residents for their own use. This requirement has been met.

Figure 45 Streets paved with old asphalt at 7.4 km section

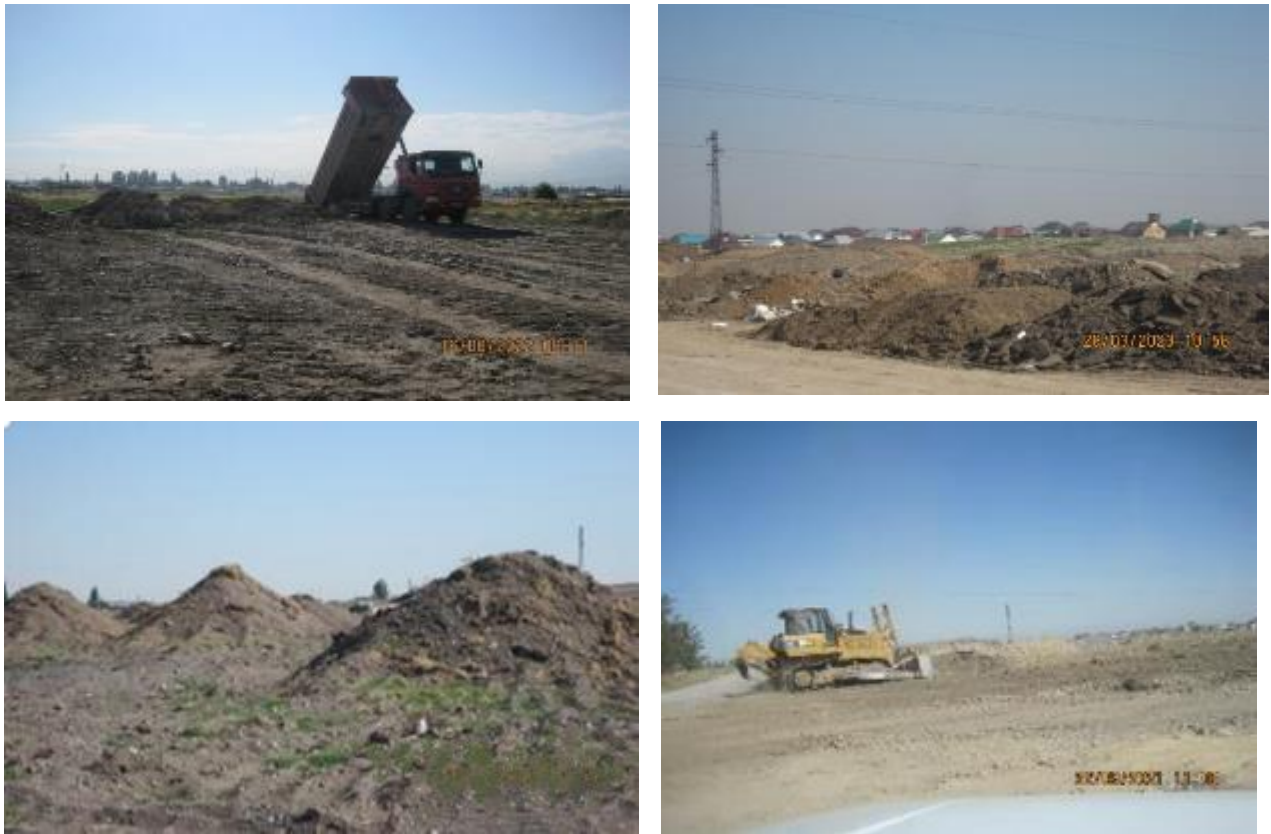
167. At the soil storage site, the soil layer was initially removed and stored. Then the unsuitable soil in the villages of Voенno-Antonovka and Novopavlovka was stockpiled in dumps. Then the unsuitable soil was relocated to a prepared site in a ravine. Partially it was levelled. After completion of all work, the soil was evenly spread on the surface of the dumps.

Figure 46. Storage of unsuitable soil for further use in the villages of Voенno-Antonovka

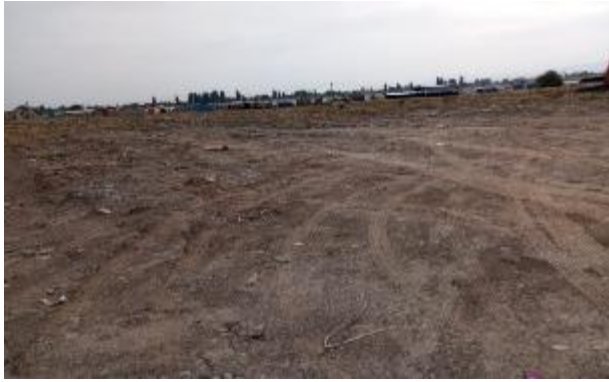
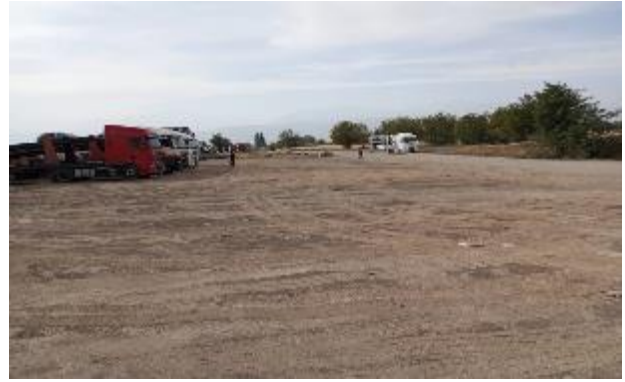
170. Later, large volumes of unsuitable soil were disposed to the dump area in the village of Voенno-Antonovka. Upon completion of the main construction work, the Contractor levelled the area and spread a soil layer.

Figure 47 Levelled dump area for soil

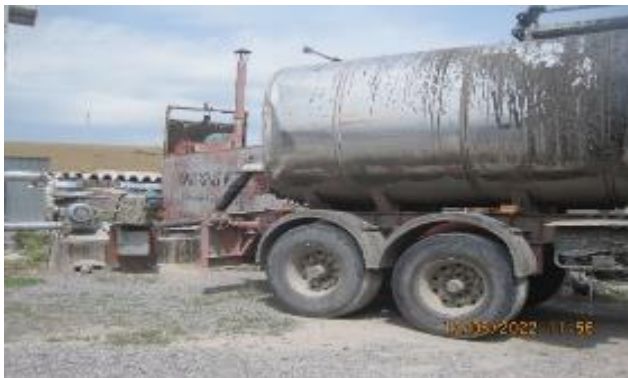
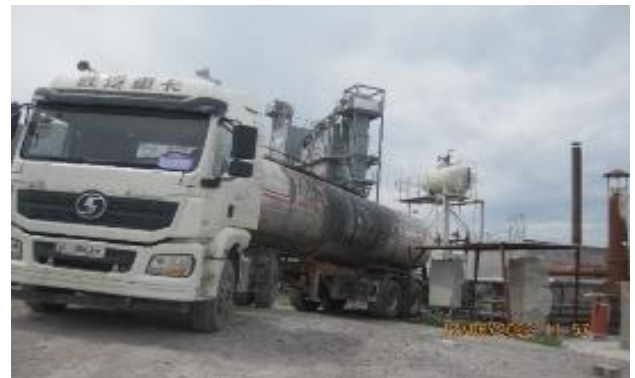
172. In the previous period of work, a large number of barrels with bitumen were delivered to the production site for the preparation of asphalt mix. After bitumen was used, empty barrels were stored on the territory, creating a problem with transportation. During the reporting period, bitumen was delivered by bitumen trucks from rented bitumen pits, barrels with bitumen were not delivered.

Figure 48 Filling of asphalt plants' tanks with bitumen using bitumen trucks

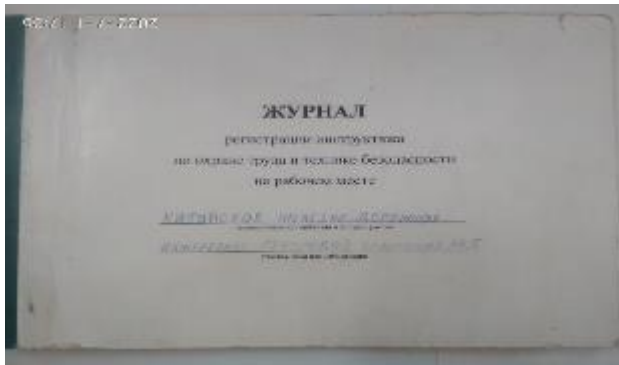
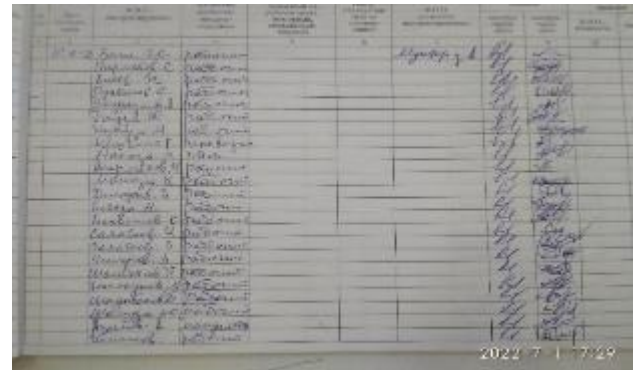
Figure 49 Logs for registration of briefing conducted at the workplace
