Semi-annual environmental monitoring report

July - December 2023

Central Asian Regional Economic Cooperation Corridor 3 Improvement Project (Bishkek-Osh Road), Phase 4, Bishkek-Kara-Balta section (km 8.5 - km 61).

Prepared by: Joint Venture Temelsu International Engineering Services Inc., E. Gen Consultants Ltd., and Desh Upodesh Ltd. in association with Kyrgyz TREC International, Ltd. for the Ministry of Transport and Communications of the Kyrgyz Republic and the Asian Development Bank.

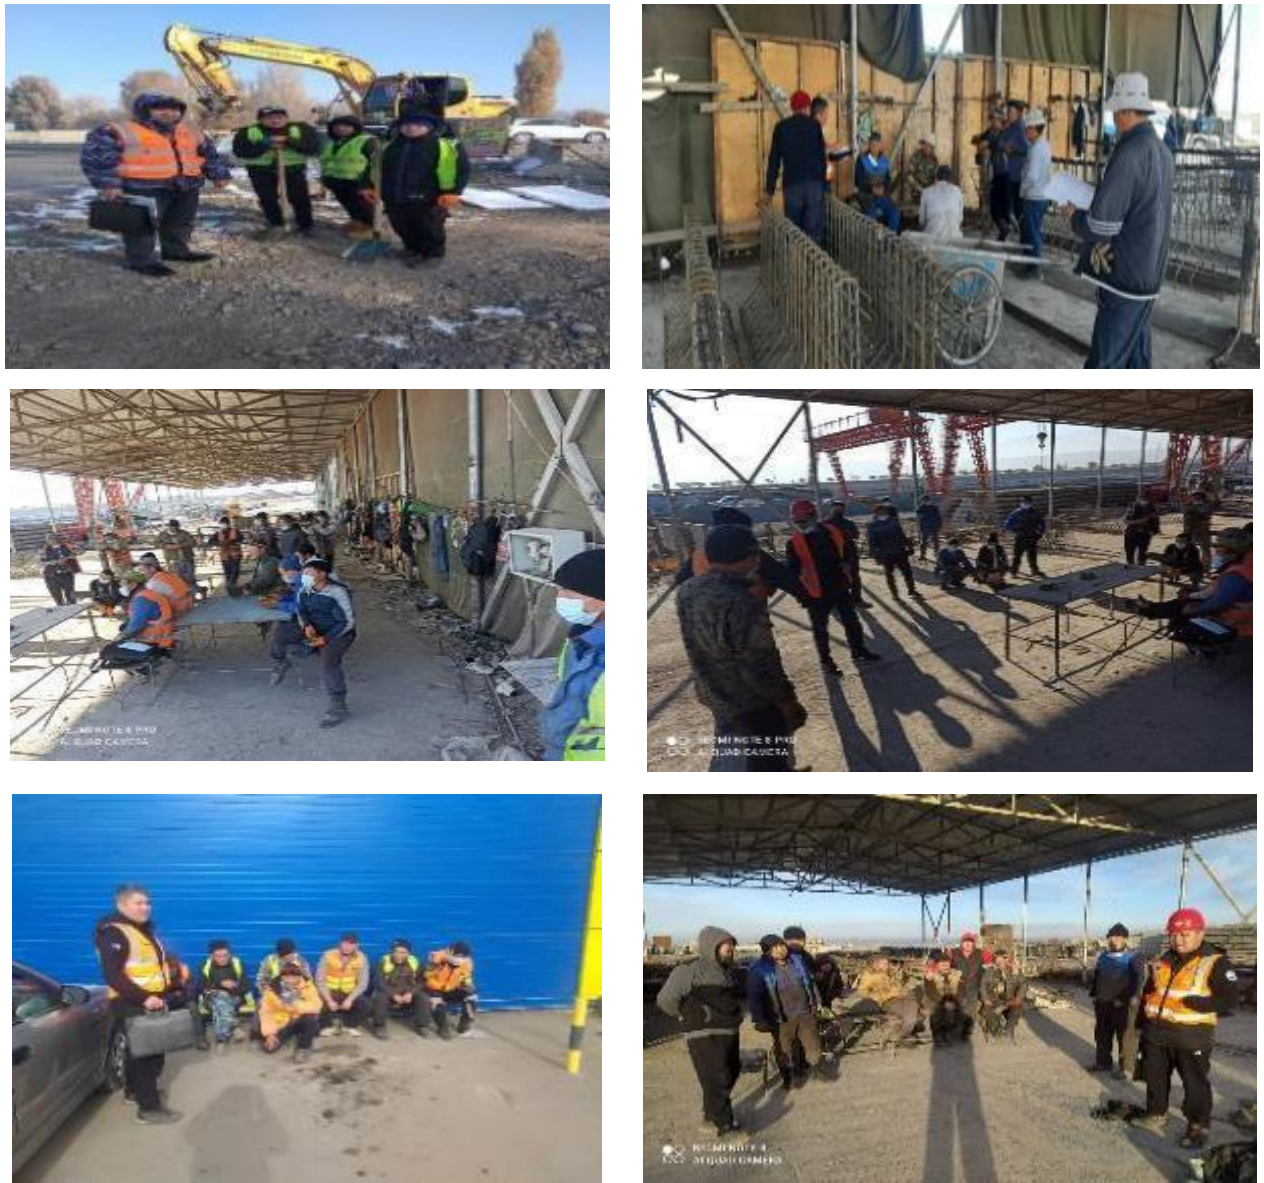
Figure 50 Briefings at workplaces

186. In order to comply with safety requirements, workers have been issued respiratory protection means (masks). However, there are cases when workers show carelessness when using protective means, especially when wearing protective helmets. The contractor's OHS specialist is constantly monitoring and talking to employees about the need to use helmets.

187. But, despite the regular training of workers, the construction supervision consultant noted non-compliance with safety precautions, especially during work at height and installation of drainage ditches. Also, there were noted non-compliances when moving load by crane. The workers were in the crane operation area without personal protective means. Cases of non-compliance with safety precautions were noted both at the site for the manufacture of reinforced concrete structures and during installation of ditches. Verbal and written warnings were repeatedly given to the Contractor. Despite repeated verbal and written warnings to the Contractor, violations recurred.

188. The contractor was recommended to regularly check the workers knowledge of the requirements of occupational safety and health and, if necessary, to conduct repeat training on OHS.

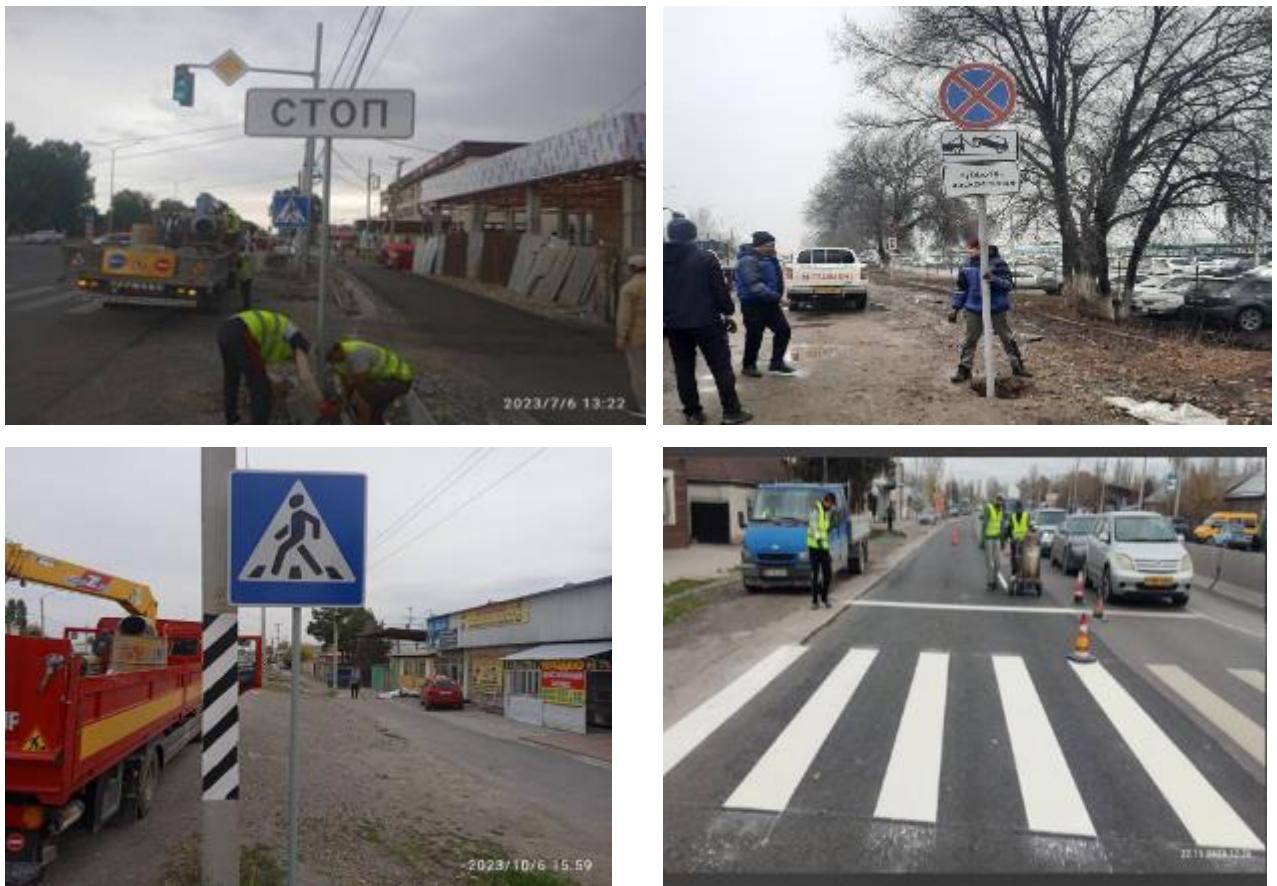
190. The Consultant's road safety specialist monitors the Contractor's road safety on a regular basis. Constant site visits, monitoring of the state of the carriageway, bypass roads, pedestrian crossings, and underpasses are carried out. There is also a constant monitoring over the condition of the relevant road signs, road markings, fences installed to fence work sites and at the places of oncoming traffic. All road signs have been installed. Road marking applied at all required places.

Figure 52 Installation of road signs and application of road marking

191. Road safety specialist gave a written instruction to the Contractor on the installation of road signs according to the approved locations, in areas where asphalt laying and installation of fences on the dividing strip have been complete.

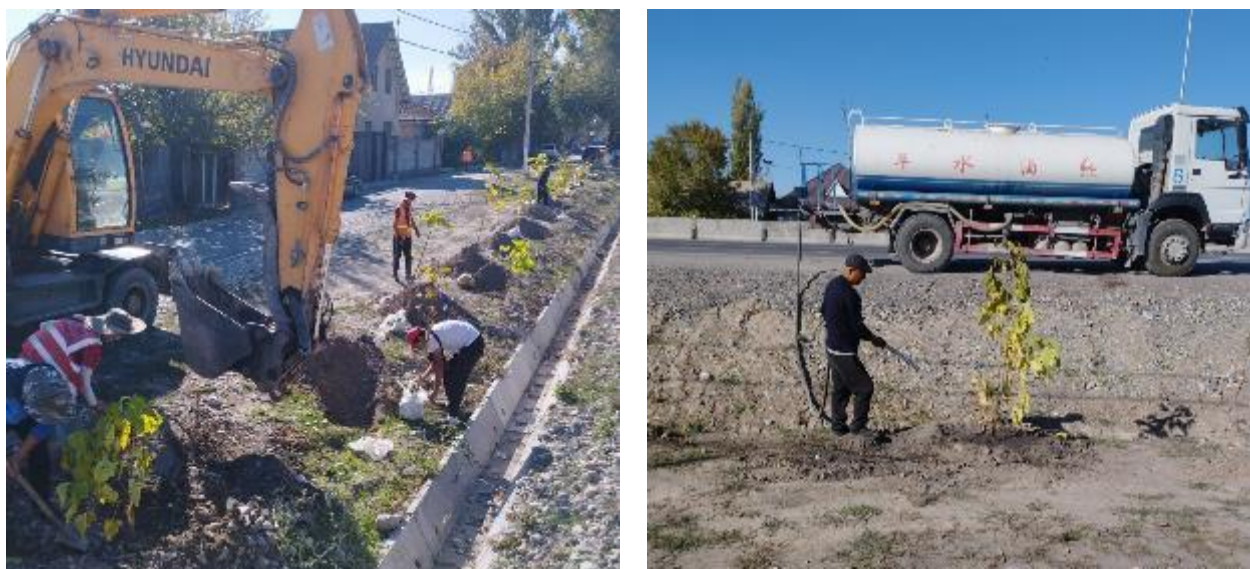
Figure 8 Seedlings planted in October 2023

60. To date, 1000 pieces of young seedlings have been planted.

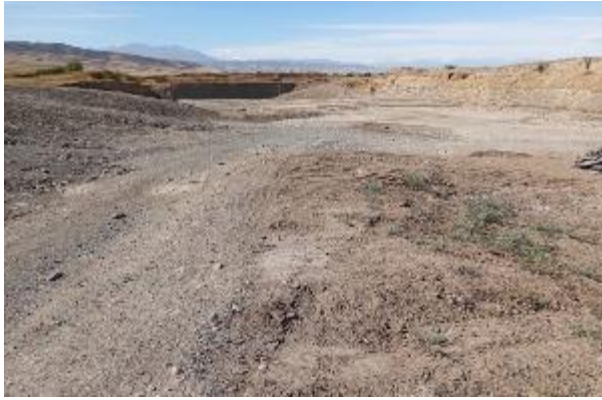
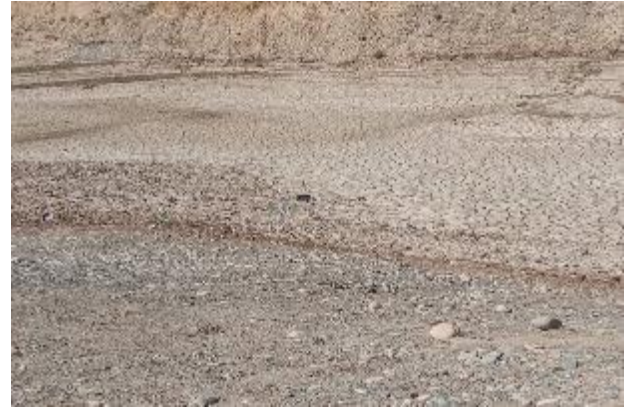
69. To date, the development of borrow pit was completed. It was reclaimed. Subsequently, the borrow pit will be handed over to the Reclamation Commission.

Figure 13 Belek borrow pit after reclamation works

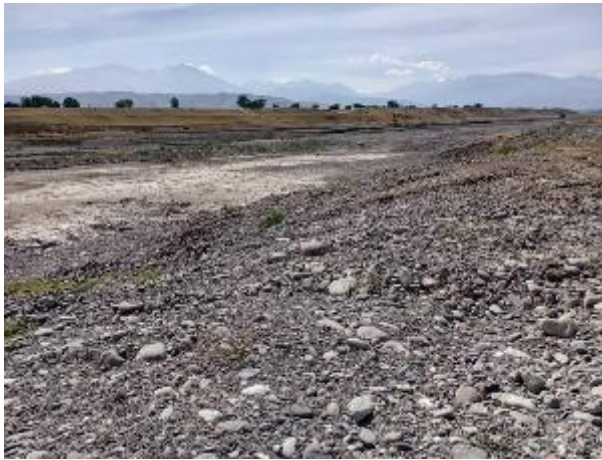
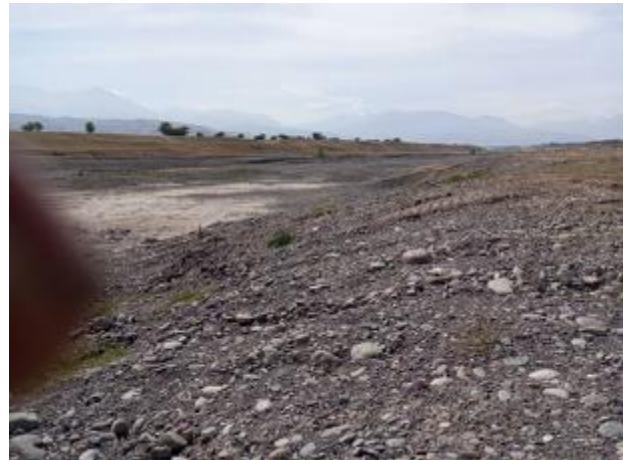
73. The borrow pit has operated until the completion of work on the 7.4 km section. Subsequently, the borrow pit was reclaimed and will be handed over to the reclamation commission.

Figure 16 Ak-Suu2 borrow pit after reclamation works

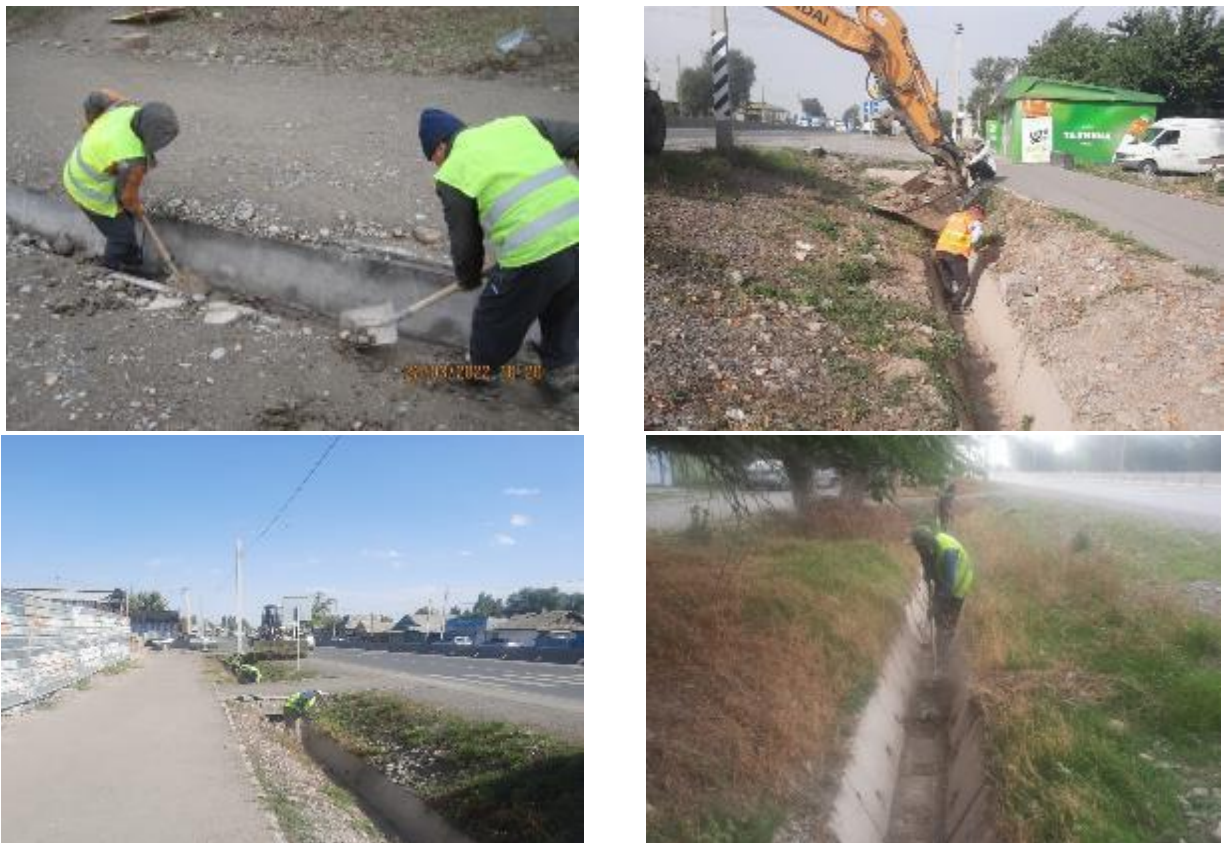
93. During the reporting period, work was also carried out on the road to clean previously installed drainage ditches from stones and debris.

Figure 27 Cleaning of drainage ditches

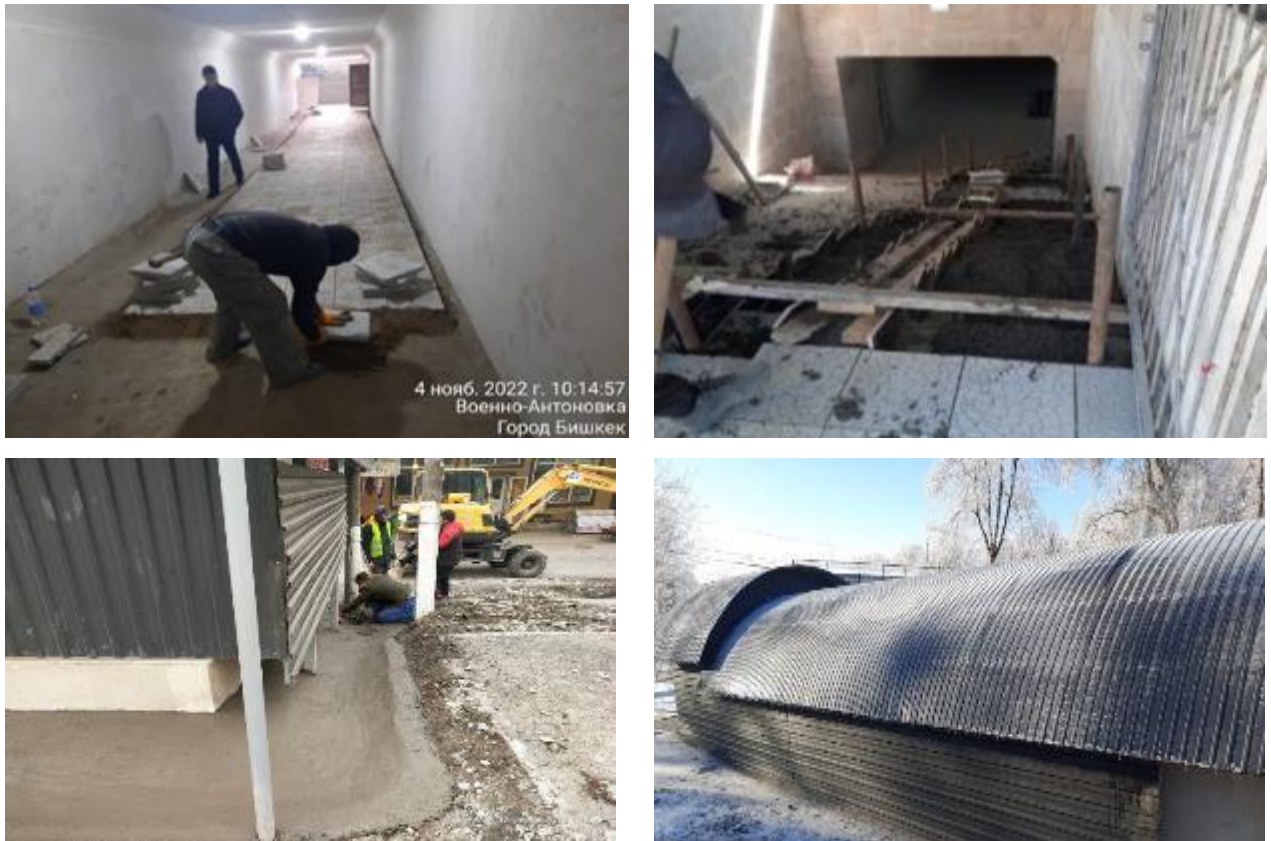
98. There were 3 underpasses at this section. Underpasses were in unsatisfactory condition; major repairs were required.

99. At the underpasses, walls and steps were covered with finishing tiles. The floors were built up and a concrete perimeter pavement was done.

Figure 32 Construction works at the underpasses

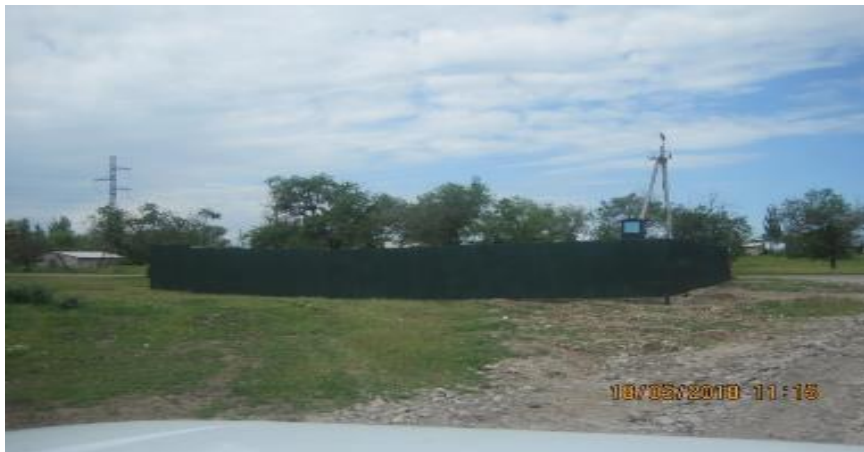
112. The well was restored by the Contractor, a pipeline was laid to the plant. Currently, there are no problems with water at the plant.

Figure 38 Restored well to supply the plant with water

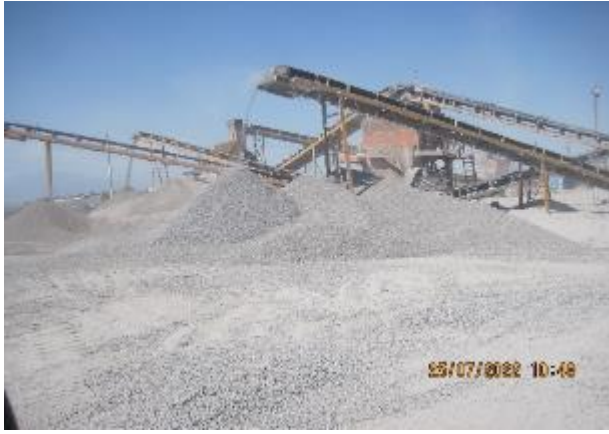
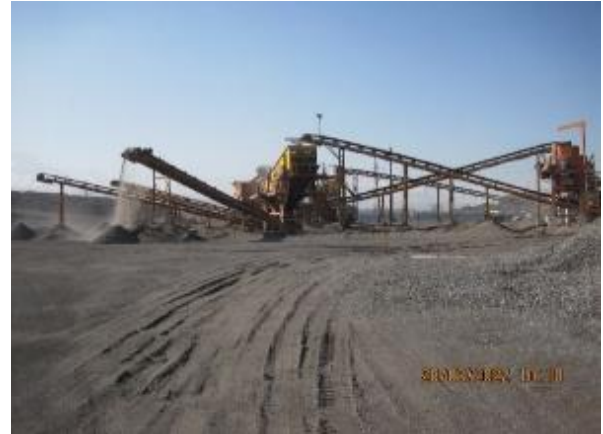
Figure 40 Operation of a stone crushing plant on moistened raw materials

116. *Problems with the stone crusher.* It has been repeatedly found that the stone crushing plant operates without water sprinkling, thus polluting the territory of the plant and the territory adjacent to the plant, causing harm to health and the environment. Several letters of non-compliance were sent to the contractor, but the violation continued. The contractor explained the current situation by breakdowns in pipelines.

117. At the same time, the requirements of the general conditions of the Contract-Technical Specifications, paragraph 1.2.10 (j), were violated: “Crushing plants should only work with dust control devices”.

118. Water supply has been restored. But this problem recurred periodically throughout the entire construction period.

176. During the construction period, dusting was periodically observed at the stone crushing plant. The main cause of dusting during the operation of the crusher was clogging of spray nozzles or failure of water pipes.

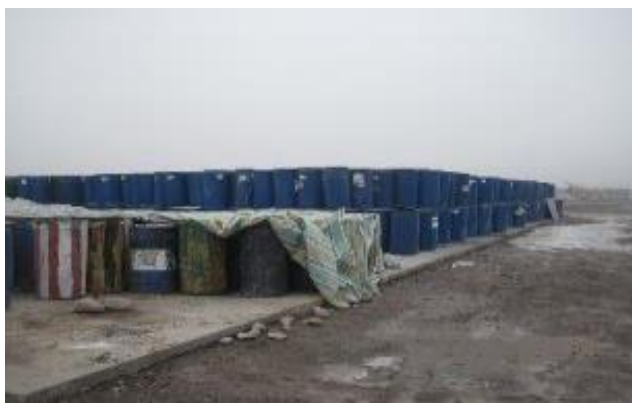
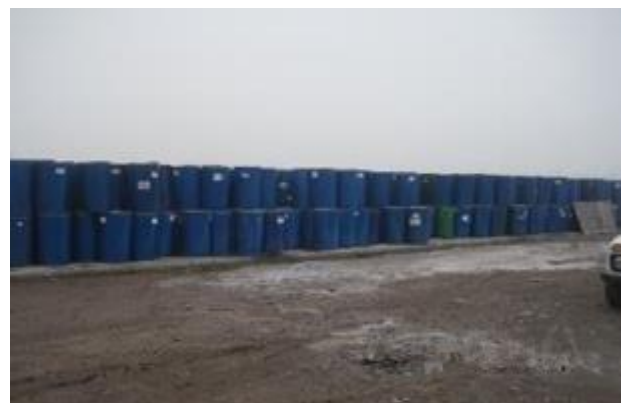
Figure 46 Bitumen in metal barrels stored on a prepared site

124. There were problems with the disposal of empty bitumen barrels.

125. Further, bitumen pits were rented for the production of asphalt and bitumen was delivered to the territory of the plant by bitumen trucks.

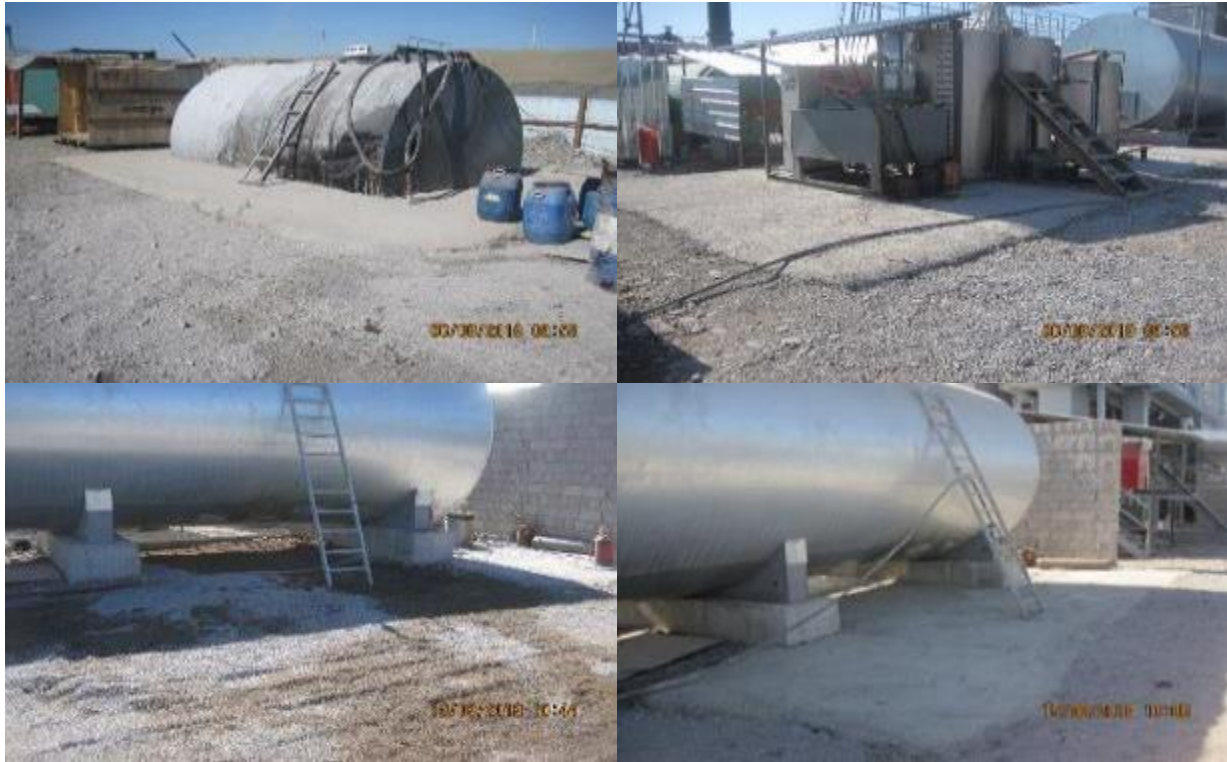
126. During the operation of the plant, all soil around the containers with chemicals must be protected from runoff and spills of hazardous materials by an impenetrable protective coating.

127. The Contractor was recommended to protect the soil around the containers with chemicals from runoff and spills of hazardous materials with an impenetrable protective coating. These recommendations were taken into account and implemented by the Contractor.

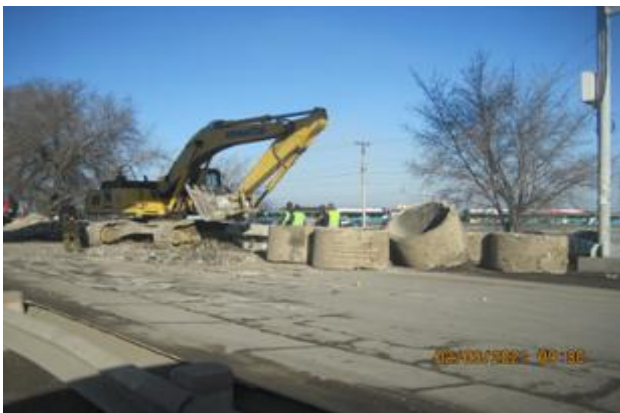
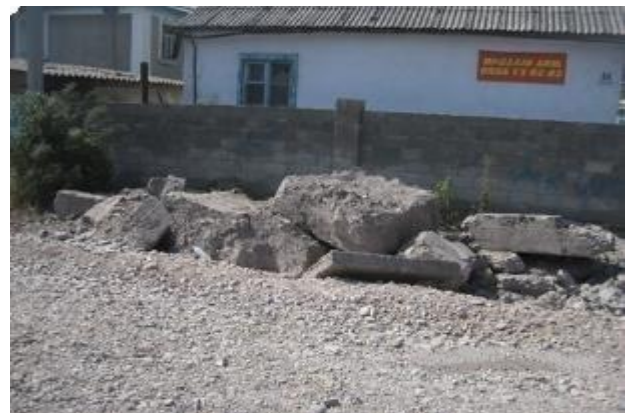
138. Construction reinforced concrete waste was accumulated during the dismantling of bridges and culvert pipes.

Figure 51 Reinforced concrete construction waste

139. In the spring of 2021, together with the local authorities, places were determined for the placement of old reinforced concrete products. Mostly, it were the areas where already been pits.

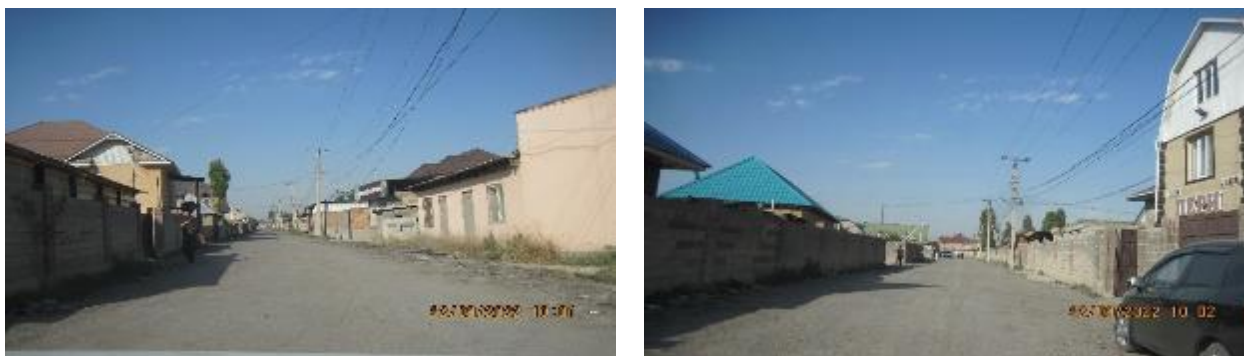
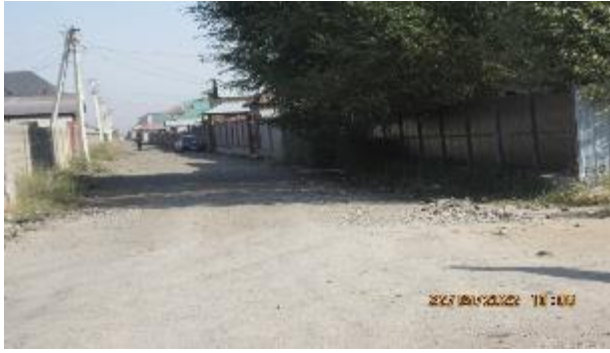
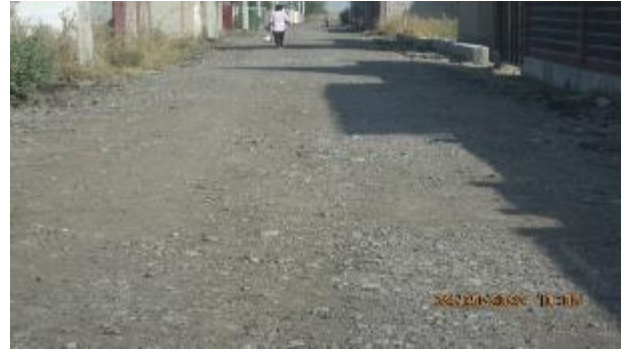
143. Later, by an agreement with the local authorities, it was decided to take out the old asphalt to the streets proposed by the local administration. The problem was that large pieces of uncrushed asphalt remained on the sides of the backfilled roads. Considering this fact, the Contractor leveled the old asphalt with its own equipment. Separate places were noted where, after the backfilling and levelling works, uncrushed pieces of asphalt left on the roadsides. The contractor was given instructions to correct and bring to the proper condition the found shortcomings. There were no complaints from the local population regarding the disposal of the removed asphalt.

Figure 53 Streets backfilled with old asphalt

186. Future contracts should take into account the conditions for the removal and disposal of old asphalt. It is advisable to send it for reuse, so it is important to record the sizes of the removed pieces of asphalt that will be possible to use.

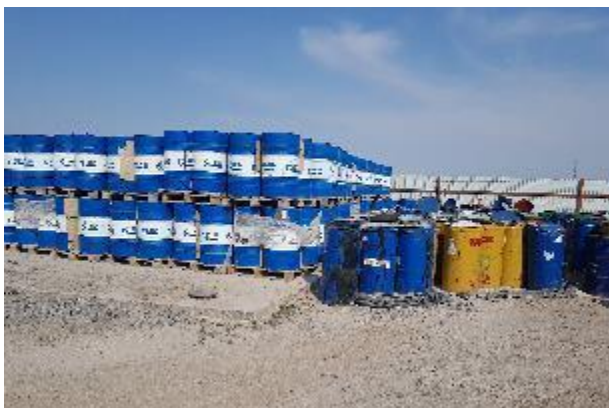
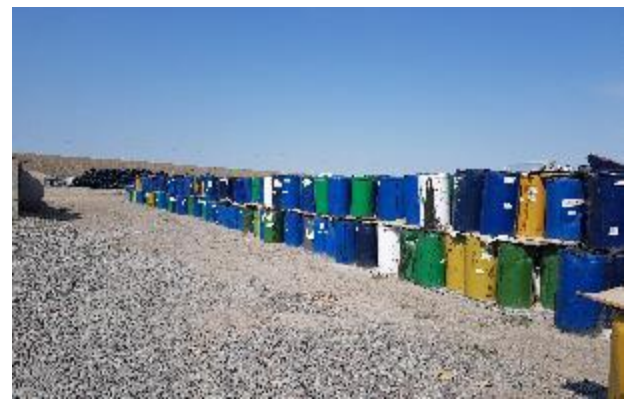
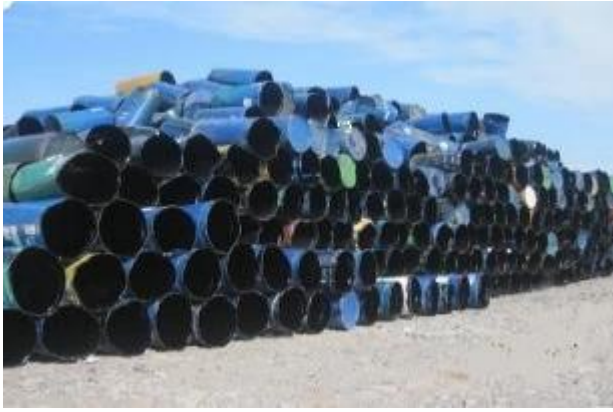
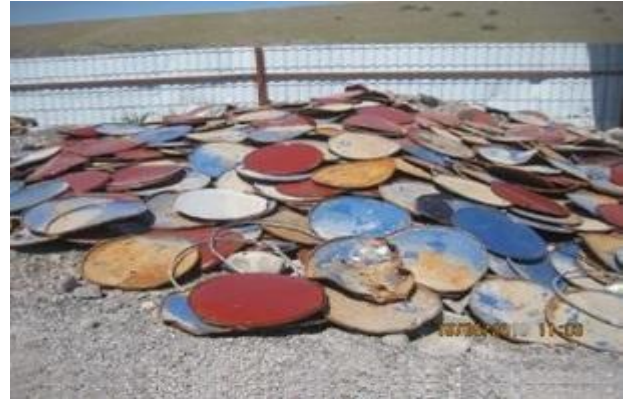
148. On the territory of the asphalt plant, waste was accumulated during the production of asphalt. Basically, these were empty barrels from used bitumen. The barrels were partly used for construction work on the road, most of them were sold for scrap. There were problems with the disposal of barrels.

Figure 56. Waste on the territory of the asphalt plant. Waste barrels and metal drum lids

149. Later, it was decided to deliver bitumen by bitumen trucks from rented bitumen pits; bitumen no longer was delivered in barrels.

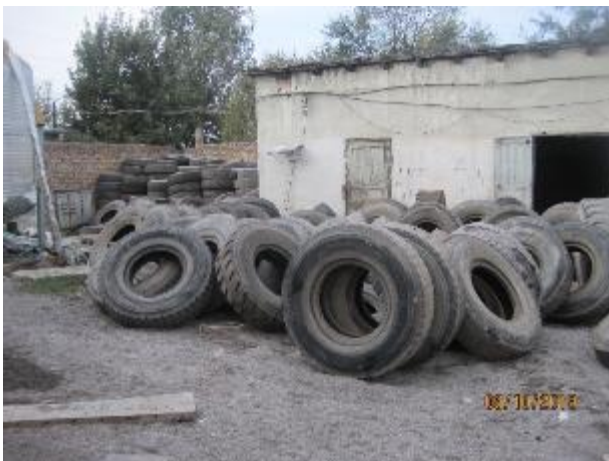
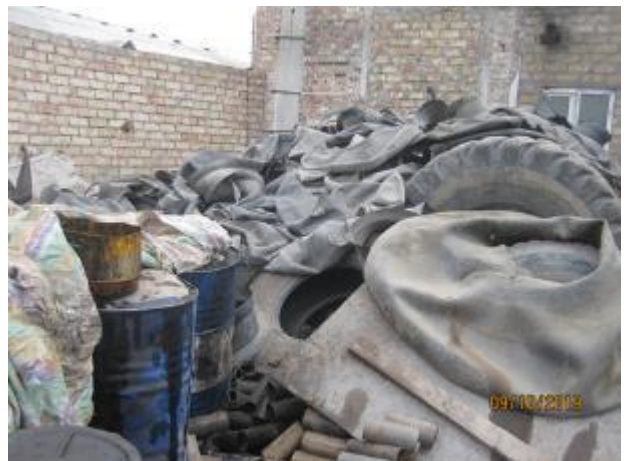
150. Production waste also included old car tires and scrap metal waste, which were removed and disposed of under an agreement with specialized companies.

Figure 58 Old car tires to be recycled

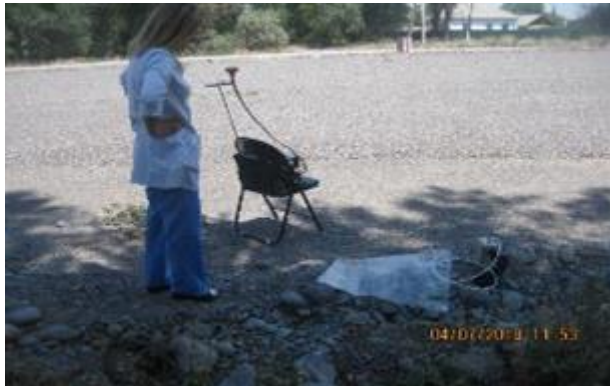
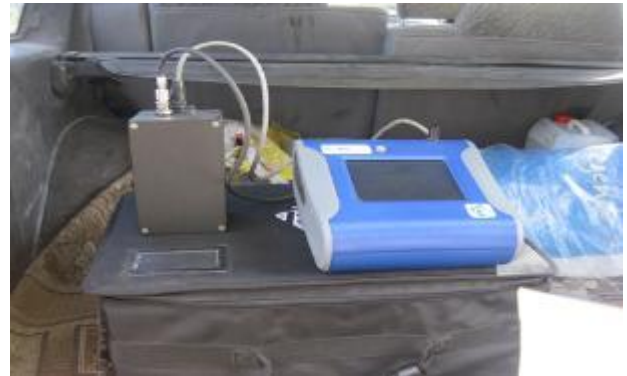
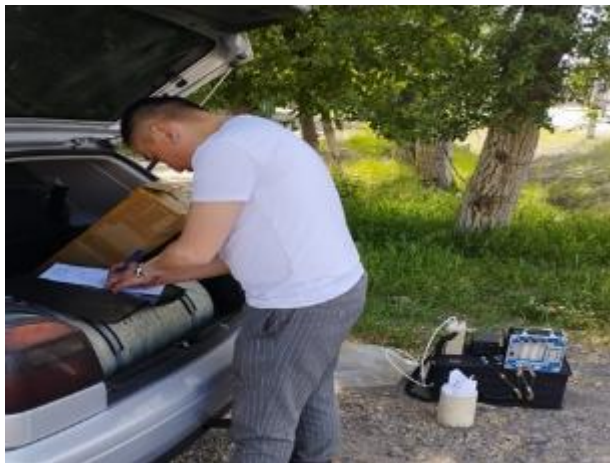
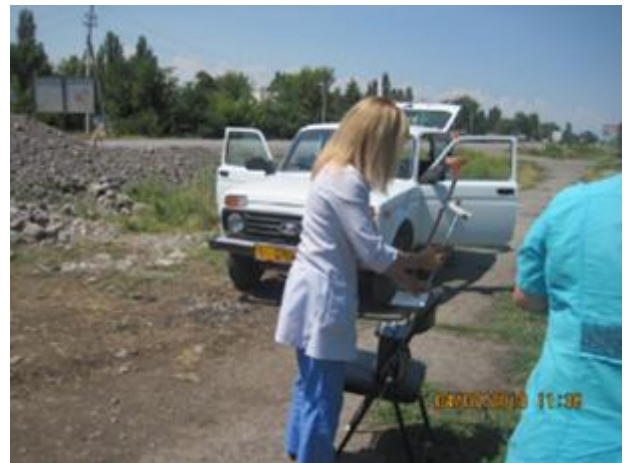
Figure 59 Air quality monitoring

161. *Conclusion based on the results of air quality measurements:* according to the results of air quality tests, the maximum permissible concentration (MPC) was exceeded for nitrogen dioxide up to 2.5 MPC. This excess was observed regularly from the very beginning of the monitoring on the project road, starting in 2013, even before the start of construction.

164. It should be noted that the excess of dust content in the air was also observed in 2013 before the start of construction work on the road, in this regard, it cannot be said that the cause of this excess is only construction work.

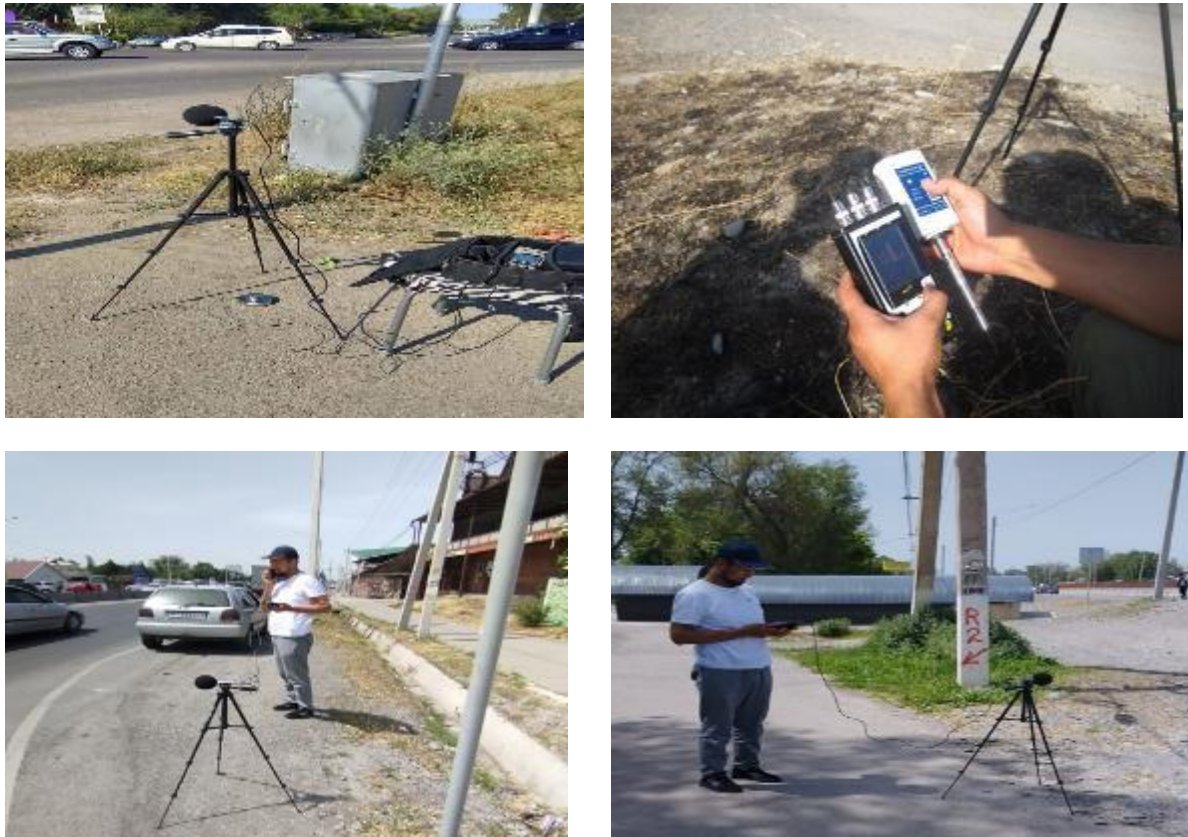
Figure 60 Noise and vibration monitoring

168. *Conclusion based on the results of measurements of background noise and vibration level:* at the time of the measurements, the background noise level at the measurement points at a distance of 5–41 m from the edge of the road when vehicles were passing was 61–83 dBA while maximum permissible level is 75 dBA. When the construction equipment was operated, the excess of the sanitary norm was from 5 to 10 dBA, and when the construction equipment was turned off, the noise level exceeded the sanitary norm by up to 2 dBA. These indicators were short-term.

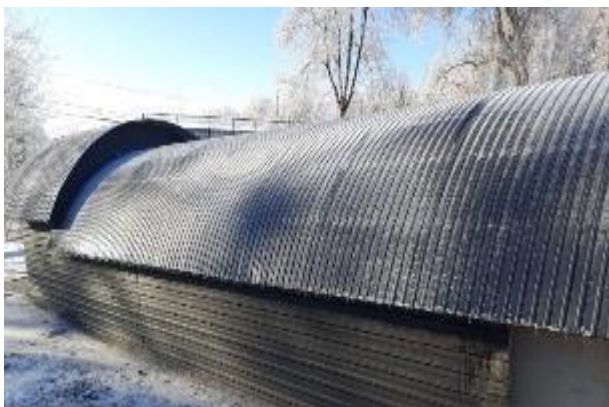
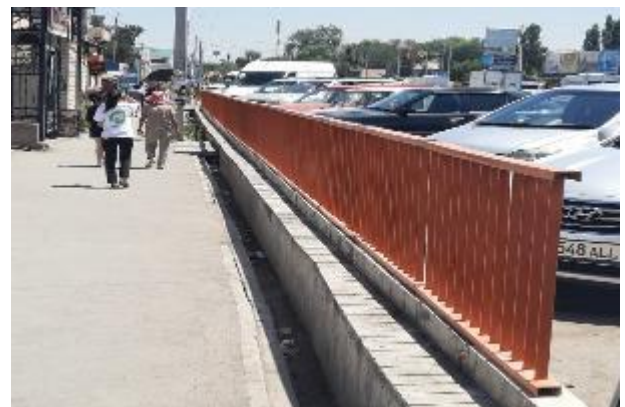
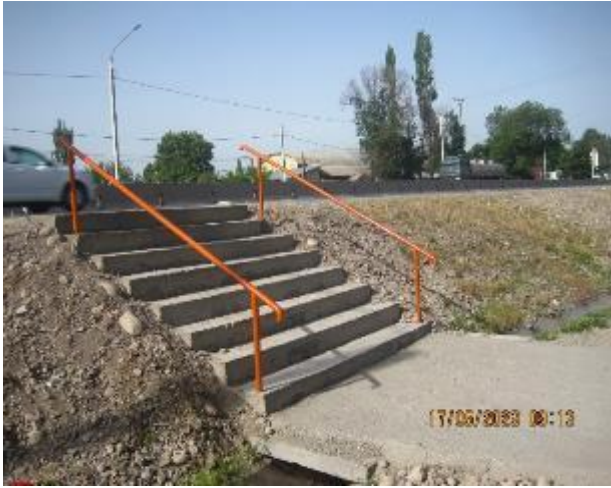
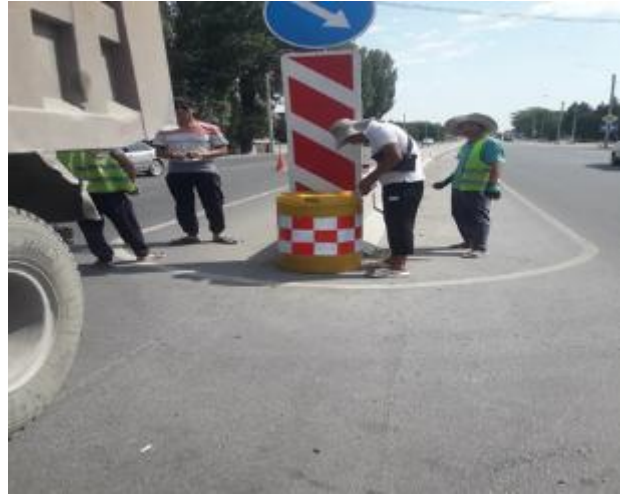
179. Another positive example is that the problems found during the operation of the road were eliminated, which improved the quality of the constructed structures. An example is extended roofs on underpasses to prevent icing on the steps, installed metal gratings above the parapets in particularly dangerous places to prevent the population from jumping over the parapets, creating an emergency situation on the road, built steps with handrails on slopes in pedestrian crossings.

181. The buffers are filled with sand, have a height of 80 cm, a diameter of 55 cm and a weight of 200 kg. The buffers are installed next to the parapet on the road, have a reflective film and are therefore visible from afar at night.

182. In case of an accident, buffers can withstand hits and deformations, reducing damage to vehicles and ensuring the safety of passengers.

Figure 61 Examples of good practices
