# Semi-annual Environmental Monitoring Report

Semi-annual Environmental Monitoring Report  
January to June 2024

## **CAREC Corridors 1 and 3 Connector Road, Section 2B Epkin-Dyikan [Bashkugandy], Km: 89+500 – 159+200 Project**

Olga Syzonenko, International Environmental Consultant,  
Gentek International Engineering and Consulting Ltd.  
Jumaliev Talantbek, Local environmental specialist,  
Gentek International Engineering and Consulting Ltd.  
Bishkek, Kyrgyzstan: July 2024

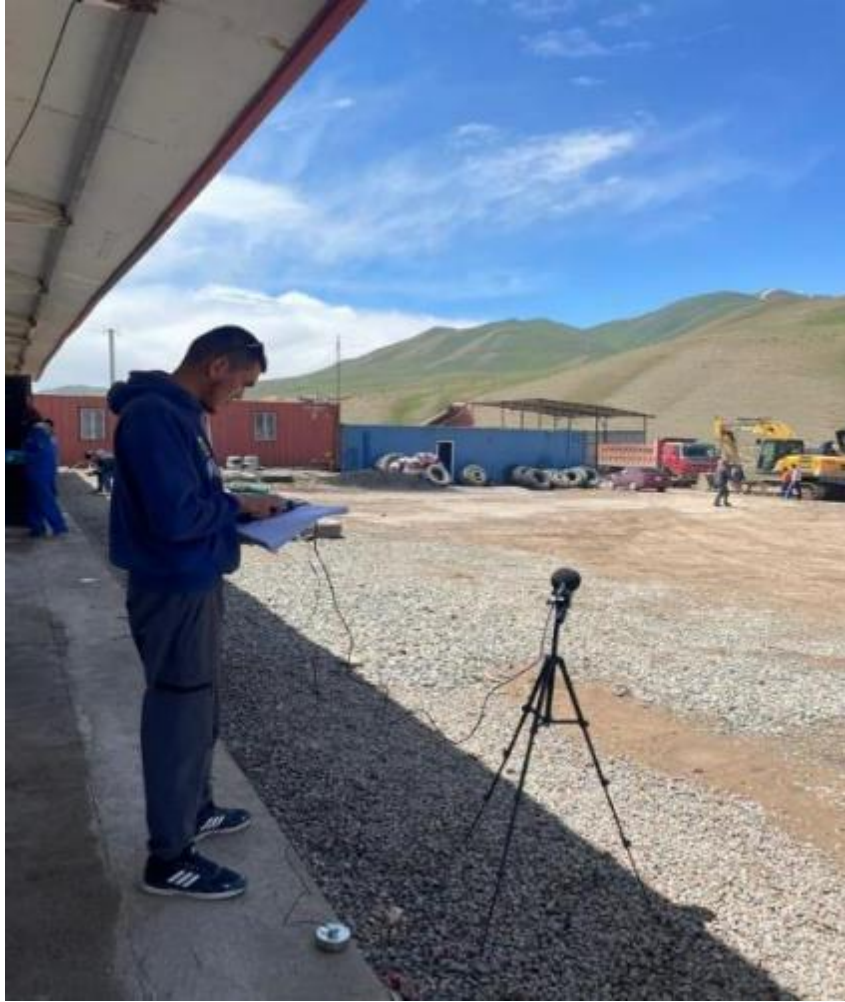
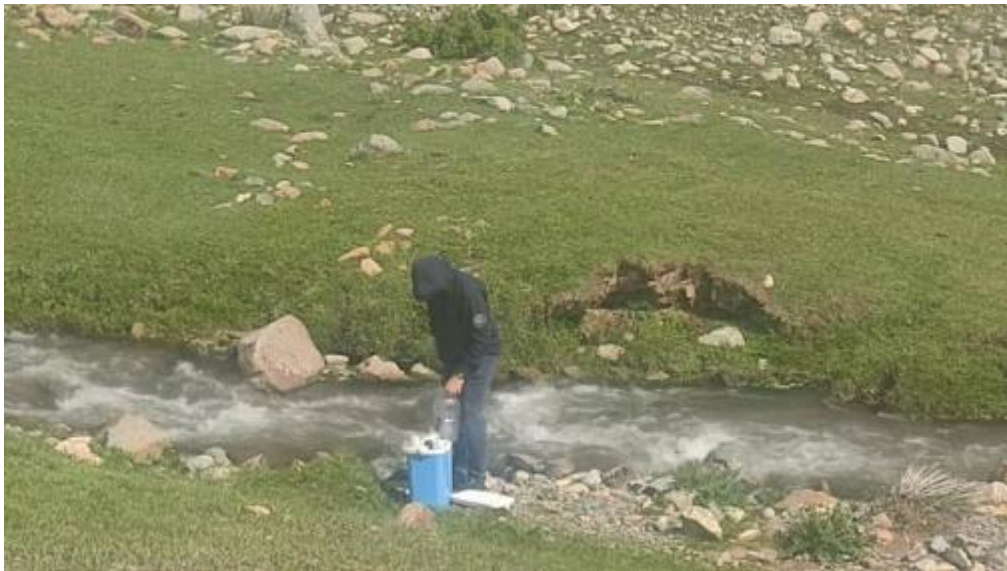
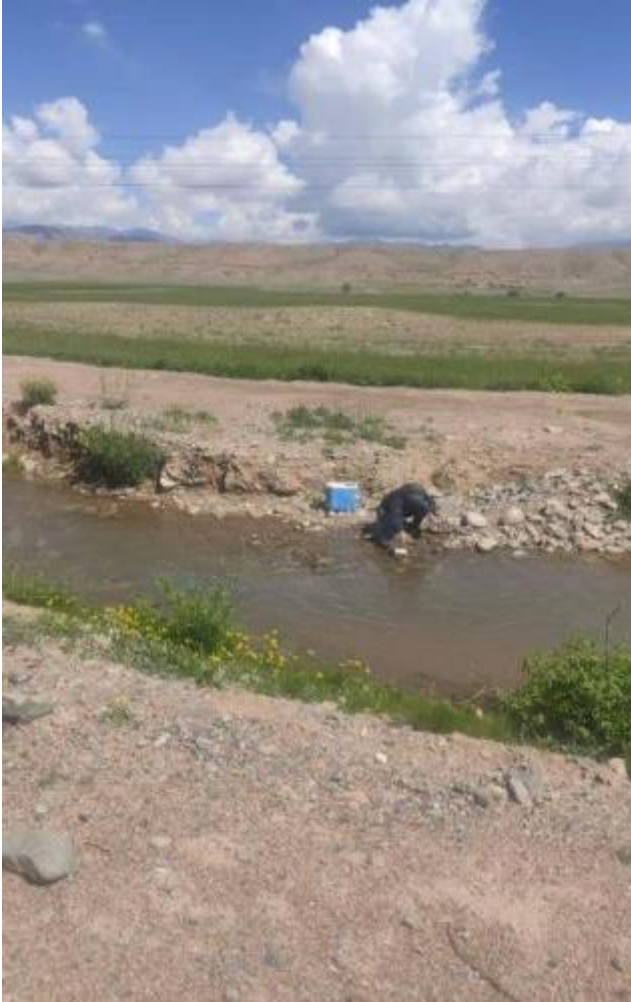
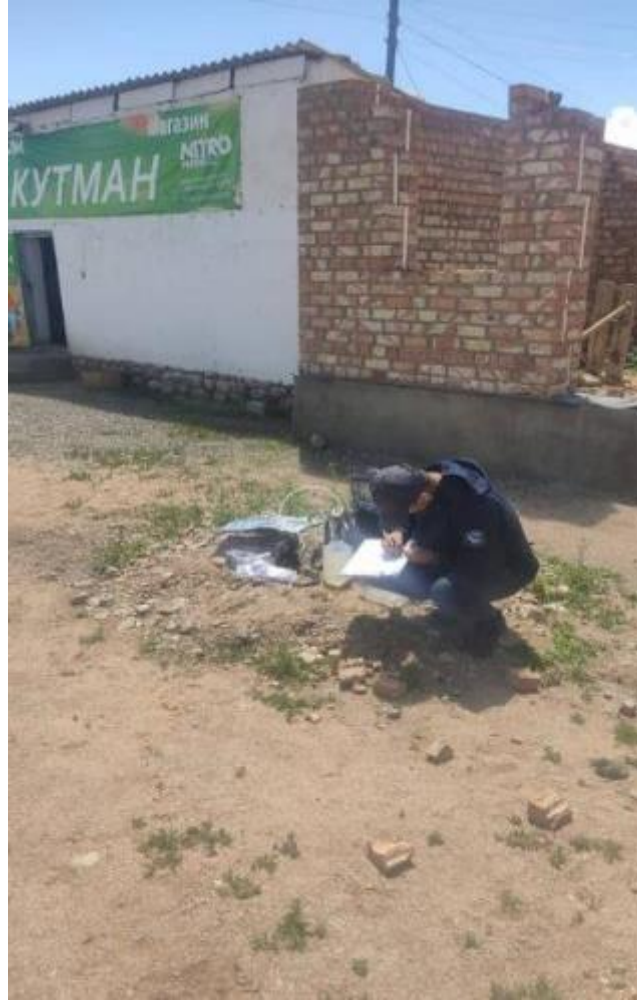
**Figure 27: Instrumental Monitoring on Project Road.**

The results of vibration measurements at selected points show that no exceedance of permissible standards was recorded.

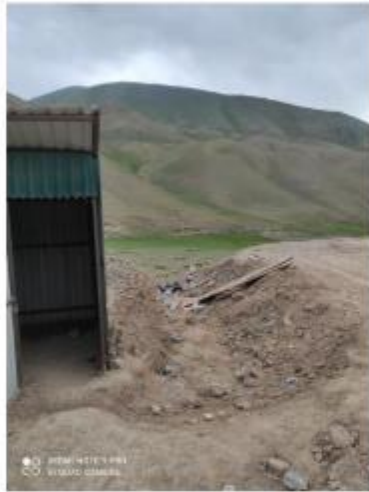
Nº	Photo
3.2

3.2 Are the generating wastewater sent to the reservoirs and removed from there to specially designated places (Are the walls of the reservoirs equipped with internal and external waterproofing)?	<input type="checkbox"/>	<input checked="" type="checkbox"/>	See photo № 3.2

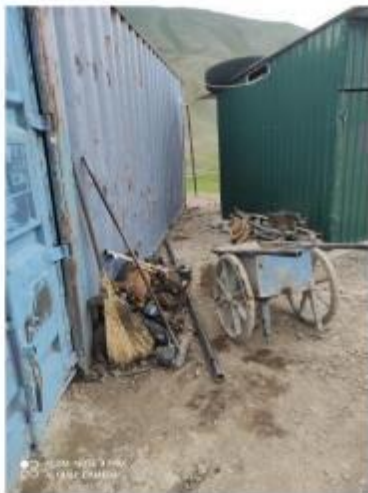
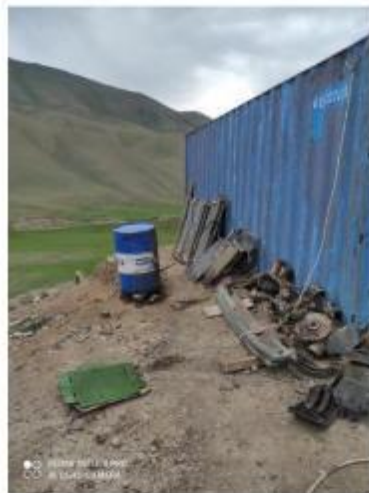
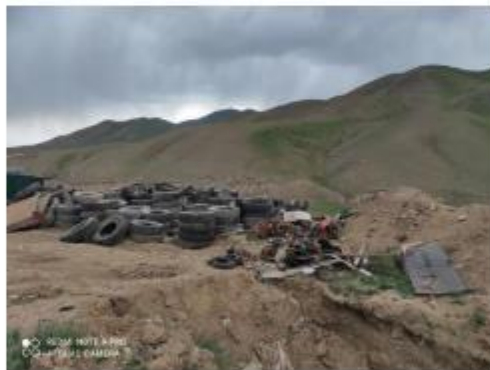
4.3	Are there any signs of soil damage?	<input type="checkbox"/>	<input checked="" type="checkbox"/>	
4.4	Have you observed fuel or oil spills during the visit?	<input checked="" type="checkbox"/>	<input type="checkbox"/>	See photo 4.1

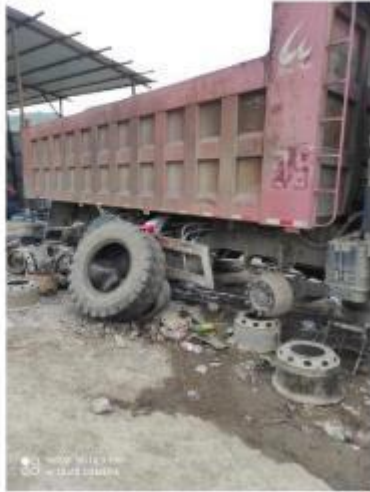
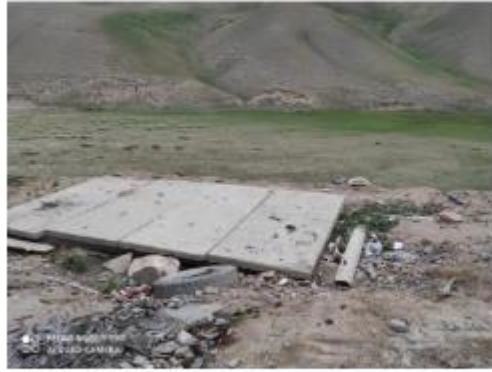
6.4	Contrary to para 2 of Appendix xii SSEMP, the workshop area isn't kept clean.
7.1	Poor sanitary and hygienic conditions in the workers' camp, which is contrary to the para 2 of Appendix xii SSEMP

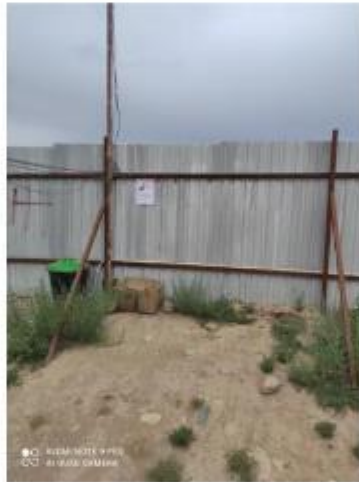
7.9	There is no smoking area, which is unsafe from a fire safety point of view.
7.10	There is no notice board on the camp and workshop with emergency contact details, brochures on first aid, fire safety rules, and rules for using a fire extinguisher, which is contrary to the Annex xv of SSEMP

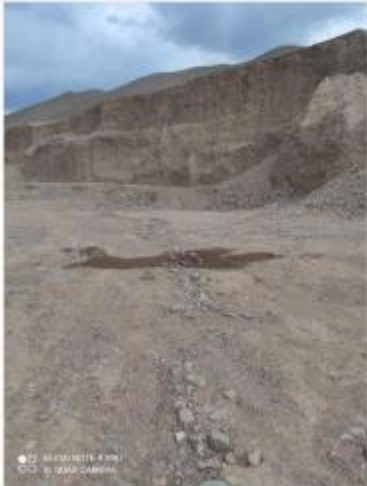
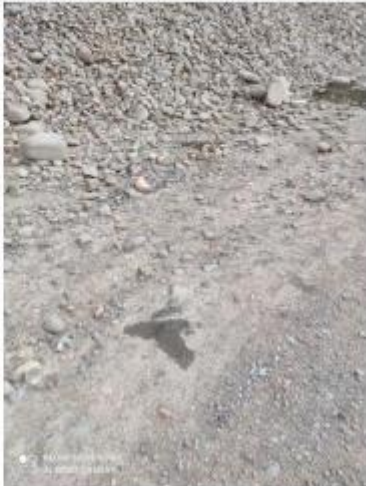
Nº	Photo	
3.1

3.1	Is there a spillage of oil from machines	<input checked="" type="checkbox"/>	<input type="checkbox"/>	See photo 3.1 _____
3.2	Are equipment and materials available to clean up fuel spills?	<input type="checkbox"/>	<input checked="" type="checkbox"/>	_____
<b>4. Dust</b>
