Semi-annual Environmental Monitoring Report

Semi-annual Environmental Monitoring Report
July to December 2024

CAREC Corridors 1 and 3 Connector Road Project, Section 2B Epkin-Dyikan [Bashkuugandy], Km: 89+500 – 159+200 Project

Olga Syzonenko, International Environmental Consultant,
Gentek International Engineering and Consulting Ltd.
Jumaliev Talantbek, Local environmental specialist,
Gentek International Engineering and Consulting Ltd.
Bishkek, Kyrgyzstan: January 2025

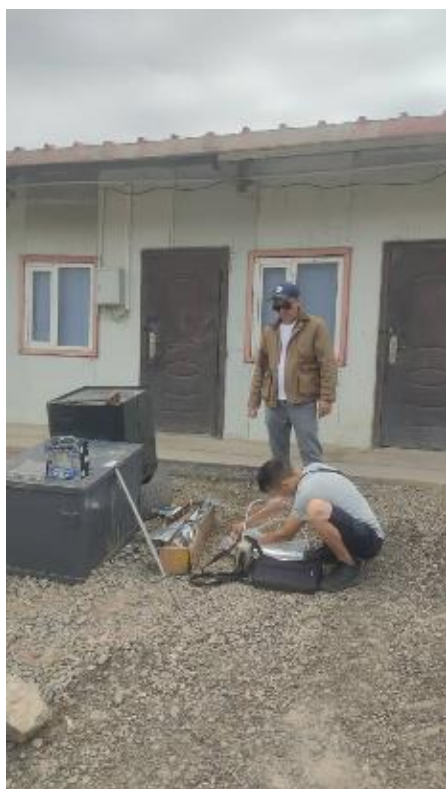
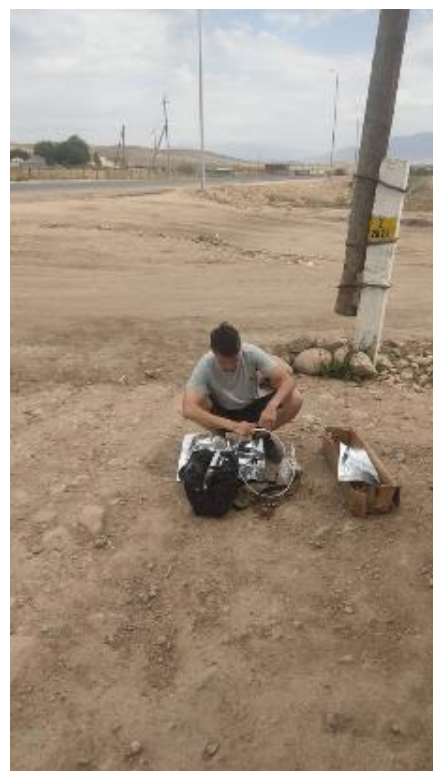
Figure 32: Instrumental monitoring of water quality.

Figure 33: Instrumental monitoring of air quality.

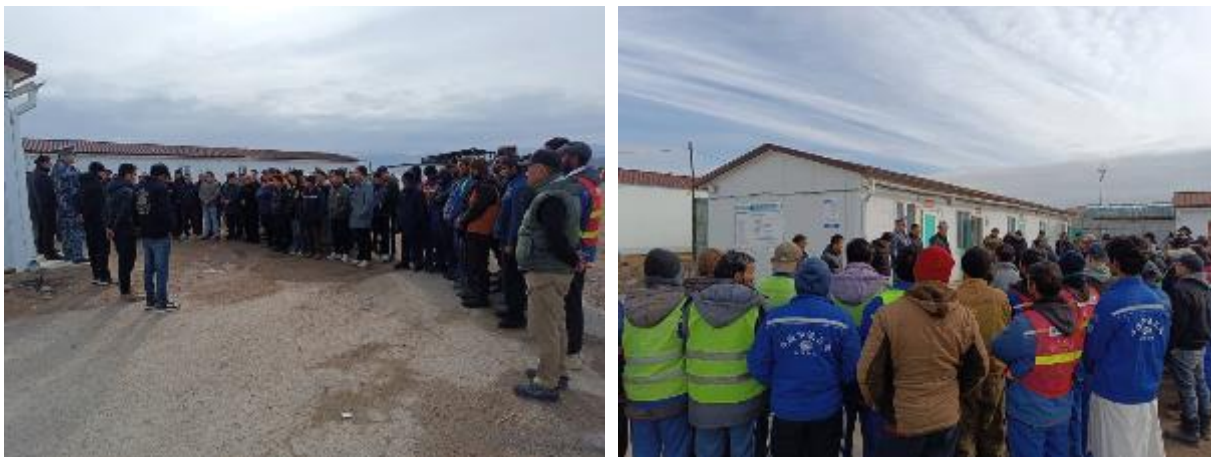
161. On October 28, 2024, representatives of the Territorial Road Safety Department of the Ministry of Internal Affairs of the Kyrgyz Republic conducted informational and awareness sessions with workers in the camp (km 148+630) on the importance of complying with traffic regulations.

Figure 34: Conducting awareness-raising work among workers on the importance of complying with traffic regulations (28/10/2024).

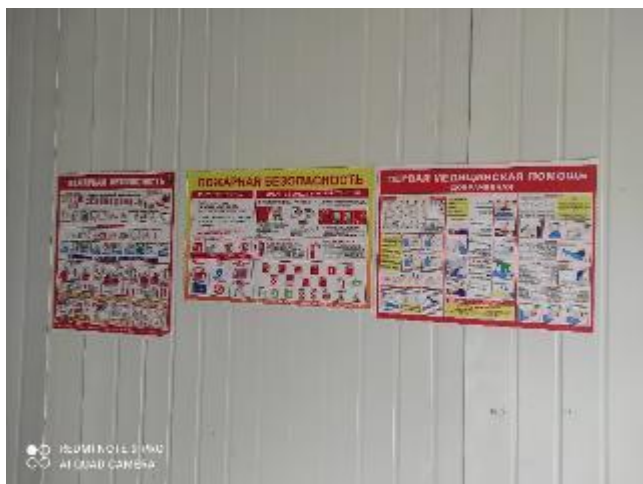
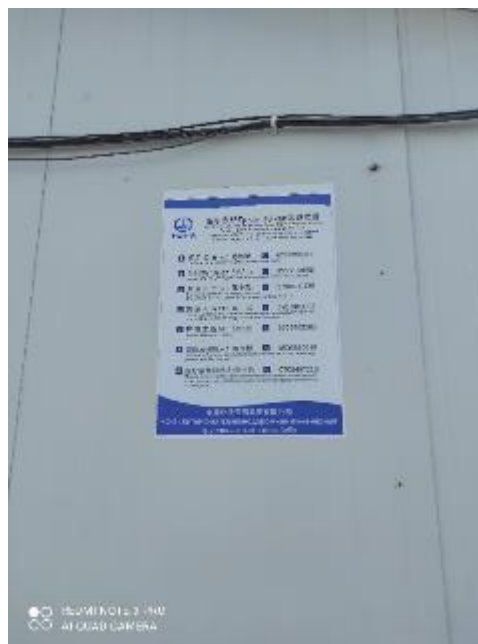
168. On September 7, 2024, the Contractor updated the Emergency Response Plan and installed notice boards in construction camps displaying contact details of emergency services, brochures on first aid, fire safety rules, and instructions for using fire extinguishers.

Figure 35: Notice boards displaying contact details of emergency services, brochures on first aid, fire safety rules, and instructions for using fire extinguishers.

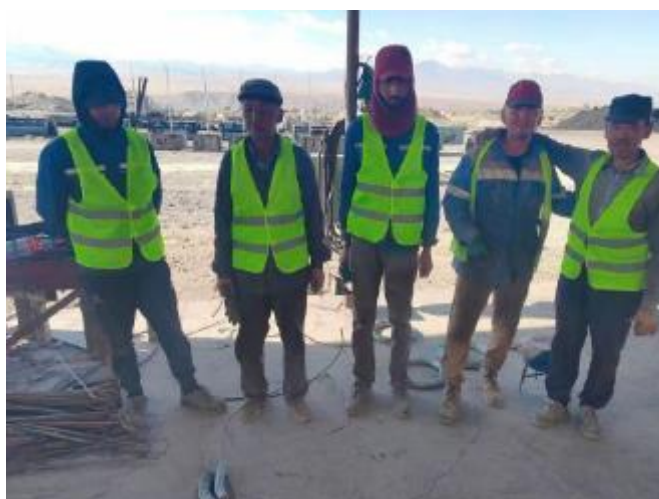
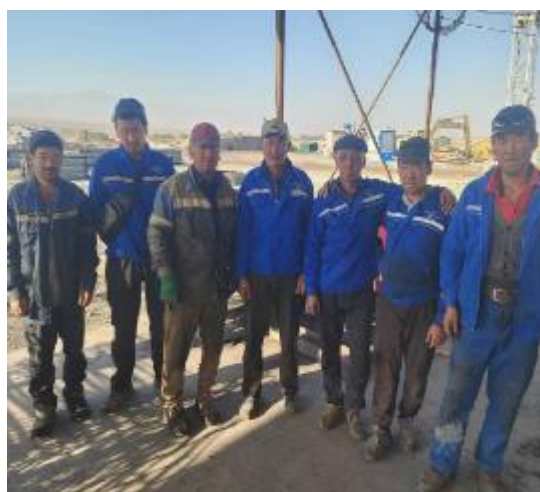
171. All workers working at the facilities are provided with a complete set of PPE (overalls, helmets, boots, welding shields, aprons, gloves, headphones, and safety glasses) but neglect to wear a complete set of PPE.

Figure 36: Conducting awareness-raising work among workers the importance of PPE (02/09/2024).

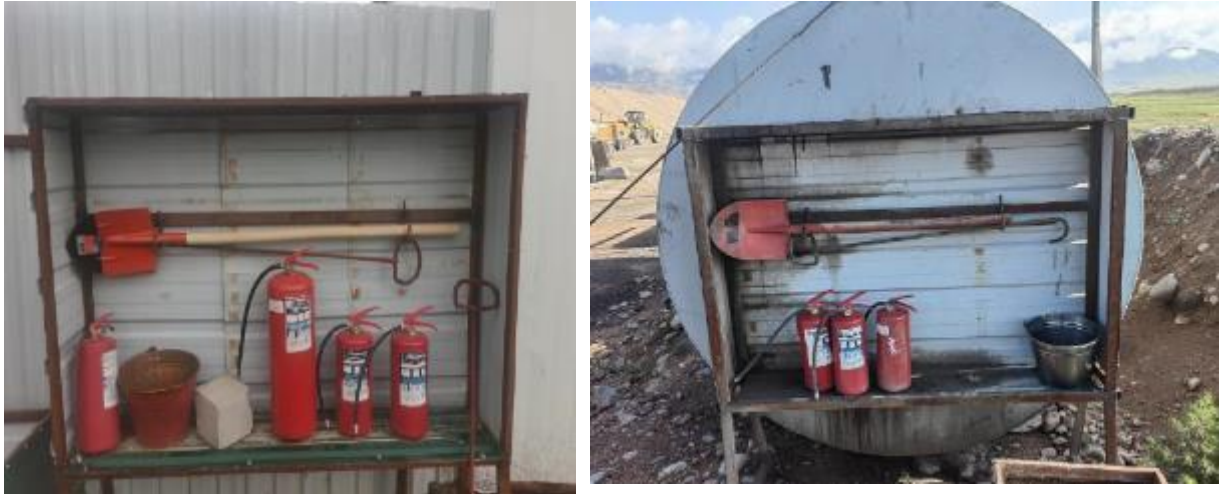
Figure 37: Equipped fire safety boards.

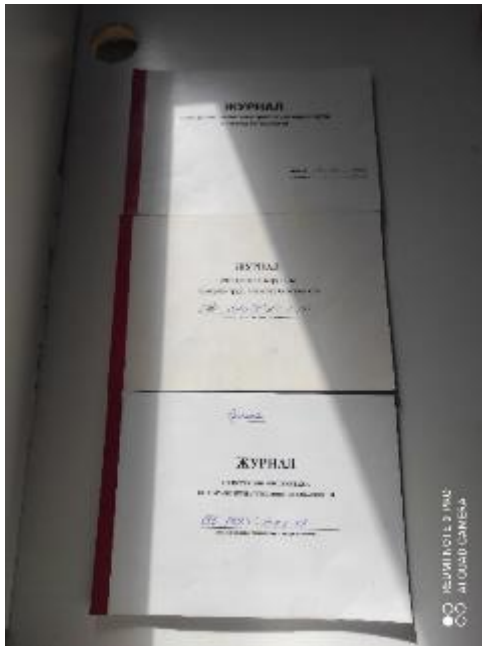
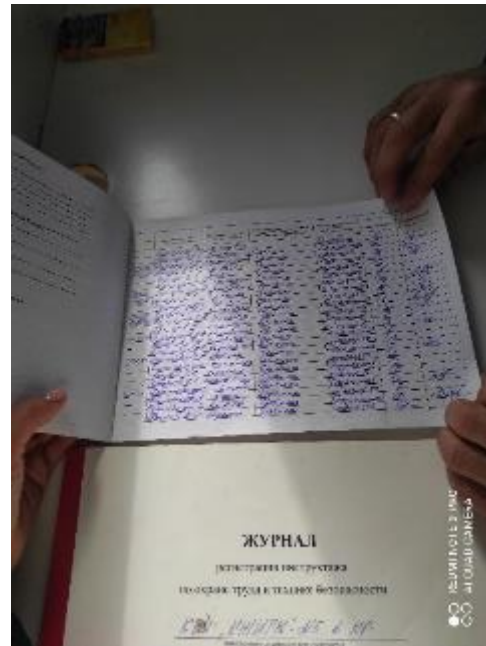
175. The introductory orientations are conducted for each new employee, and records of their completion are documented in the "Register of Introduction Briefings on Occupational Safety."

Figure 38: Register of Introduction Briefings on Occupational Safety.

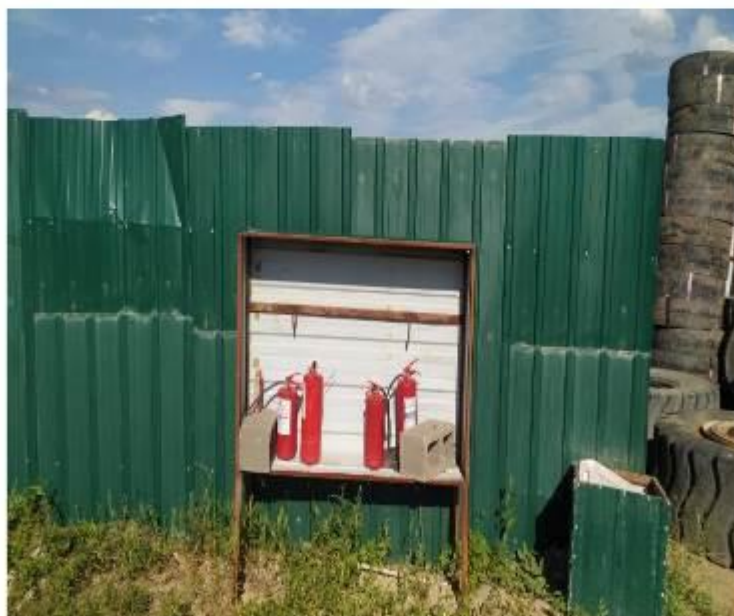
Photo 3. Gas cylinders are not protected from direct sunlight

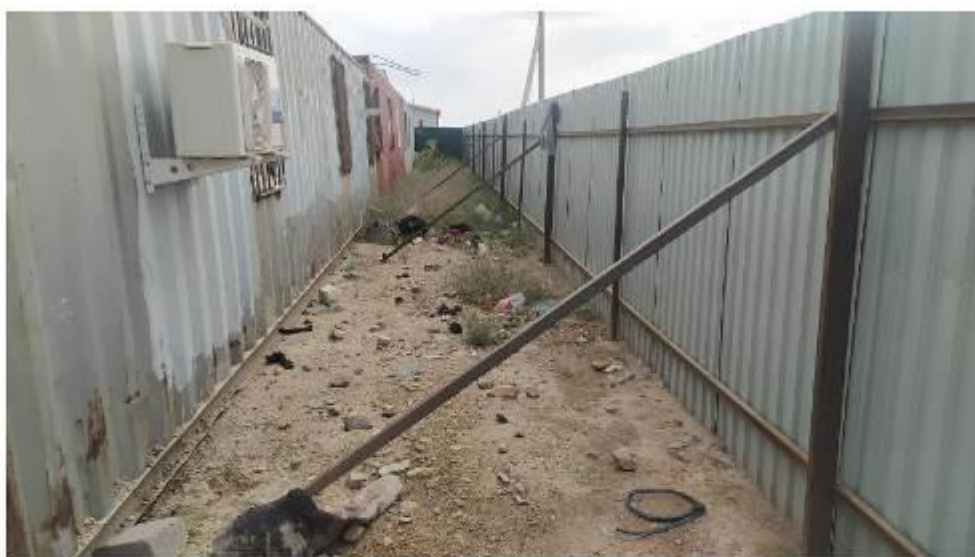
Photo 10. On the territory of the camp 106+300 km, the garbage has not been removed

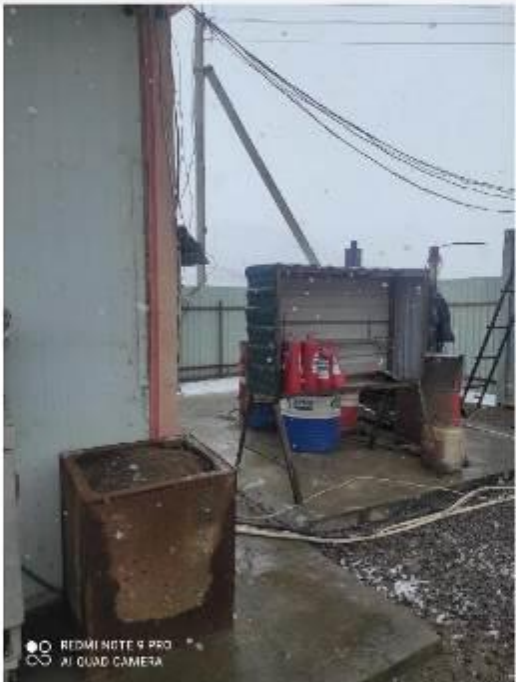
Nº	Photo
4.5

4.4	Have you observed fuel or oil spills during the visit?	<input type="checkbox"/>	<input checked="" type="checkbox"/>	
4.5	Does the camp have the equipment and materials to clean up fuel spills?	<input checked="" type="checkbox"/>	<input type="checkbox"/>	See photo 4.5
5 Noise

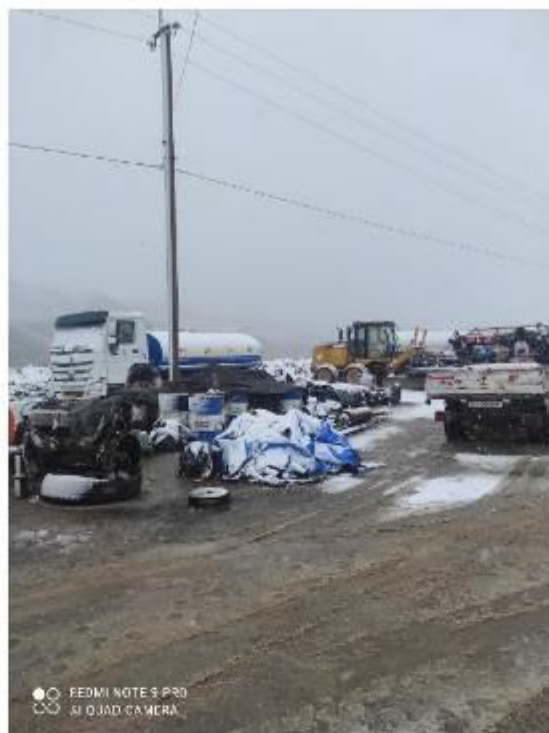
6.3	Are containers or barrels marked?	<input type="checkbox"/>	<input checked="" type="checkbox"/>	See photo 6.3
6.4	Maintenance of clean and tidy on the territory of the construction camp	<input checked="" type="checkbox"/>	<input type="checkbox"/>

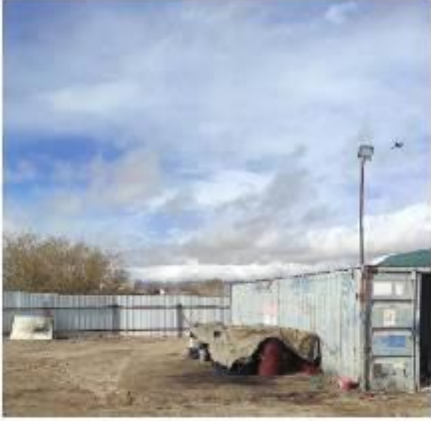
№	Photo
6.3

6.3	Are containers or barrels marked?	<input type="checkbox"/>	<input checked="" type="checkbox"/>	See photo 6.3
6.4	Maintenance of clean and tidy on the territory of the construction camp	<input checked="" type="checkbox"/>	<input type="checkbox"/>

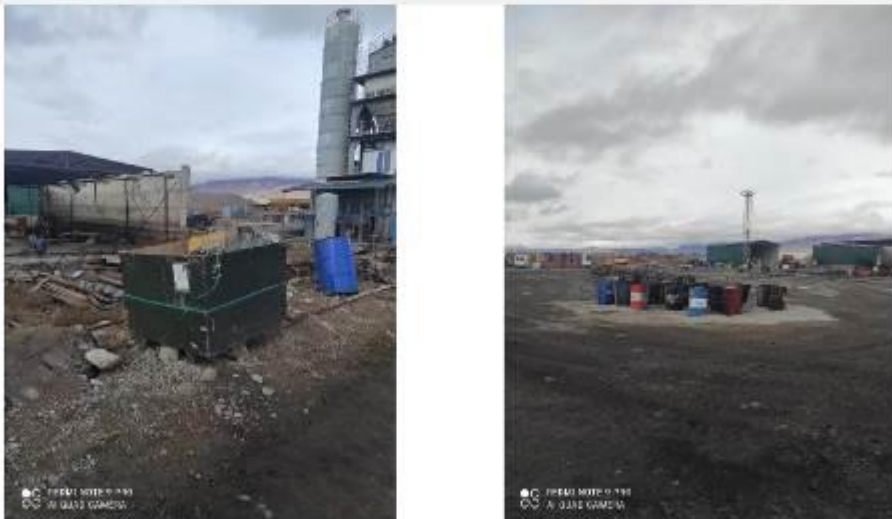
Nº	Photo
5.4

5.4	Are containers or barrels marked?	<input type="checkbox"/>	<input checked="" type="checkbox"/>	See photo № 5.4
6. <u>Health and safety of the residents/workers</u>

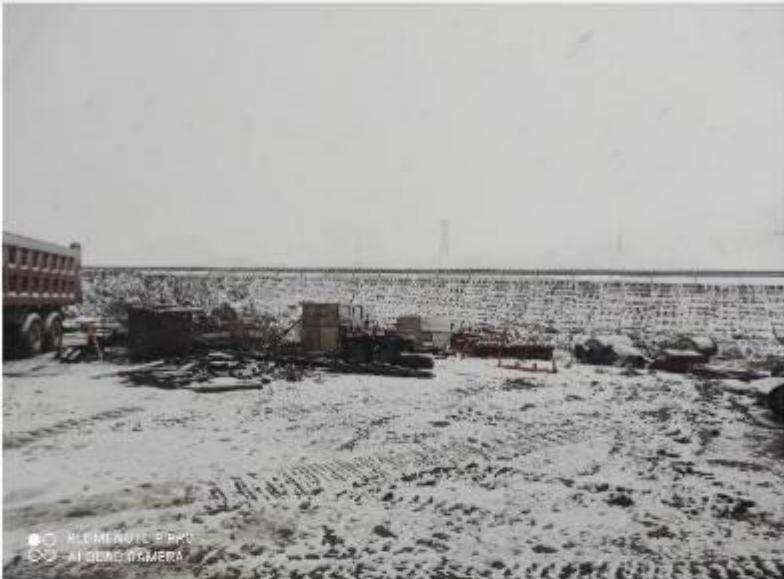
No	Photo
5.3

5.2	Is there place for collection of solid waste ?	<input checked="" type="checkbox"/>	<input type="checkbox"/> _____
5.3	Is there a tank for collection of polluted material ?	<input type="checkbox"/>	<input checked="" type="checkbox"/> See photo № 5.3

5.4	Are containers or barrels marked?	<input type="checkbox"/>	<input checked="" type="checkbox"/> See photo № 5.3
6. <u>Health and safety of the residents/workers</u>
