# Semi-annual environmental monitoring report

Project number: TA-8887 KGZ

## January-June 2023

### Kyrgyz Republic: Central Asia Regional Economic Cooperation Corridors 1 and 3 Connector Road Project (Phase 2) - Additional Financing

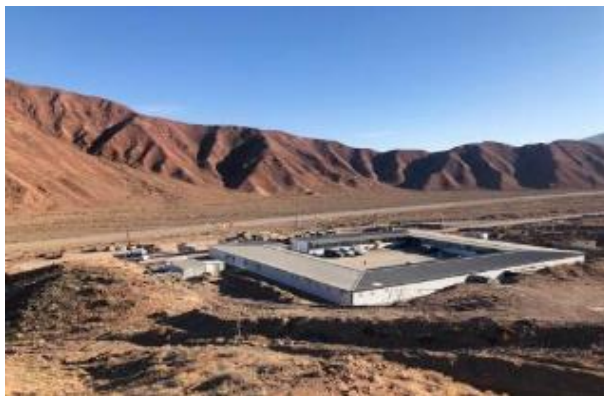
Photo 37. General view of camp Lot 1 km 16 + 100 (RS).

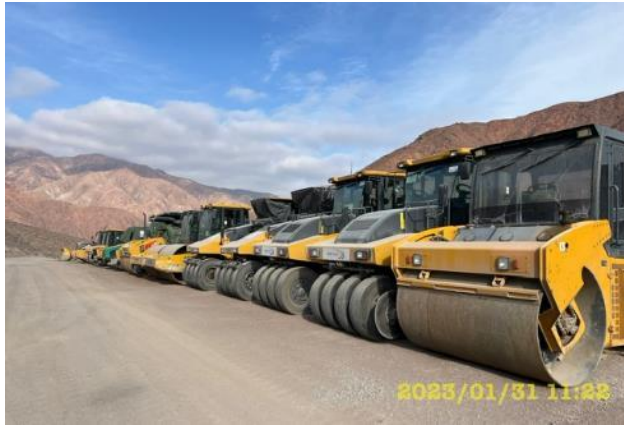
Photo 55. Lot 1. Sanitary condition of construction equipment parking is satisfactory. January

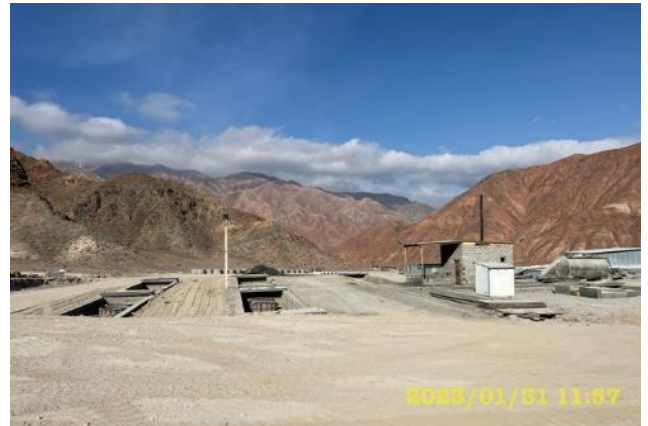
Photo 56. Reinforced concrete production site. Sanitary condition of territory is satisfactory. January.

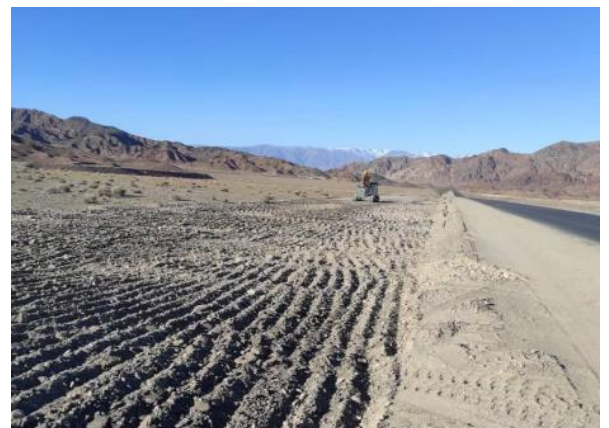
Photo 67. Bypass road at km. 22+000-23+000. Reclamation has been carried out.

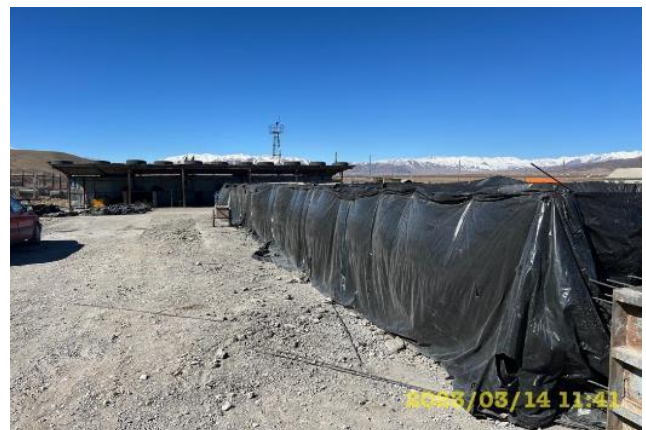
Photo 82. Lot 2. March. Sanitary cleaning of the area along the project road at km 63+480

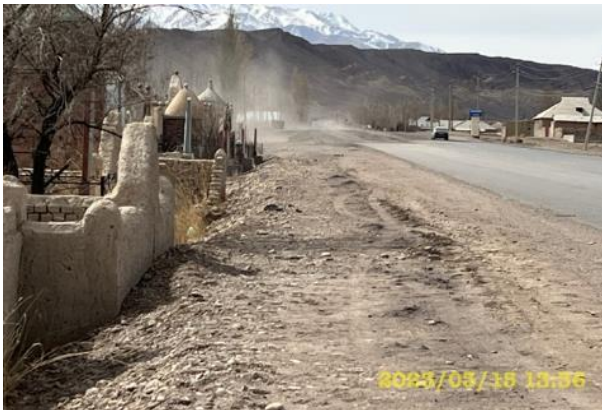
Photo 86. Lot 2. March The cemetery km 68 road LHS not fenced and close proximity to road: as a result of roadside construction, some sections of grave fence have been filled with soil

3	Proper watering of saplings planted along project road from km. 9+350 -10+460 (Photo 78 and 79).	Ensure watering of seedlings, increase the frequency of watering in hot weather.	Permanent.	Constant.
<b>Lot - 2</b>				
4	Cemetery fence foundation located along road km. 68 RHS and fence foundations of some graves located LHS are filled with soil as a result of roadside construction (Photos 84 and 85).	Provide soil cleanup	Due by 3/21/2023.	Done (photos 86, 87)
5	Production site. Pollution near fuel and lubricant storage (Photo 90).	Ensure cleanup	Immediately	Done (photo 91)
6	Production base. Bitumen spill near reinforced concrete production site (photo 92).	Ensure cleanup	Immediately	Done (photo 93)
7	Wastewater after washing the concrete mixing plant is discharged into a waterproof pit,	Provide a watertight tank to collect wastewater from concrete mixing plant.	By March 15, 2023.	In process.

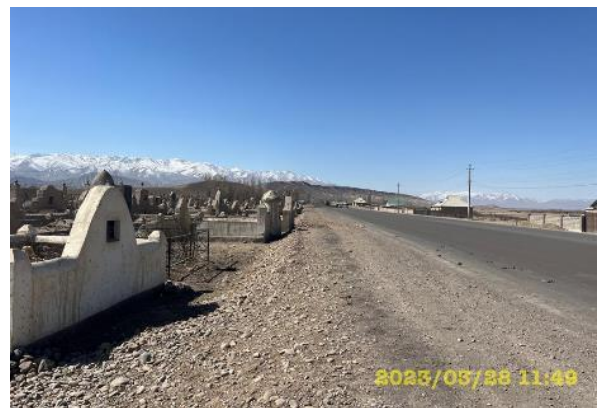
Photo 87. Lot 2. March Cemetery km 68 road LHS: after clearing sections of grave fences from backfill soil.

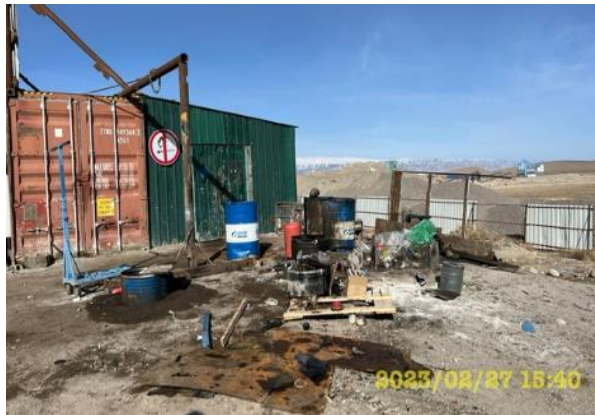
Photo 90. Lot 2. Front of fuel storage warehouse at production base polluted with oil products and littered with garbage

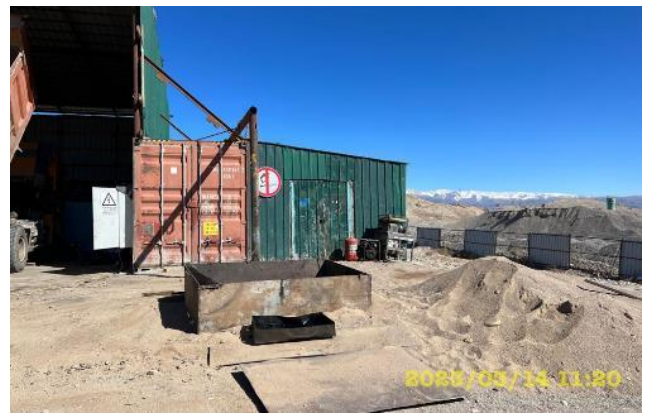
Photo 91. Lot 2. Front of fuel and lubricant storage at production base after cleaning from contamination and debris.

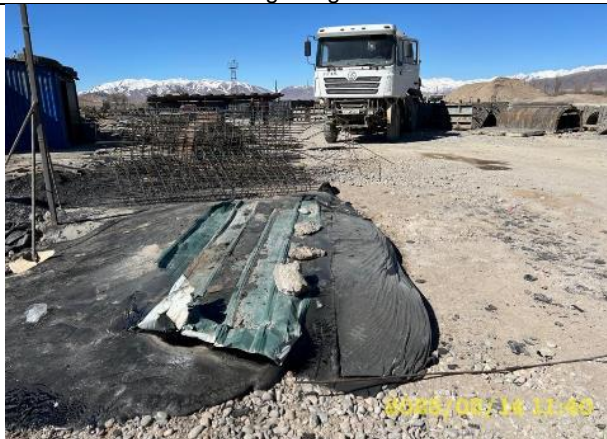
Photo 92. Lot 2. Reinforced Concrete Production site. Bitumen spill.

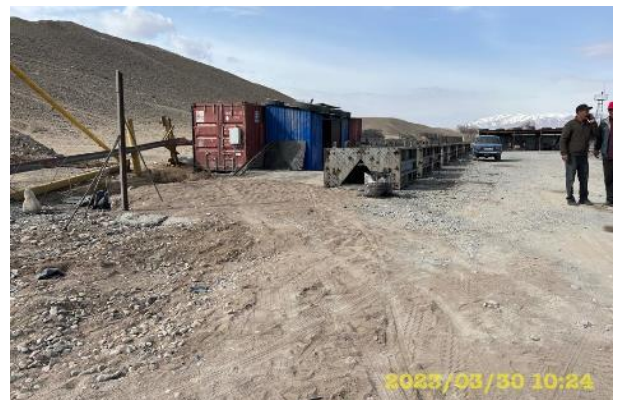
Photo 93. Lot 2. Reinforced Concrete Production site. After cleaning from bitumen spills.

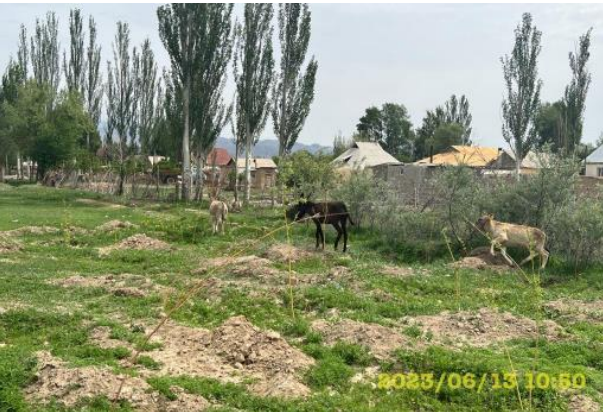
Photo 106. Kok-Jar village. Free access of livestock to the area of planted seedlings, near the school stadium

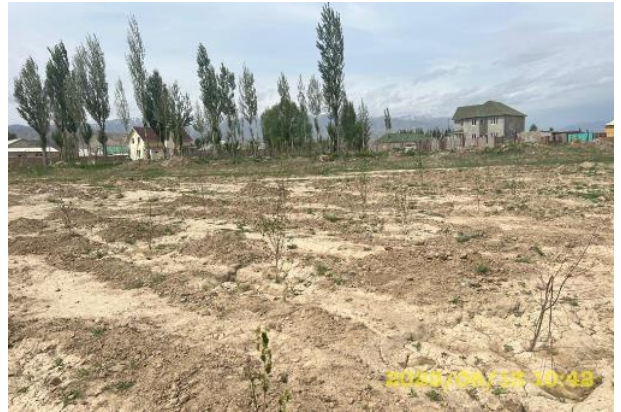
Photo 107. Kok-Jar village, planted seedlings on the territory near the school stadium: seedlings are not properly watered.

8	Proper watering of seedlings planted on Chekildek v. and Kok-Jar v. school territory is not provided (Photo 104, 105, 107).	Provide watering of seedlings, increase frequency of watering in hot weather.	Up to June 22, 2023.	Extended to July 10, 2023.

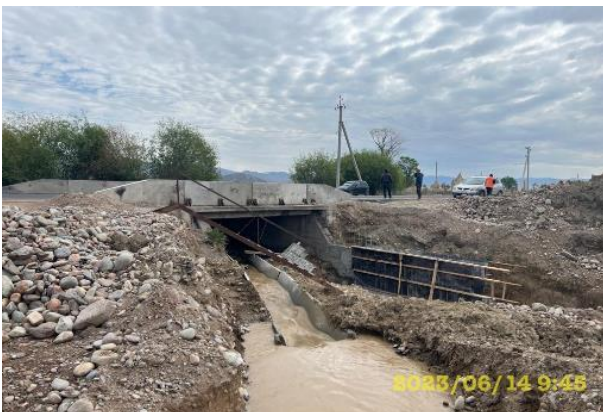
Photo 108. Mukandyn-Suusu river bridge, km. 68+040 It is necessary to provide protective measures to prevent soil from entering the river during construction works.

63. Probable cause of suspended solids exceedance in rivers is possible soil flowing into water:

- During construction of bridge km. 68+040 the prevention of soil flow into Mukandyn-Suus River is not ensured (Photo 108).
- Construction of bridge km 86+261 and km 88+795 has already been completed, but temporary bypass road built for construction period has not been disassembled. At these sections, there is a possibility of soil slumping and falling into river (Photo 110 and 111).

– during bridge construction km. 68+040 soil inflow into Mukandyn-Suusuu r. was not prevented (Photo 108)

To prevent soil inflow into water objects, Contractor was recommended to: - ensure proper water drainage without soil inflow into Mukandyn-Suusuu r. Upon completion of works to conduct laboratory tests of water for suspended solids content. Recommendation has been implemented (Photo 111). Laboratory tests are required.

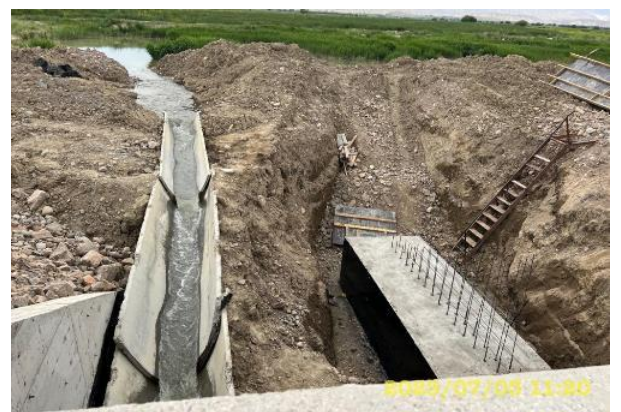
Photo 109. Mukandyn-Suusu river bridge, km. 68+040 It is necessary to provide water diversion measures to prevent soil from entering the river during construction works.

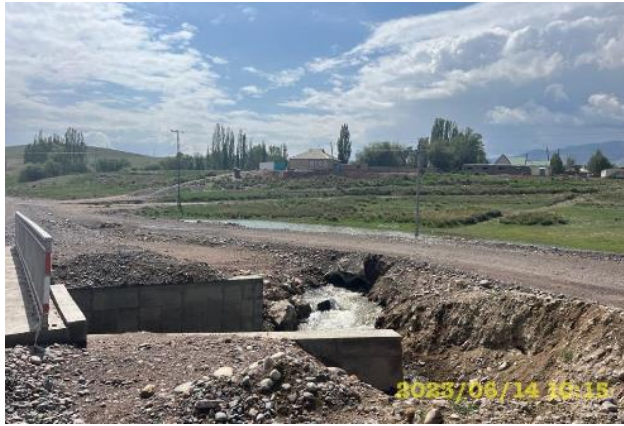
Photo 110. Bypass road of the bridge at km 86+261. r. Sazdyn-Suusu,. Construction of the bridge is completed; the bridge bypass is open. The bypass road is subject to reclamation.

9.	Construction of bridges km. 86+261 and 88+795 have been completed. Use of bypass road has been discontinued (Photos 110, 111).	Ensure reclamation of land allocated for bypass road	Extended to July 10, 2023.	Ongoing.

– bridge construction km.86+261 and km.88+795 has already been completed, but the bypass road constructed during the construction works has not been dismantled. At these sections, there is a possibility of soil slumping and falling into the river (Photos 110 and 111).

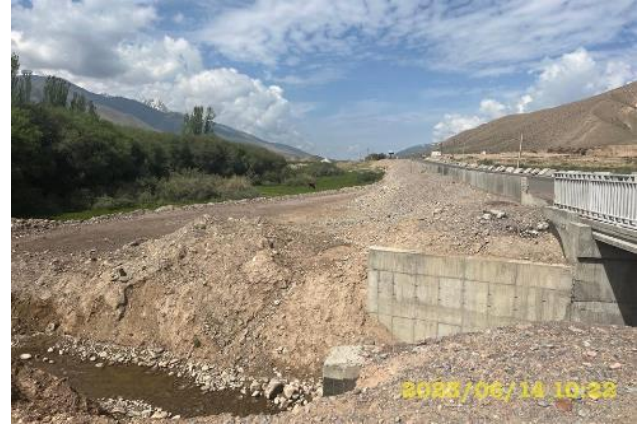
Photo 111. Bypass road of the bridge at km 88+795. r. Zhar-Korundu. Construction of the bridge is completed; the bridge bypass is open. The bypass road is subject to reclamation.

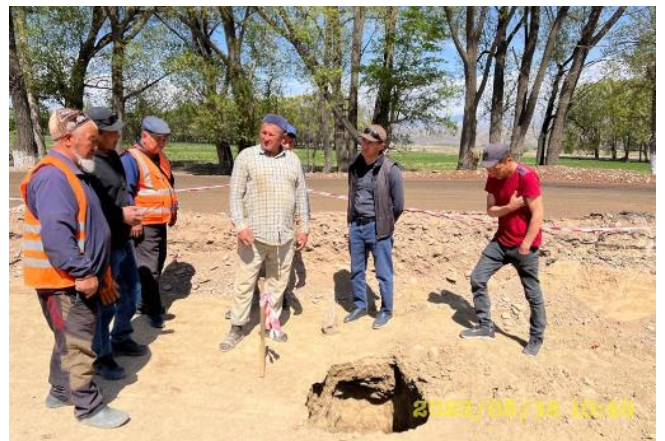
May 16, 2023 during construction works on Lot 2 at road section km. 62+050 v. Tendik, next to the existing cemetery: during removal of the existing old road, a burial site / grave was discovered under its base (Photo 127).

Photo 127. Lot 2. Found burial, under existing road base at km 62+500, Tendik v.
