Semi-Annual Environmental Monitoring Report

January – June 2024

Central Asian Regional Economic Cooperation Corridor 3 Improvement Project (Bishkek-Osh Road), Phase 4, Bishkek-Kara-Balta section (km 8.5 - km 61).

Prepared by: Project Implementation Unit of the Ministry of Transport and Communications of the Kyrgyz Republic and the Asian Development Bank.

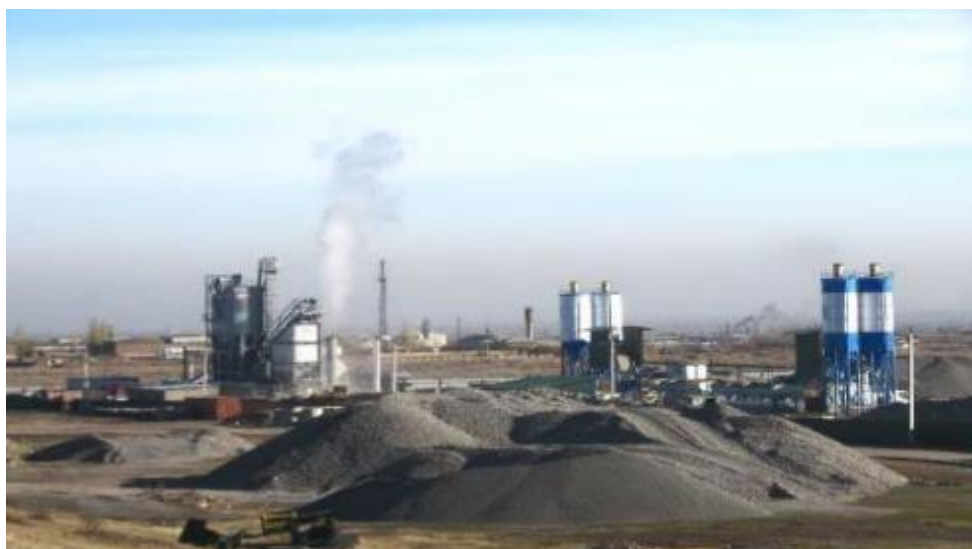
Figure 6 Production site. Concrete mixing plant. Asphalt Bitumen Plant

39. The contractor carried out partial dismantling of structures at the plant. In December 2023, the Contractor entered into an additional agreement with the owner of the site (the owner of the site is the Ministry of Emergency Situations of the Kyrgyz Republic) to extend the lease and use further this site for the needs of the Contractor, outside the project activities.
