# Semi-annual environmental monitoring report

Project number: 45169-001

January - June 2022

Central Asian Regional Economic Cooperation Corridor 3 Improvement Project (Bishkek - Osh road), Phase 4, Bishkek-Kara-Balta section (km 8.5 - km 61).

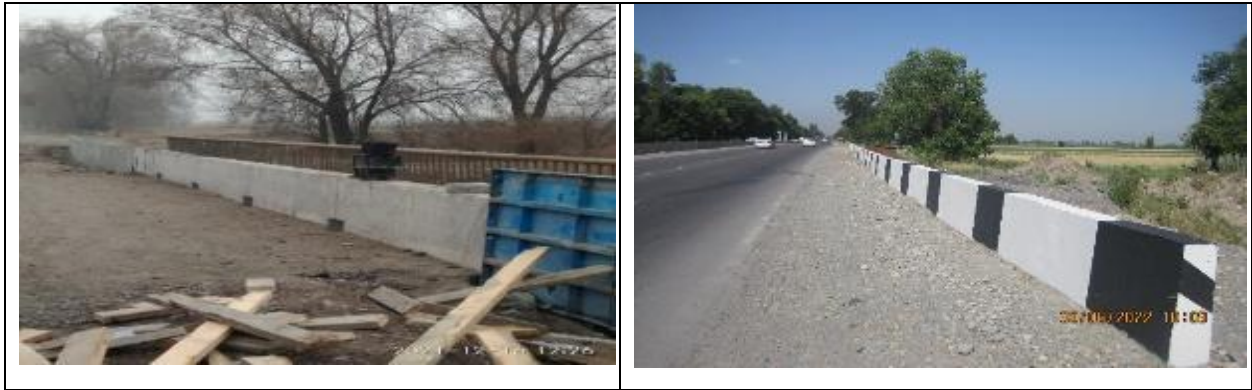
38. At the Jelamysh River (km 18 + 360), wheel-safety parapet barriers of BO2 type were constructed.

Figure 11 Construction of a wheel-safety parapet barriers at the Jelamysh river

117 Near the Jelamysh River (km 18 + 360), wheel-safety parapet barriers of BO2 type were constructed. After the completion of the construction work, a large amount of soil, construction waste, and reinforced concrete structures remained in the Jelamysh riverbed.

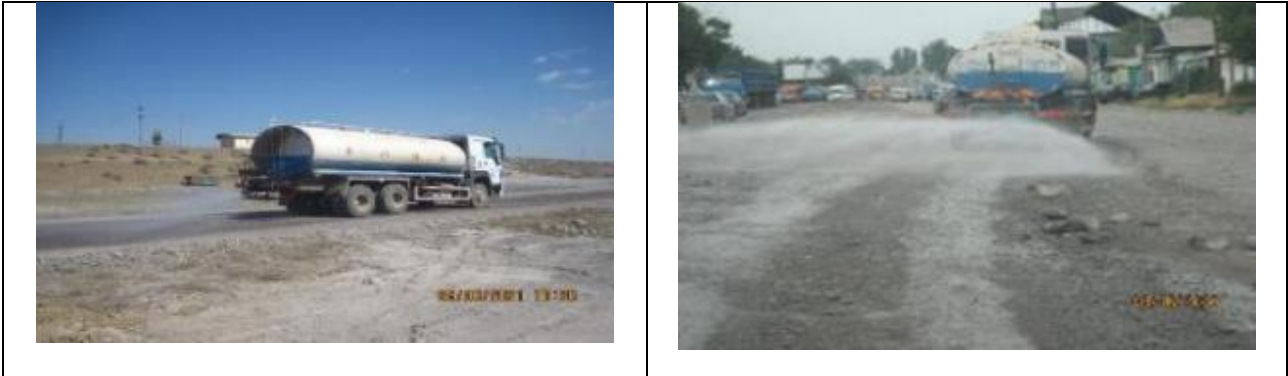
110. The main impact on the environment during excavation work in the previous periods was increased dust formation. In the reporting period, there were only single cases of dust formation, about which the Contractor was immediately warned. Wate sprinkling on the road, including shoulders, in the construction sites was carried out from 7 am to 8 pm without a lunch break. The contractor has drawn up a schedule for watering the road with an indication of the interval between watering of 30 minutes. Considering the small scope of work on the road and the fact that several

Figure 27 Water sprinkling works. Road to the production site and at the road construction site in the Voенno-Antonovka

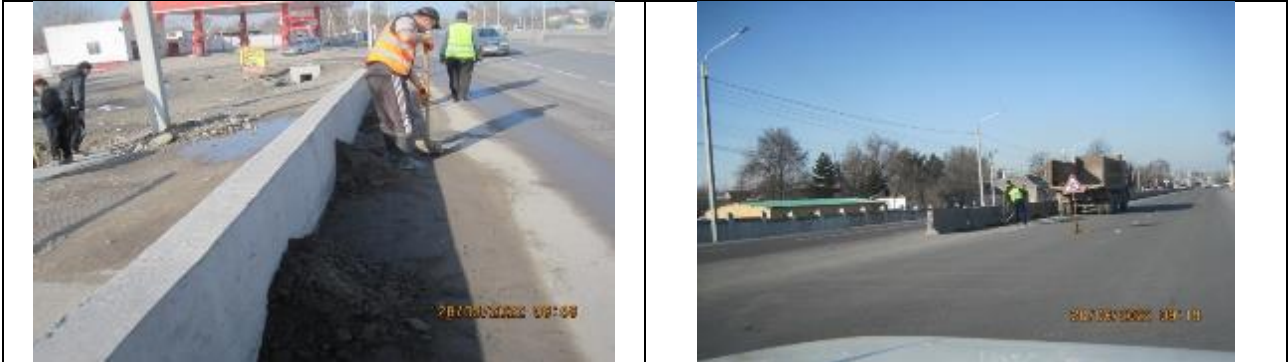
112. Work on the installation, cleaning and strengthening the parapets of "New Jersey" type included welding work, concreting cut on the carriage way between the parapets. During the monitoring, it was found that on the road shoulders, where work was carried out to strengthen the parapets, the soil waste remained uncollected in the form of small piles. Under the impact of atmospheric precipitation, the waste was eroded and polluted the surrounding area. A letter was sent to the contractor to fix this violation with an indication of deadlines. In due time, the soil waste on the shoulders was collected and removed. Further, the soil accumulated near the parapets was cleaned and removed in a timely manner.

Figure 28 Cleaning of area near parapets from earth waste and removal of waste from the road

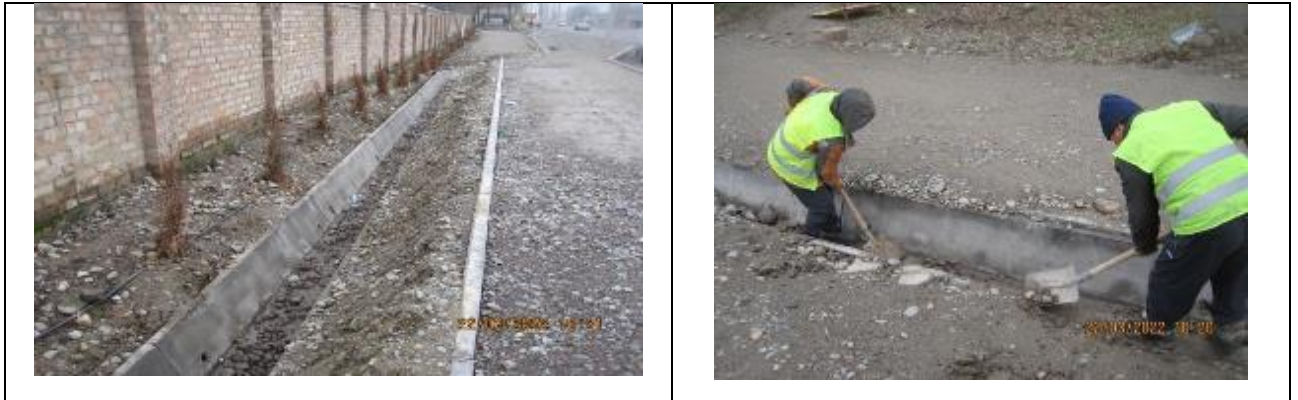
113. During the reporting period, work was also carried out on installation and cleaning the stones and debris on the previously installed culvert ditches.

Figure 29 Cleaning of side culvert ditches

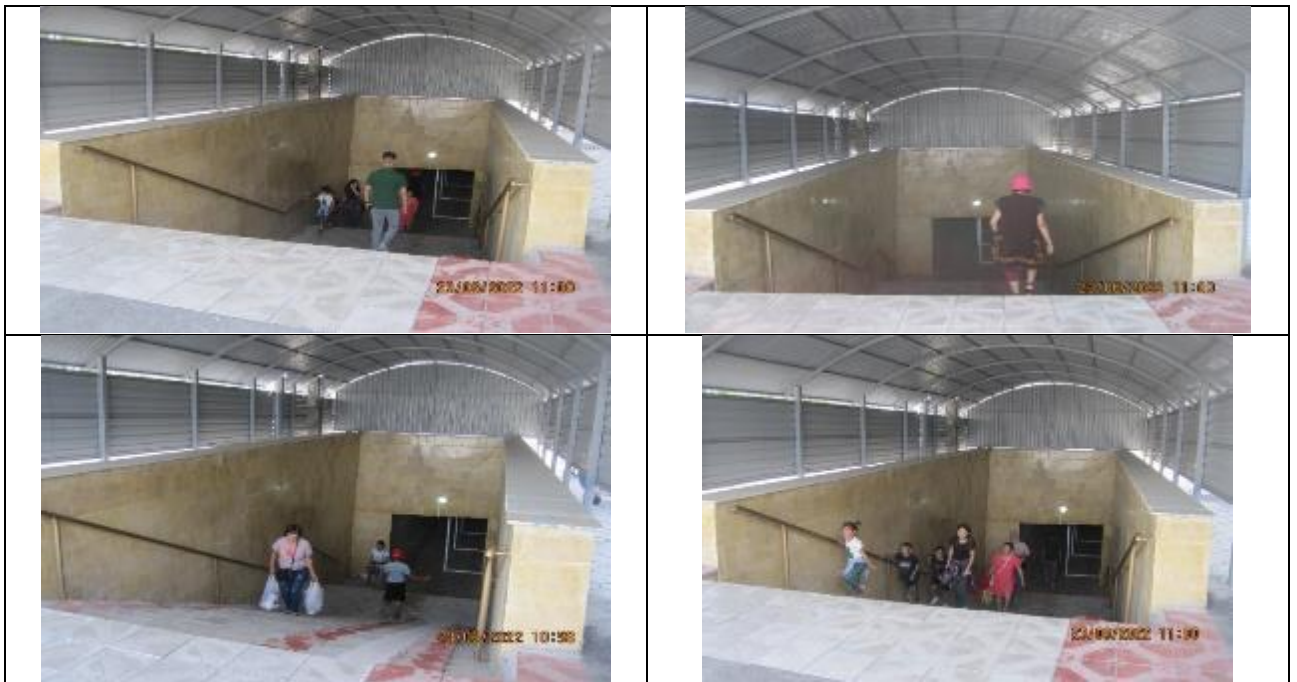
Figure 34 Underpass in the Sokuluk

121. Adults and children are currently crossing the road using some of the underpasses.

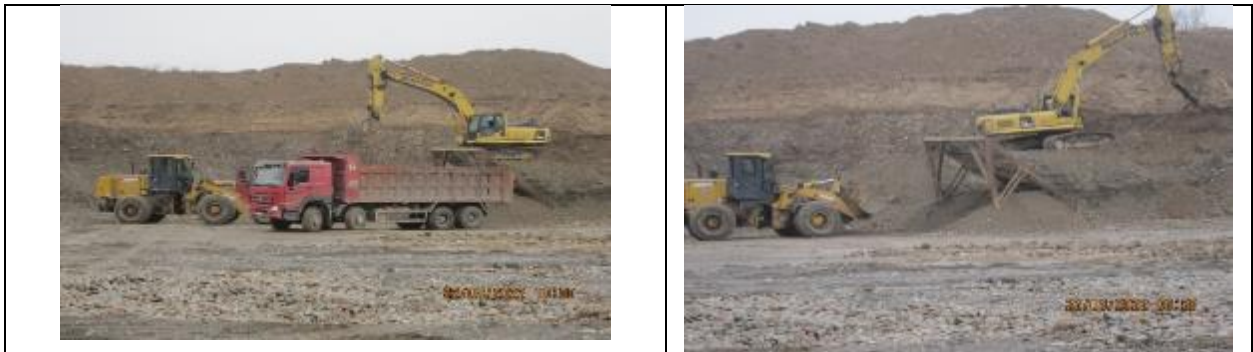
123. **Belek borrow pit.** During the reporting period, the extraction of inert materials was carried out only at the Belek borrow pit at km 8.5 - 15.9 section (km 7.4 section). The material was delivered directly to the construction of the road for levelling.

Figure 36 Development of Belek borrow pit.

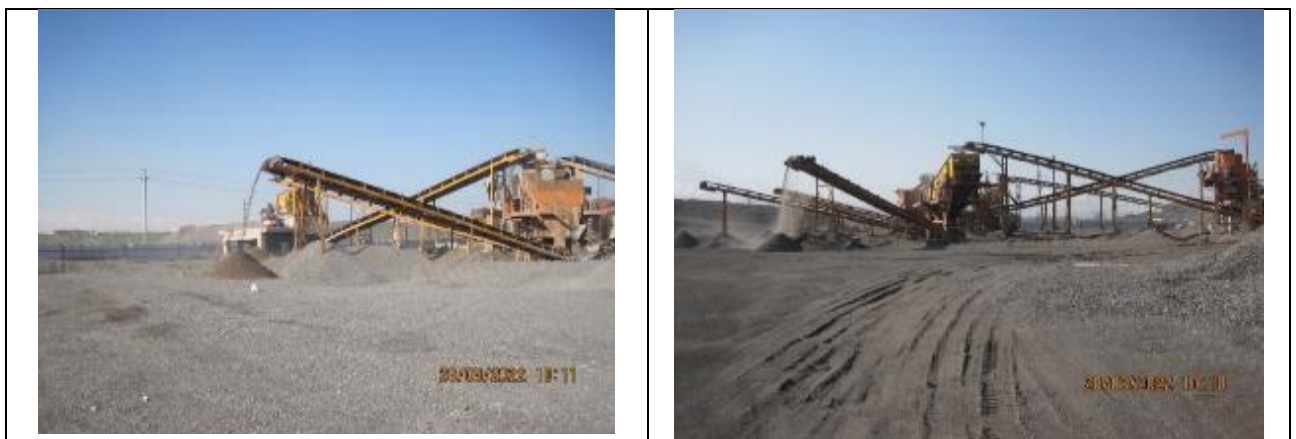
128. During the reporting period, the stone crushing plant operated on moistened raw materials without dusting. The watering of the inert material before crushing is sufficient for dust suppression. The nearest villages are located at a long distance from the production site. There is no impact on the population of villages because of the operation of the plant.

Figure 38 Operation of a stone crushing plant on moistened raw materials

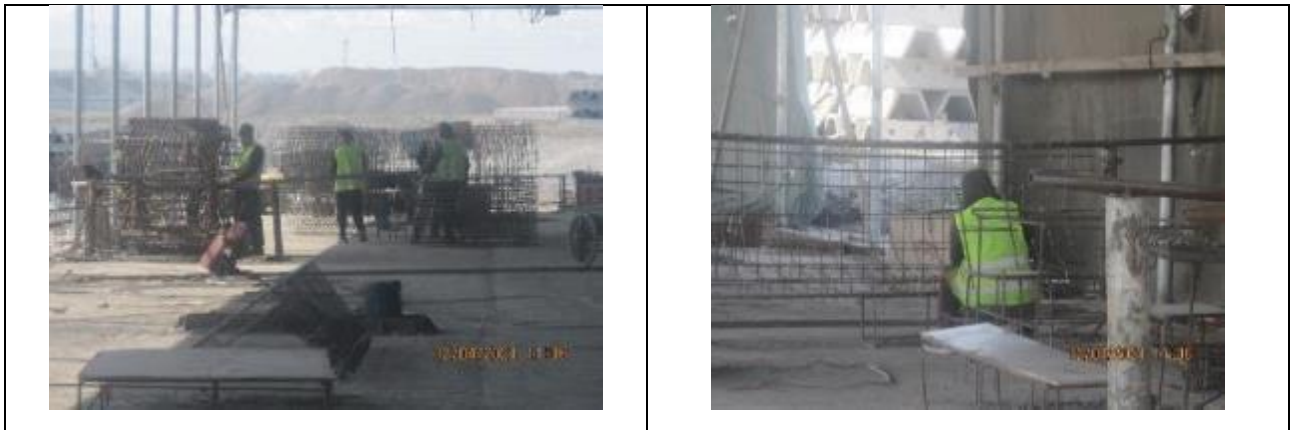
129. At the production site, manufacture of welded reinforcing meshes, frames for the production of reinforced concrete structures, pouring of various reinforced concrete products for the road needs (concrete rings, ditches, curbs, New Jersey-type fences, etc.) was also carried out. Workers are not provided with sufficient personal protective equipment.

Figure 40 Production of reinforcing welded meshes, frames for the production of reinforced concrete structures

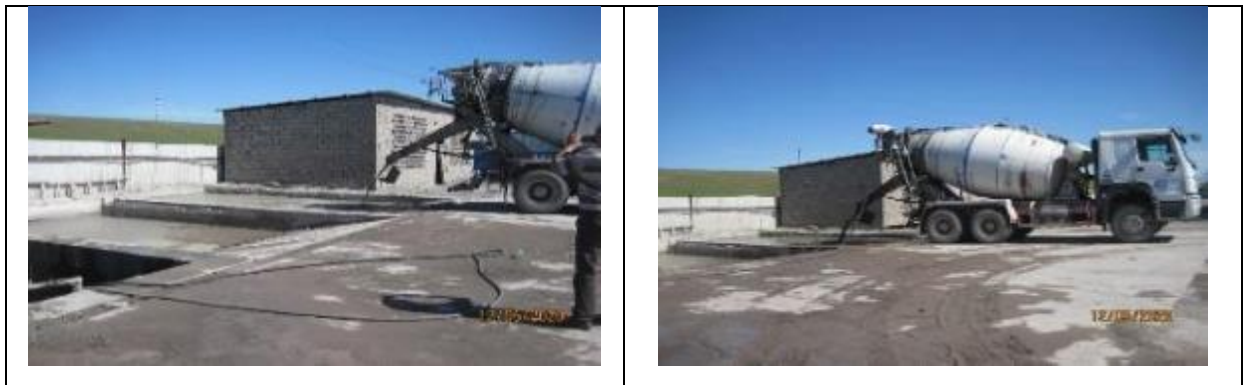
131. Washing of concrete mixers is carried out on a specially designated area. The flushing water is discharged into a special three-section sump. Further, the flushing water, after settling, is used for water-sprinkling the area of the production site.

Figure 42 Washing of concrete mixer trucks.

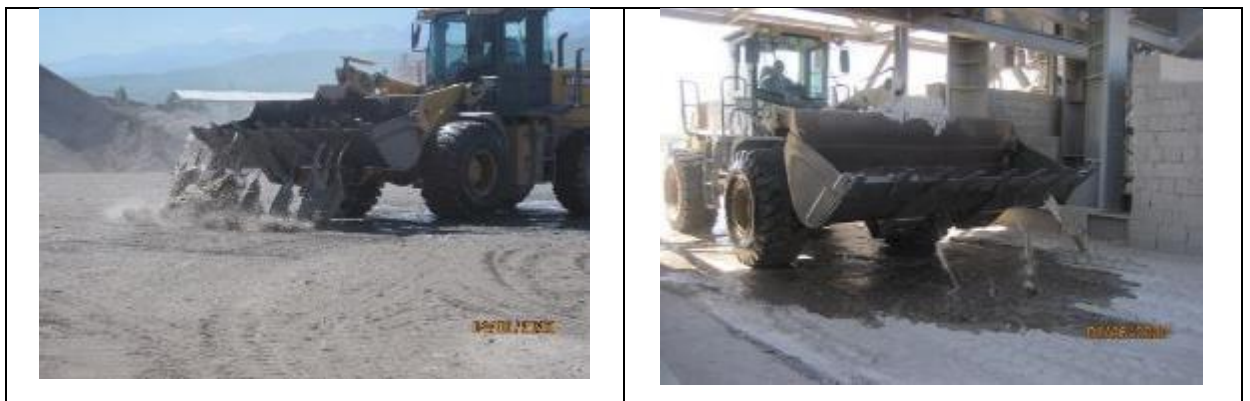
Figure 43 Watering of the production site with flushing water.

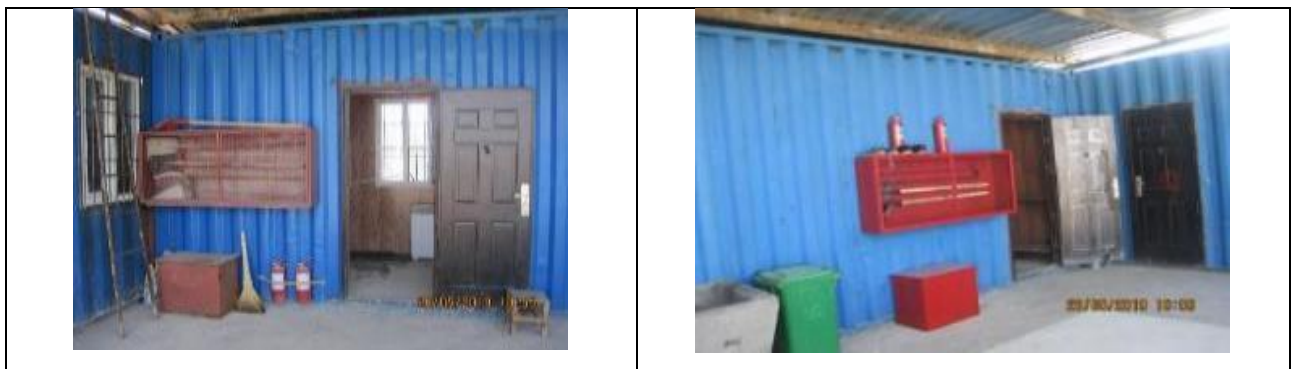
136. In the new camp sewage water is discharged into an existing septic tank by pipelines. 2 fire shields were installed in the camp.

Figure 45 Fire shields on the territory of the camp

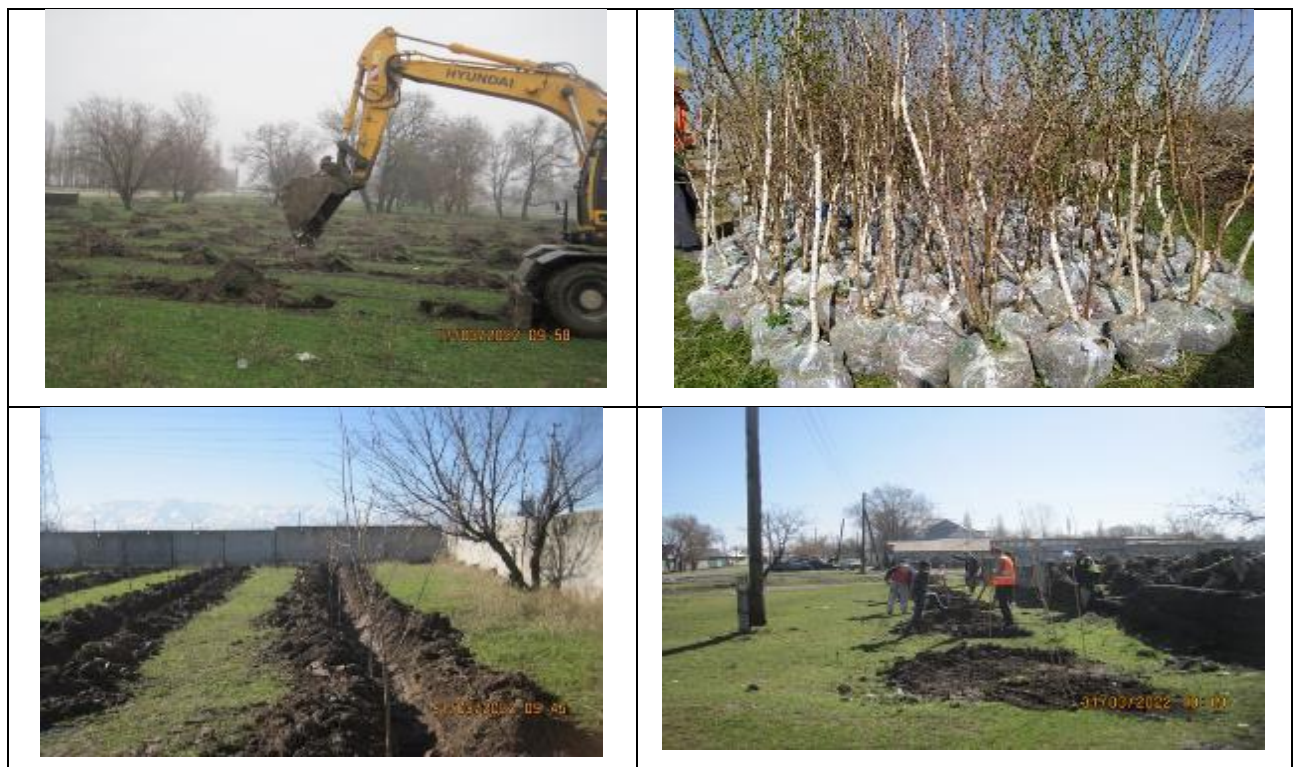
147. For the reporting period, 6 125 young seedlings were planted:

Figure 48 Planting seedlings in March 2022

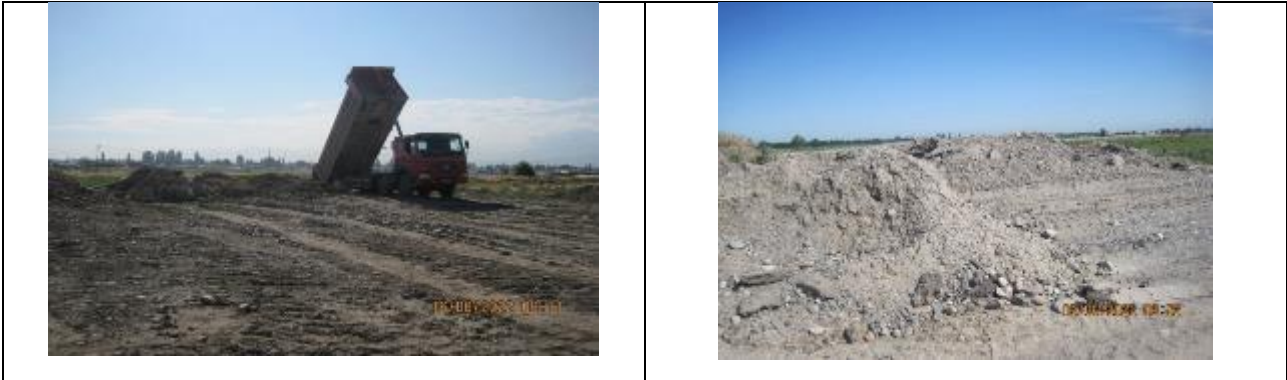
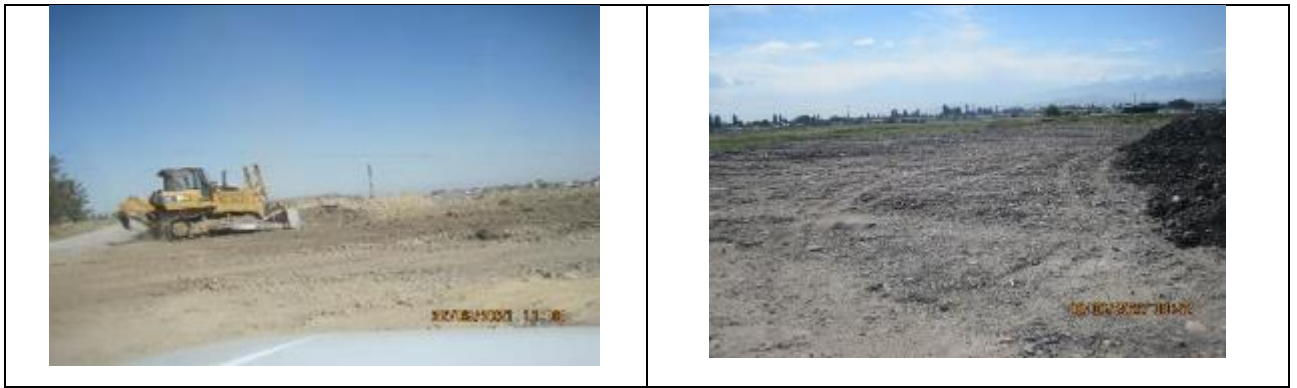
192. At the soil storage area, the soil layer was initially removed and stored. Then the unsuitable soil in the village of Voенno-Antonovka was stockpiled in dumps. Then the unsuitable soil was relocated to a prepared site in a ravine. Partial leveling was carried out. After completion of all works, the top layer will be evenly speraded on the surface of dumps.

Figure 54 Storage and levelling of unsuitable soil for further use in the village of Voенно-Antonovka.

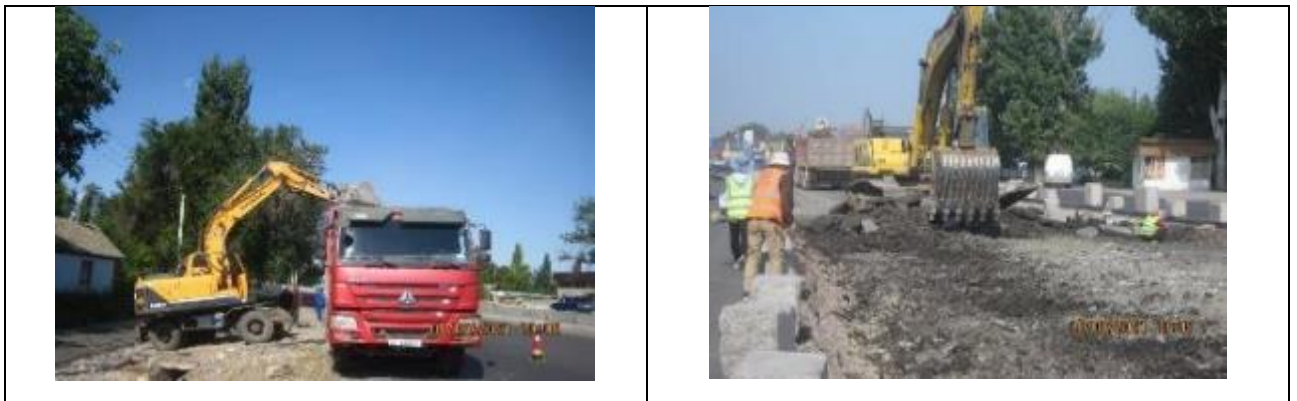
191. During the reporting period, the old asphalt was dumped in the village of Voенno-Antonovka on rural streets. Unsuitable soil for road construction is taken to land plots provided by local authorities.

Figure 55 Taking out of the removed asphalt in the village of Voенно - Antonovka.

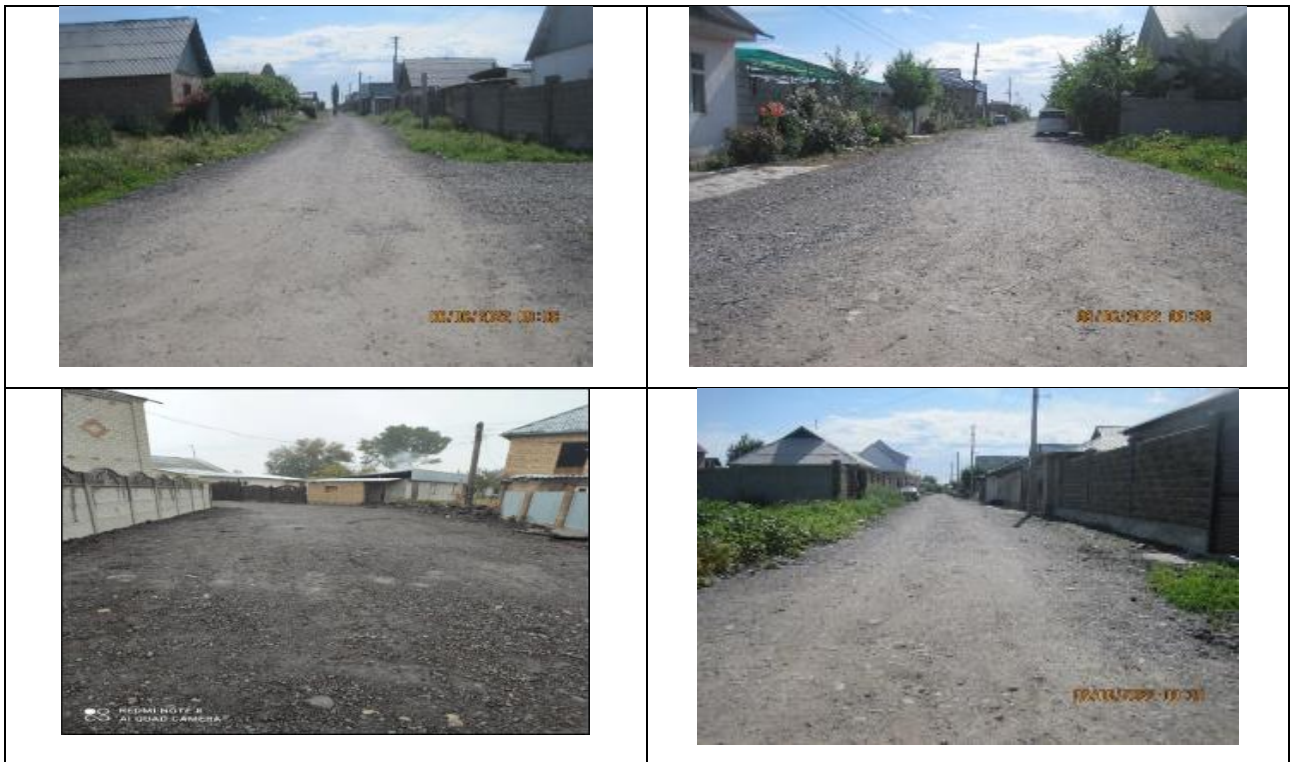
Figure 56 Backfilling of old asphalt on internal roads in the village of Voенно – Antoovka

193. The problem of crushing old asphalt remains unresolved. After laying the old asphalt on secondary roads, the contractor compacts it with its equipment. The consultant will continue to
