Semi-annual environmental monitoring report

Project number: 45169-001

January - June 2022

Central Asian Regional Economic Cooperation Corridor 3 Improvement Project (Bishkek - Osh road), Phase 4, Bishkek-Kara-Balta section (km 8.5 - km 61).

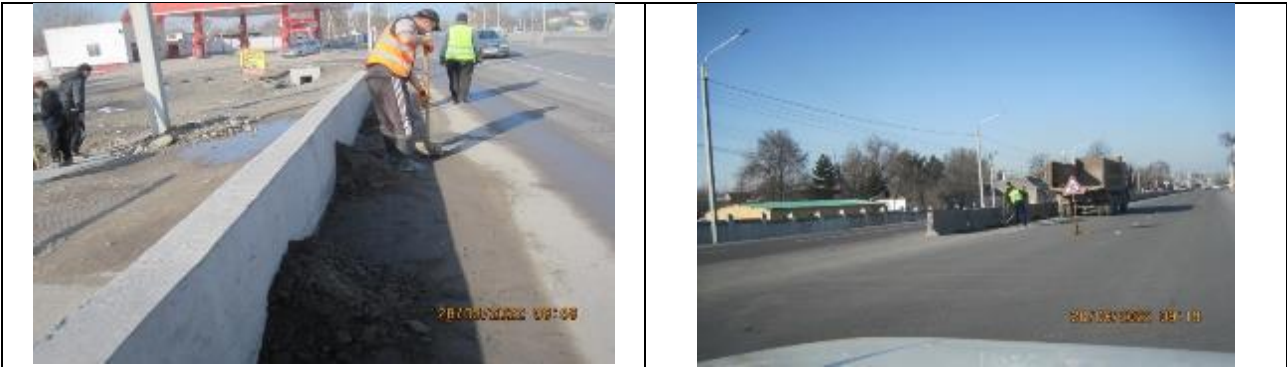
No	Organization Name	Role in project	Responsible person for the environmental safeguards	Contacts
1	ADB	Environment Specialist	Ninette R. Pajarillaga	npajarillaga@adb.org
2	ADB's Kyrgyz Republic Resident Mission (KYRM)	Consultant	Sultan Bakirov	Sbakirov.consultant@adb.org
3	PIU under MoTC KR	Executive Agency	Asylbek Abdygulov	asylbeka@piumotc.kg
4	Temelsu	Consultant	Tatiana Volkova	volkova_ti55@mail.ru
5	The limited liability company "China Railway Engineering Group No. 5»	Contractor	Uzbekov Kanatbek	kanatbek.uzbekov.88@mail.ru

Figure 28 Cleaning of area near parapets from earth waste and removal of waste from the road

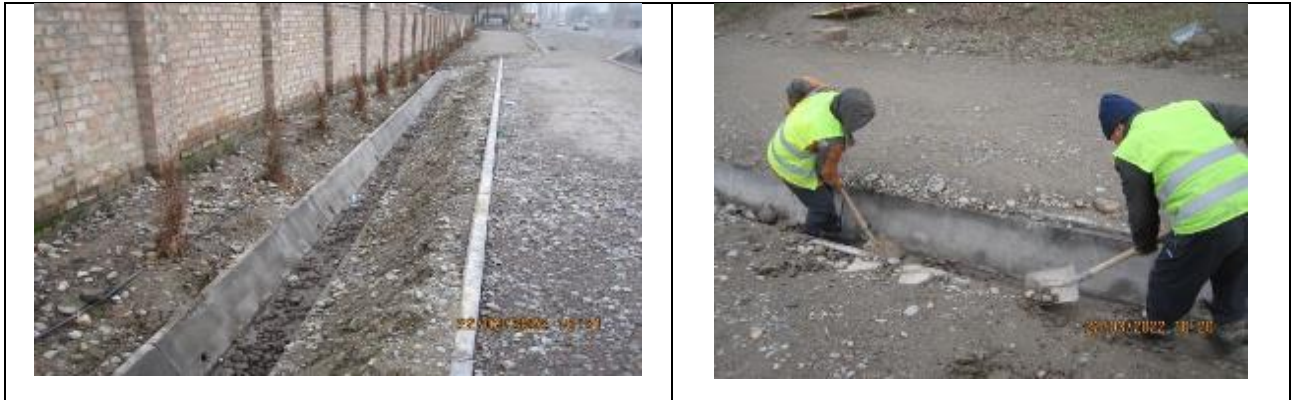
112. During the reporting period, work was also carried out on installation and cleaning the stones and debris on the previously installed culvert ditches.

Figure 29 Cleaning of side culvert ditches

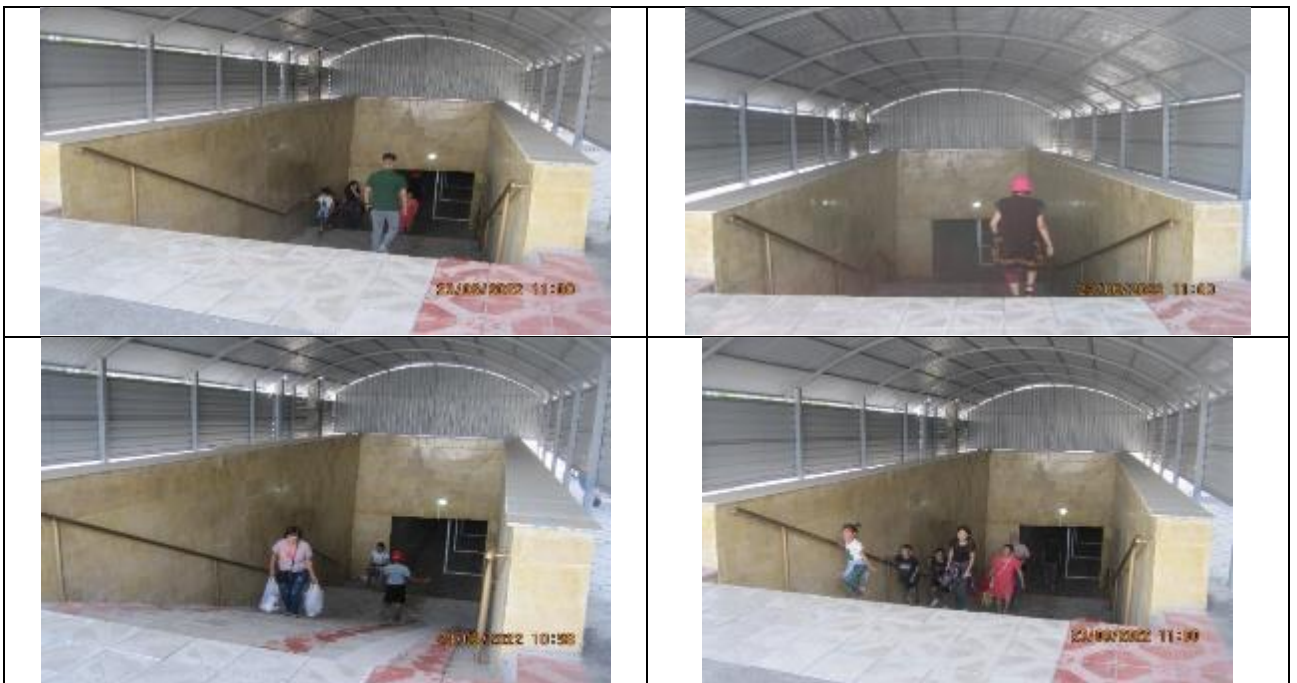
Figure 34 Underpass in the Sokuluk

120. Adults and children are currently crossing the road using some of the underpasses.

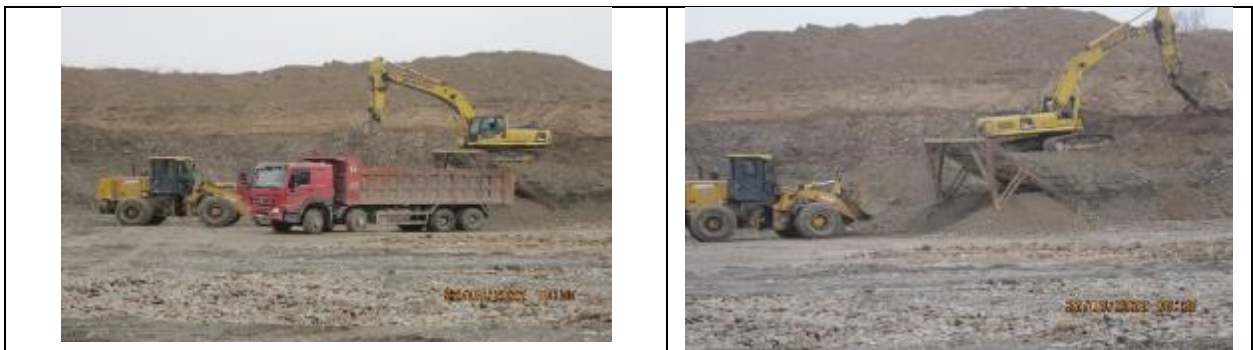
122. **Belek borrow pit.** During the reporting period, the extraction of inert materials was carried out only at the Belek borrow pit at km 8.5 - 15.9 section (km 7.4 section). The material was delivered directly to the construction of the road for levelling.

Figure 36 Development of Belek borrow pit.

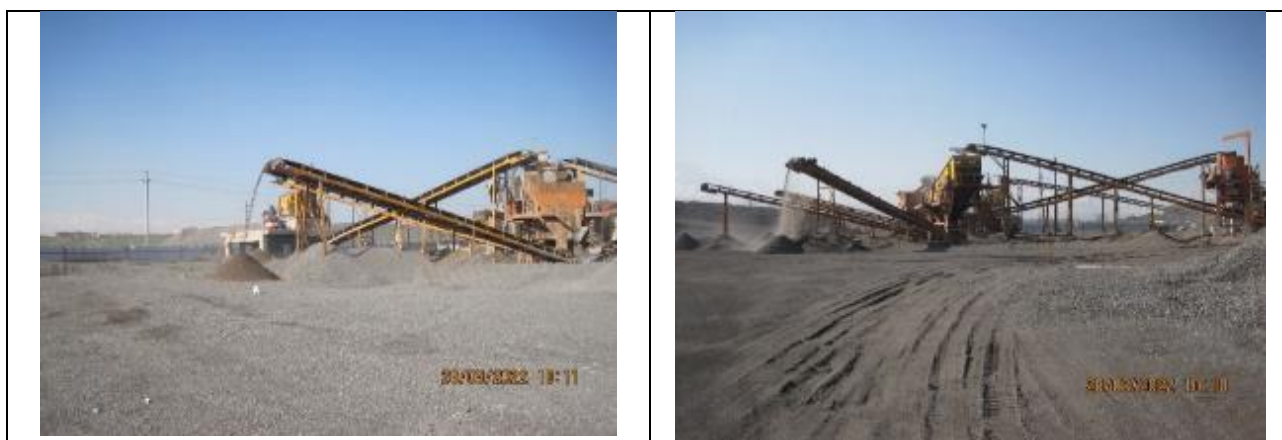
127. During the reporting period, the stone crushing plant operated on moistened raw materials without dusting.

Figure 38 Operation of a stone crushing plant on moistened raw materials

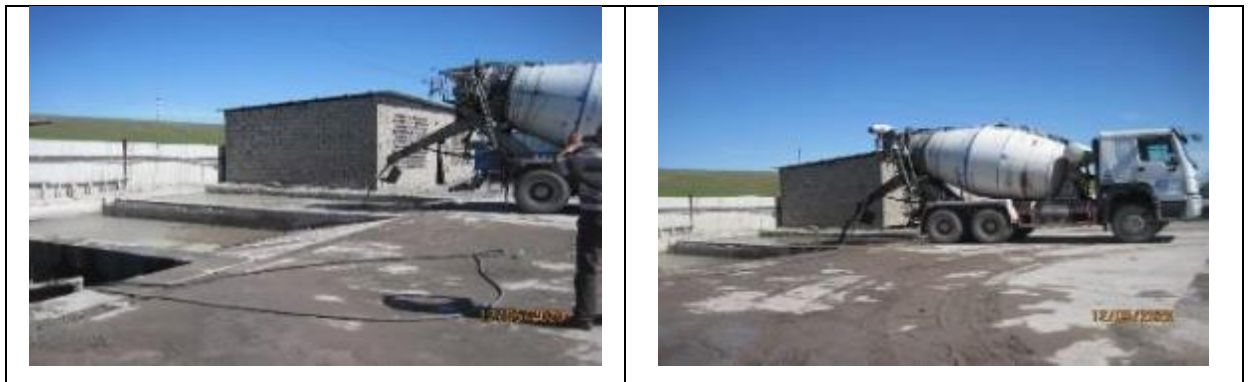
130. Washing of concrete mixers is carried out on a specially designated area. The flushing water is discharged into a special three-section sump. Further, the flushing water, after settling, is used for water-sprinkling the area of the production site.

Figure 42 Washing of concrete mixer trucks.

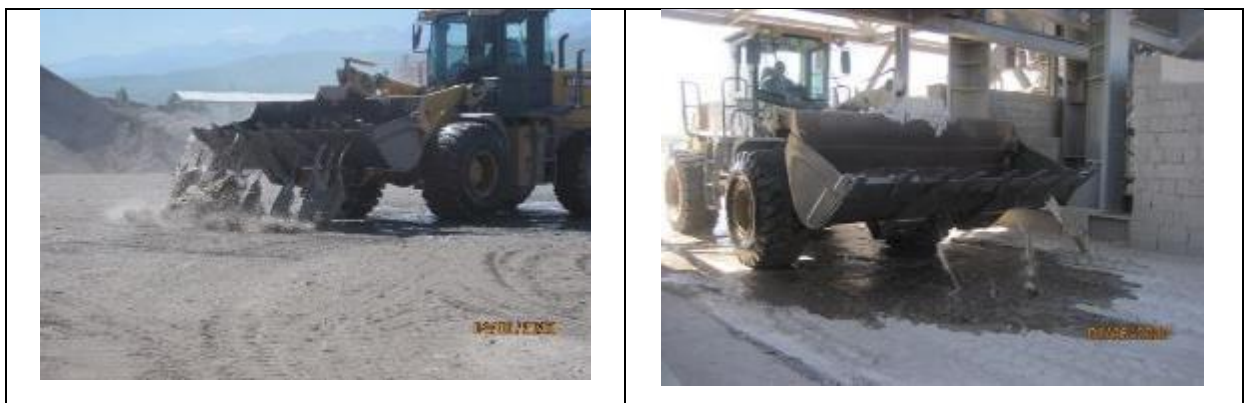
Figure 43 Watering of the production site with flushing water.

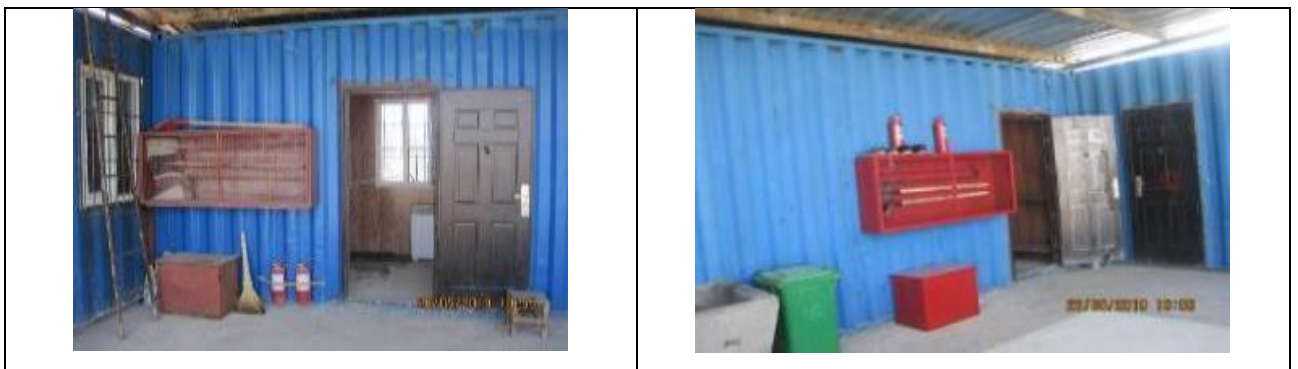
135. In the new camp sewage water is discharged into an existing septic tank by pipelines. 2 fire shields were installed in the camp.

Figure 45 Fire shields on the territory of the camp

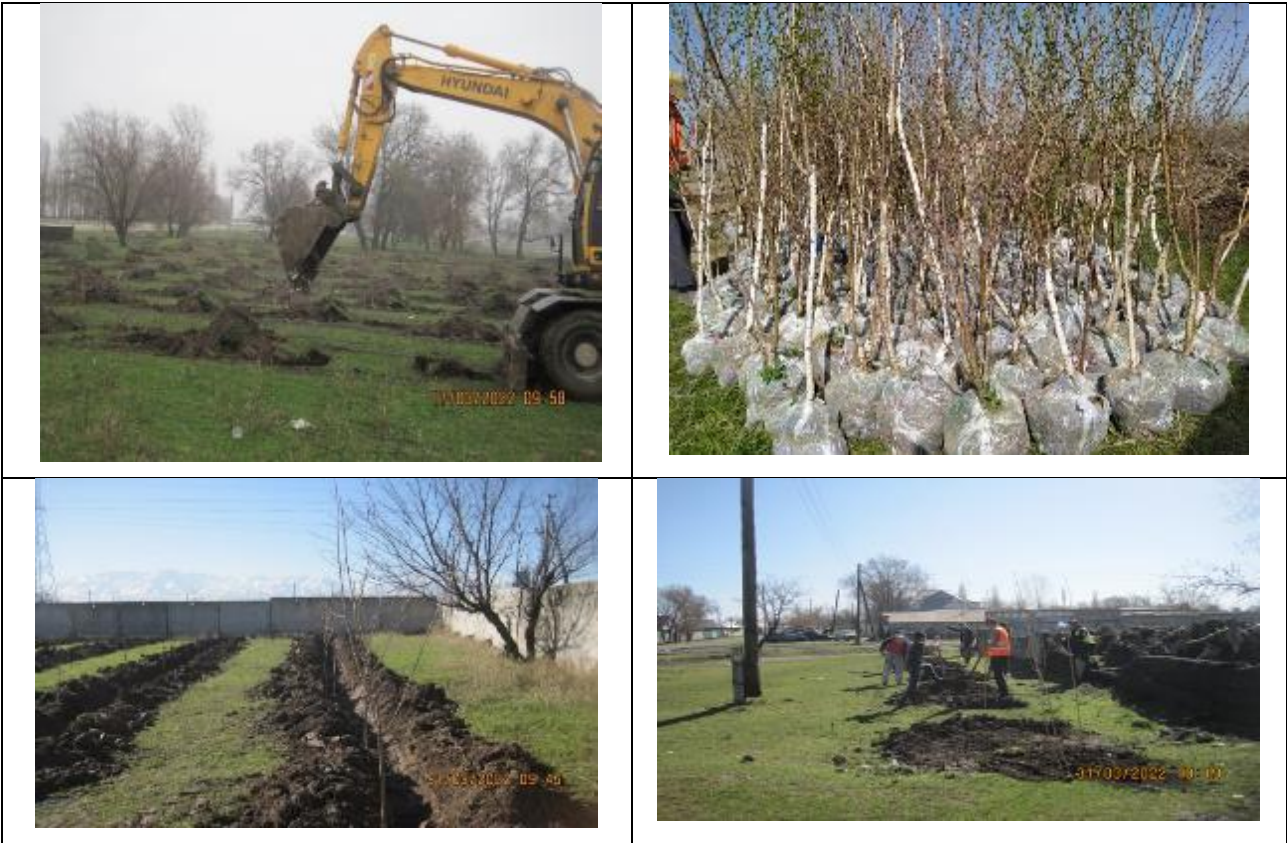
146. For the reporting period, 6 125 young seedlings were planted:

Figure 48 Planting seedlings in March 2022

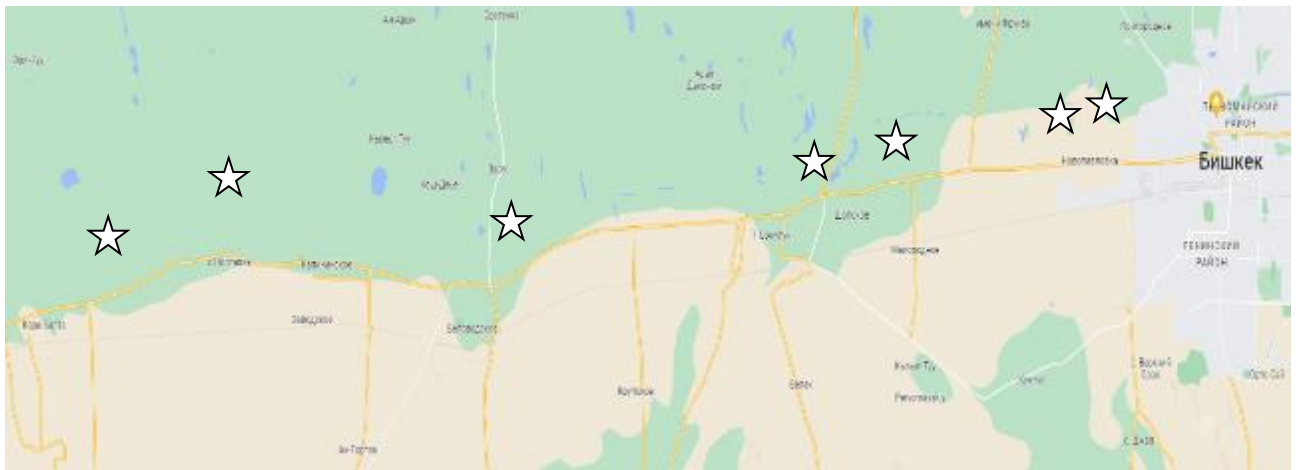
Figure 50 Noise measurement points

167. **Conclusion on the results of measurements:** At the time of the measurements, the background noise level at the measured points during the passage of vehicles near the road was up to 76 dBA in the daytime. During the operation of vehicles and construction equipment of the Contractor, the noise level at the measured points is from 76 dBA to 78 dBA.

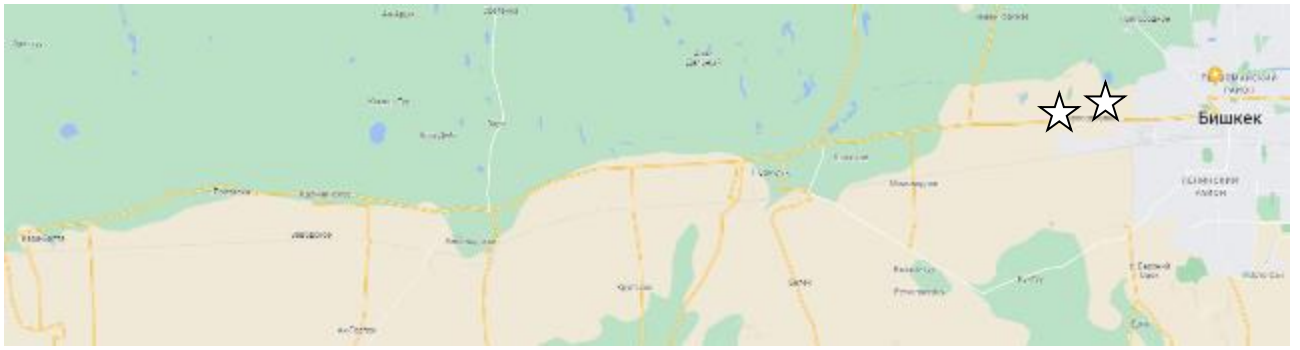
Figure 51 Vibration measurement points

168. **Conclusion based on the results of measurements:** According to the results of instrumental measurements, the vibration level during the operation of vehicles and equipment of the Contractor ranges from 78 dB to 93 dB. The background vibration level is between 76 dB and 88 dB.

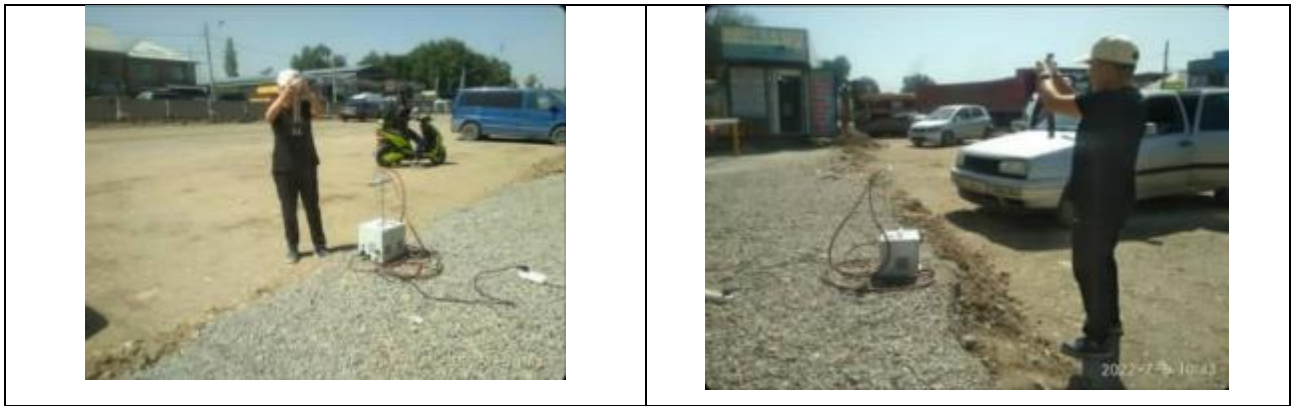
Figure 53 Air quality monitoring

170. Conclusions: Analyzing the data of the monitoring results of environmental components, it is necessary to take into account that the project road section is located in a densely populated area with a large flow of vehicles. Therefore, when analyzing the impact of construction work on the environment, it is necessary to take into account indicators of background levels.

171. After analyzing the data of the monitoring results, it can be noted that, taking into account the data of background levels, construction works do not have a significant impact on the environment.

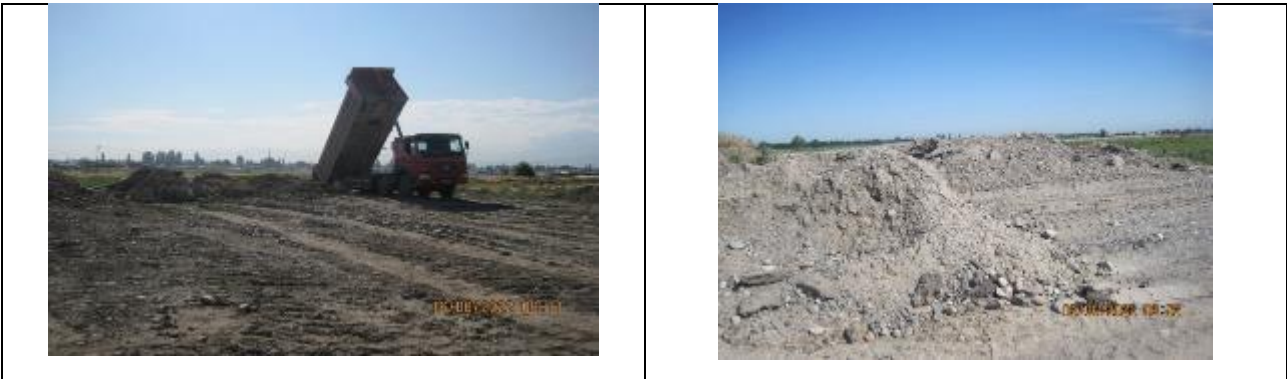
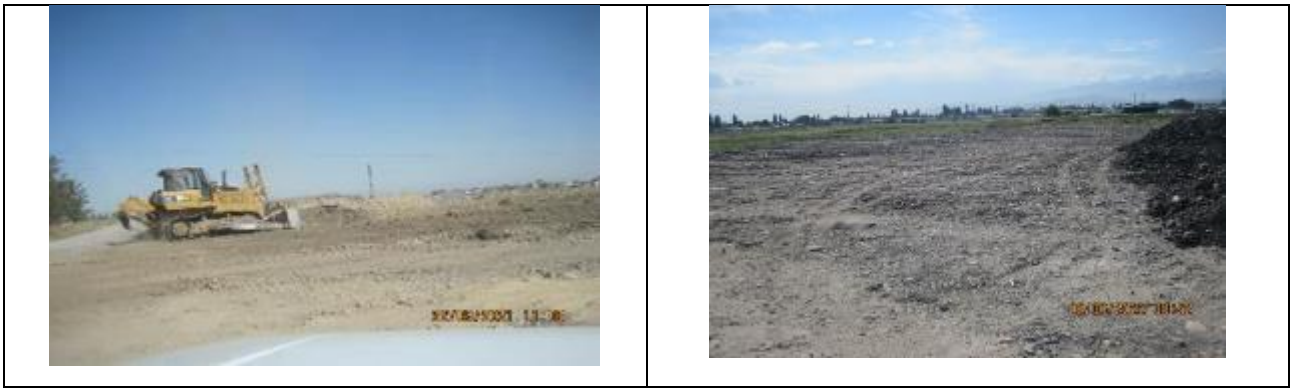
189. At the soil storage area, the soil layer was initially removed and stored. Then the unsuitable soil in the village of Voenno-Antonovka was stockpiled in dumps. Then the unsuitable soil was relocated to a prepared site in a ravine. Partial leveling was carried out. After completion of all works, the top layer will be evenly speraded on the surface of dumps.

Figure 54 Storage and levelling of unsuitable soil for further use in the village of Voенно-Antonovka.

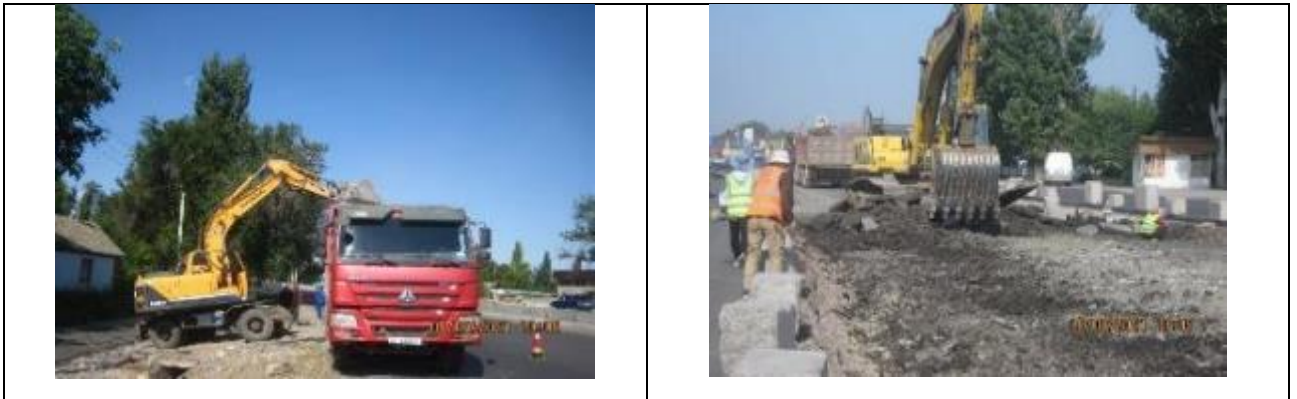
188. During the reporting period, the old asphalt was dumped in the village of Voenno-Antonovka on rural streets. Unsuitable soil for road construction is taken to land plots provided by local authorities.

Figure 55 Taking out of the removed asphalt in the village of Voенно - Antonovka.

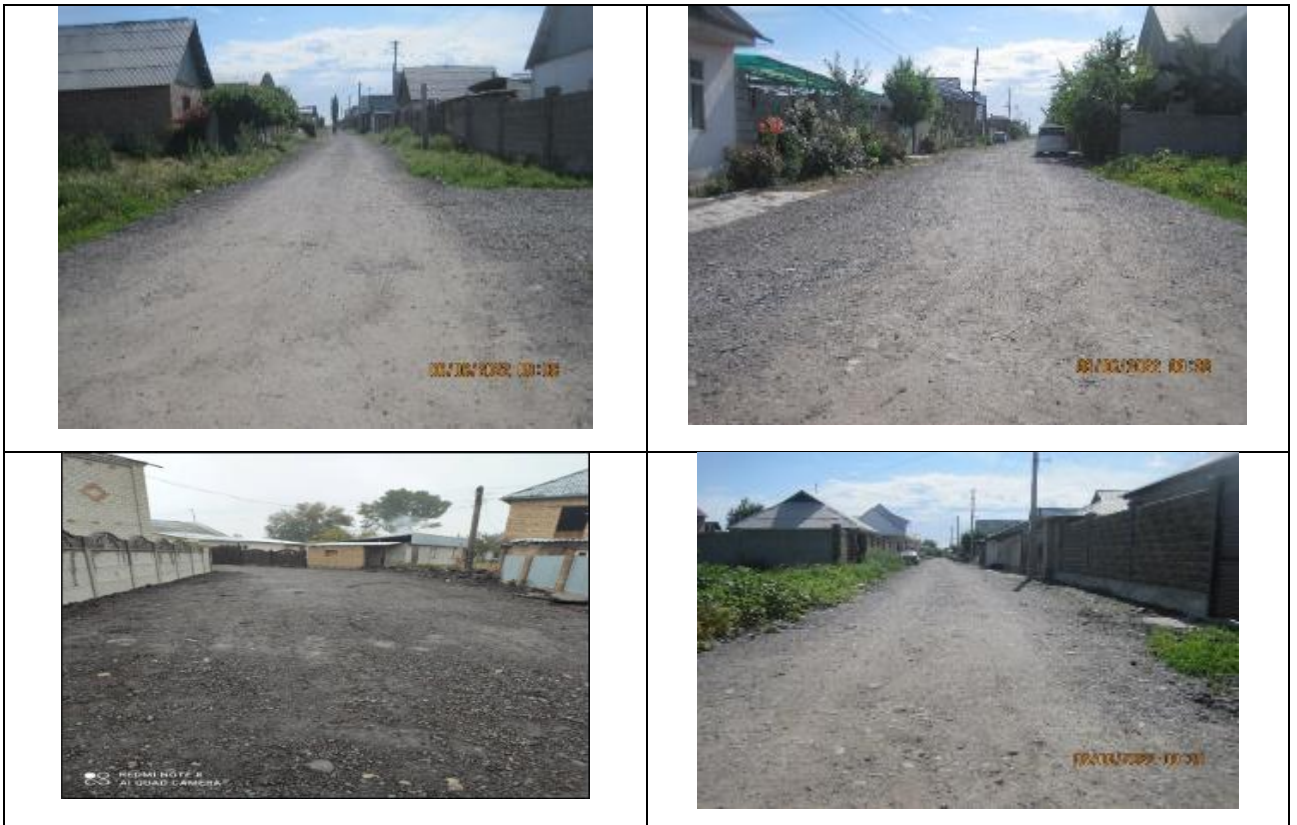
Figure 56 Backfilling of old asphalt on internal roads in the village of Voенno – Antoovka

190. The problem of crushing old asphalt remains unresolved. After laying the old asphalt on secondary roads, the contractor compacts it with its equipment. The consultant will continue to monitor the implementation of this work. There were no complaints from the local residents regarding the disposal of the removed asphalt.

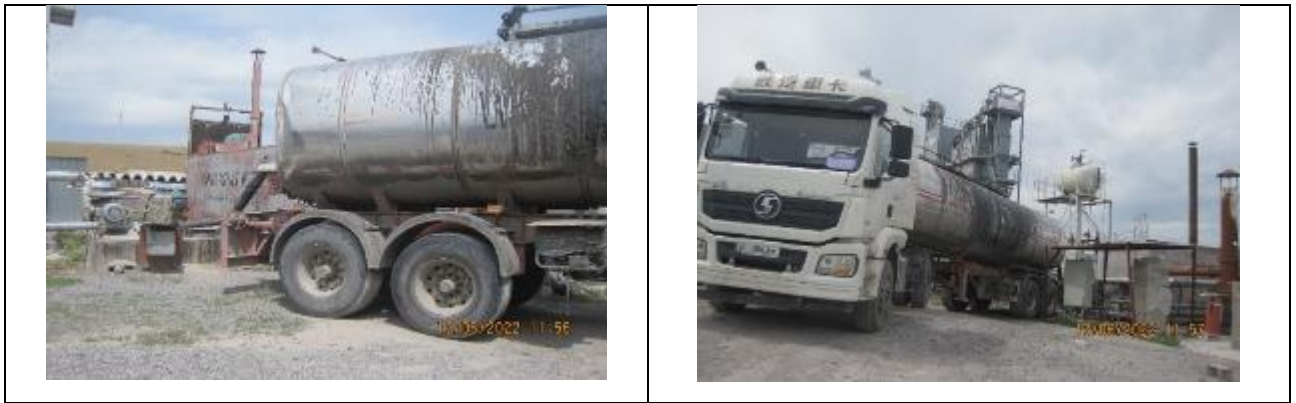
196. In the previous period of work, a large number of barrels with bitumen were delivered to the production site for the preparation of asphalt mix. After bitumen was used, empty barrels were stored on the territory, creating a problem with transportation. During the reporting period, bitumen was delivered by bitumen trucks from rented bitumen pits, barrels with bitumen were not delivered.

Figure 58 Refueling of asphalt plant tanks with bitumen by bitumen trucks
