Environmental Monitoring Report

January–June 2022

Kyrgyz Republic: Central Asia Regional Economic Cooperation Corridors 1 and 3 Connector Road Project (Phase 2) - Additional Financing

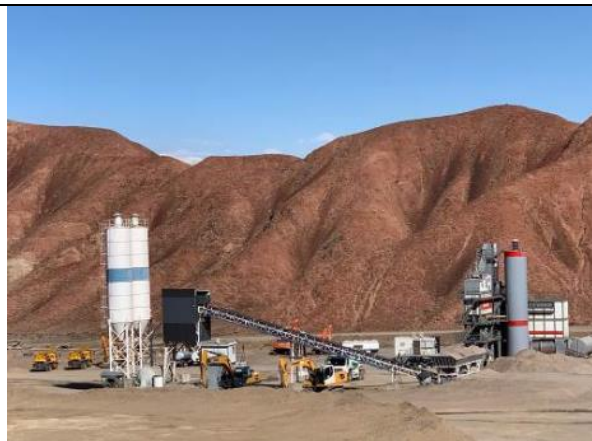
Photo 41. Lot 1 concrete and asphalt batching plants.

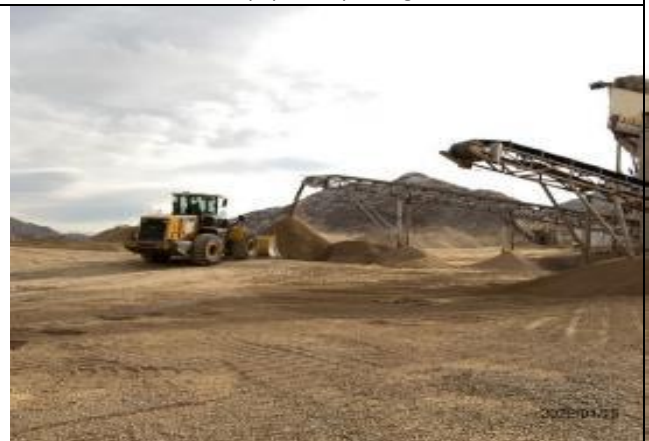
Photo 42. Lot 1 rock crushing plant.

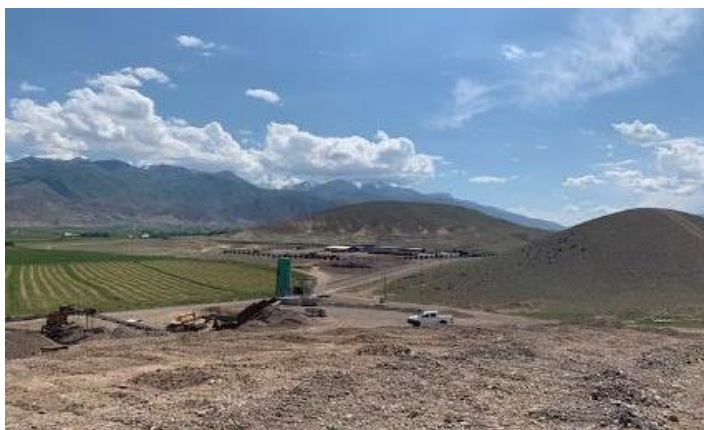
Lot 2 facility area with the rock crushing plant at the foreground and the Contractor's camp at background.

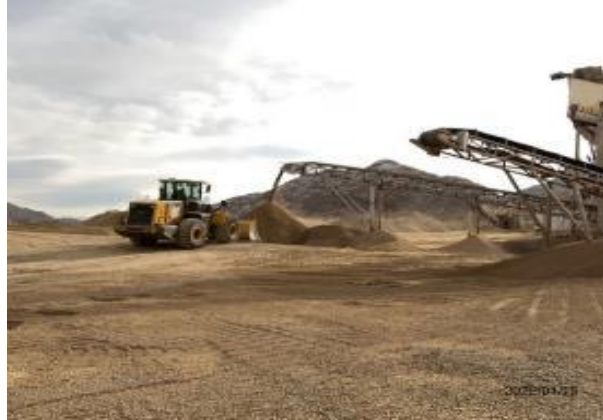
Photo 51. Rock crusher of Lot 1 in operation.

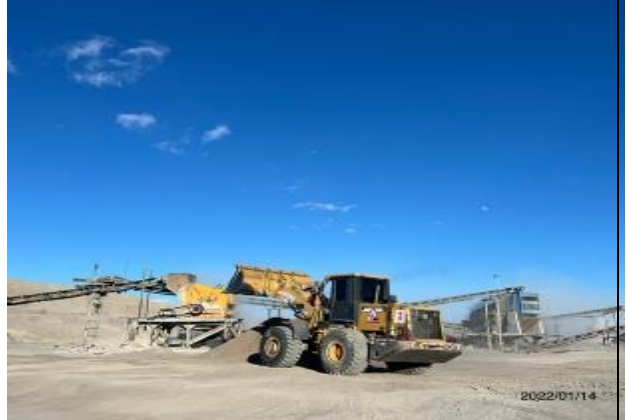
Photo 52. Rock crusher of Lot 2 in operation.

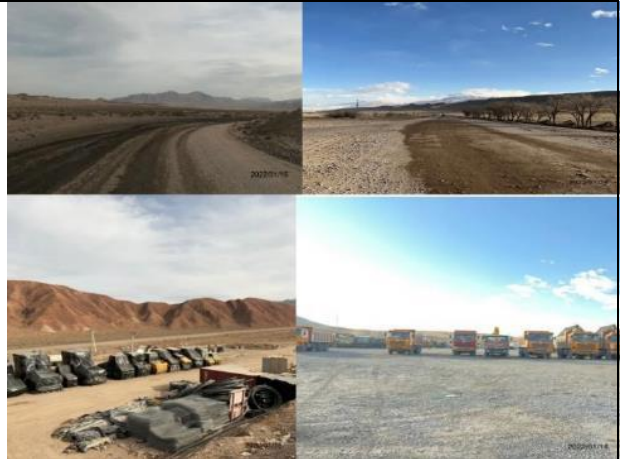
Photo 54. Top: Dust control at Lot 1 and Lot 2
Bottom: Well-maintained parking areas Lot 1 and Lot 2.

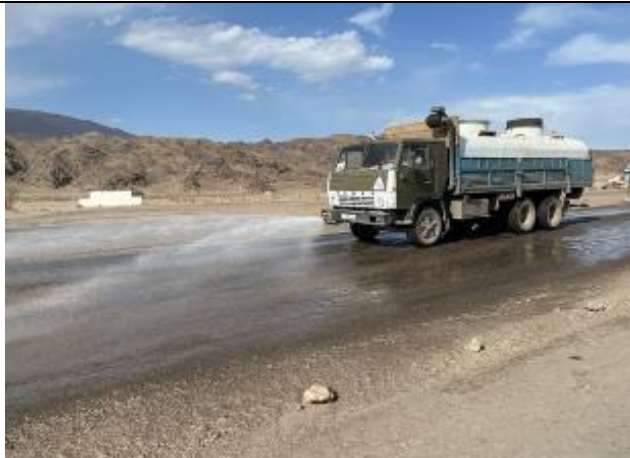
Photo 57. Watering along Lot 1 to control dust.

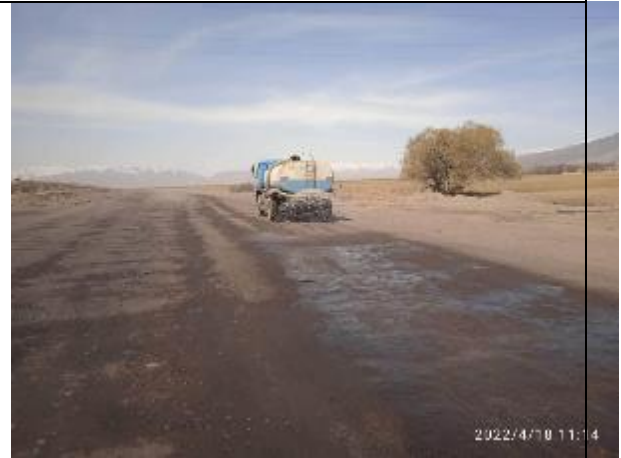
Photo 58. Watering along Lot 2 to control dust.

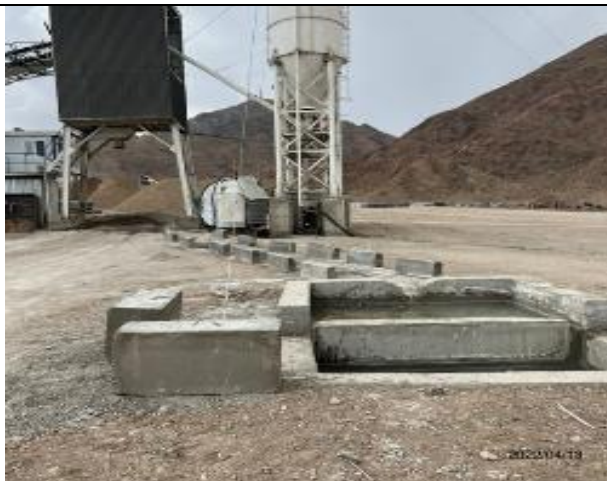
Photo 59. Concrete batching plant's 3-chamber wastewater primary treatment tank at Lot 1.

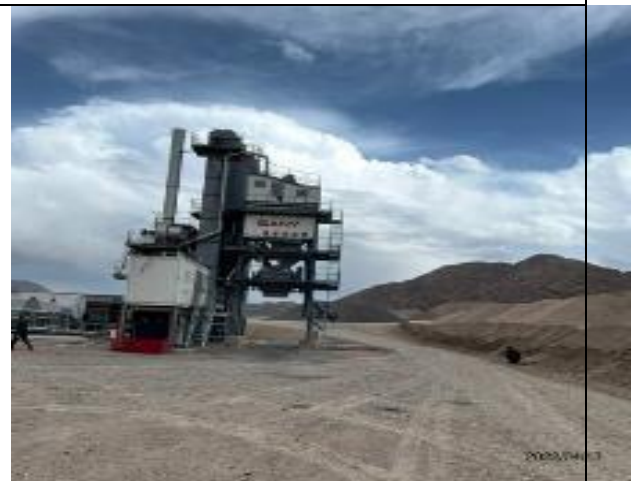
Photo 60. Asphalt plant in operation at Lot 1. Good facility and site maintenance.

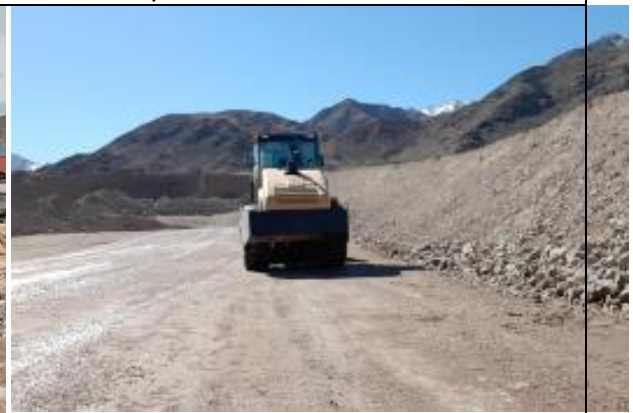
Photo 62 Laying and compaction of clay layer for scarified asphalt disposal site before use.

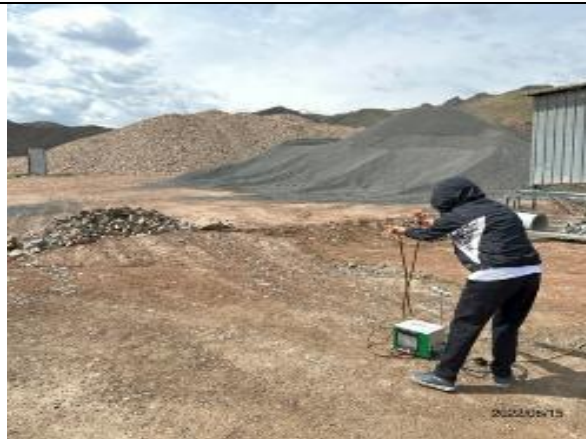
Photo 72. Air quality sampling at the Contractor’s rock crushing plant for Lot 2, km 81+200.

68. The results of the air quality, noise, and vibration monitoring at the quarry areas during this reporting period were also within the MPL. It would be noted that the measured dust level at the production area at km 81+200 exceeded the MPL in October 2021 but was less than the detection limit for dust (2.0mg/L) in June 2022. The abrupt decrease may be attributed to the Contractor's change in quarrying methodology and to more frequent watering of the sites, in response to the CSC's instructions and notice to correct.

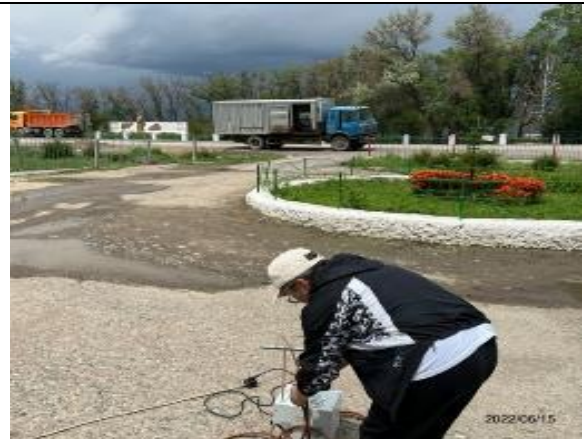
Photo 73. Air quality sampling at Kok-Zhar village, km 66+100.
