Semi-annual environmental monitoring report

Project number: TA-8887 KGZ

July-December 2022

Kyrgyz Republic: Central Asia Regional Economic Cooperation Corridors 1 and 3 Connector Road Project (Phase 2) - Additional Financing

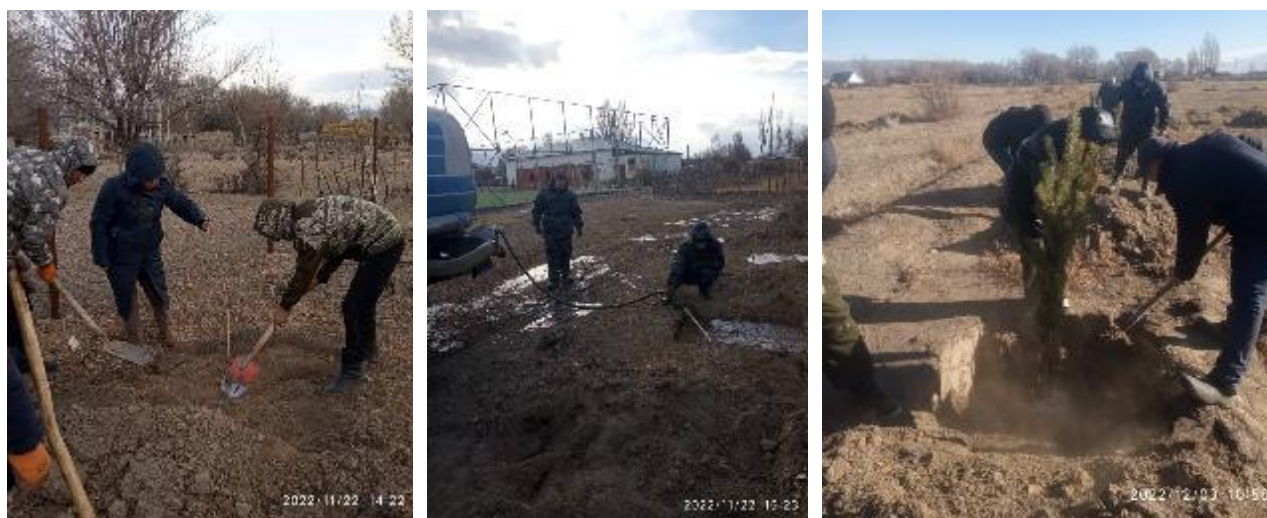
Photo 1-3. Planting of seedlings and watering on the plot under the park in Cholpon village

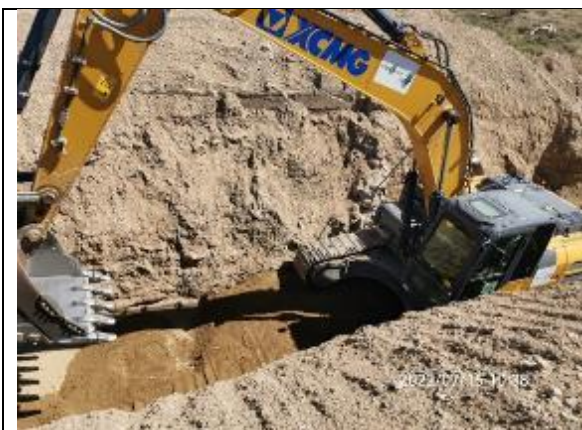
Photos 11. Pipe excavation at km 22+575

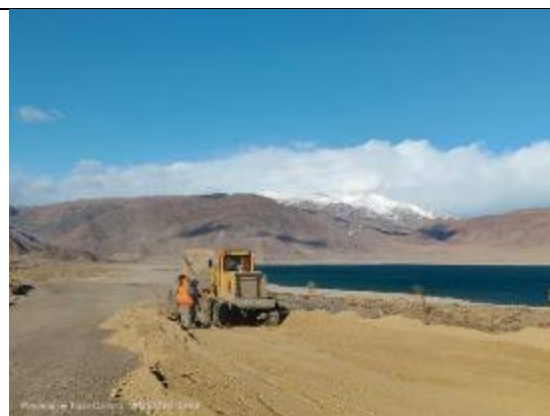
Photos 12. Backfill and leveling of embankment at km 36+000-36+500 RHS

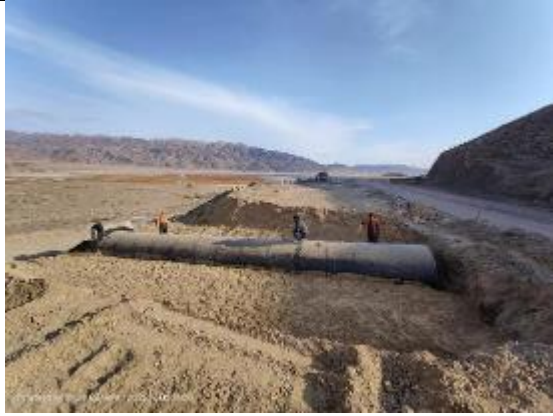
Photos 13. Backfill pipe 3rd layer km. 40+811

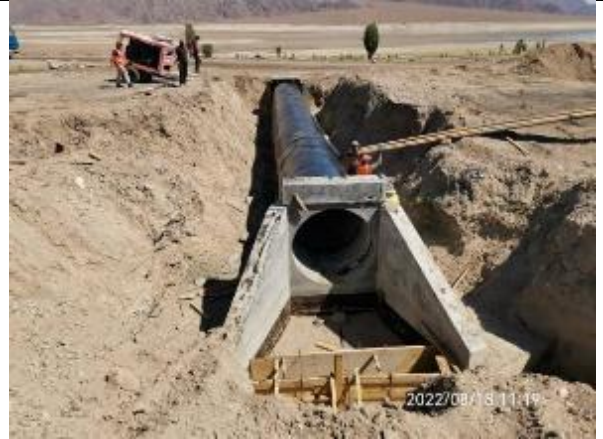
Photos 14. Completed culvert installation and waterproofing km 37+161

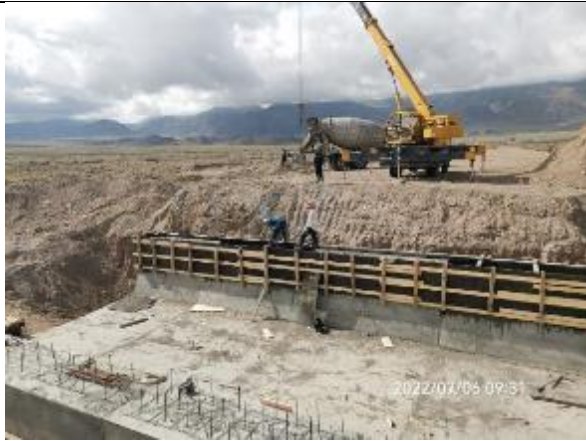
Photos 15. Concrete pouring of pipe wall km.22+255

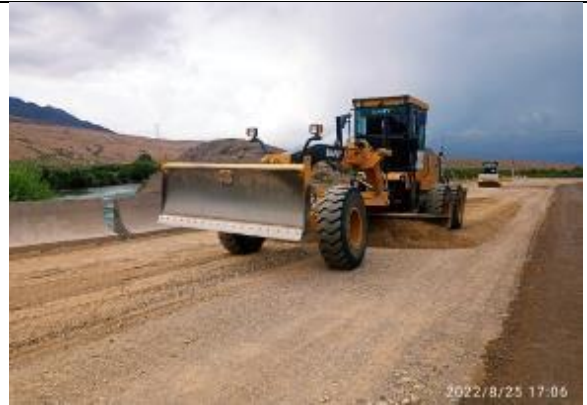
Photos 16. Subbase construction km 11+320-11+380

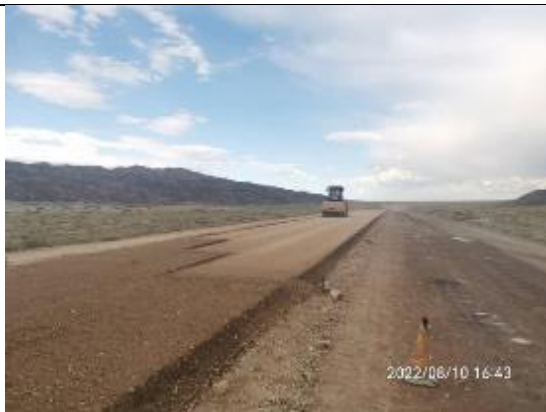
Photos 17. Base layer km 33+000 - km 33+340 RHS.

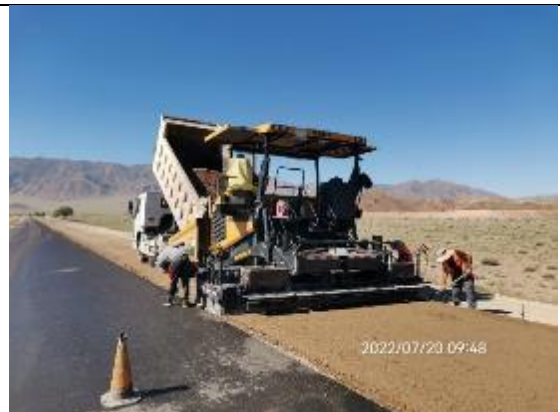
Photos 18. Paving base in the 21+500-22+000 RHS section.

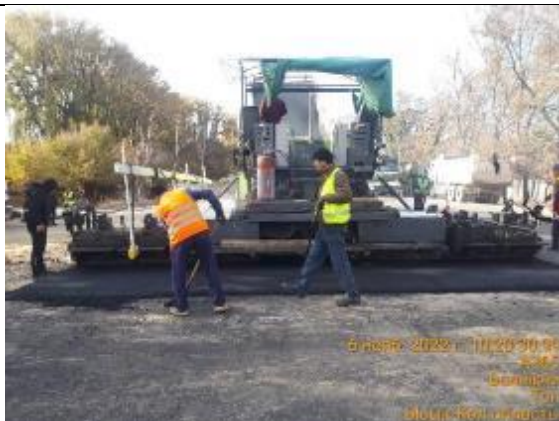
Photos 19 binder km 2+100-2+600 LHS

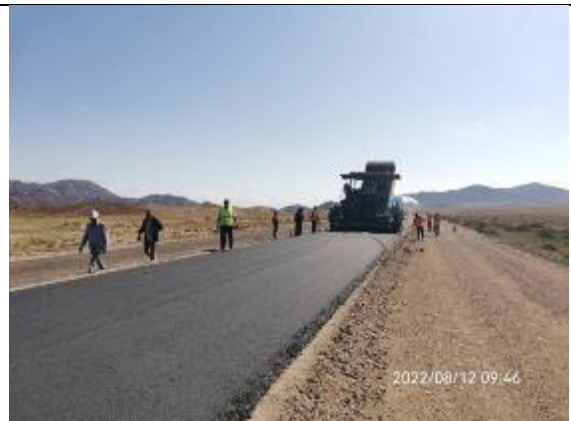
Photos 20. Paving binder at km 17+230 - km 17+500.

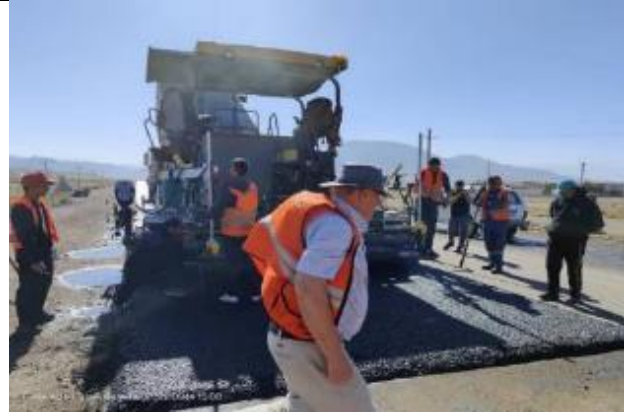
Photos 21. Paving SMA 3+140 LHS

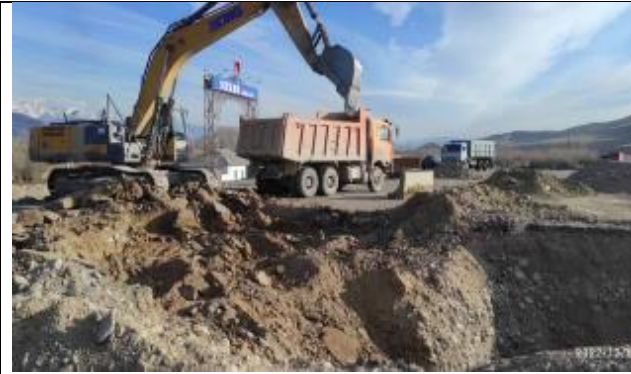
Photos 22. Digging a pit for the construction of an underpass at km 86+325 RHS

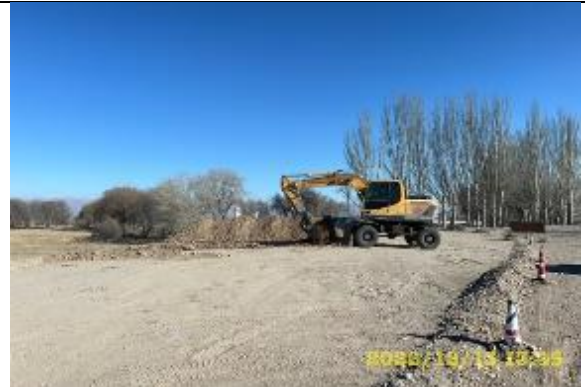
Photos 23 Trenching and excavation at km 0+153 (new circle) for a new culvert

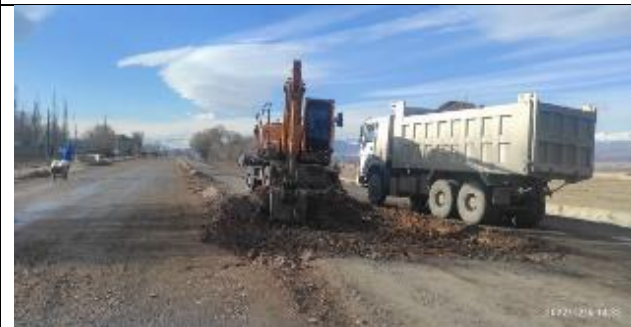
Photos 24. Grubbing the existing road surface at km 65+980 - km 66+220.

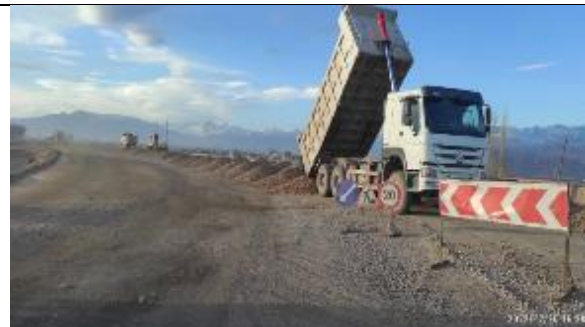
Photos 25. Backfilling of 3 layers of embankment 65+520-65+620

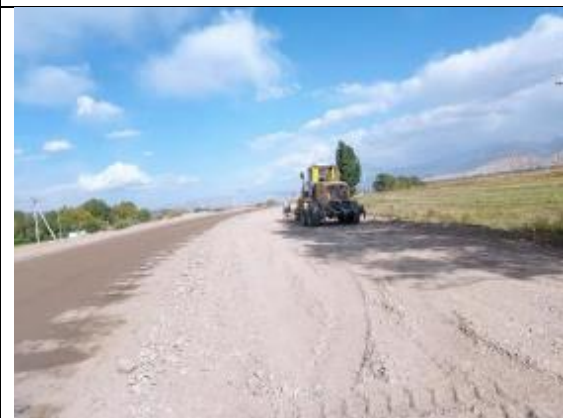
Photos 26. Planning sub-base material km 69+000-69+400 LHS

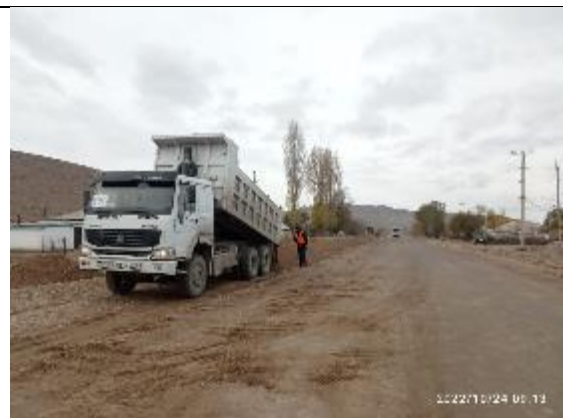
Photos 27. Subgrade material fill (2nd layer) km 69+820-70+400 LHS

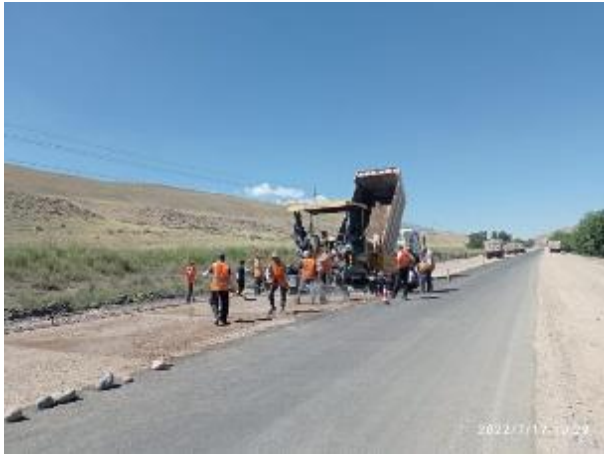
Photos 28. Paving of base material km 85+248 RHS

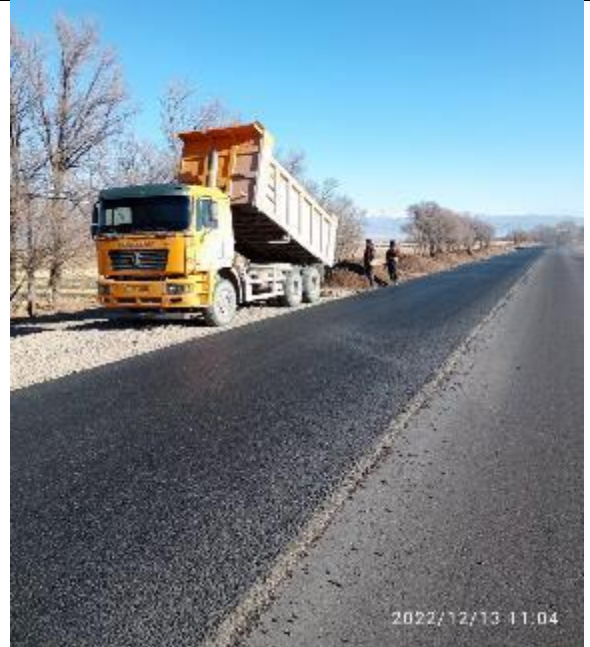
Photos 29. Installation of the top layer of roadsides of km 84+000-84+300 RHS.

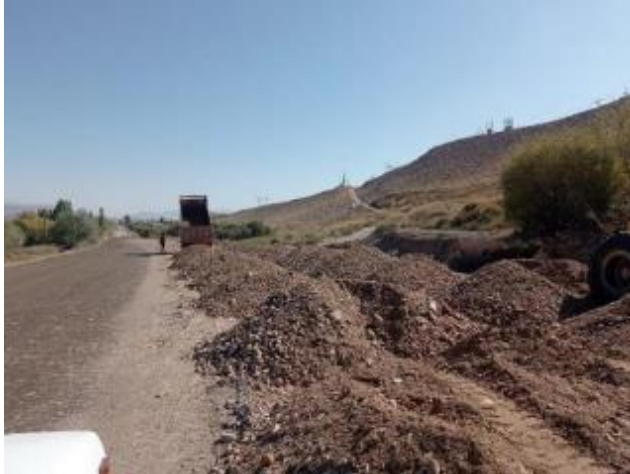
Photos 30. Backfill subgrade material at km 71+160-71+500 LHS.

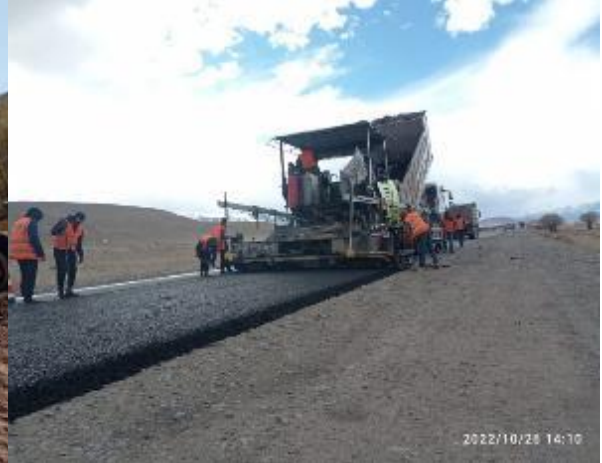
Photos 31. Construction of the SMA at km 81+675-82+000 RHS.

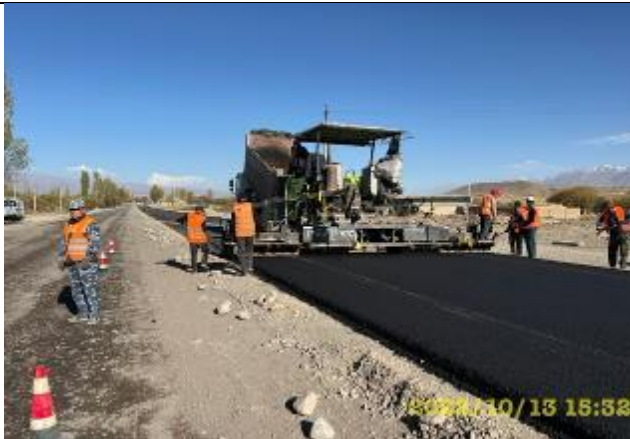
Photos 32. Laying of binder layer km 87+100

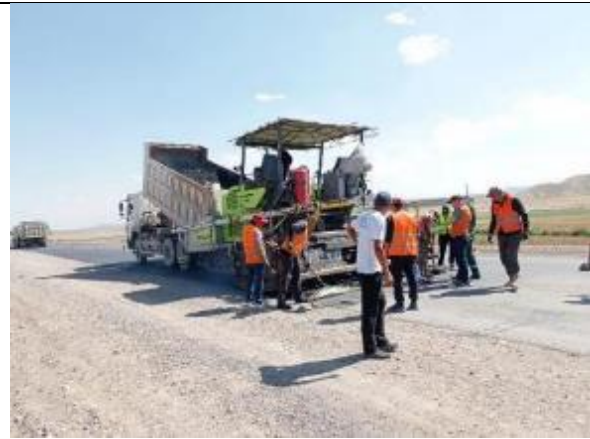
Photos 33. Construction of the SMA at km 79+600-80+100 RHS.

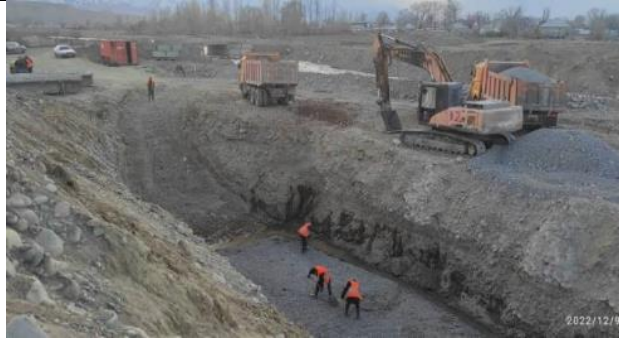
Photos 34. Construction of the bridge at km 65+410. Construction of the foundation for the bridge piers

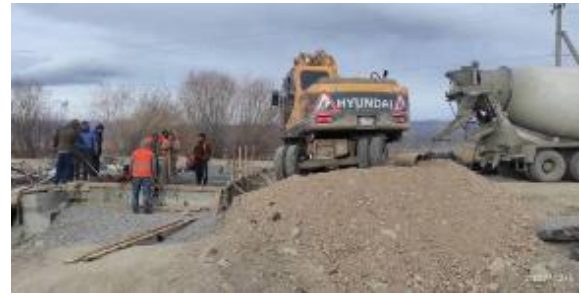
Photos 35. Concrete pouring of transition slab 1 km 68+044

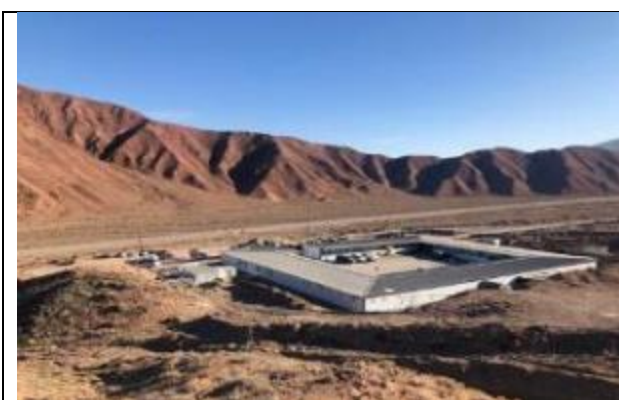
Photos 36. General view of the camp Lot 1 km 16 + 100 (RS).

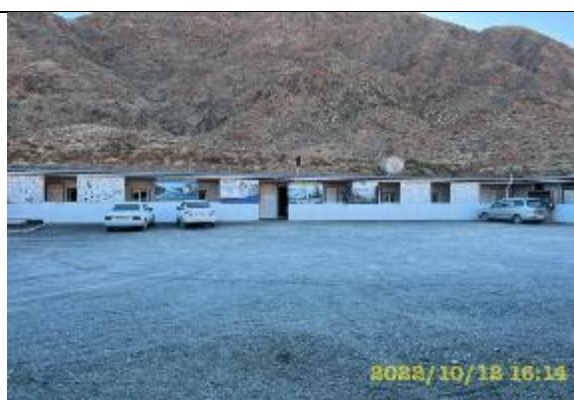
Photos 37. Lot 1 camp and parking lot at km 16 + 100 (RS)

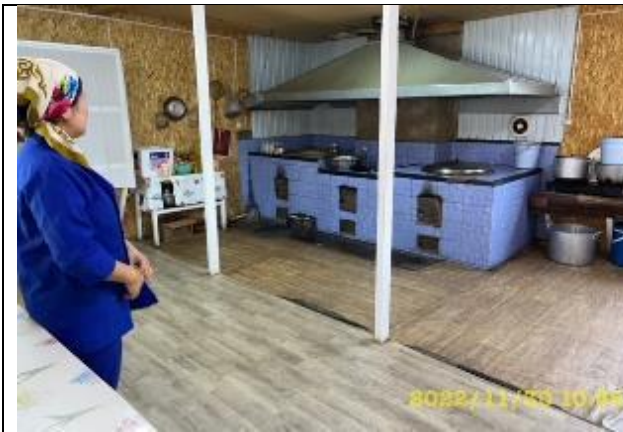
Photos 43. Lot 1 Dining room kitchen unit and cook.

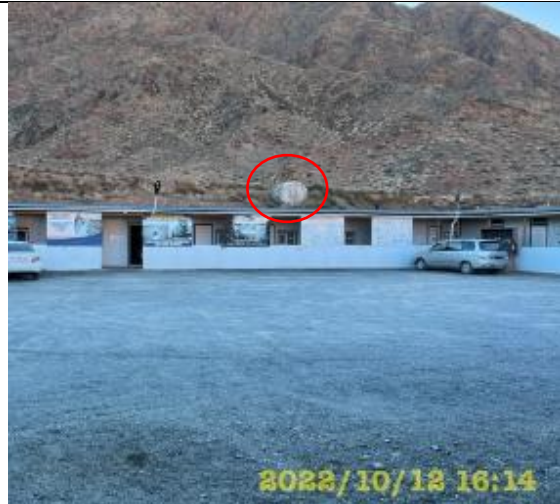
Photos 45. Domestic water tank (built-in).

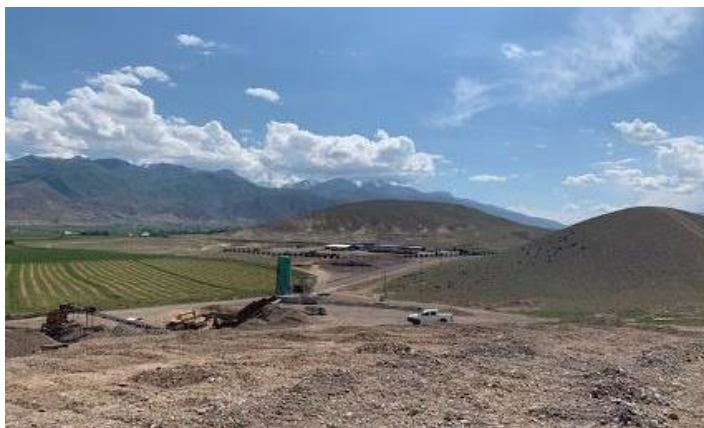
Lot 2 facility area with the rock crushing plant at the foreground and the Contractor's camp at background.

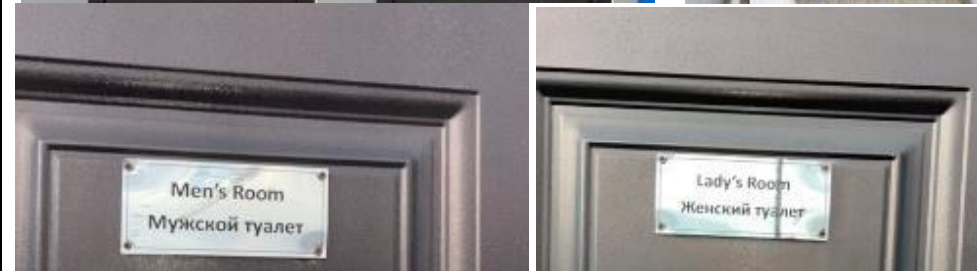
Photos 49. Women's and men's restrooms

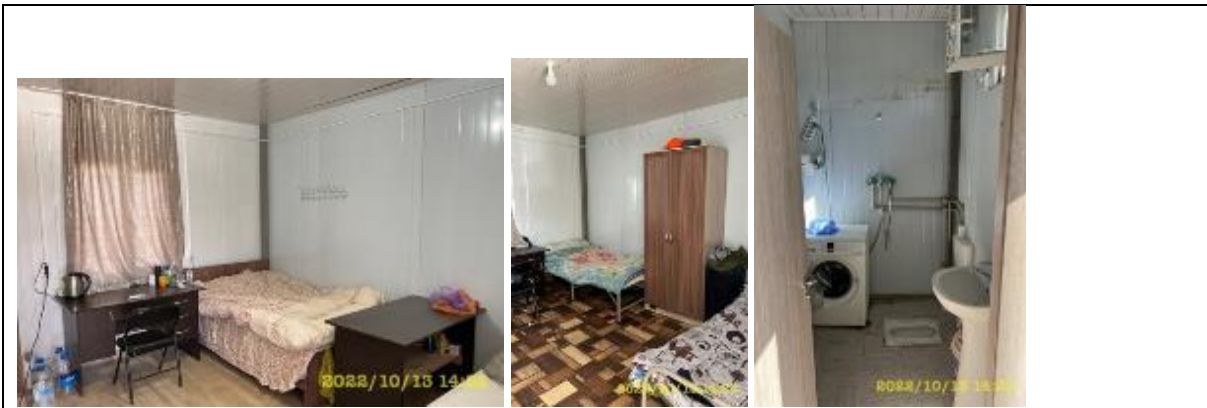
Photos 51. Living rooms with bathrooms and showers in each room for the Contractor's employees

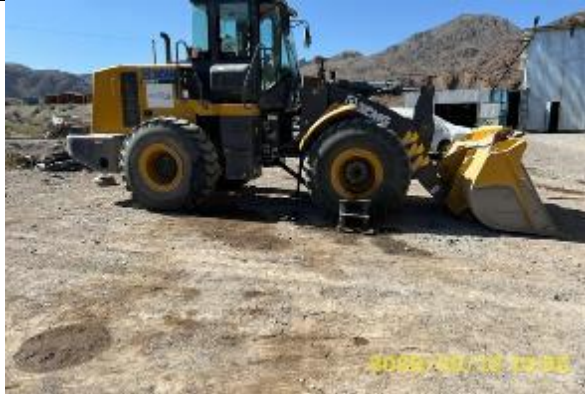
Photos 58. Territory of the industrial base on Lot 1, polluted with oil products

| No n/n | Comments, violations, recommendations | Corrective measures (CM) | Due dates | Status of the previous execution of the CM/ Timeframe for elimination of violations |
|---|---|---|---|--|
| 2 | Pollution of area near the equipment repair box | Ensure cleaning up | Immediately | Done |

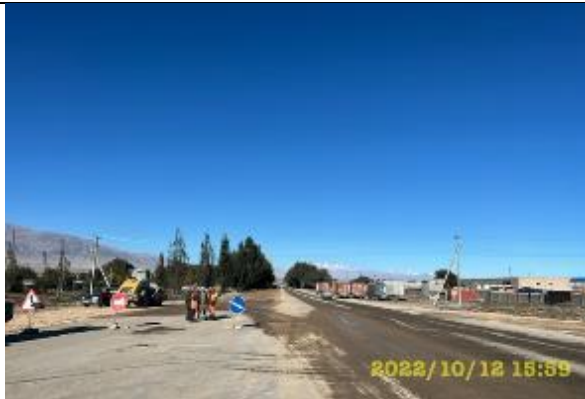
Photos 60 Lot 1. Watering of unpaved sections of the road km. 03+200.

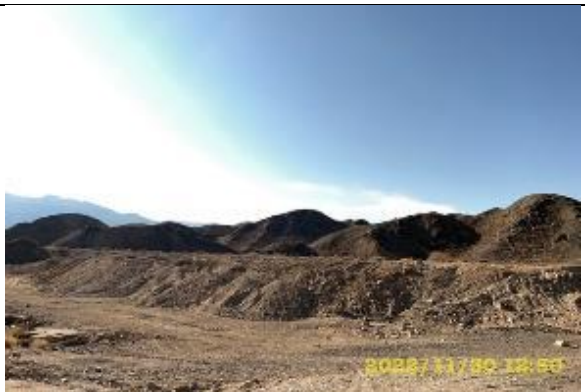
Photos 62. Reclamation of the old asphalt

of the old asphalt located at km. 20+100 RHS

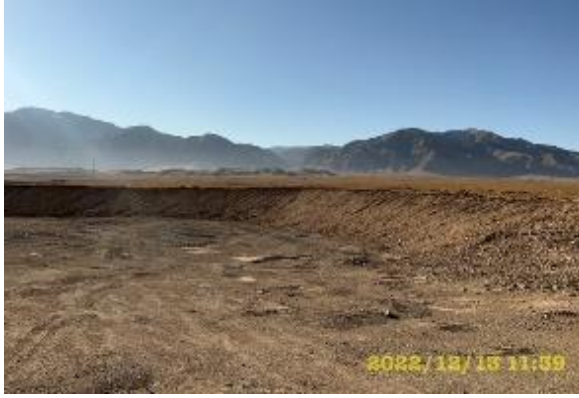
Photos 64. Performed technical reclamation of the quarry located at km.26+800 LHS.

82. During reporting period, quarry development at km.26+800 was completed and technical reclamation was performed in December (photo 64).

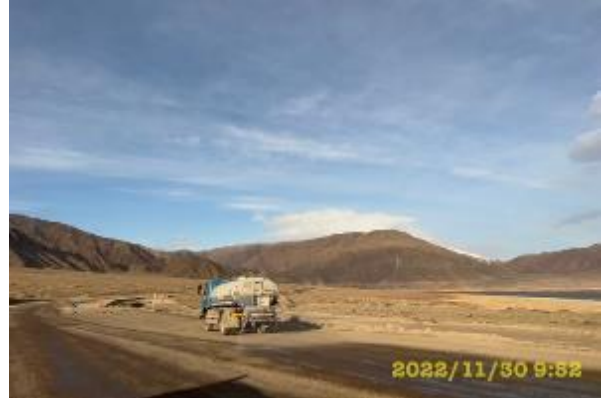
Photos 65. Lot 1. Irrigation of unpaved sections of the road km. 32+350

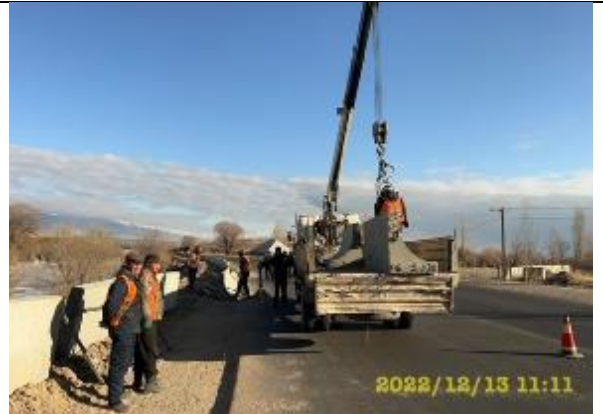
Photos 67. Installation of parapets on Lot 1

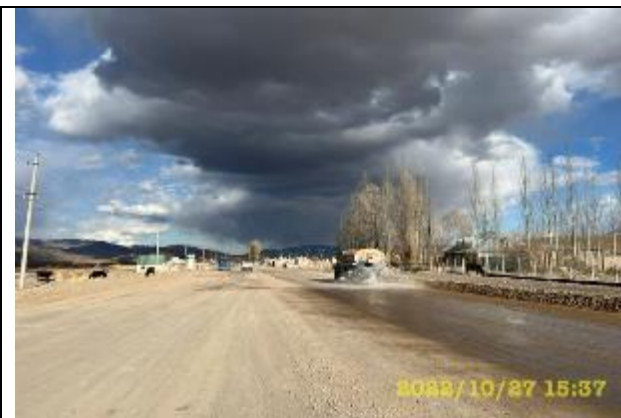
Photos 68. Watering unpaved areas of roads to prevent dust.

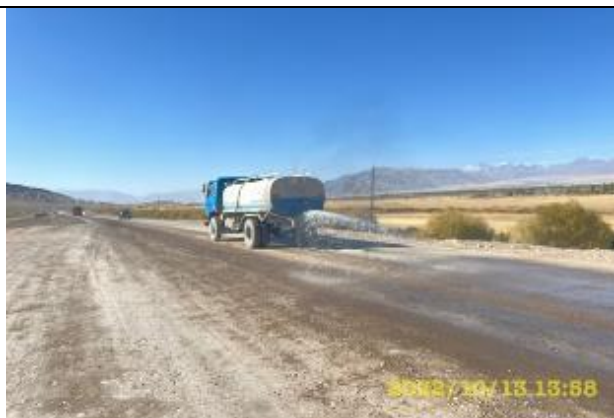
Photos 69. Watering along Lot-2 for dust control.

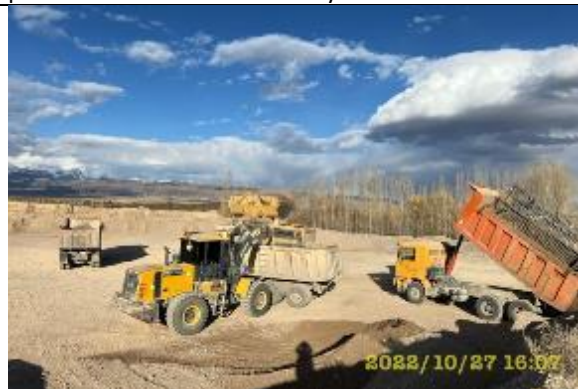
Photos 72. Pit development at km 75+400

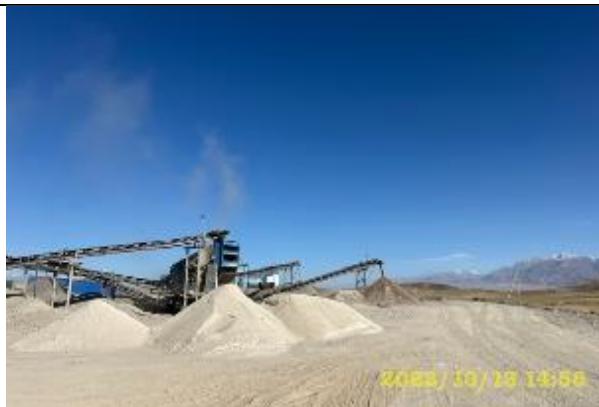
Photos 73. Stone Crusher in operation

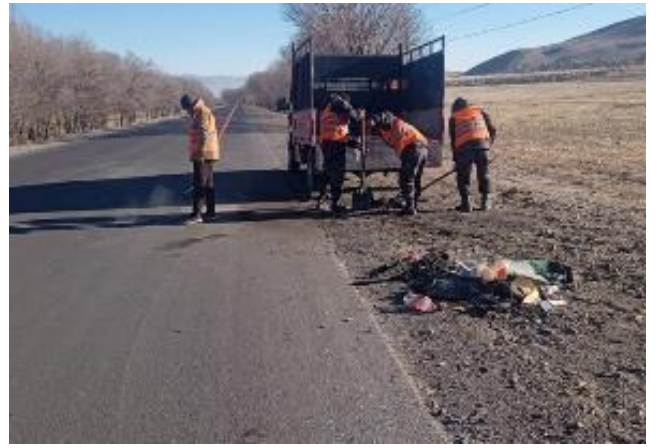
Photos 75. Sanitary cleaning of the project road

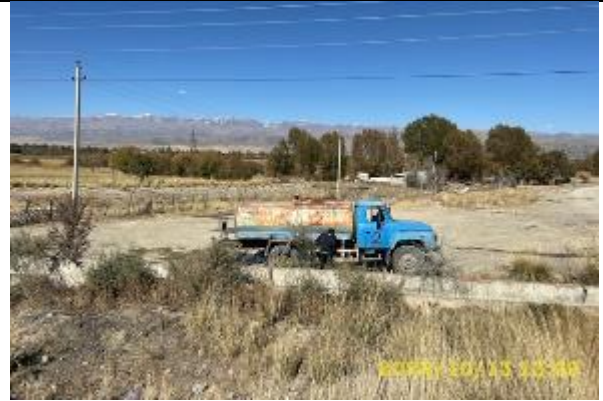
Photos 77. Lot 2. Water intake

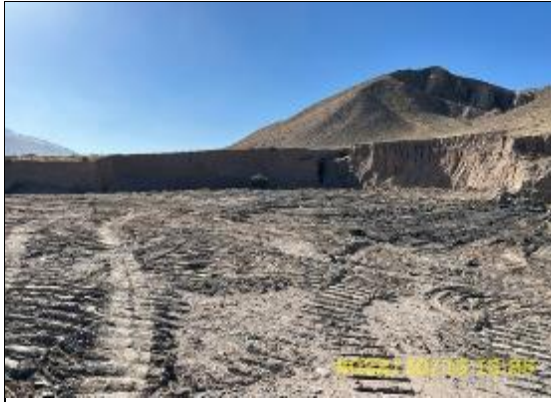
Photos 80. Leveling of the old asphalt dump located on the right side of the road at km. 89+093

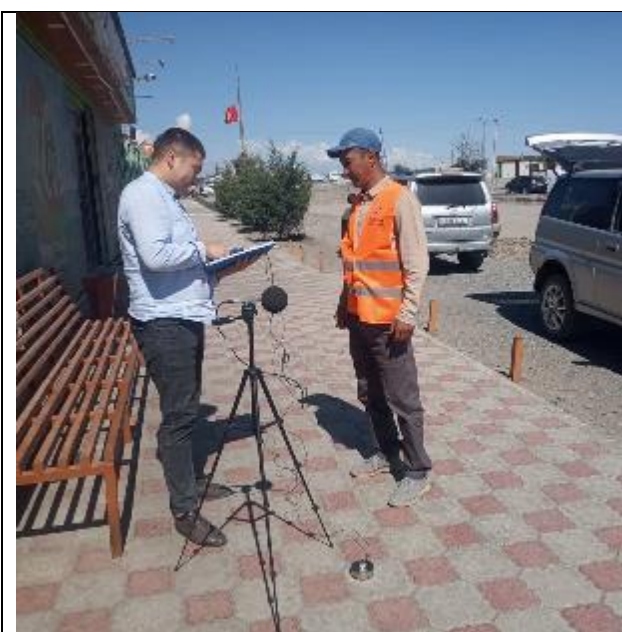
Photos 81. Lot 1, km 0+050. Noise and vibration measurements

72. The noise and vibration levels during the operation of the Contractor's vehicles and equipment in quarries and production bases and during construction works were within the maximum permissible levels (MPL). The vibration levels of operating construction equipment were also within the MPL.

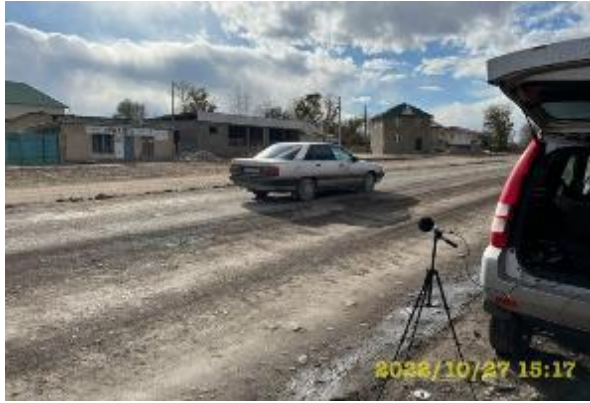
Photos 83. Lot 2. km.66+125, Kok-Zhar village. Noise and vibration level measurements.

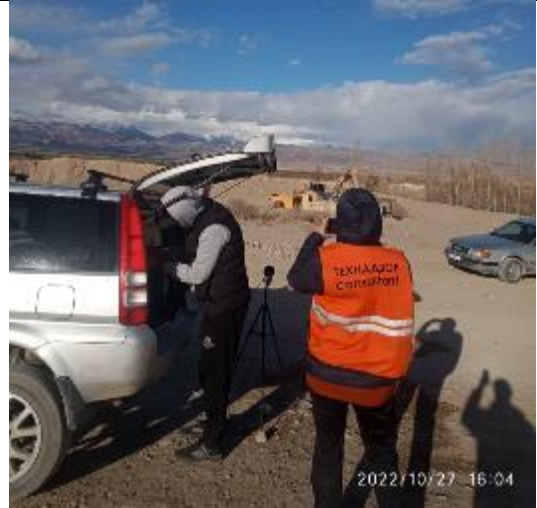
Photos 84. Lot 2. Quarry km.75+400. Noise and vibration level measurements.

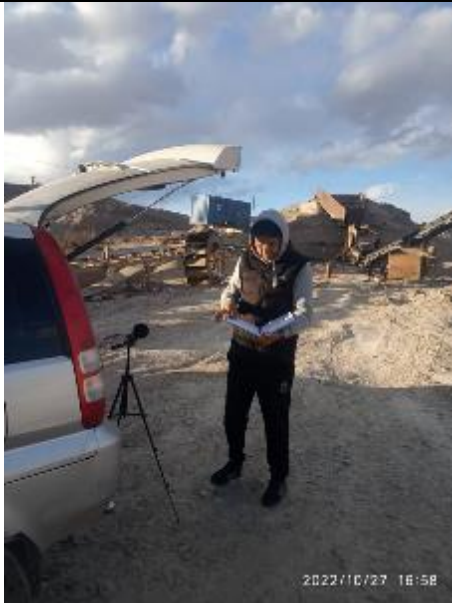
Photos 85. Lot 2. Production base. Noise and vibration measurements

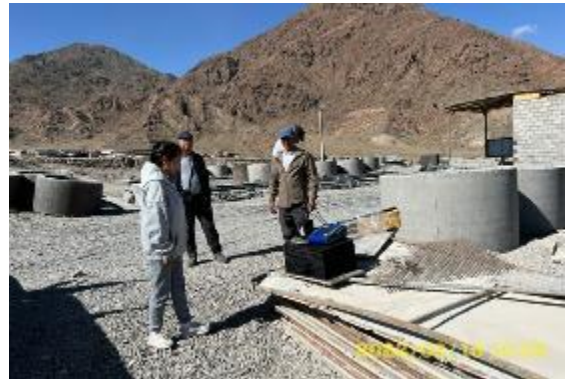
Photos 86. Lot 1. Production base. Noise and vibration measurements

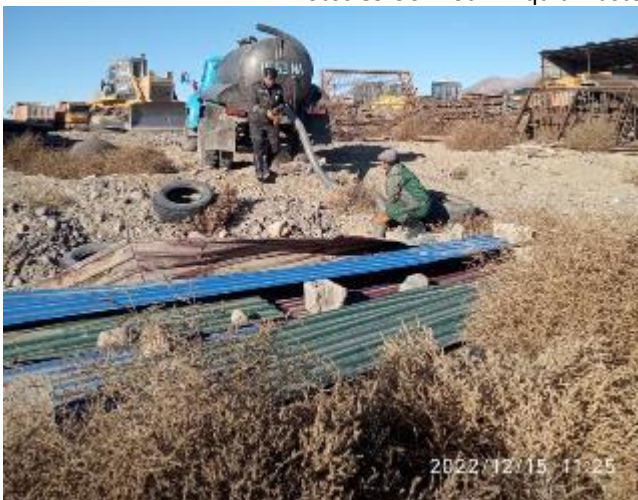
87. Solid domestic waste is removed (photos 87, 88 and 93) and placed in municipal landfill in Balykchy and Cholpon villages. Cholpon. Wastewater is transported (photos 89, 90 and 92) to treatment facilities of Balykchy in accordance with contract with the municipal enterprise of Balykchy - "Gorvodokanal". Balykchy - "Gorvodokanal".

Photo 92. Lot 2. Liquid waste removal

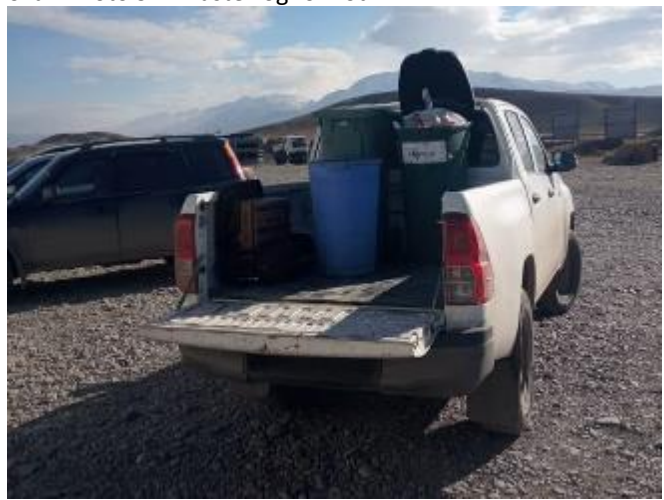
Photo 93. Removal of solid waste on Lot 2.
