**ADB GRANT 0084-KGZ:  
CAREC REGIONAL ROAD CORRIDOR  
IMPROVEMENT PROJECT**

**ENVIRONMENTAL MONITORING  
REPORT**

**ENVIRONMENTAL MONITORING REPORT  
MAY 2010**

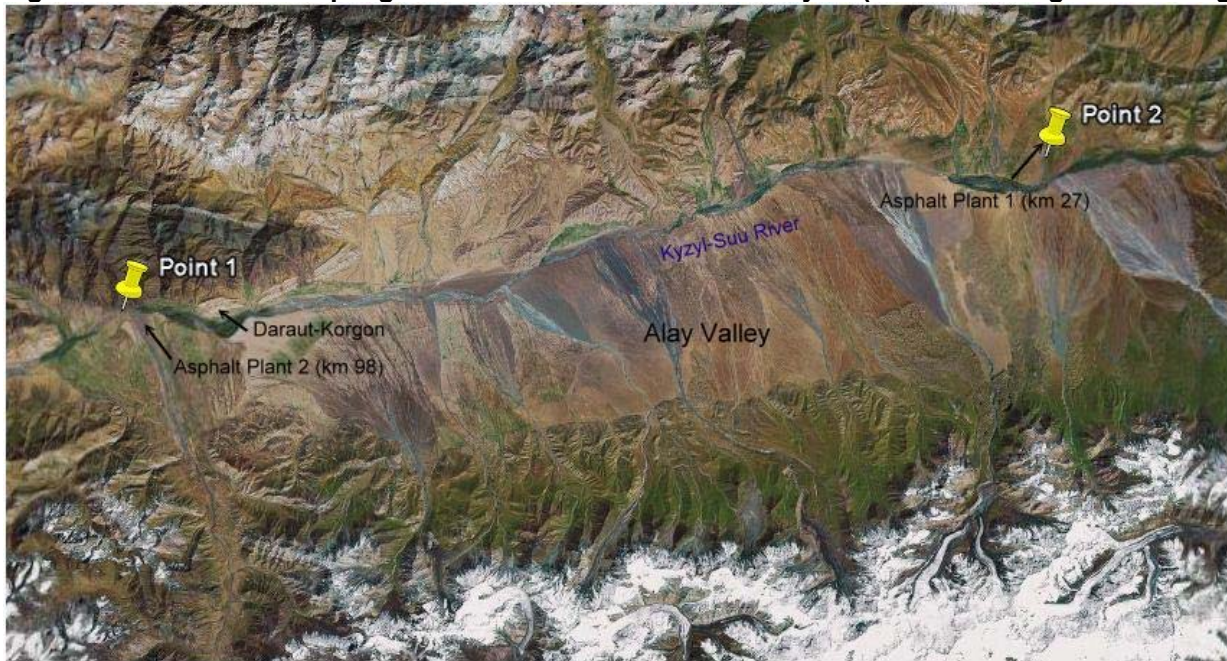
**Figure 2: Location of Sampling Points for Macrozoobenthic Analysis (based on Google Earth image)**

20. Data interpretation is based on assessment of samples taken on 30<sup>th</sup> September, 2009 as described below. Samples containing water and sludge were preserved in the sampling bottle under specific conditions until the day of analysis. The locations of samples (in total 2 points) are shown in Figure 1.
