Semi-Annual Environmental Monitoring Report

July - December 2021

CAREC Corridors 1 and 3 Connecting Road Project (Phase 2). Additional Financing. Lot 1 "Balykchy km 0 -km. 43", Lot 2 "Kochkor - Epkin (km. 62+400 - km. 89+500)".

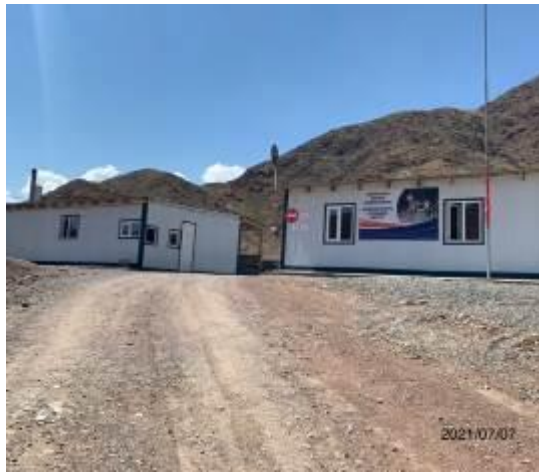
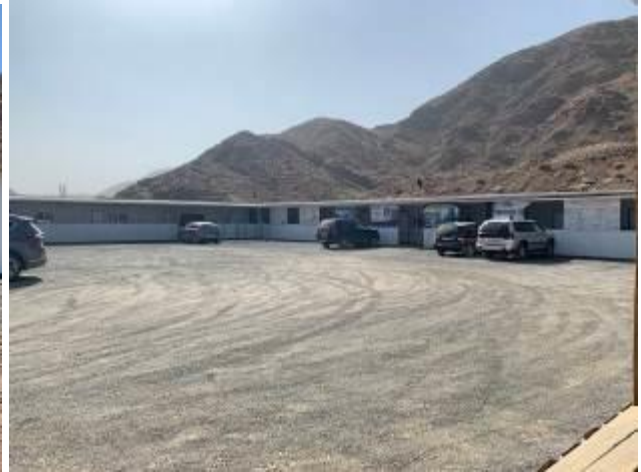
Photos 35, 36. Lot 1. Camp area.

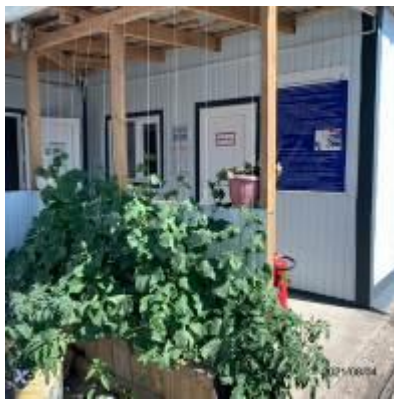
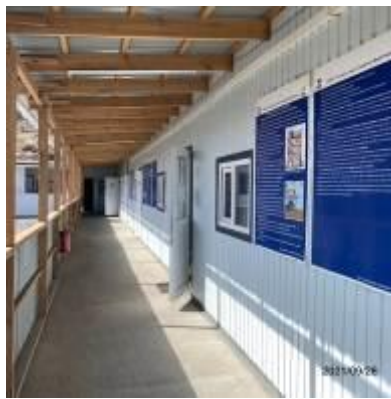
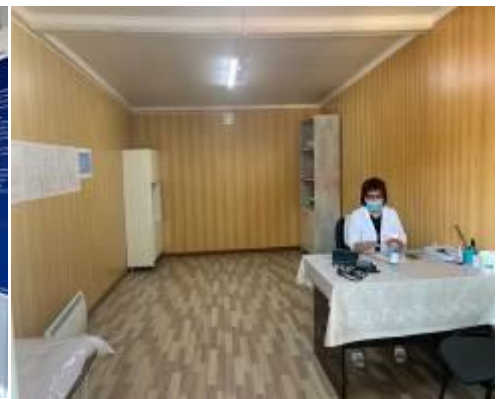
Photo 37, 38. Arrangement of the camp.

Photo 39. Medical Unit.

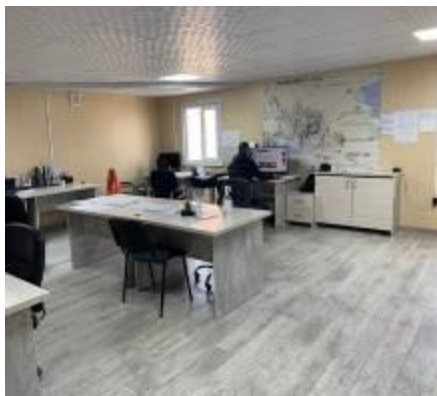
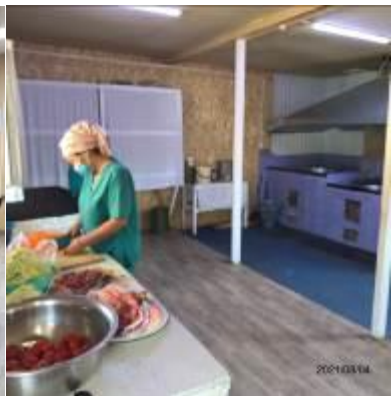
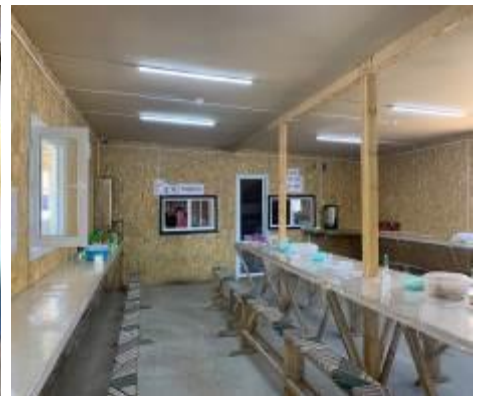
Photo 40. Office.

Photo 41. Kitchen.

Photo 42. Dining Room.

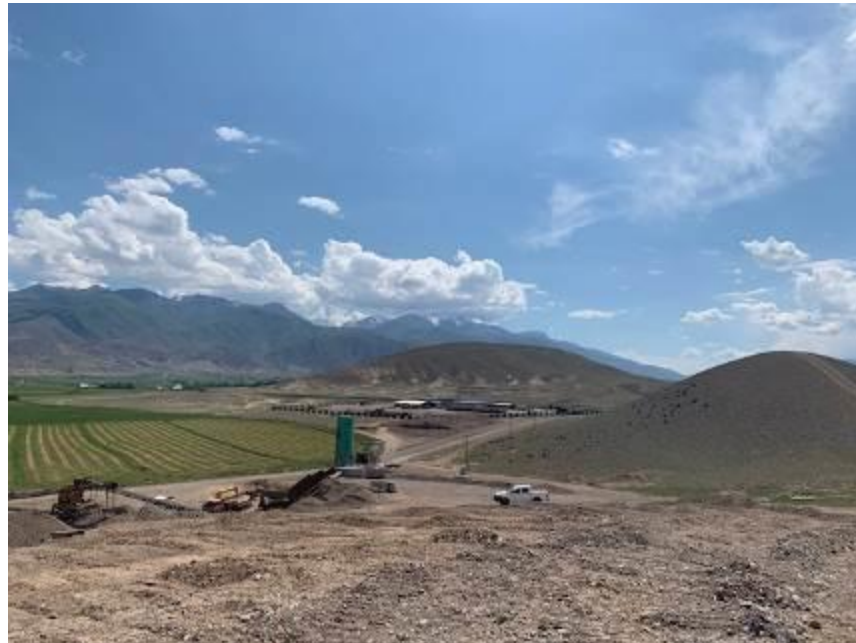
Photo 43. Location of CSU production base in foreground and Contractor's camp in background.

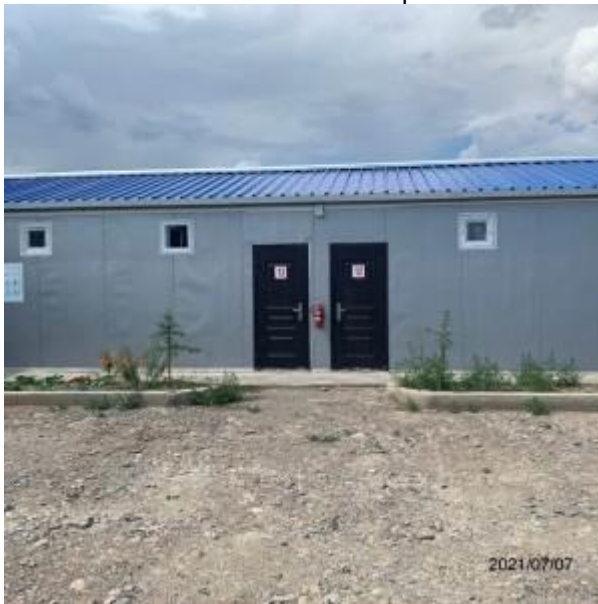
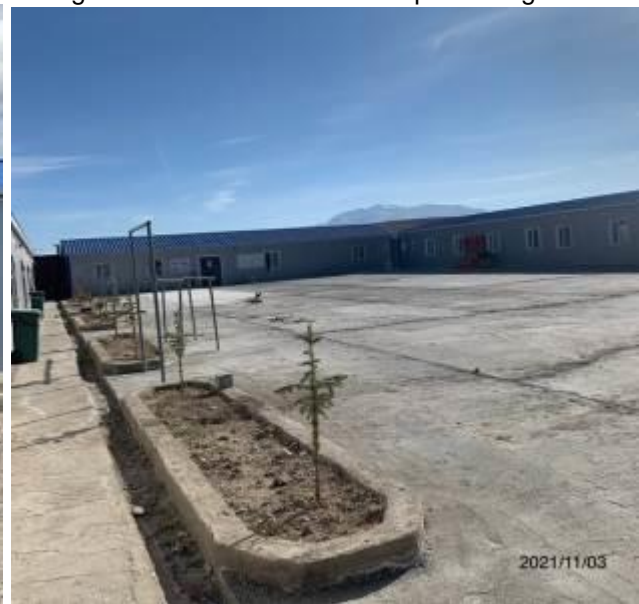
Photo 44, 45. Lot 2. Contractor's camp area.

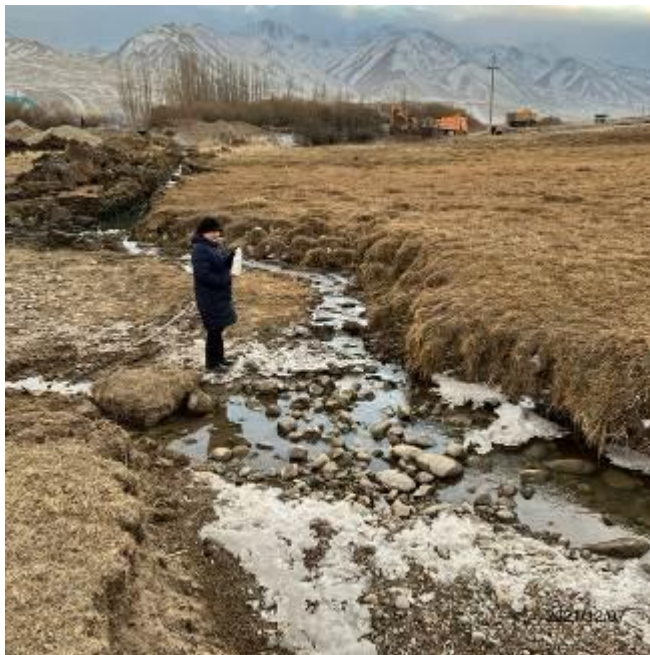
Photo 69. Lot 2. Water sampling from Sazdyn-Suusuu km. 86+261.

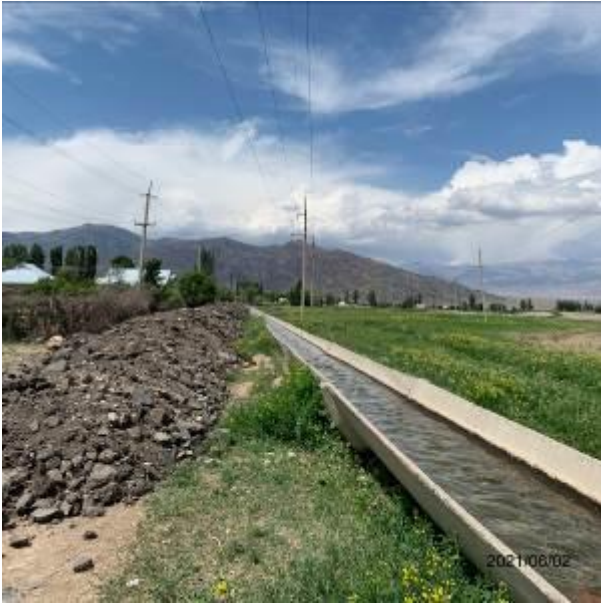
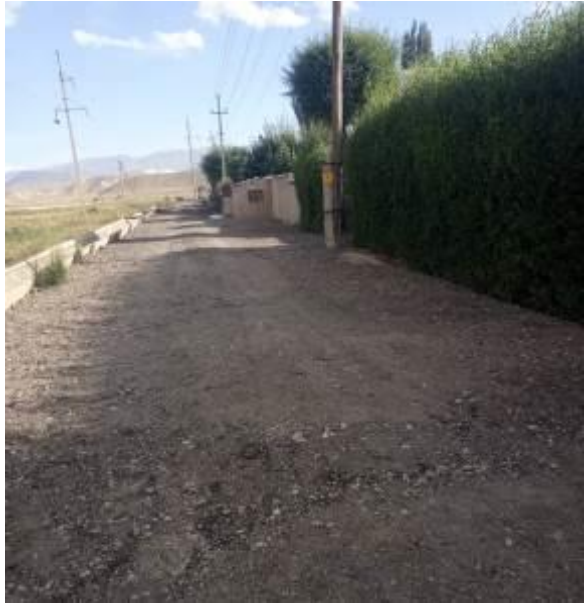
Photo 81, 82. Improvement of peripheral street with old asphalt (laying and leveling) in Cholpon village

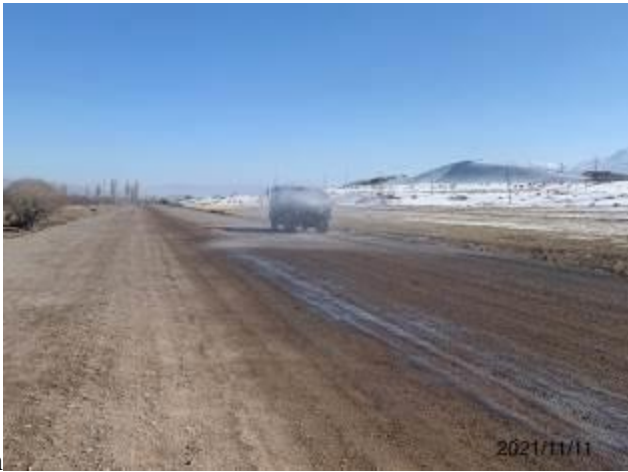
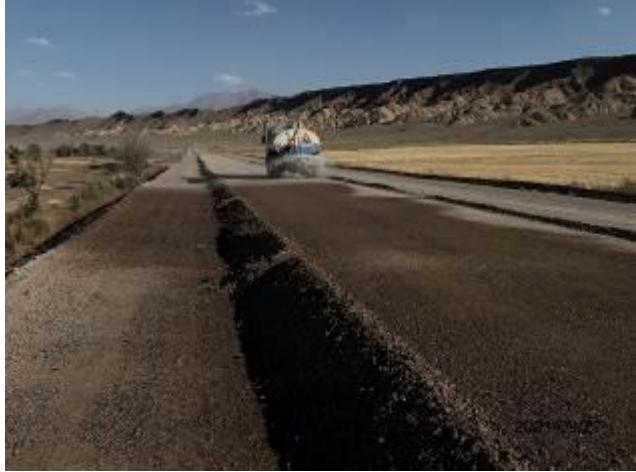
Epkin
Photos 84, 85. Water sprinkling of unpaved road sections on Lot 2.

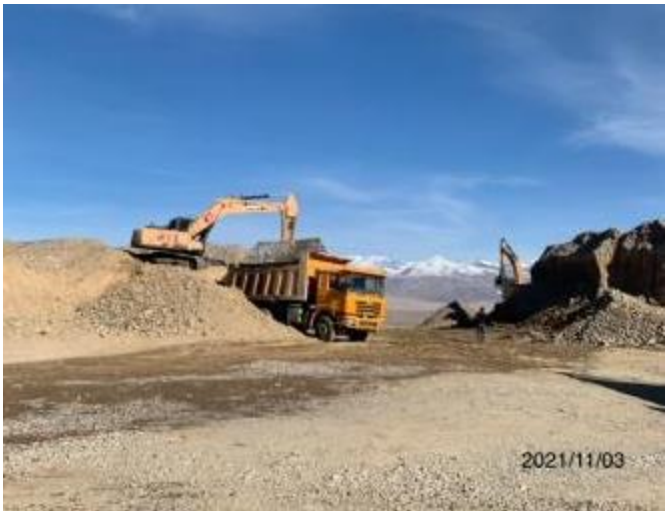
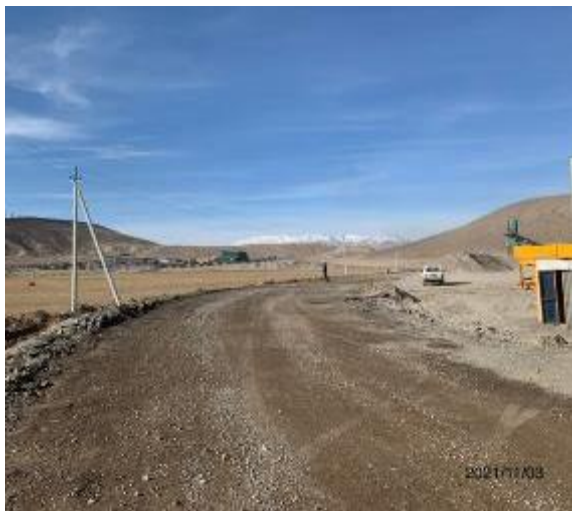
Photo 87. Water sprinkling of access roads to quarry and Photo 88 to production base of the CSU on Lot 2

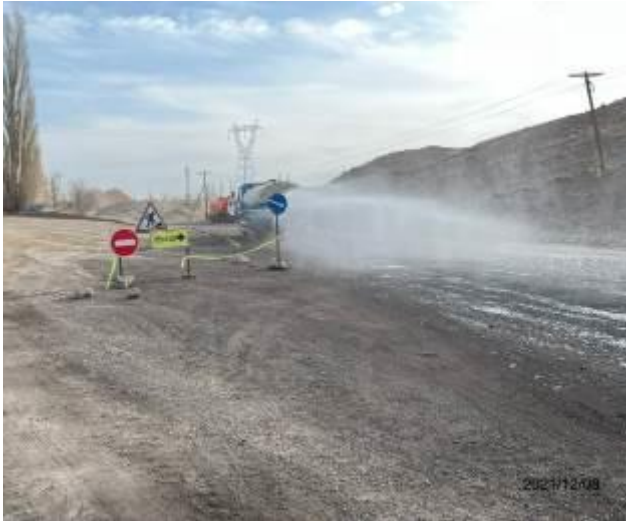
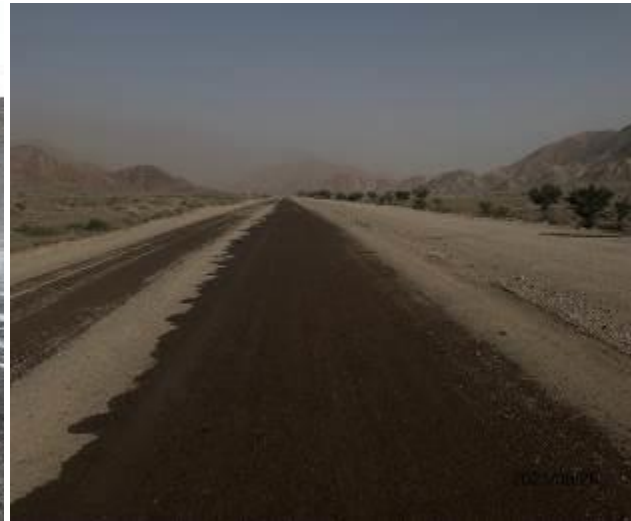
Photo 89, 90. Watering the unpaved roadbed on Lot 1.
