Environmental Monitoring Report

Semestral Report (January–June 2021)
July 2021

Kyrgyz Republic: Central Asia Regional Economic Cooperation Corridors 1 and 3 Connector Road Project (Phase 2)-Additional Financing

Section 1: Balykchy–Kochkor Road (km 0–km 43) and
Section 2A: Kochkor–Epkin Road (km 64–km 89)

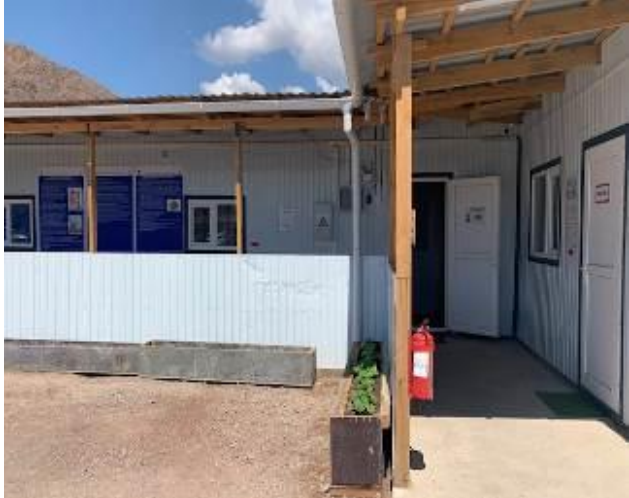
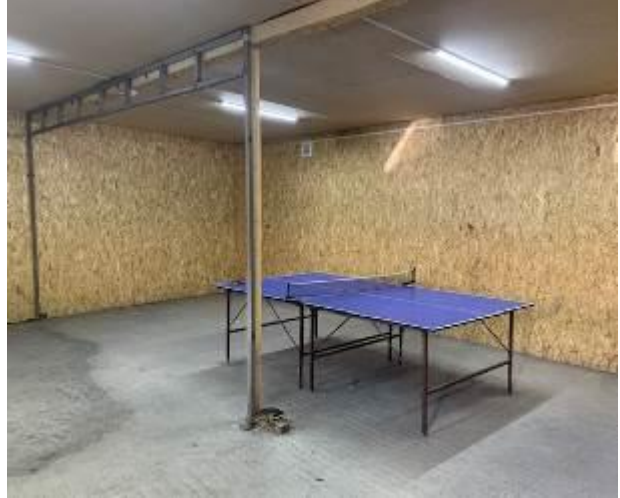
Photos 32, 33. Lot 1. Camp arrangement.

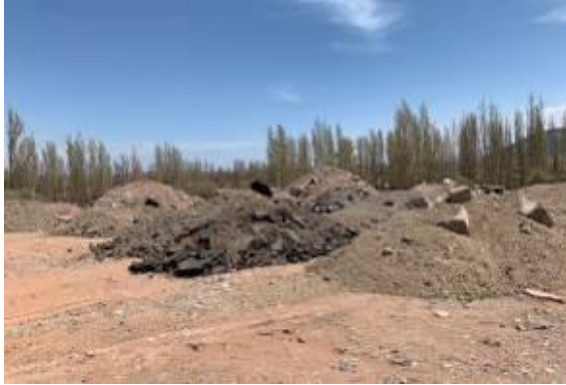
Photo 57. Lot 1. Stored old a asphalt concrete dump of unusable soil km 12 + 000.

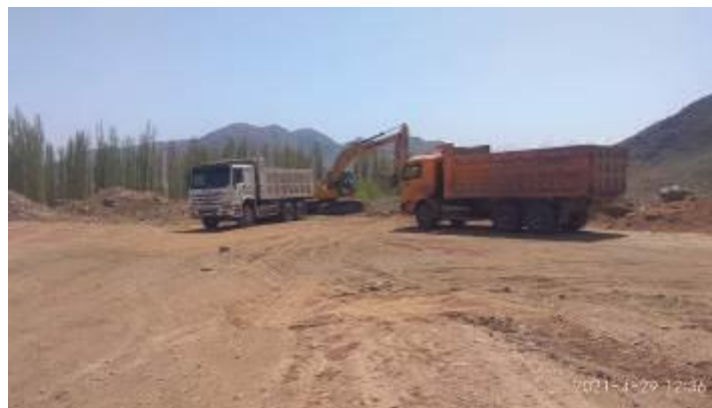
Photo 59. Lot 1. Work on the removal of waste from the old asphalt concrete from spoil bank at km. 12 + 000.

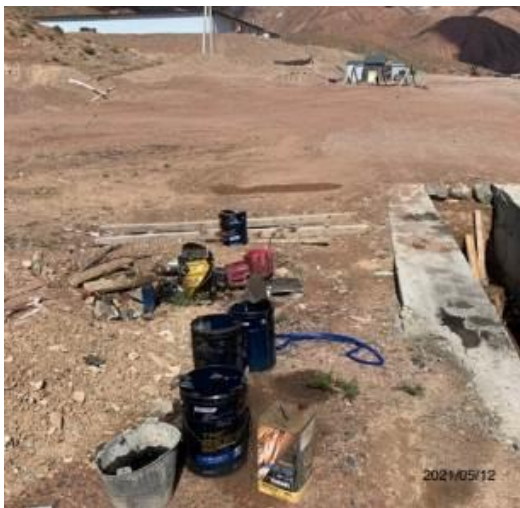
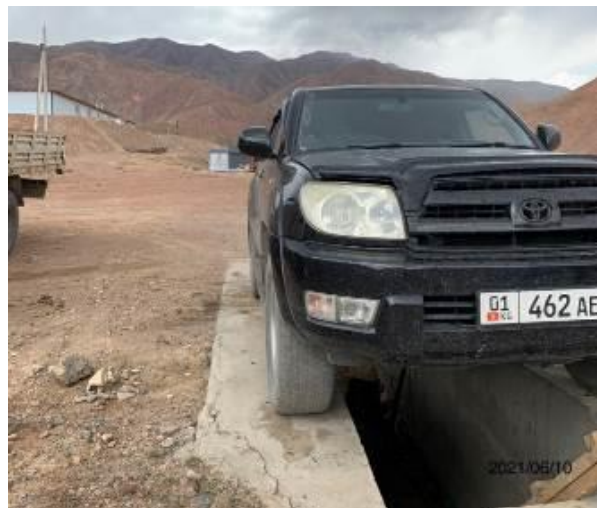
Photo 60 Before and after cleaning (photo 61).

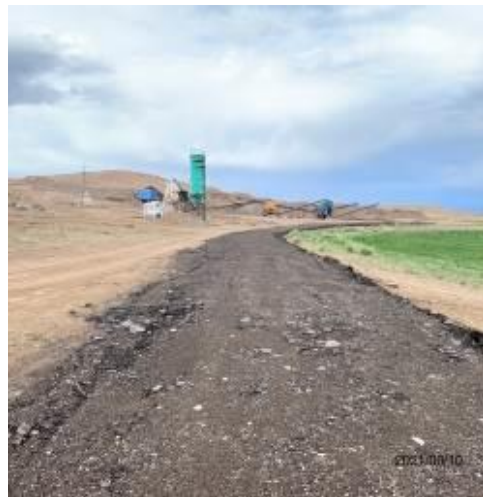
Photo 72. Lot 2. Work of crusher plant after the installation of the irrigation system with water: no dust.

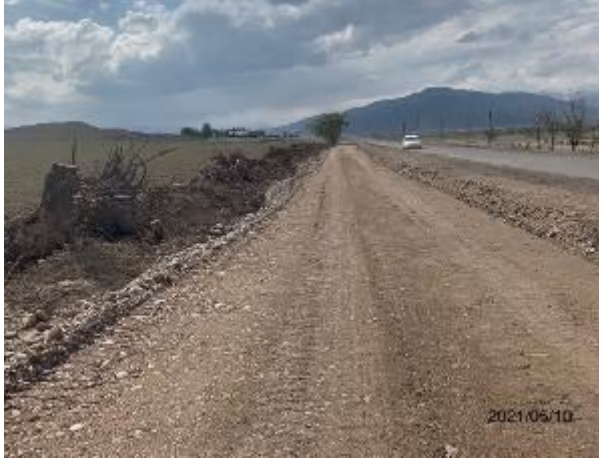
Photo 78. Lot 2. Uprooted roots.

No п/п	Comments, non-compliances, recommendations	Corrective measures	Responsible Executor. Deadlines	Status of the previous Corrective measures execution Terms of non-compliance elimination
				start is August 15. Therefore, deadline for corrective actions extended to August 25, 2021.
13	The WC in one of the living rooms is adapted to a kitchen (photo 76).	To bring WC into compliance (as it should be by initial purpose)	Urgently	<u>Done</u> (photo 77).
14	The uprooted roots from the felled trees were not removed on the roadside at km 75. (Photo 78).	Ensure the removal of the uprooted roots of felled trees.	Until 25.05.2021.	<u>Done</u> (photo 79)

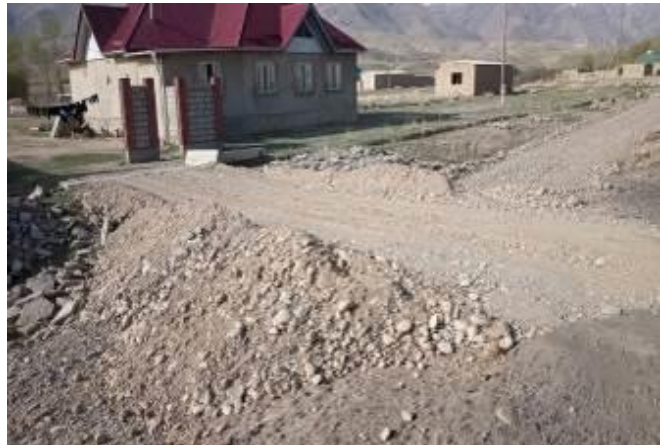
Photo 84. Reconstructed passage to the house.

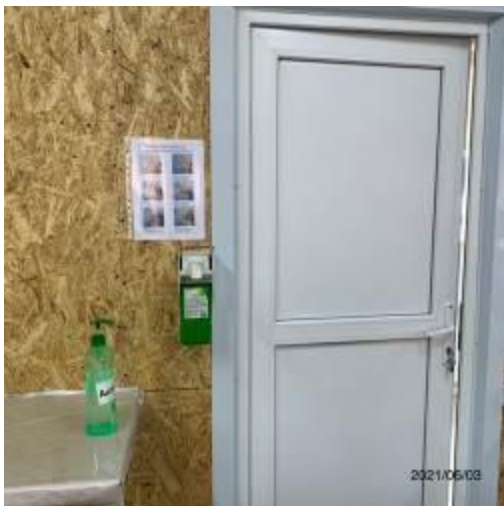
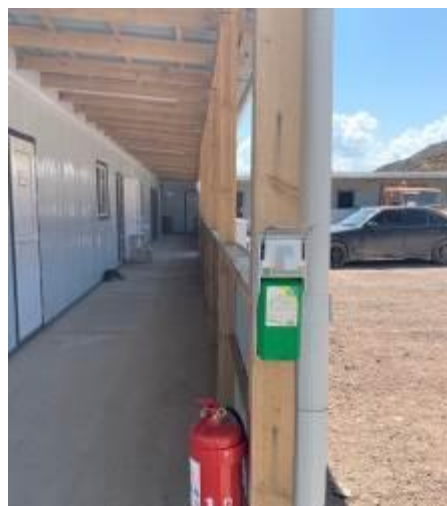
85. During the reporting period, there were no accidents or illness among the Contractor's working personnel. The workers' housing camps on Lot 1 and Lot 2 are kept in good condition and comply with hygienic and sanitary standards. Good living conditions have been created for the employees (photo 32, 33, 35-44, 50-52). The contractor provided workers with disinfectants, antiseptics and personal protective equipment (masks, respirators, gloves), disinfectants and antiseptics were installed in all public places (photos 85 and 86).

Photos 85 and 86. Lot 1. Disinfectants and antiseptics.

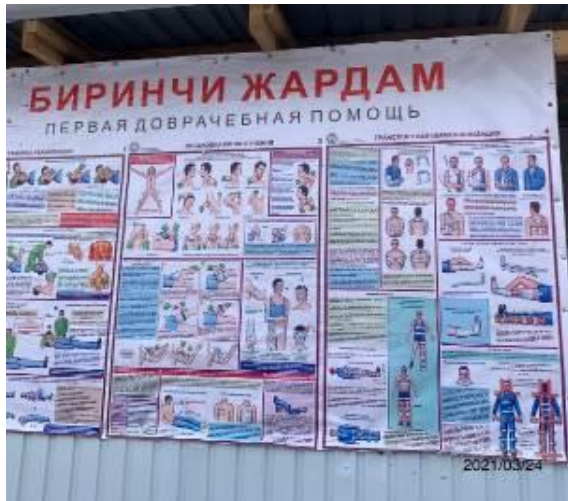
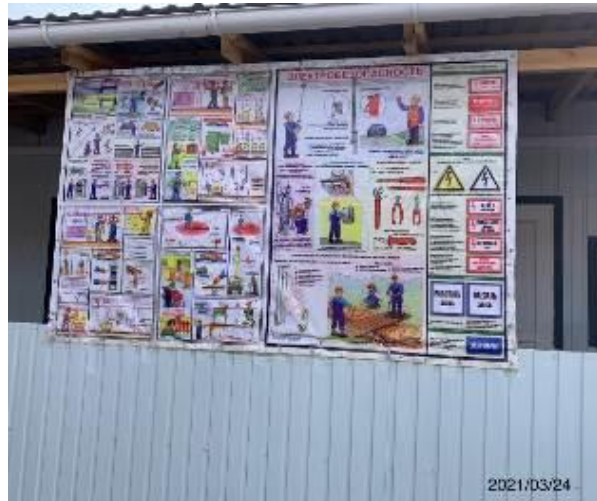
- the structure of the organization of safety management. Responsible persons and their contact details.
- information posters on protective measures against COVID-19, safety, first aid (photo 87-90).
- Fire shields and fire extinguishers have been installed (photos 91-92).

Photos 87 and 88. Lot 1. Contractor's Camp. Information posters on safety and first aid.

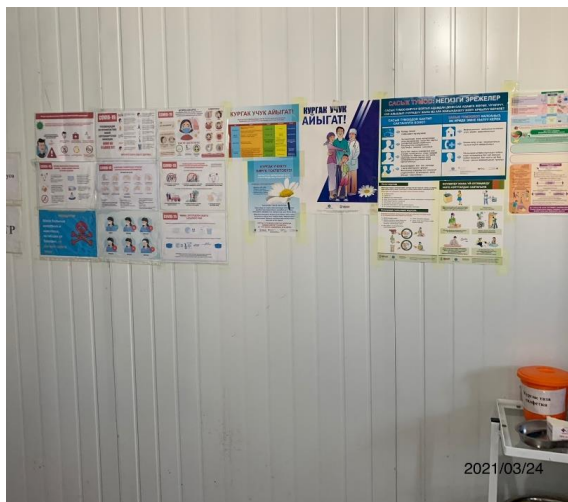
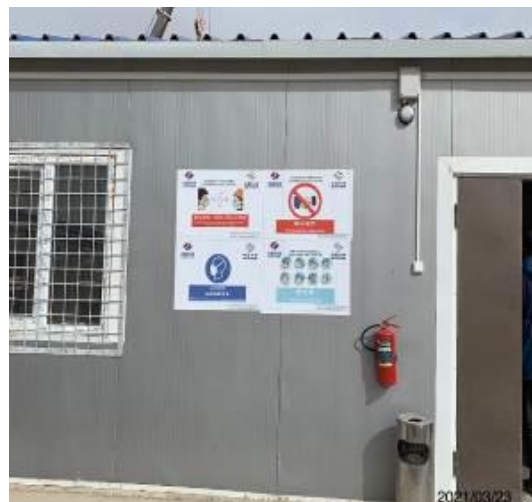
Photos 89 and 90. Lot 2 A. Contractor's Camp. Information posters on COVID-19 protective measures and hygiene.

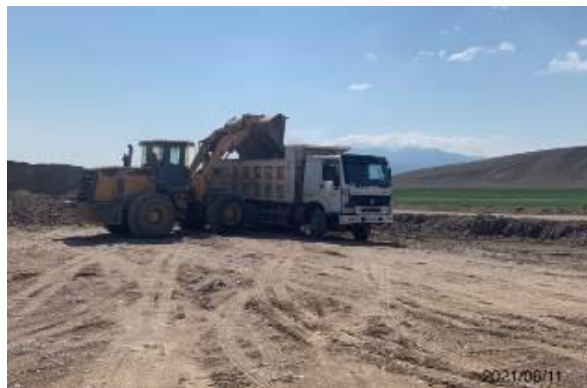
Photo 98. Lot 2. Loading material at the quarry.
