# Semi-annual environmental monitoring report

Project number: TA-8887 KGZ

## January-June 2023

### Kyrgyz Republic: Central Asia Regional Economic Cooperation Corridors 1 and 3 Connector Road Project (Phase 2) - Additional Financing

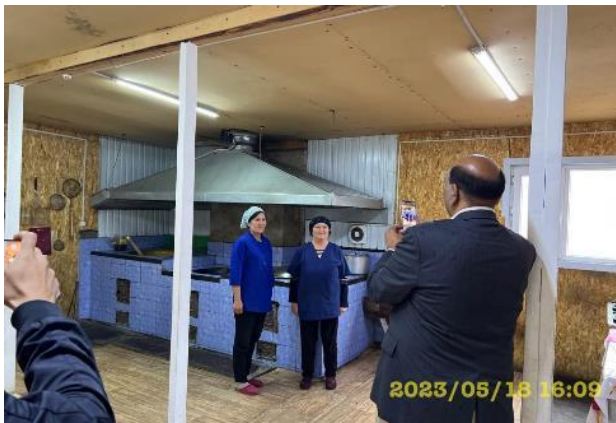
30	14.06.2023	Akhmatova N.. Beisheev I.	Inspection of planted trees Lot 1	Increased watering frequency during hot weather is required (Photos 72 and 73).

Photo 72. Lot 1. Contractor's Camp. Kitchen Block.

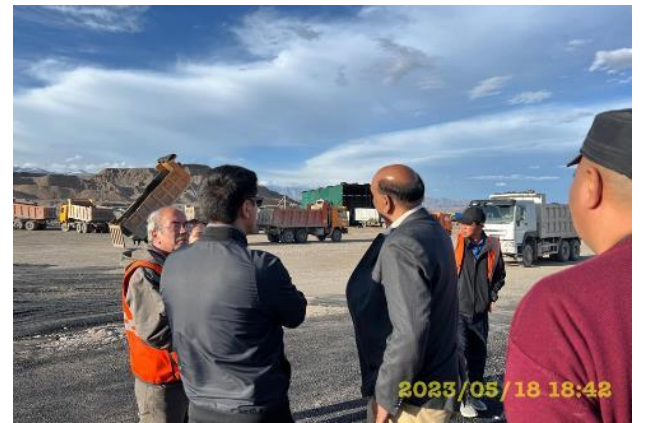
Photo 73. Lot 2. ADB Mission. Production base.

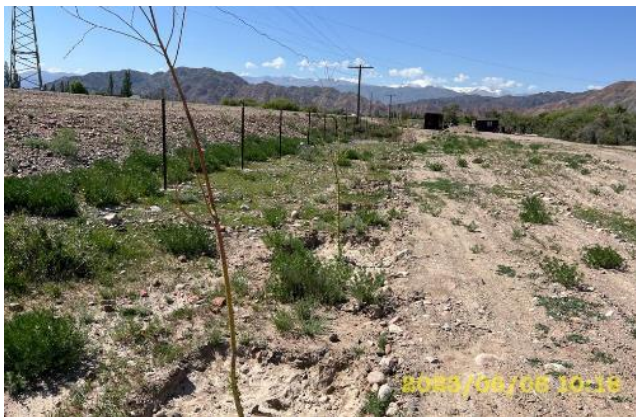
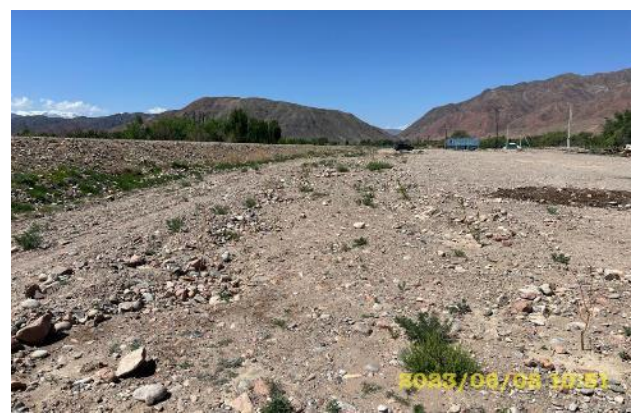
Photos 78 and 79. Watering of saplings planted along the project road at km. 9+350 to km.10+460. June.

3	Proper watering of saplings planted along project road from km. 9+350 -10+460 (Photo 78 and 79).	Ensure watering of seedlings, increase the frequency of watering in hot weather.	Permanent.	Constant.
<b>Lot - 2</b>				
4	Cemetery fence foundation located along road km. 68 RHS and fence foundations of some graves located LHS are filled with soil as a result of roadside construction (Photos 84 and 85).	Provide soil cleanup	Due by 3/21/2023.	Done (photos 86, 87)
5	Production site. Pollution near fuel and lubricant storage (Photo 90).	Ensure cleanup	Immediately	Done (photo 91)
6	Production base. Bitumen spill near reinforced concrete production site (photo 92).	Ensure cleanup	Immediately	Done (photo 93)
7	Wastewater after washing the concrete mixing plant is discharged into a waterproof pit,	Provide a watertight tank to collect wastewater from concrete mixing plant.	By March 15, 2023.	In process.

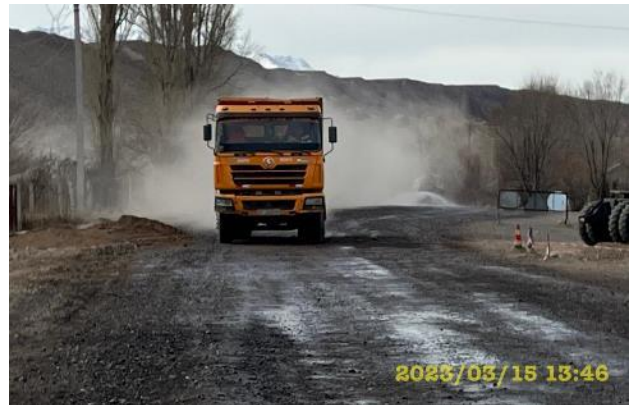
Photo 101. Dust on the dirt road section in Chekildek village.

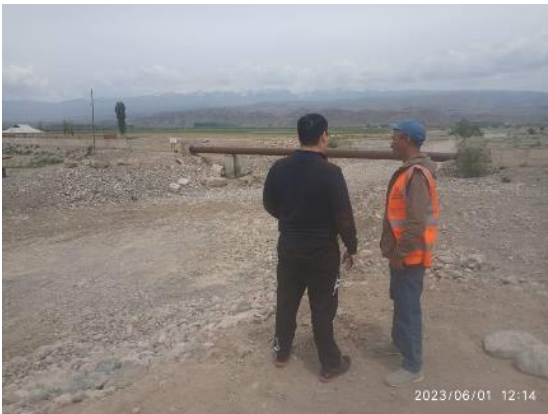
Photo 116. Lot 2. Km. 65+410 No water in Joon-Aryk River.

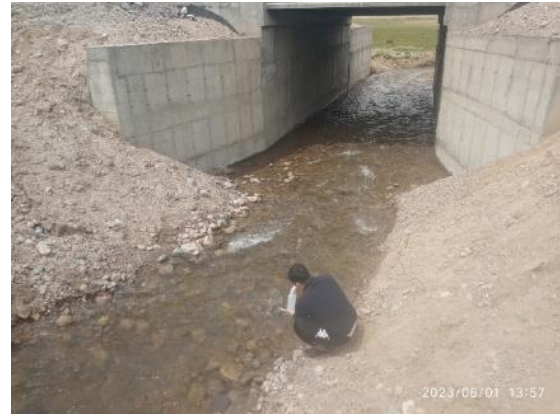
Photo 117. Lot 2. km 88+795. Zhar-Korundu River

62. Water analysis results showed suspended solids MPL values exceeded in following rivers Lot 2: Mukandyn-Suus River, Sazdyn-Suus River, Zhar-Korundu River. Water samples were taken in rivers upstream and downstream of bridge construction site. Increase in suspended solids concentration is observed at bridge construction site: water samples were taken in rivers upstream and downstream of bridges.

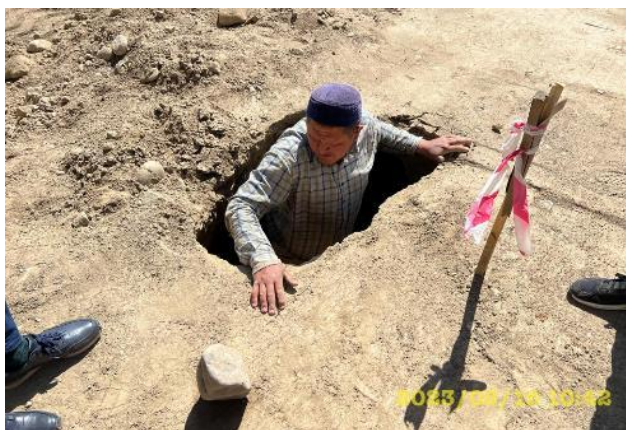
Resident Engineer and Consultant's and Contractor's environmental specialists visited the site (Photo 128).

Photo 128. Lot 2. Km. 62+500. v. Tendik. Inspection by Consultant and Imam of found burial site.

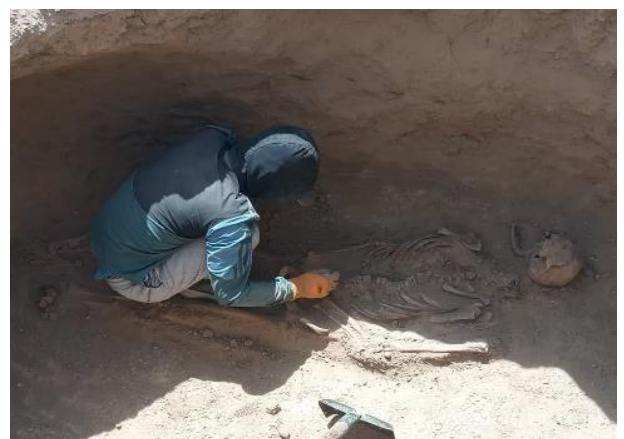
Photo 129. Lot 2. Inspection of burial by mosque imam v. Tendik.

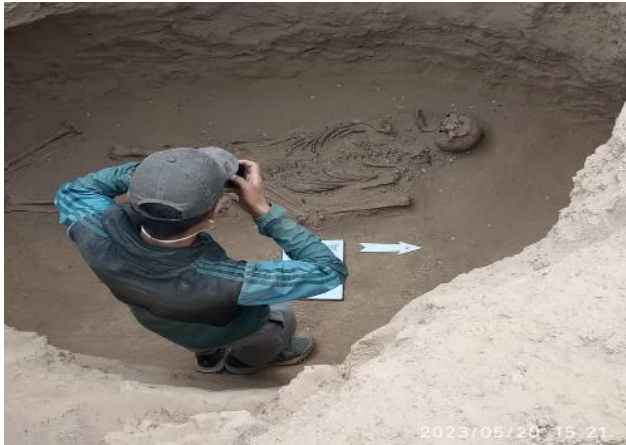
1. An archaeologist was invited to the burial discovery site to conduct an archaeological survey of the discovered burial.
2. On May 20, 2023 an archaeologist conducted a survey of the burial site (Photos 130, 131). According to the results of the archaeological survey it was determined that the burial was a modern Muslim burial corresponding to the second half of the 19th century and the first half of the 20th century and does not belong to the CHHS.
3. In accordance with the conclusion of the archaeological survey, the remains were reburied in a nearby cemetery (Photo 134) and the Koran was recited with a sacrifice according to Muslim traditions (Photo 133).

Photo 130. Lot 2. Km. 62+500. Survey of burial site by archaeologist.

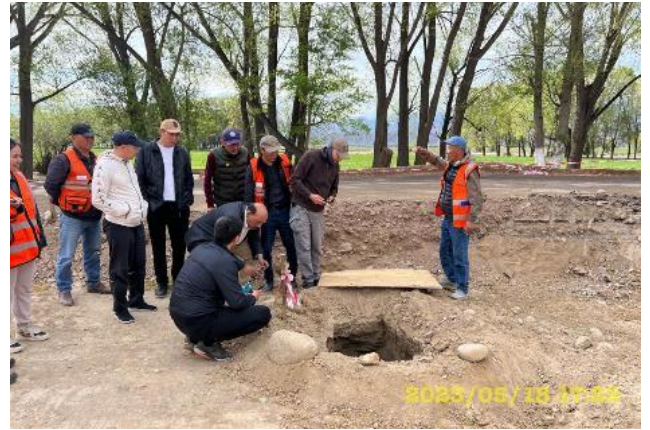
Photo 131. Lot 2. Archaeologist survey of burial site km.62+500.

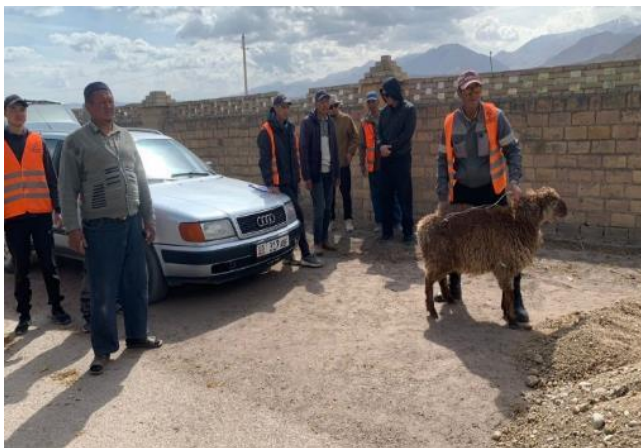
ADB Mission visited the site of found burial during a site visit May 18 (Photo 132).

Photo 132. Lot 2. Tendik v. km. 62+500. ADB mission. Inspection of found burial site.
