# Semi-annual environmental monitoring report

# July-December 2023

Kyrgyz Republic: Central Asia Regional Economic Cooperation Corridors 1 and 3 Connector Road Project (Phase 2) - Additional Financing Section 1 (Lot 1) "Balykchy - Kochkor km. 0-km. 43", Section 2A (Lot 2) "Kochkor-Epkin (km 62+400-km 89+500)".

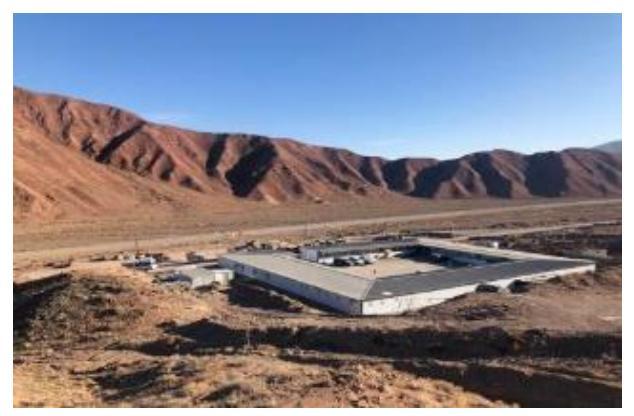
**40.** Emergency and firefighting measures are available. Fire extinguishers and fire boards are strategically distributed outside buildings, and rooms inside buildings are equipped with automated fire extinguishing systems. Various informational materials about COVID-19 and fire safety, emergency response is placed around buildings. During reporting period sanitary condition of camp space, living and working facilities were in good condition (Photos 45-54)

Photo 45. Lot 1. Camp's general view on Lot 1 km 16 + 100 (RS).

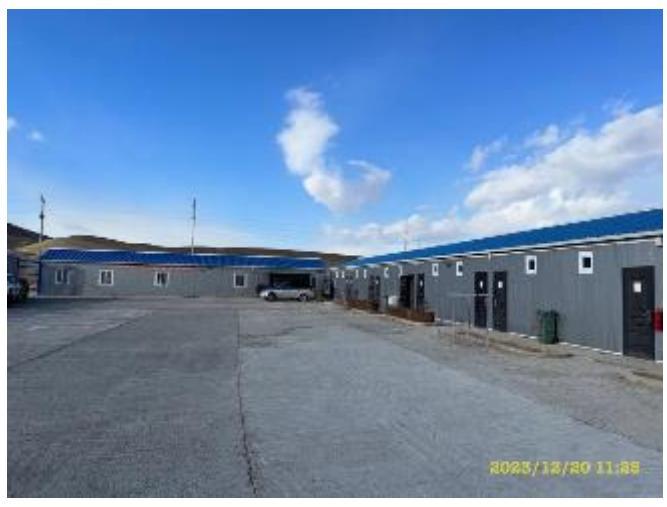
workers not living locally have a capacity of 45 people. Each living room has a bathroom and a shower room. During reporting period sanitary condition of camp site, accommodation and workplaces were in good condition (photos 55-60).

Photo 55. Contractor's accommodation camp

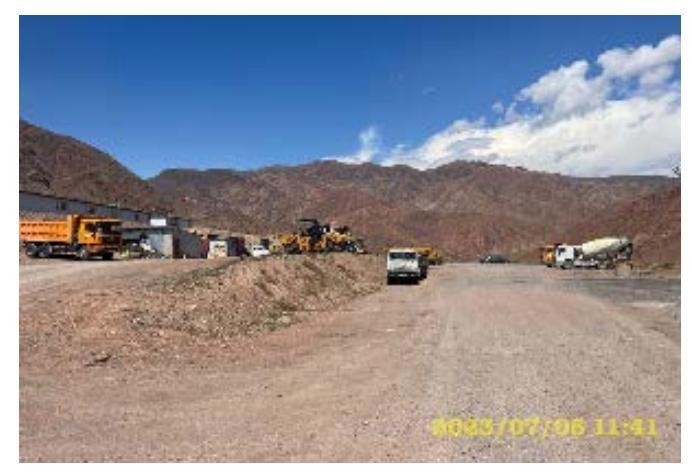
Photo 61. Sanitary condition of the construction equipment parking area is satisfactory. July

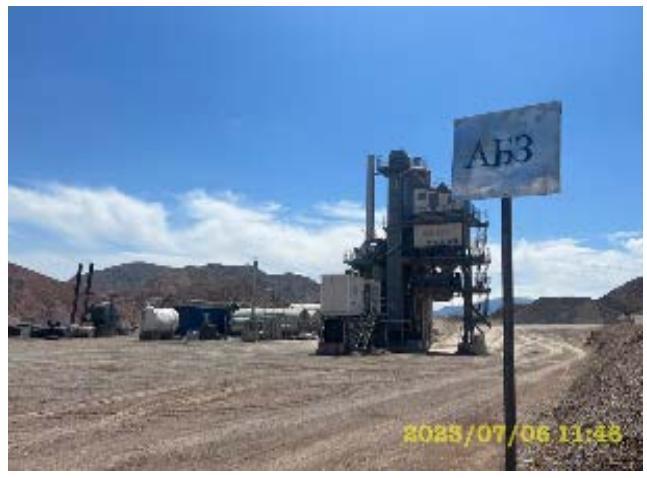
Photo 62. AC plant's production base. Sanitary condition of the territory is satisfactory. July.

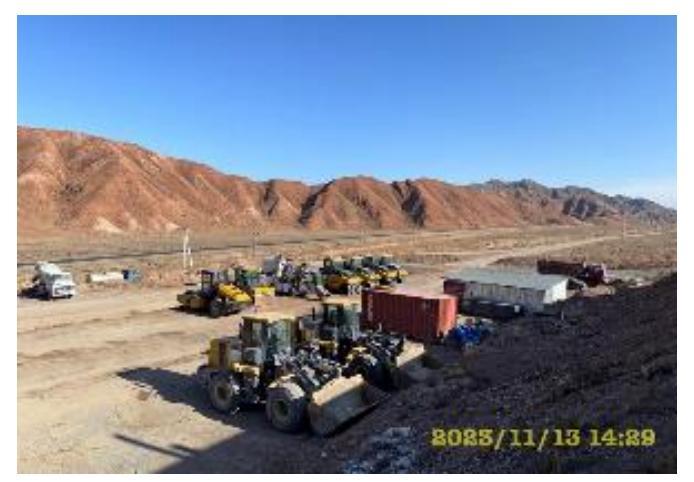
Photo 61. Sanitary condition of the construction equipment parking area is satisfactory. November.

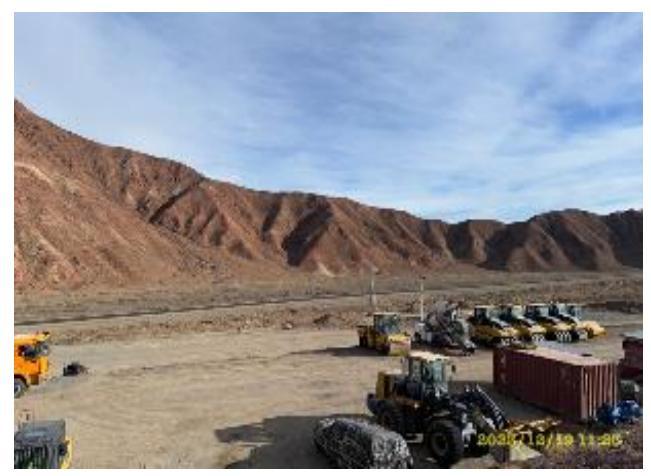
Photo 61. Sanitary condition of the construction equipment parking area is satisfactory. December.

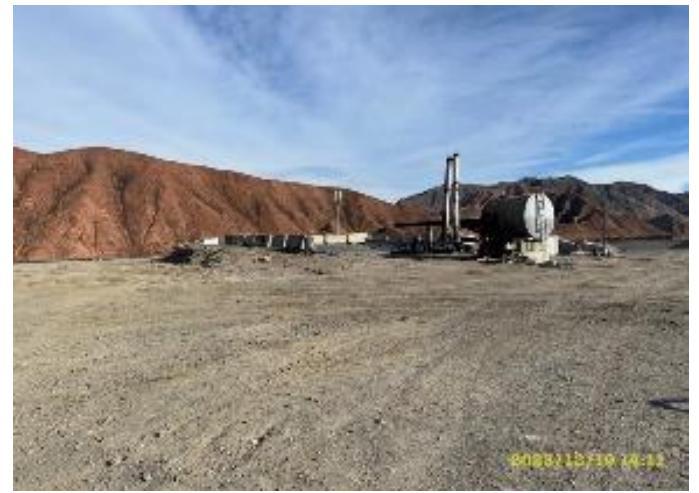
Photo 65. AC plant's production base. Sanitary condition of the territory is satisfactory. December

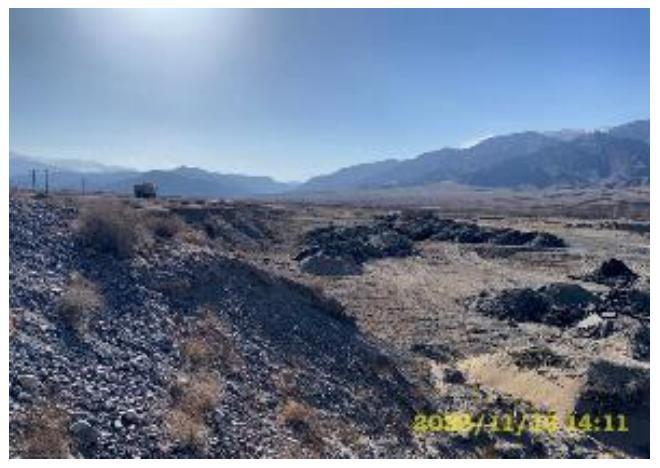
Photo 67. Old asphalt dump at km.7+000. November

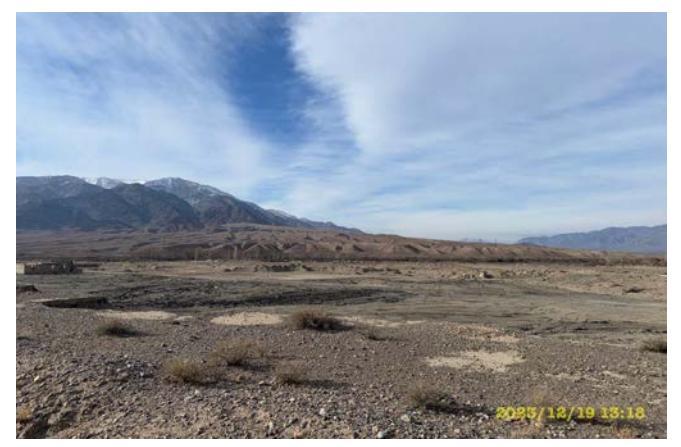
Photo 68. Old asphalt dump at km.7+000. December. After technical planning

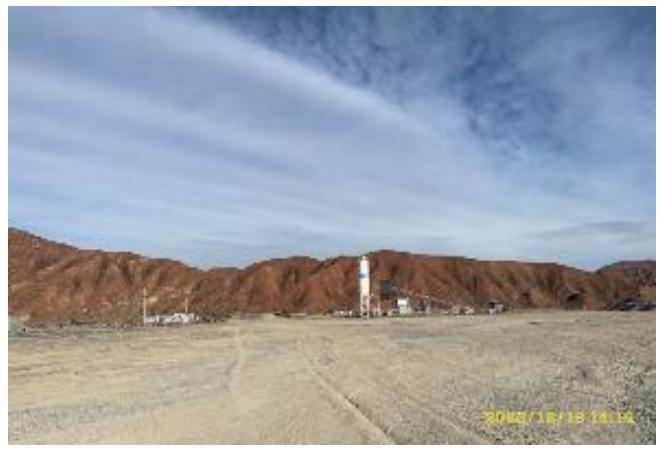
Photo 69. December. Sanitary condition of production base territory is satisfactory. No oil product pollution was observed. December

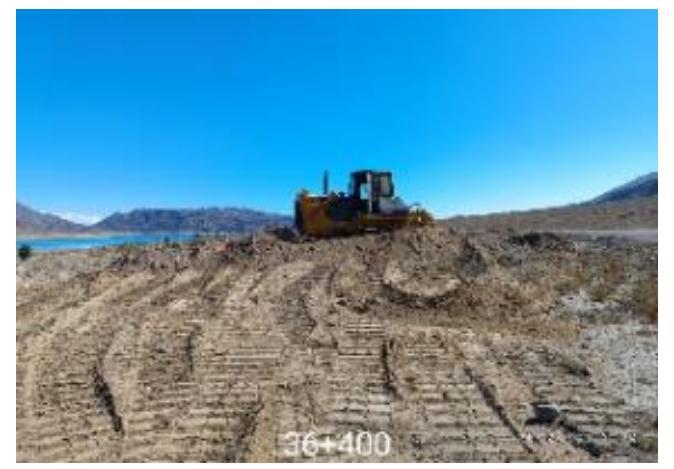
Photo 71. Unsuitable soil dump levelling at km 36+400. September

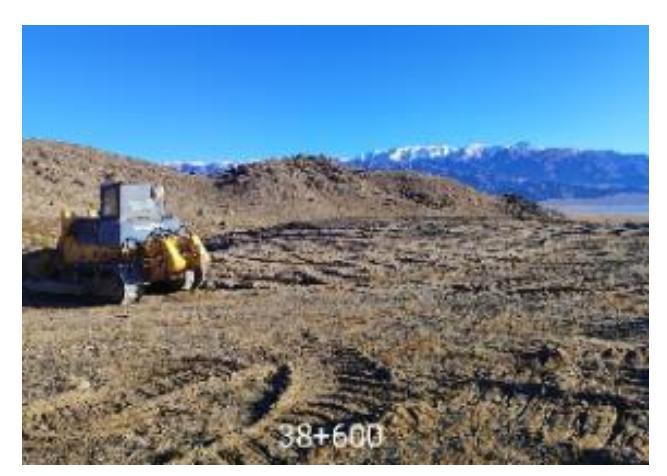
Photo 72. Levelling of the old asphalt spoil dump km. 38+600. September

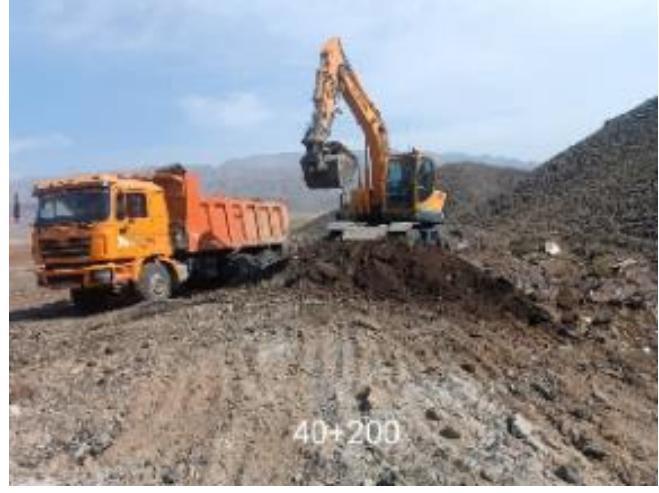
Photo 73. Levelling of the old asphalt spoil dump km. 40+200. September

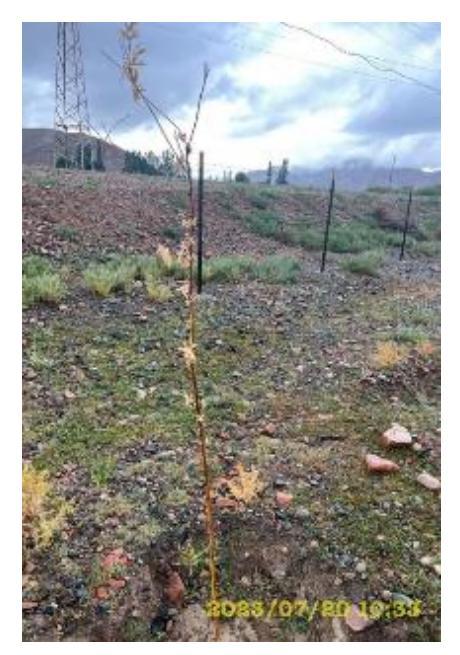
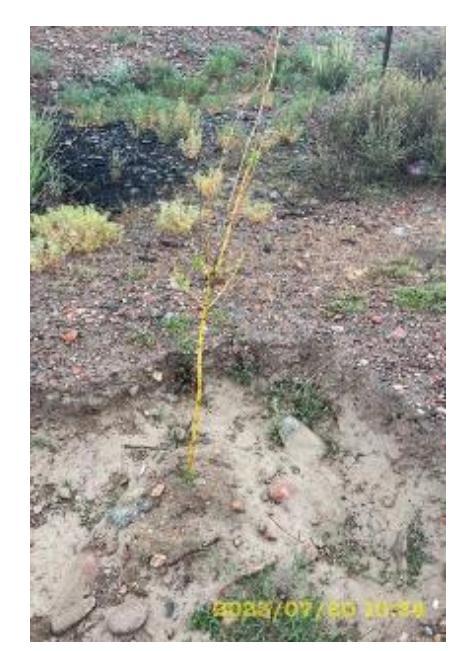
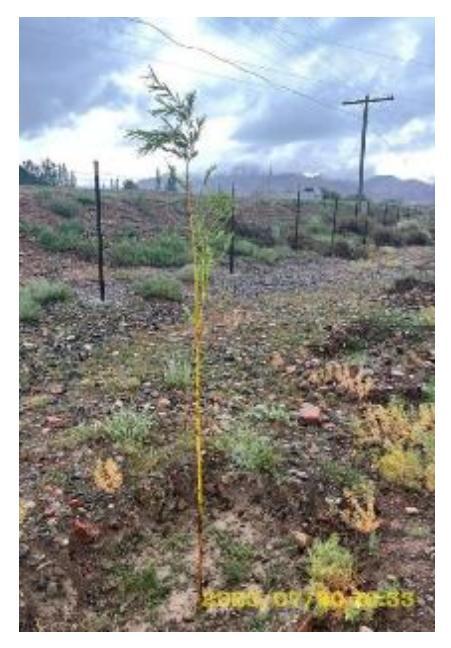
Photo 78. Condition of planted seedlings. July.

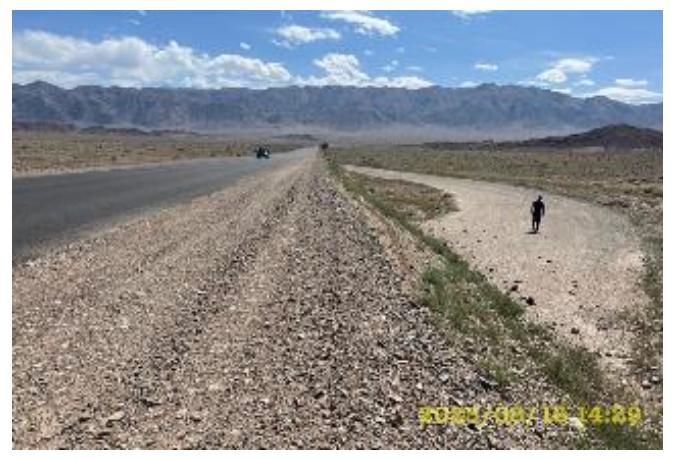
Photo 80. Bypass road km.21+430 RHS

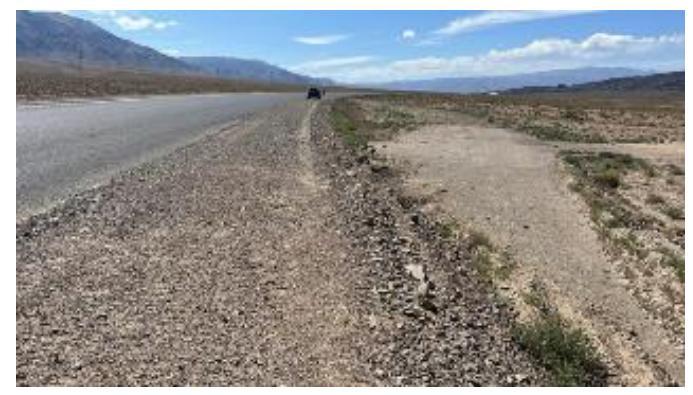
Photo 81. Bypass road km.24+430 RHS

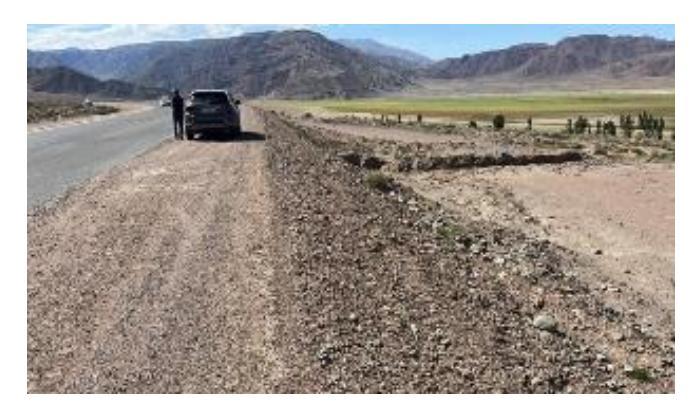
Photo 82. Bypass road km.37+700 RHS

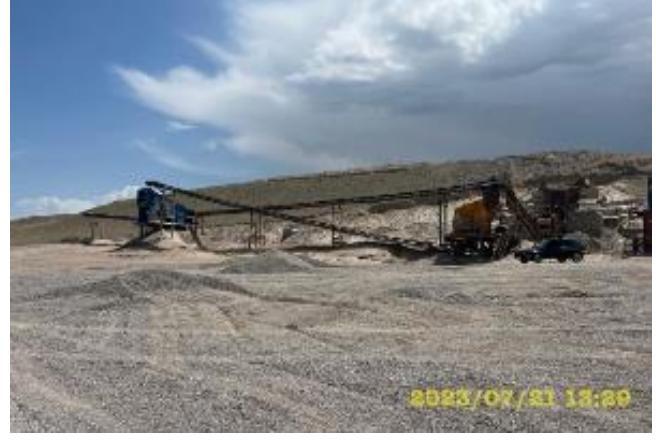
Photo 83. Crusher plant's production base. Sanitary condition of the territory is satisfactory

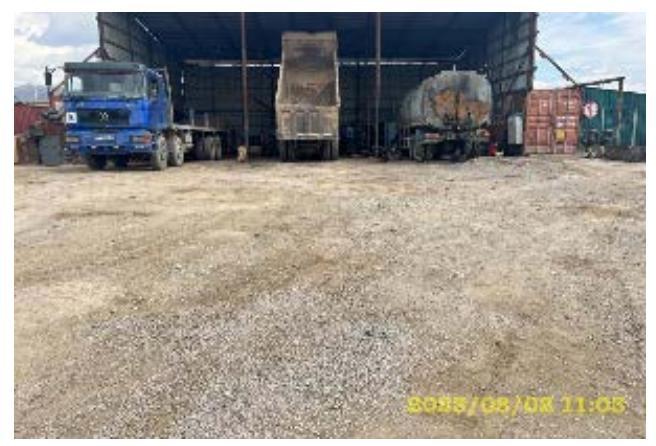
Photo 84. Production base. Sanitary condition of the repair site is satisfactory

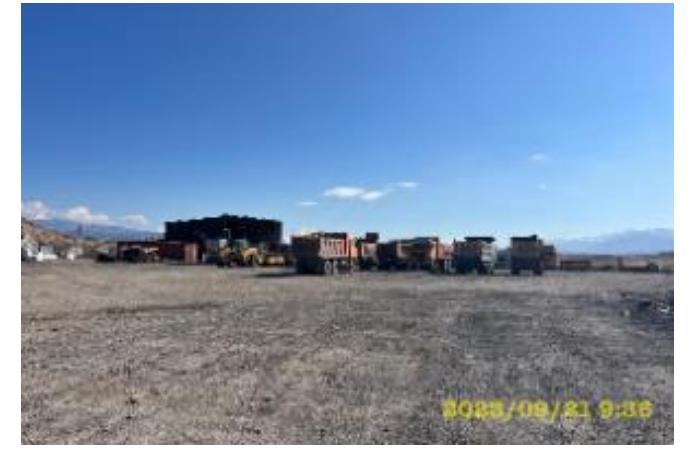
Photo 87. September. Sanitary condition of the construction equipment parking area is satisfactory.

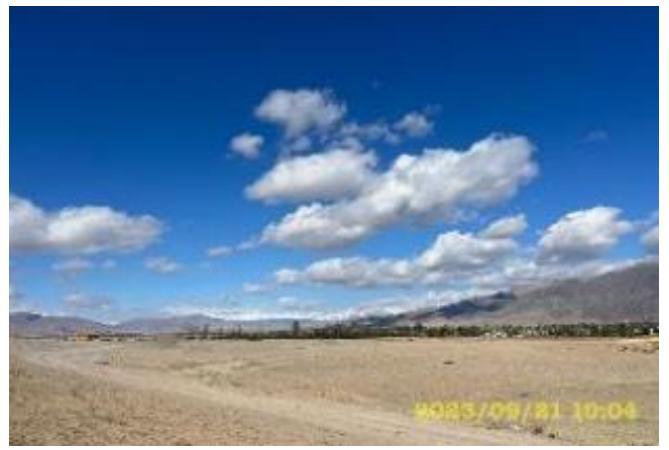
Photo 88 Unsuitable soil dump at km. 80+800 on left after reclamation

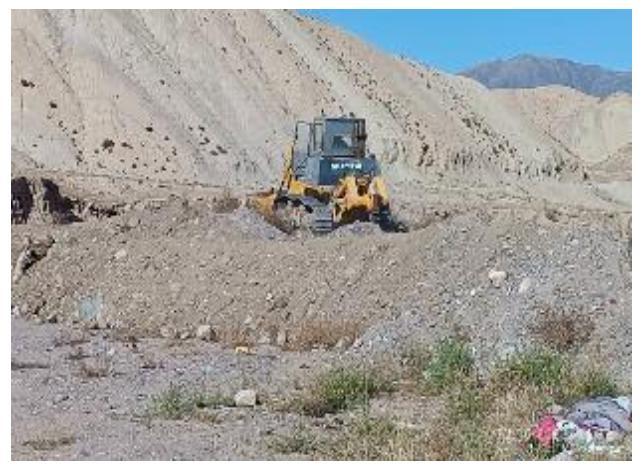
Photo 89. Levelling of the quarry km.89+093. October

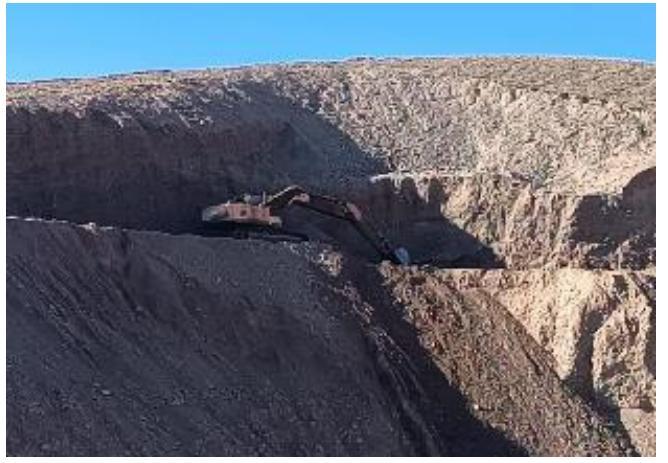
Photo 90. Quarry km. 75+400. Bringing the sides to a stable position

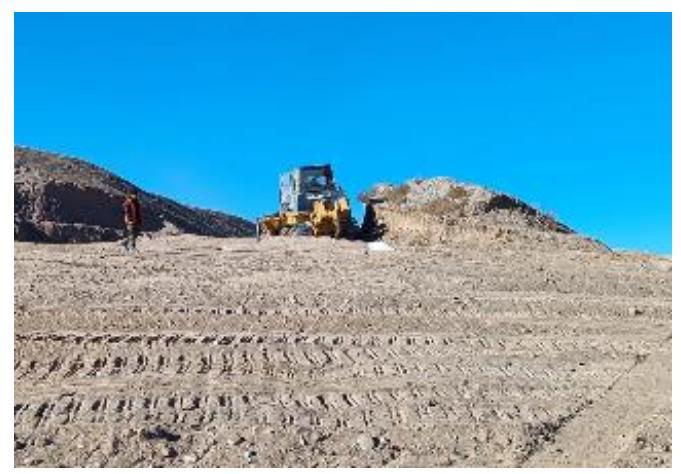
Photo 91. Quarry levelling at km. 75+400

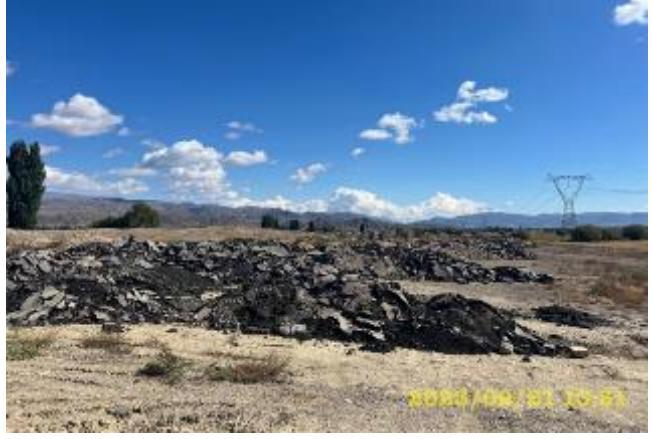
Photo 92. Old asphalt dump at km. 70+180 LHS before reclamation. September

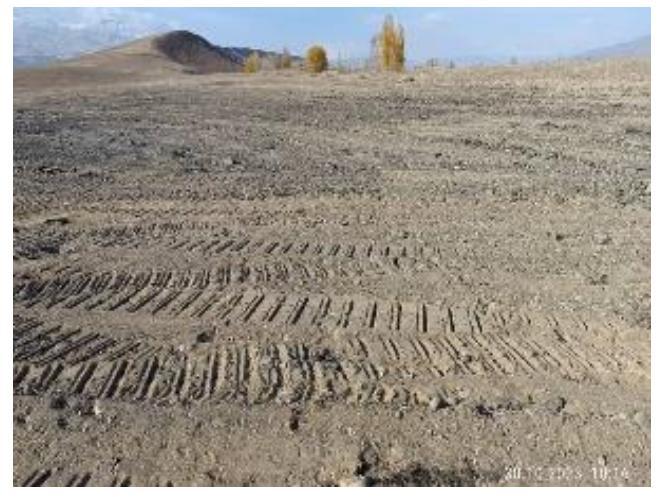
Photo 93. Old asphalt dump at km. 70+180 LHS after reclamation. October

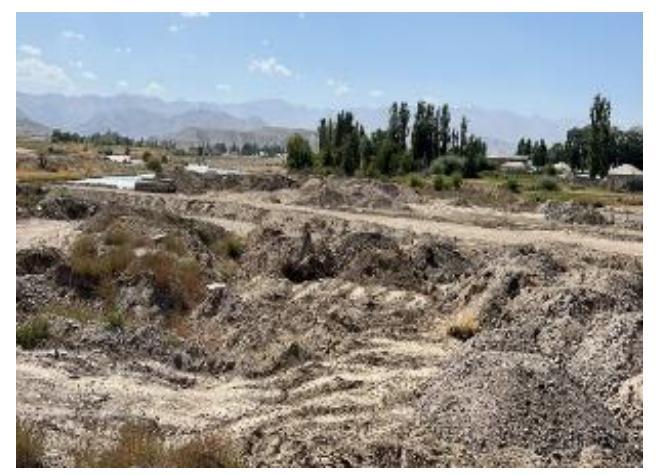
Photo 94. Spoil dump at km. 62+520 LHS before reclamation

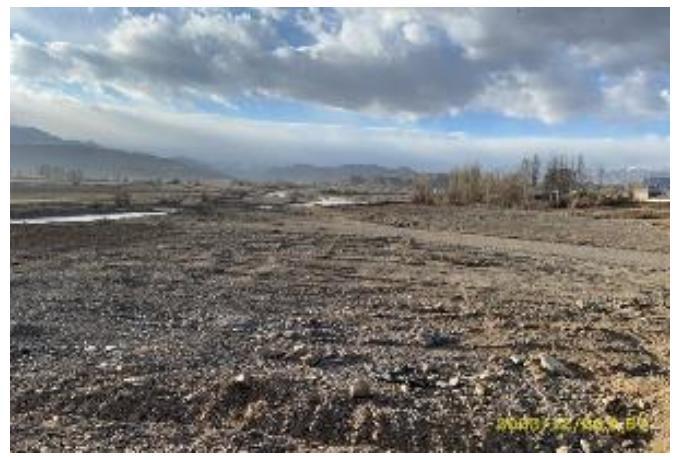
Photo 95. Spoil dump at km. 62+520 LHS after reclamation

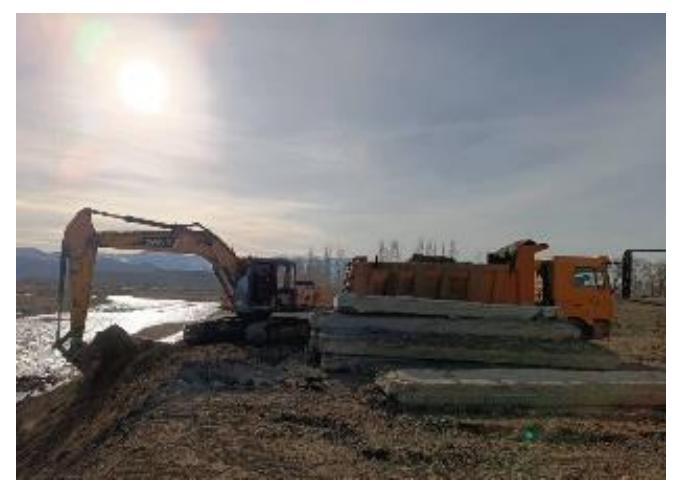
Photo 97. Temporary bridge of the bypass road dismantling at km 62+500

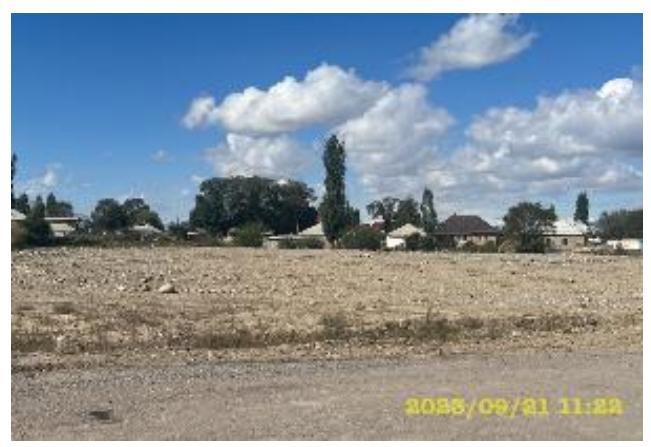
Photo 96. Spoil dump at km. 62+520 LHS after reclamation

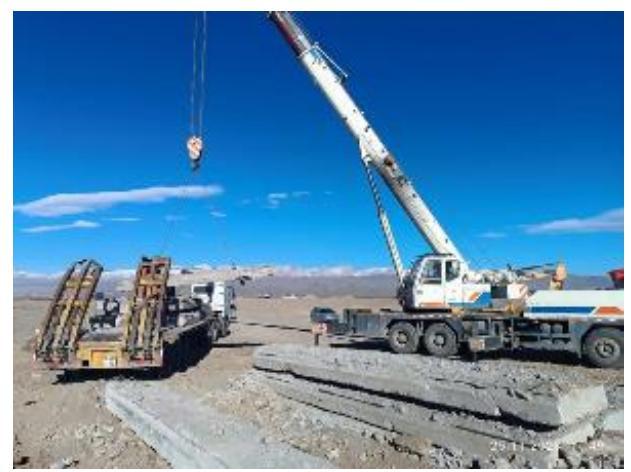
Photo 98. Dismantled parts removal of the temporary bridge of bypass road at km 62+500

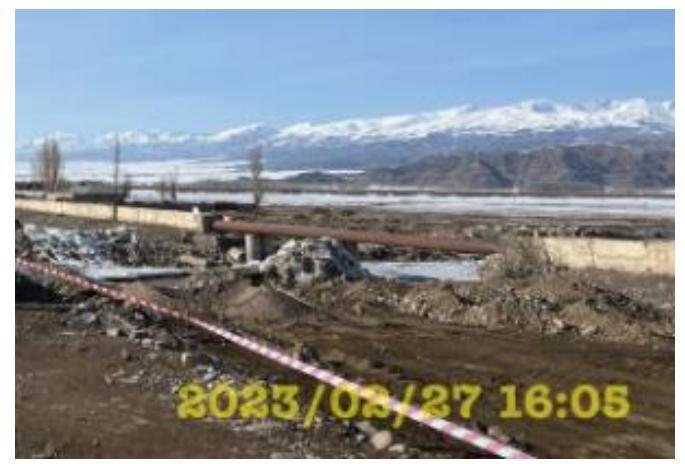
Photo 99. Spoil dump at km. 65+520 RHS before reclamation

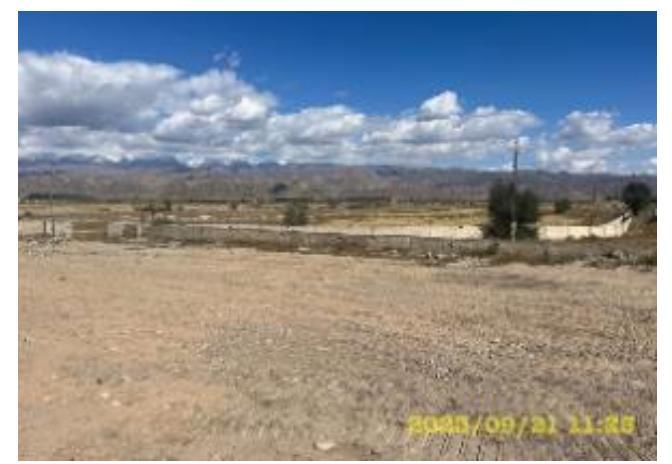
Photo 100. Spoil dump at km. 65+520 RHS after reclamation

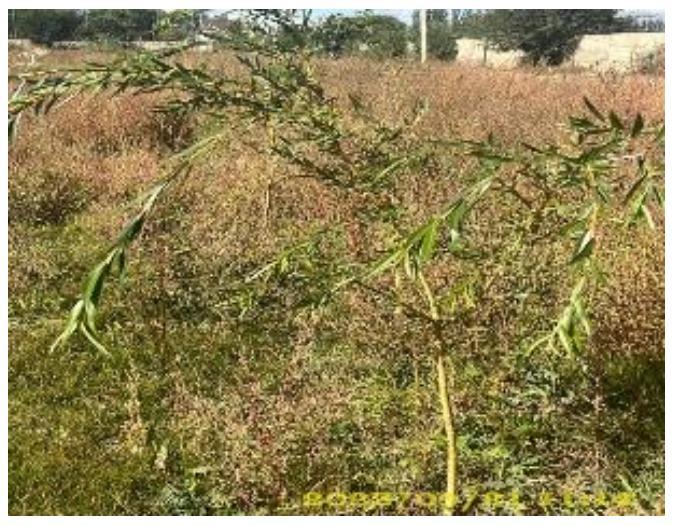
Photo 101. Planted seedlings in the village Kok-Zhar, sports centre. September

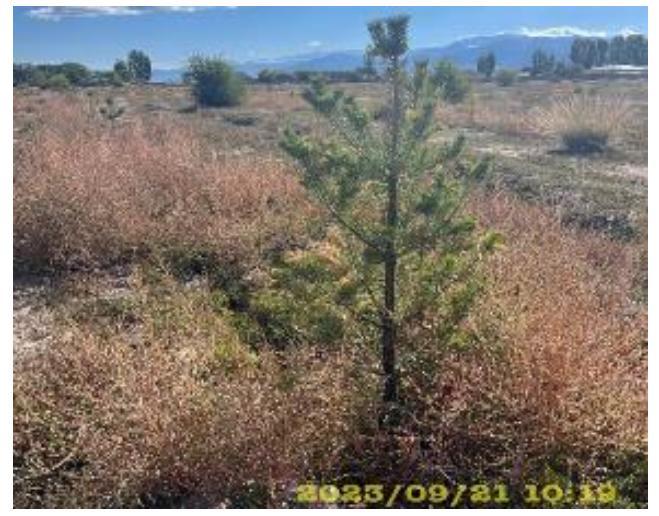
Photo 102. Cholpon village. Condition of pines. September

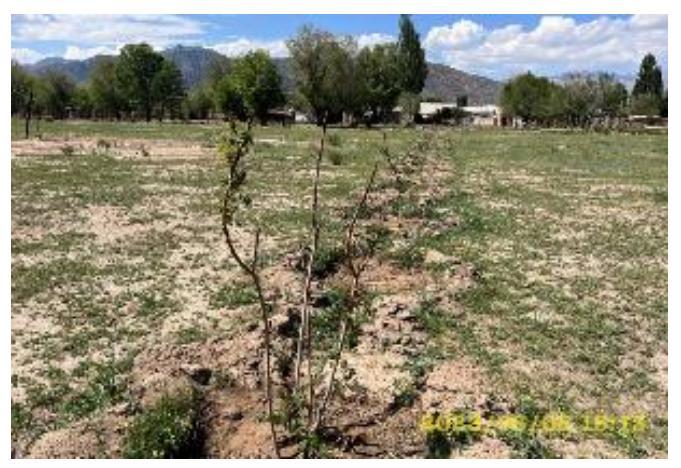
Photo 103. Cholpon village. Condition of sumai seedlings in June 2023.

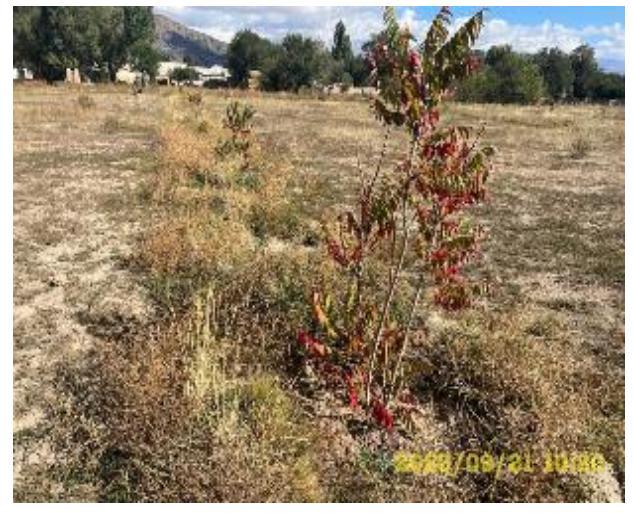
Photo 105. Cholpon village. Condition of sumai seedlings.

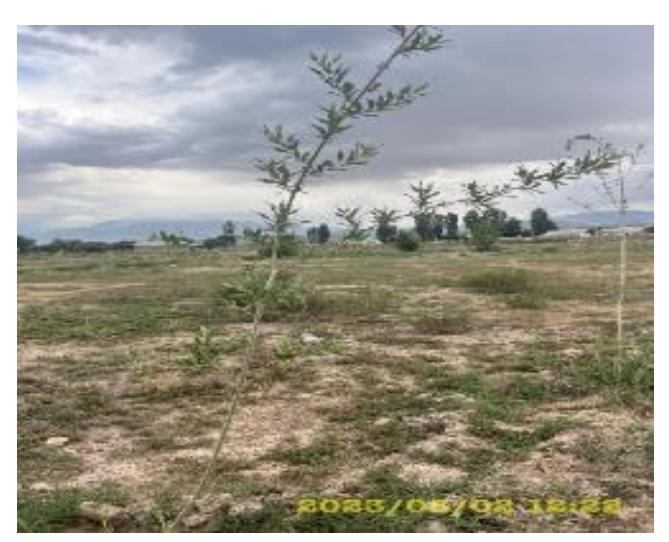
Photo 106. Cholpon village. The planted seedlings have started to grow as a result of proper watering

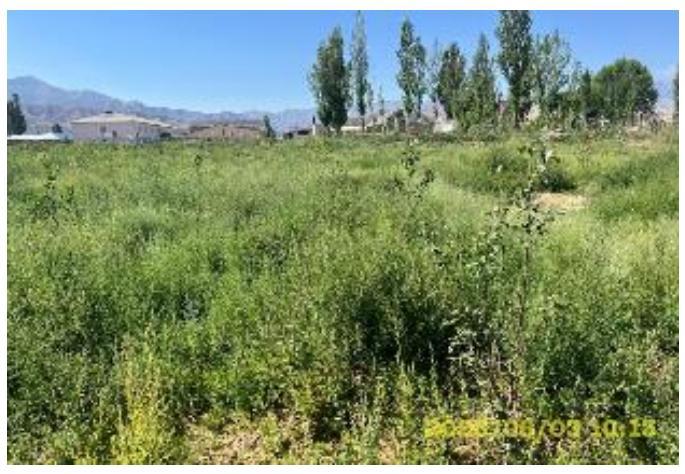
Photo 107. Overgrown grass in the area of planted seedlings near stadium in Kok-Jar village

No n/n	Comments, non-compliances, recommendations	Corrective measures (CM)	Due dates	Status of previous execution of the CM/ Timeframe for elimination of non- compliances
Lot -	1			
1	No reclamation of lands allocated for bypass roads on Lot 1 has been provided.	Ensure reclamation of sites used for bypass roads located at: km.18+300, km.21+430, km.24+430, km.24+492, km.26+330, km.26+720, km. 31, km. 34+220, km.34+646, km.35+210, km.36+102, km.36+490, km.37+050, km.37+540, km.37+700, km.38+380, km 42+582 (Photos 79-82).	Deadline February 2024.	In the process.
Lot -	2			
2	Production base. Pollution of territory near the fuel and lubricants storage warehouse (Photo 85)	Ensure cleaning of the territory from oil product pollution	Immediately	Done (photo 86)
3	Sites of planted seedlings on territory of sport complex and in stadium area in Kok-Zhar village are overgrown with grass (photo 107).	Ensure grass cutting	Deadline 15 <sup>th</sup> August 2023.	Done (photo 108)

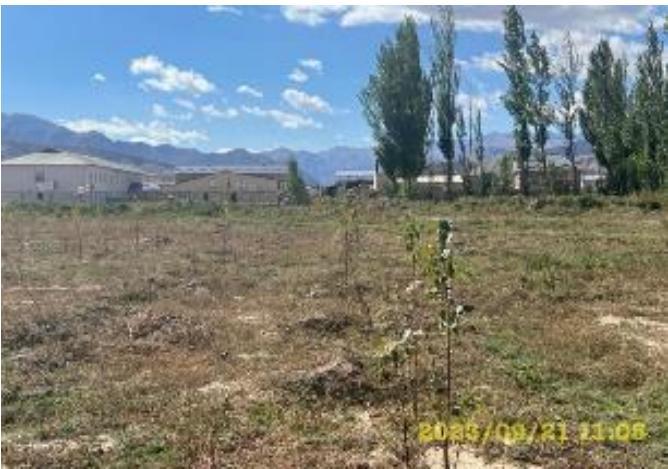
Photo 108. Area of planted seedlings in Kok-Jar village after grass cutting.

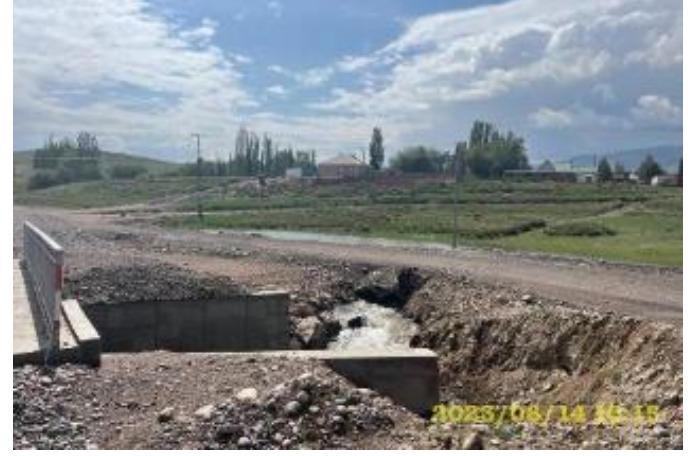
Photo 111. Bypass road of bridge at km 86+261. r. Sazdyn-Suusu, Construction of bridge is completed, bridge access is open. The bypass road is subject to reclamation.

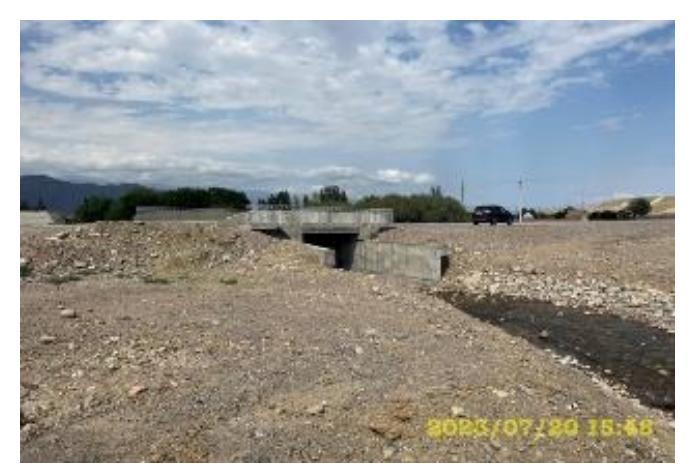
Photo 112. Bypass road of the bridge at km 86+261. r. Sazdyn-Suusu, after reclamation

4	Wastewater after washing the concrete mixing plant is discharged into a permeable pit.	Ensure construction of a waterproof tank to collect wastewater from concrete mixing plant.	Until 15 <sup>th</sup> March 2023 Until 22 <sup>th</sup> June 2023 Extended until 10 <sup>th</sup> July 2023.	Done
5	Construction of bridges at km. 86+261 and 88+795 have been completed. Usage of the bypass road has been stopped (Photo 111, 113).	Ensure reclamation of land allocated for the bypass road	Until 1 <sup>st</sup> July 2023.	Done (photo 112, 114)

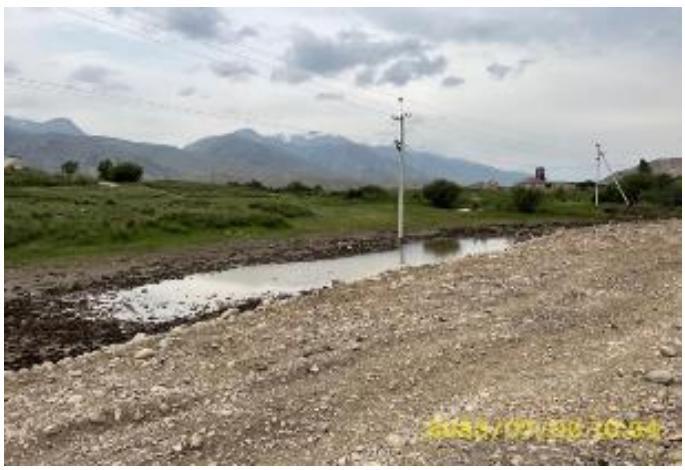
Photo 113. Bridge bypass road at km 86+261. r. Sazdyn-Suusu River, requires reclamation and drainage of the adjacent site flooded due to bypass road construction

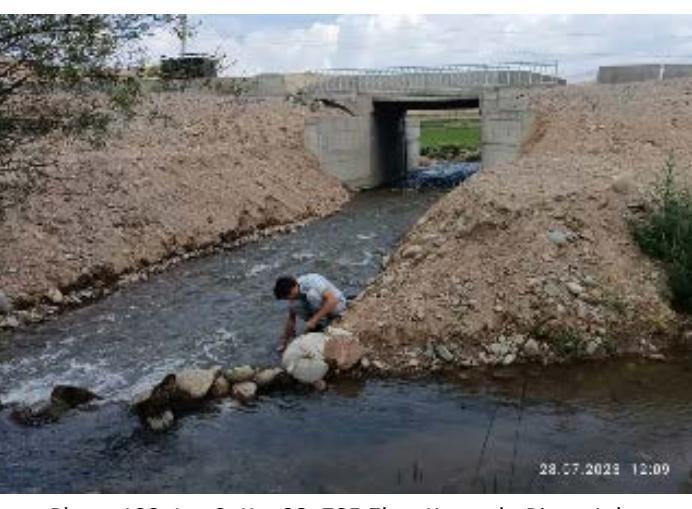
Photo 122. Lot 2. Km 88+795.Zhar-Korundu River. July

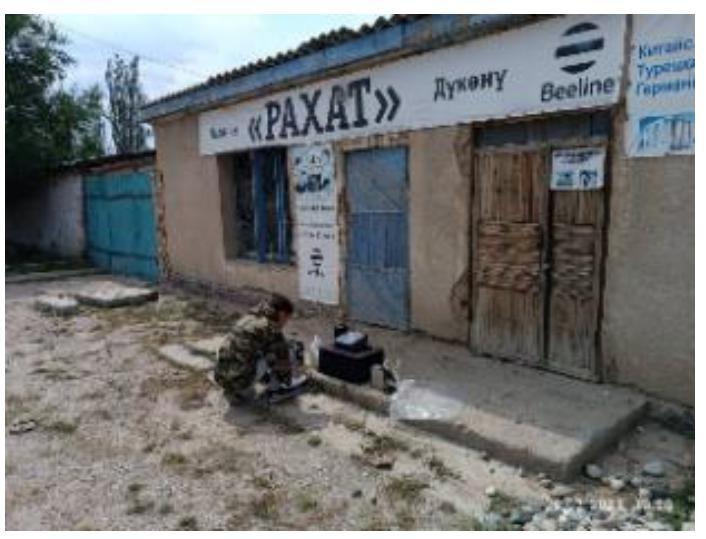
Photo 124. Lot 2. Kok-Jar village km. 65+985 Air quality measurements. October

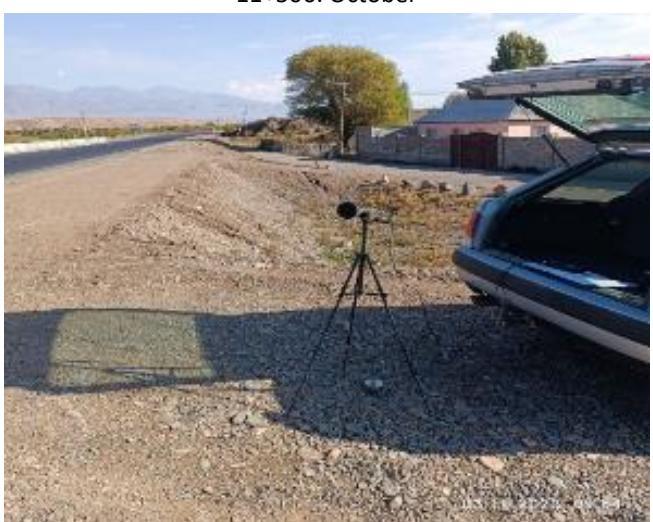
Photo 125. Lot 1. Tash-Saray village. Measurements of noise and vibration levels. October

**64.** The noise and vibration levels during operation of Contractor's vehicles and equipment in quarries and production bases and during construction works were within maximum permissible levels (MPL). Vibration levels of operating construction equipment were also within the MPL. (see annex 1)

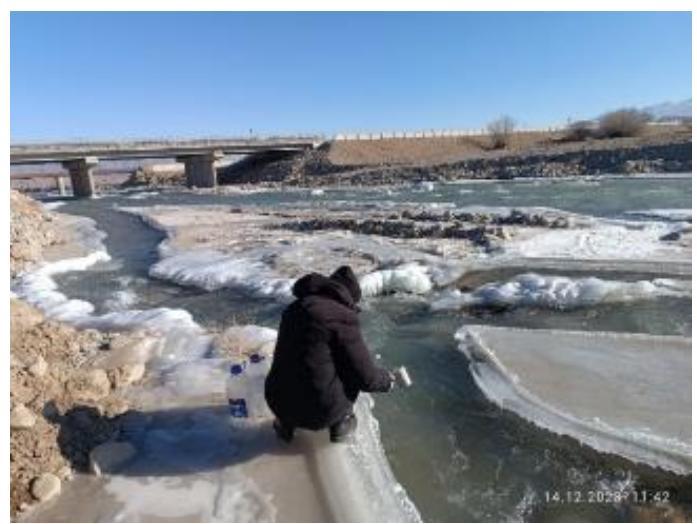
Photo 126. Lot 2. Water sampling from the Kok-Jar River. December

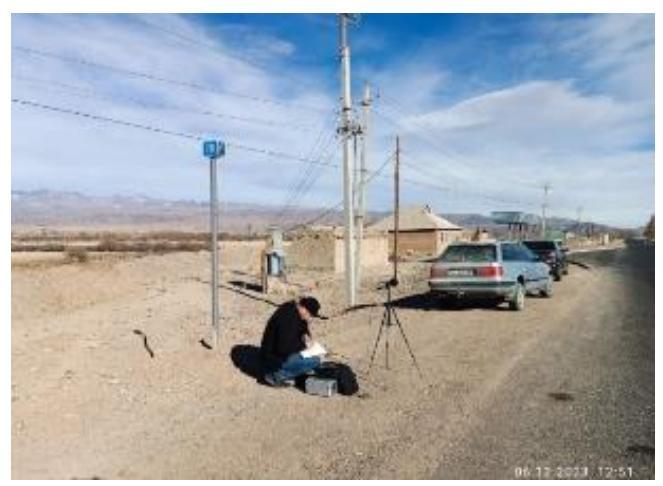
Photo 127. Lot 2. Epkin village Noise and vibration measurements. December

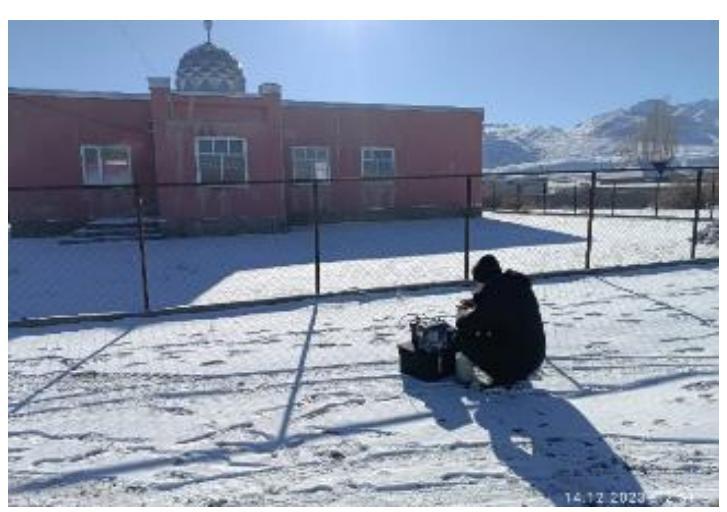
Photo 128. Lot 2. Epkin village, mosque, km 86+540. Air quality measurements. December.

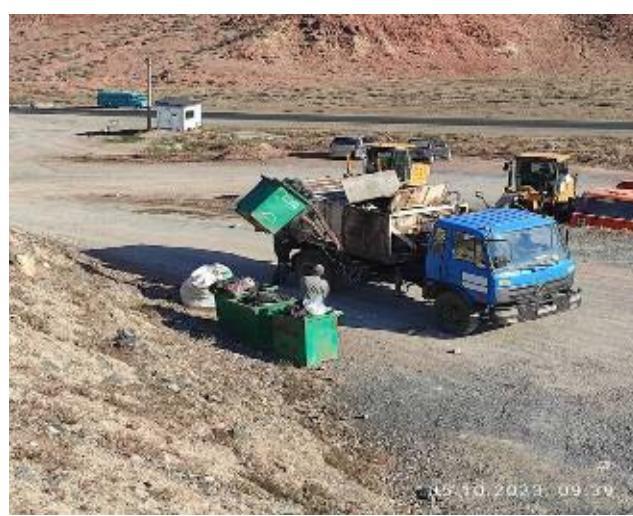
**81.** Solid domestic waste is removed (photos 118-122) and placed in municipal landfill in Balykchy and v. Cholpon. Wastewater is transported to treatment facilities of Balykchy in accordance with contract with municipal enterprise Balykchy - "Gorvodokanal".

Photo 129. Lot 1. Removal of solid waste from Contractor's camp. October

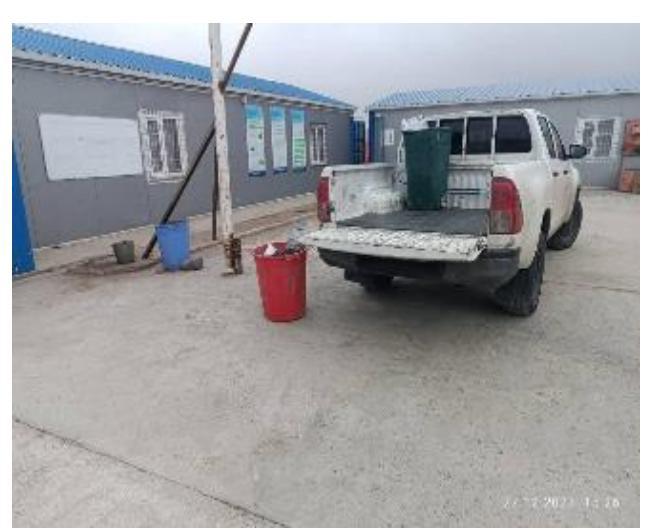
Photo 130. Lot 2. Removal of solid waste from Contractor's camp. December

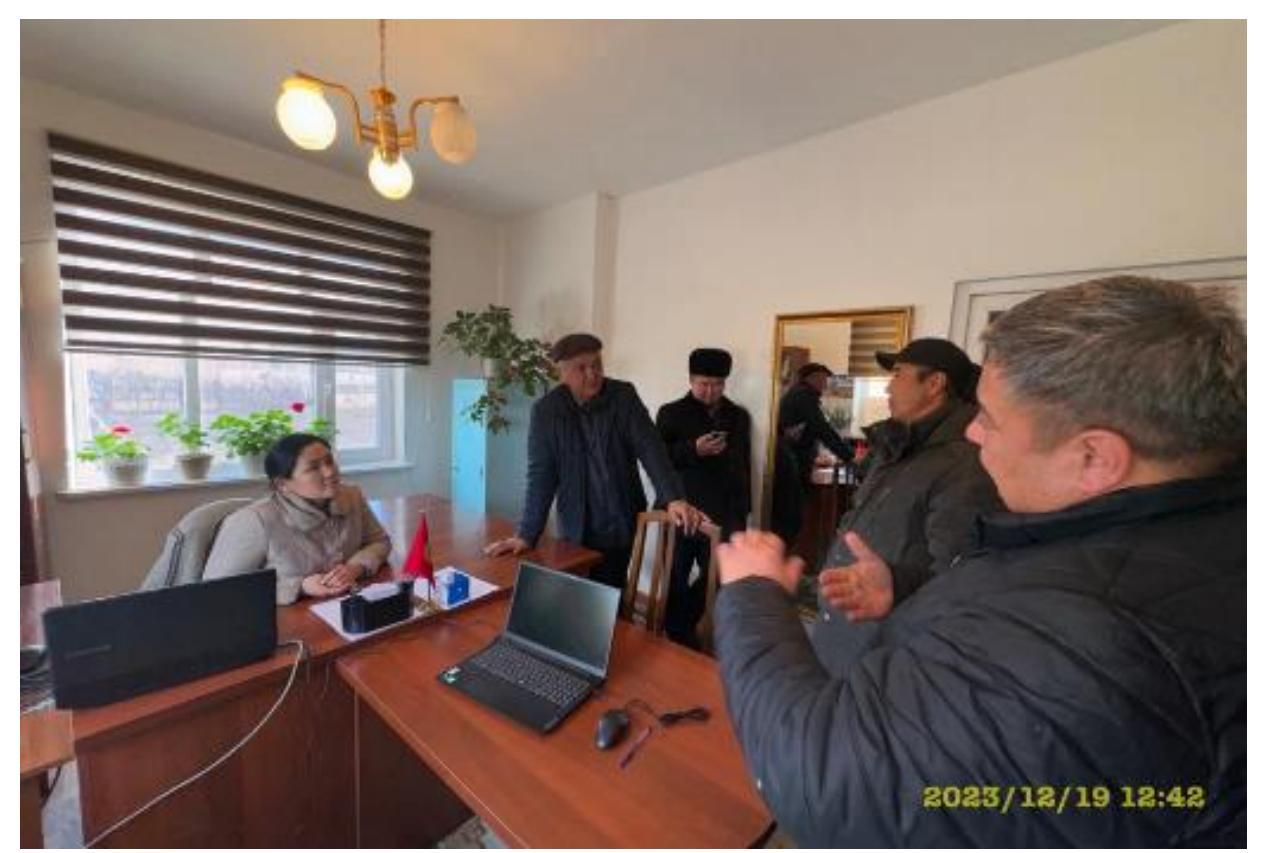
Photo 131. Lot 1. Meeting in Tash-Moinok village administration to discuss issue of lands reclamation used for Contractor's production base and accommodation camp, and establishment of a committee for acceptance-transfer of reclaimed lands.
