Environmental Monitoring Report

January–June 2022

Kyrgyz Republic: Central Asia Regional Economic Cooperation Corridors 1 and 3 Connector Road Project (Phase 2) - Additional Financing

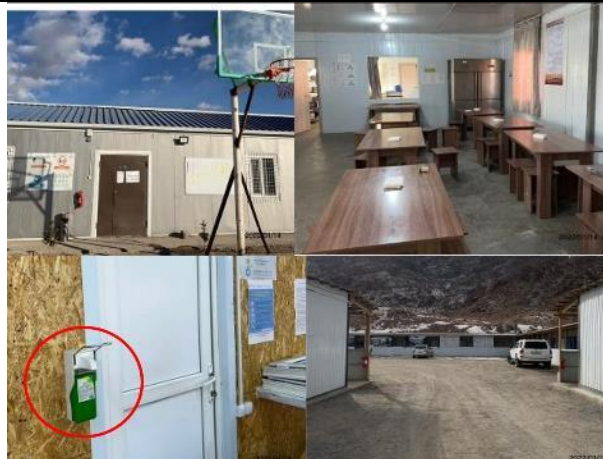
Photo 53. Well-maintained office and camp at Lot 2.

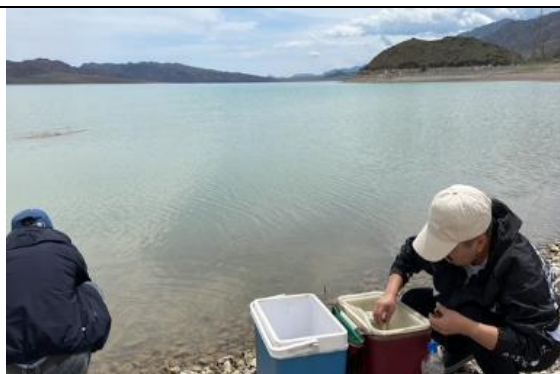
63. Instrumental monitoring of water quality, air quality, noise and vibration levels was planned for March and June 2022. Sampling for water analyses was also undertaken as planned (Photo 73) but not tested in the laboratory because DEM suspended its work to prepare the laboratory for accreditation according to international standard ISO IEC 17025-2019 based on the letter of the State Committee on Environment and Climate to the Ministry of Natural Resources, Environment and Technical Supervision of KR #206 dated 06.04.2022 (See Attachment 1).

Photo 73. Water sampling at Orto-Tokoi Reservoir

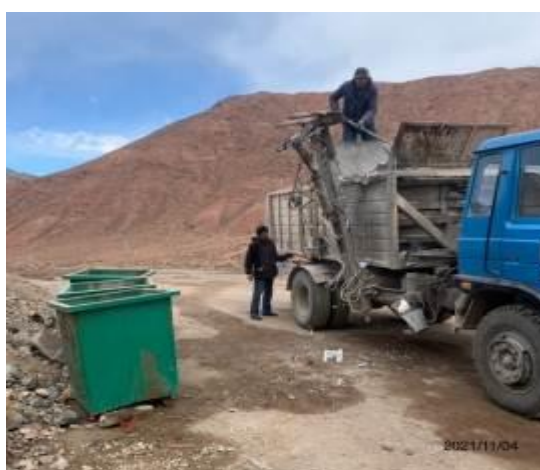
79. The solid domestic waste is removed (photo 70) and disposed at municipal landfill in Balykchy and Cholpon villages. Wastewater is transported (photo 71) to treatment facilities of Balykchy in accordance with contract with municipal enterprise of Balykchy - "Gorvodokanal".

Photo 71. Solid waste disposal.

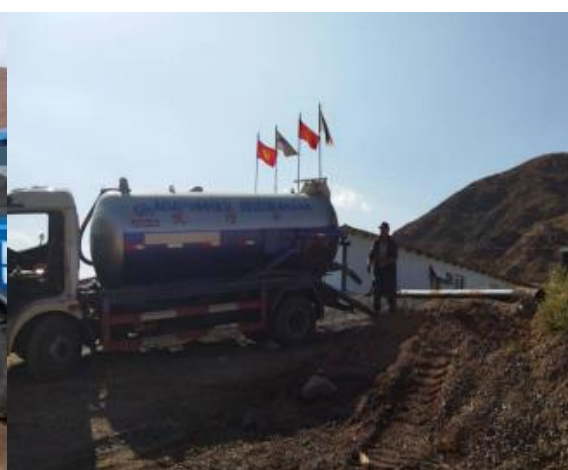
Photo 72 wastewater disposal from the production base of Lot 1.
