Semi-annual environmental monitoring report

Project number: TA-8887 KGZ

July-December 2022

Kyrgyz Republic: Central Asia Regional Economic Cooperation Corridors 1 and 3 Connector Road Project (Phase 2) - Additional Financing

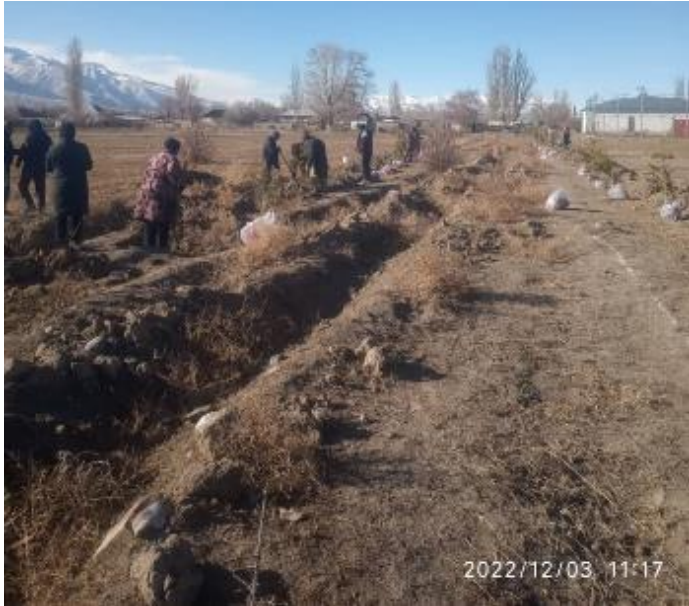
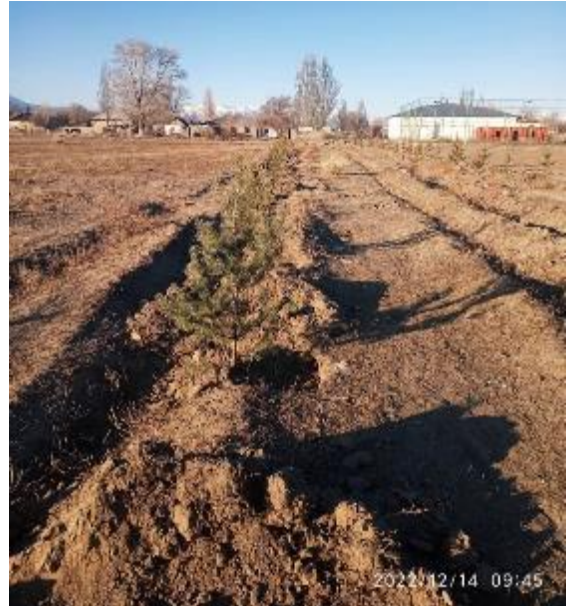
Photo 4-5. Planting pine seedlings at the Cholpon village park site

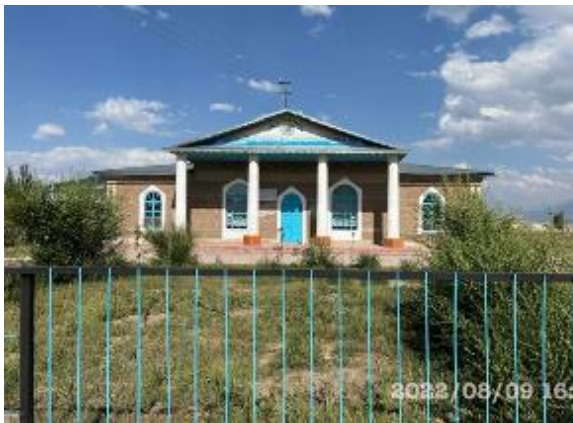
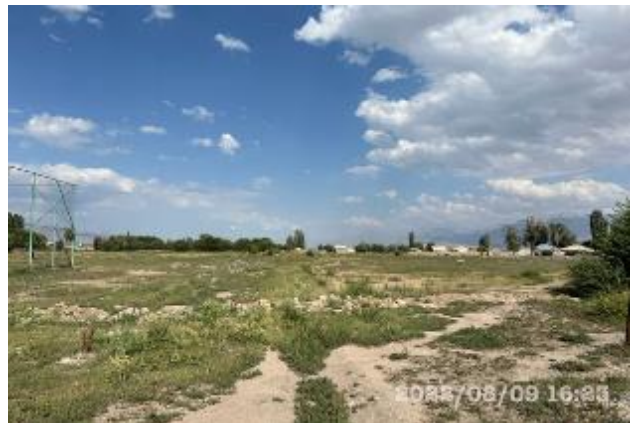
Photo 6. Lot. 2. Examination of the tree planting site. Cholpon village, House of Culture park

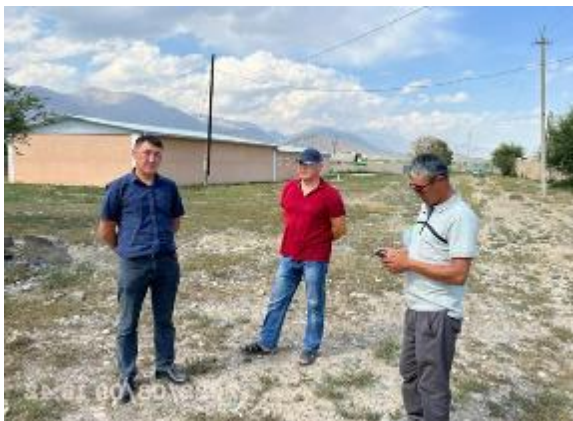
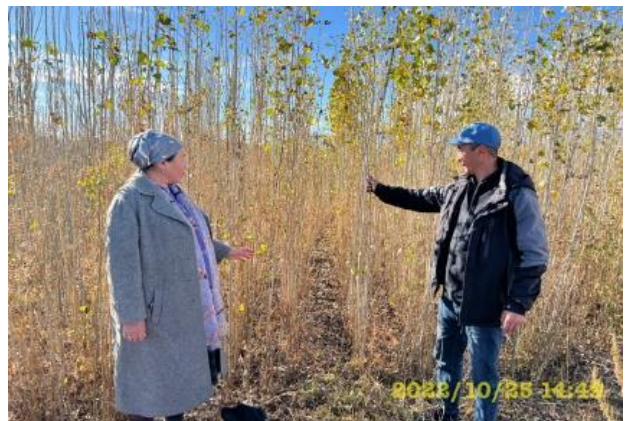
Photo 7. Lot 2. Examination of the planting site trees. A park for a sports Kok-Jar village.

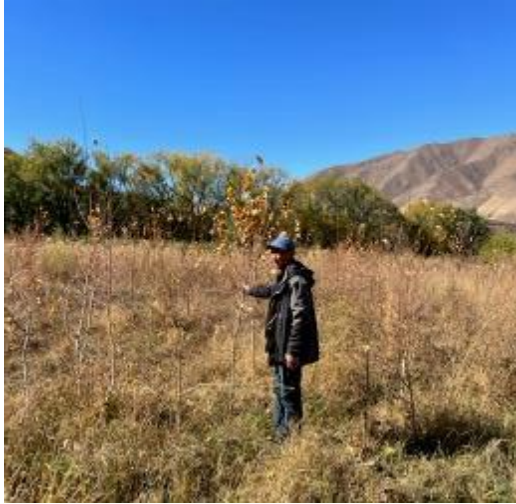
Photo 9. Nursery in Chon-Kemin

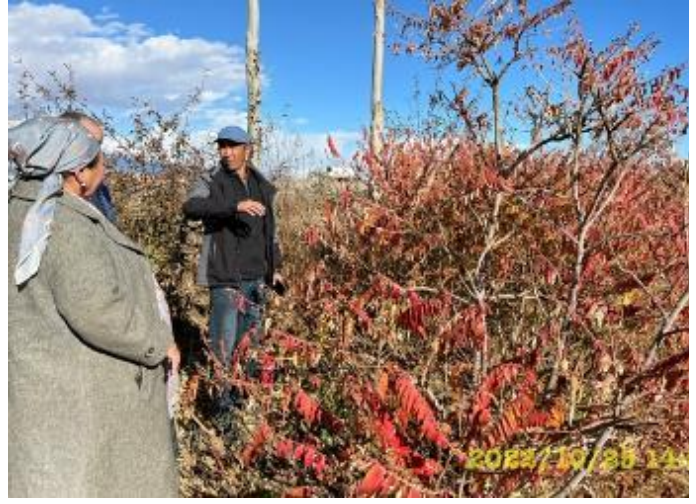
Photo 10. Issyk-Kul's "Chyrpyk" nursery

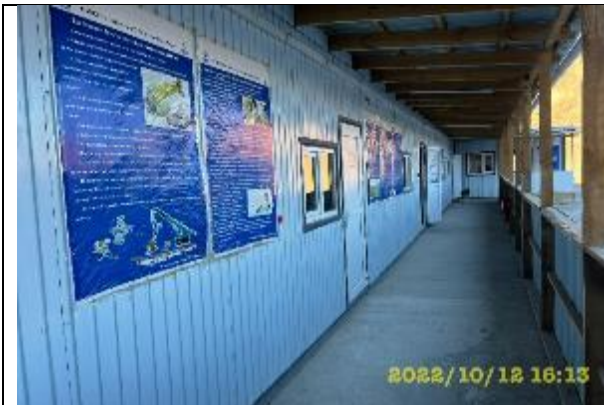
Photos 38. Lot 1 offices and information boards.

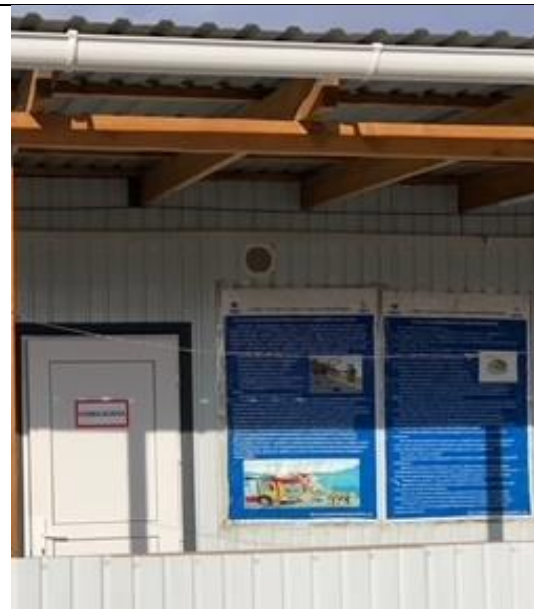
Photos 39. Namazkan Prayer Room

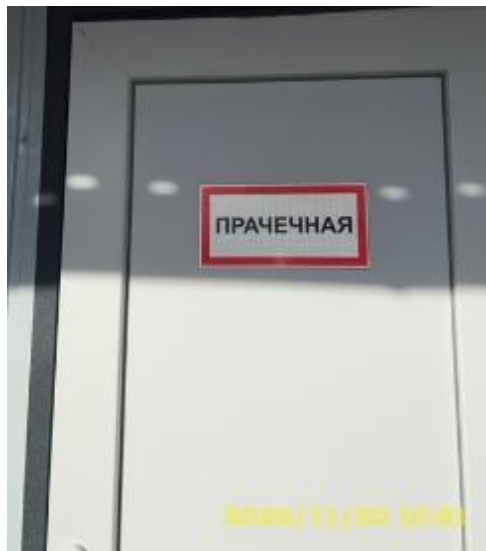
Photos 40. Laundry

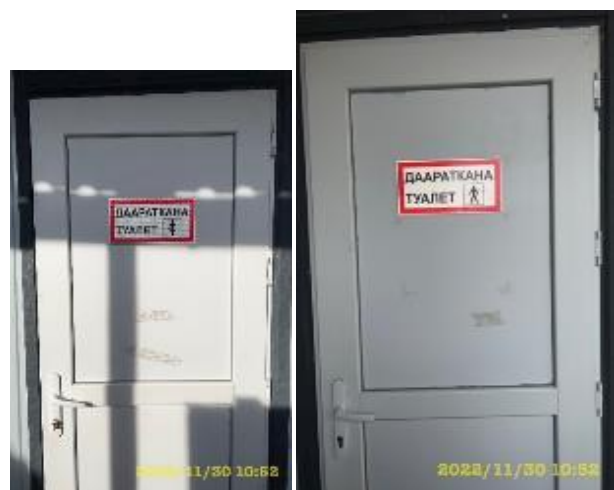
Photos 41. Women's and men's restrooms.

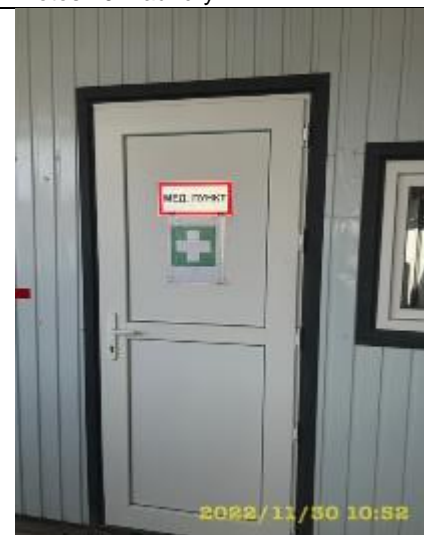
Photos 42. Lot 1 First aid station, doctor

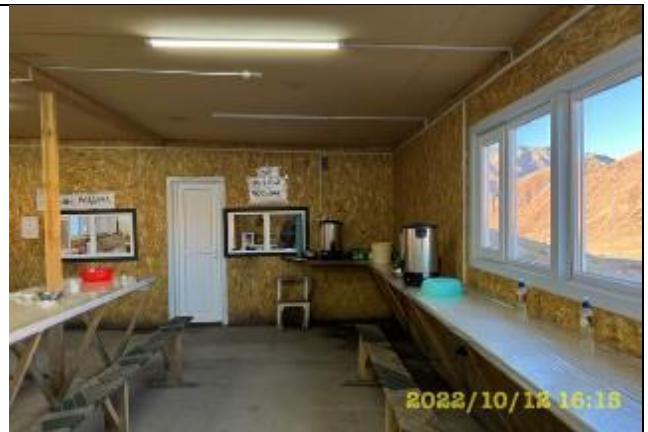
Photos 44. Lot 1 canteen in the camp.

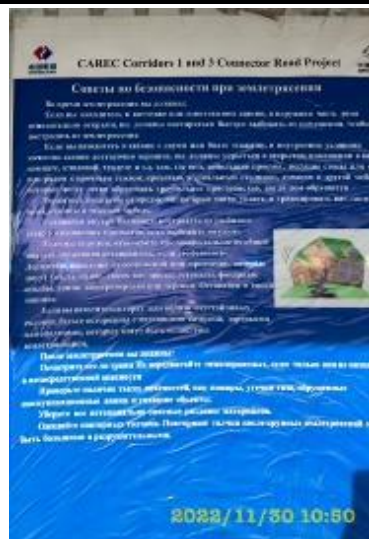
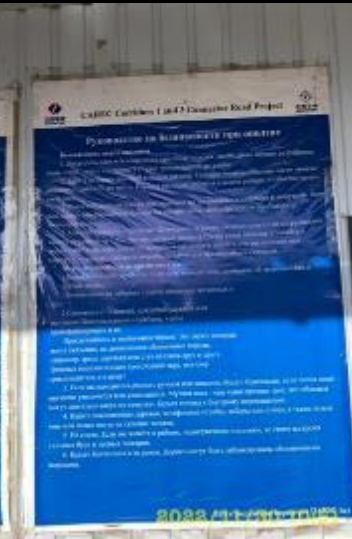
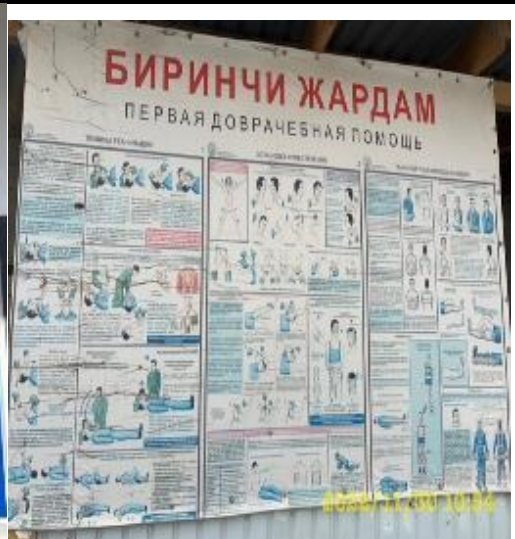
Photos 46 Information boards on first aid, emergency response (earthquakes, floods, landslides, road safety, etc.).

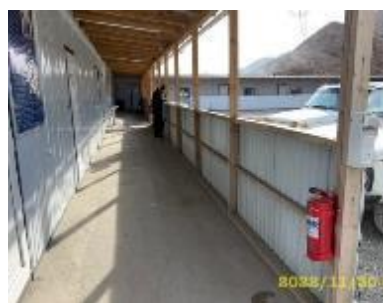
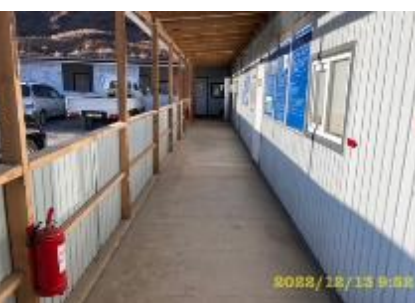
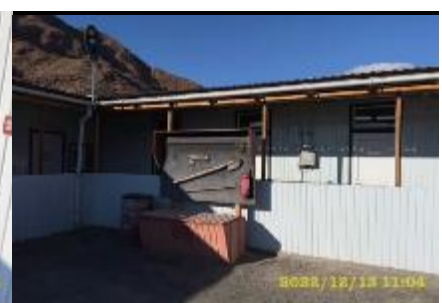
Photos 47. Extinguishing media

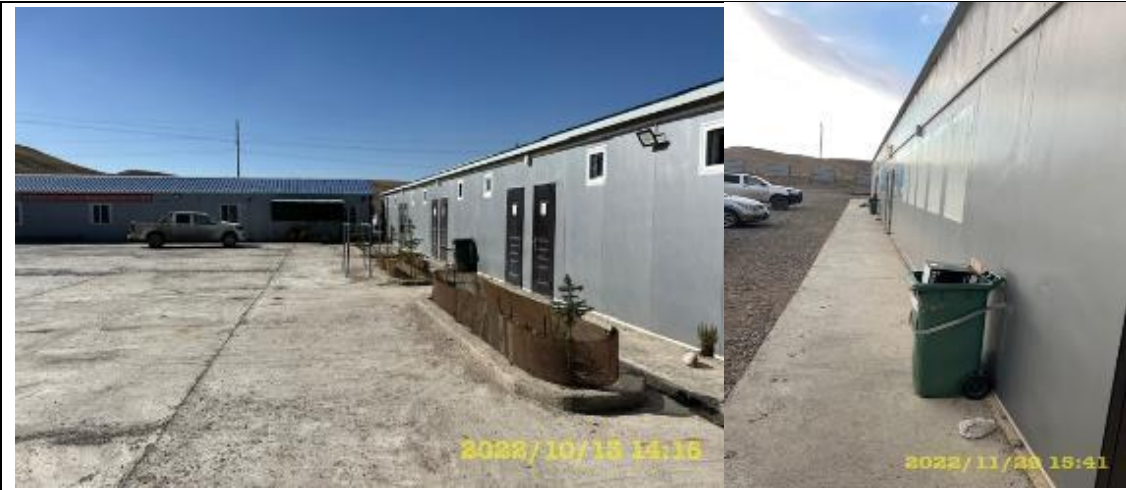
Photos 48. Offices and rooms for living in the Contractor's camp

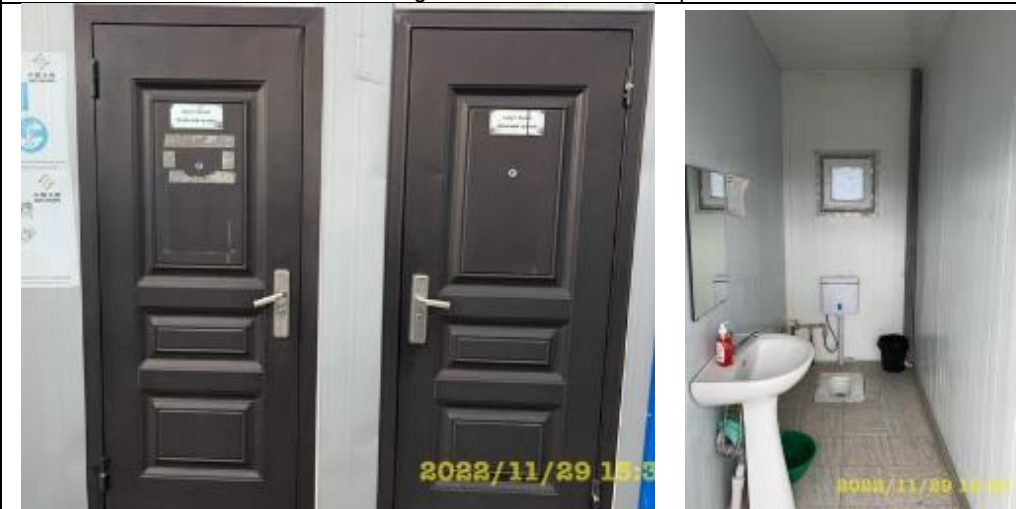
Photos 49. Women's and men's restrooms

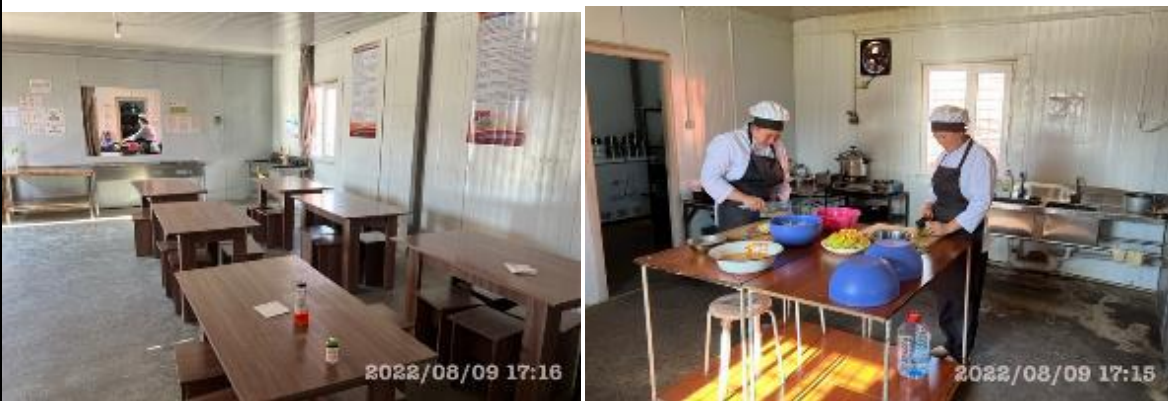
Photos 50. Dining room with kitchen unit

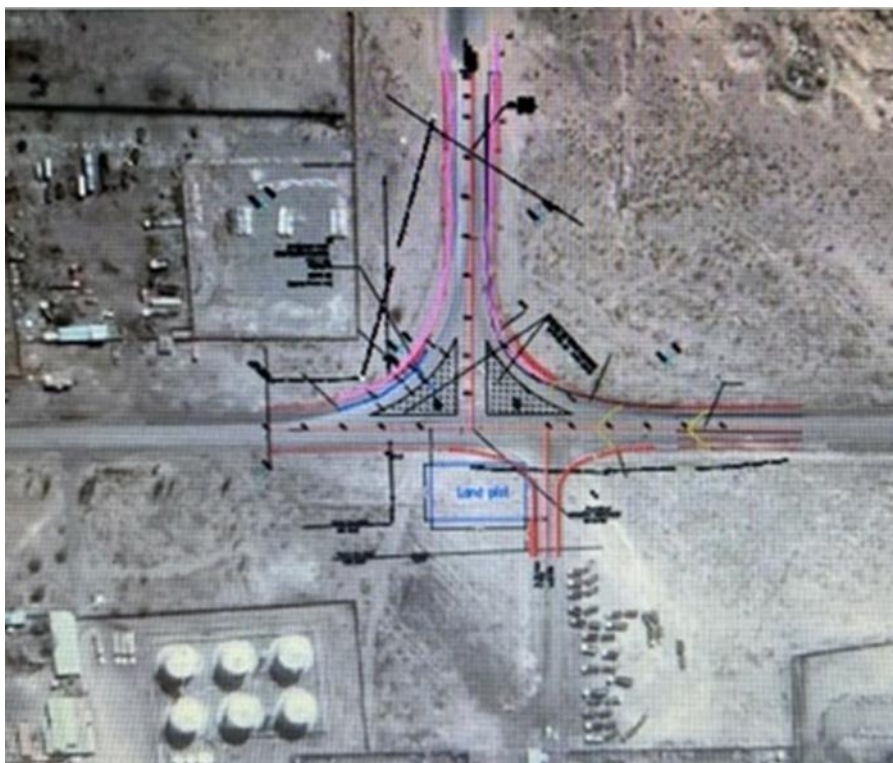
50. During reporting period, changes were made to design of junction construction at km. 02+706): changing the roundabout km. 02+706 to T-intersection (Photo 53), because of unexpected land issues at this site, i.e., in early October 2022 on Lot-1 a private land plot was identified in project road ROW within roundabout boundaries, which had not been developed to date. In November, landowner installed a fence along contour 30m*50m.

Photos 53. T-junction design

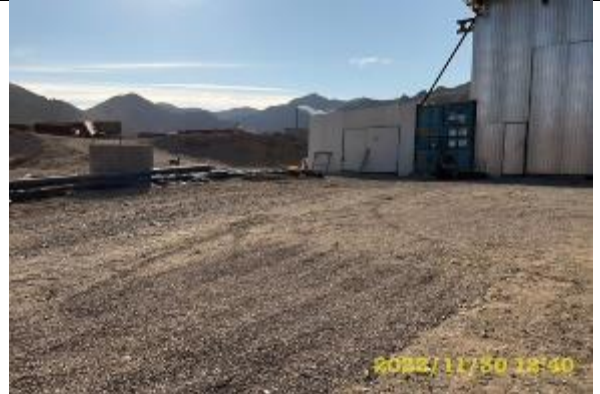
Photos 59. Territory after cleaning from oil pollution.

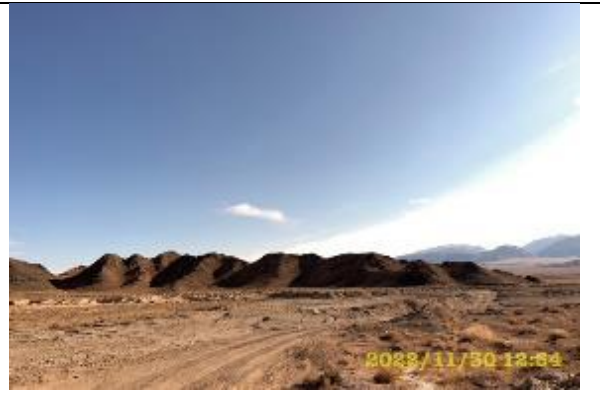
Photos 61. Recultivated old asphalt dump located at km.19+960 LHS

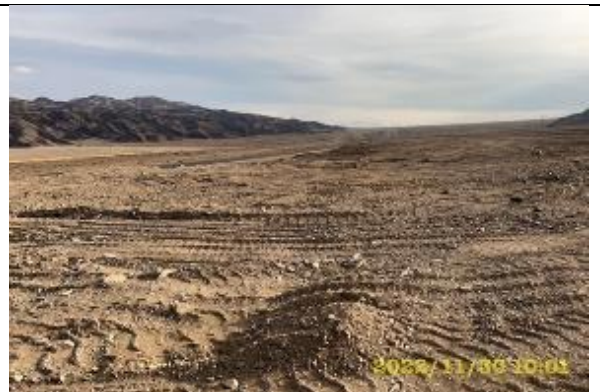
Photos 63. Recultivated spoil of the old asphalt at km. 33+000

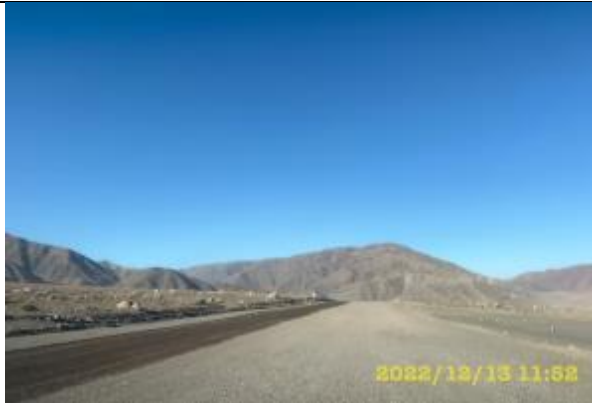
Photos 66. Watering of unpaved road sections

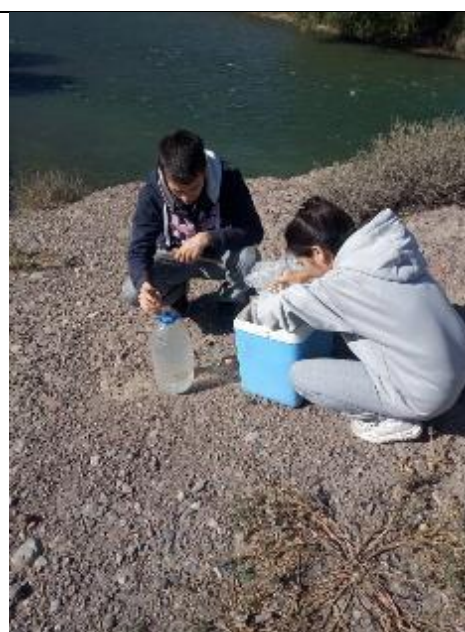
Photos 82. Lot 1. Water intake from the Chu River.

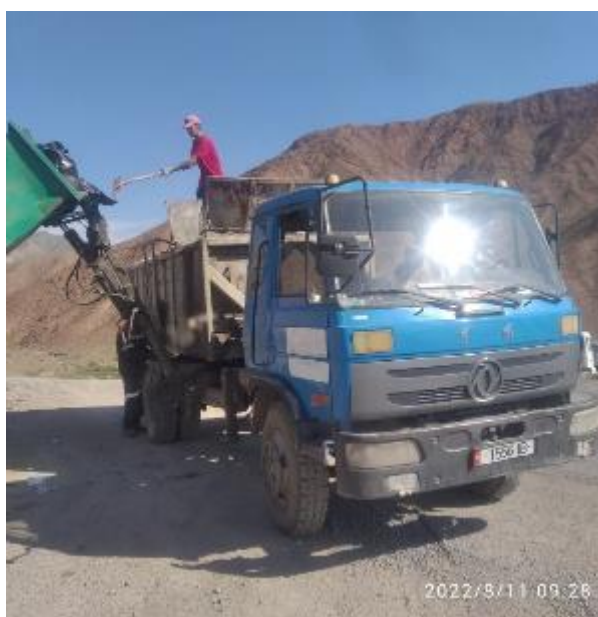
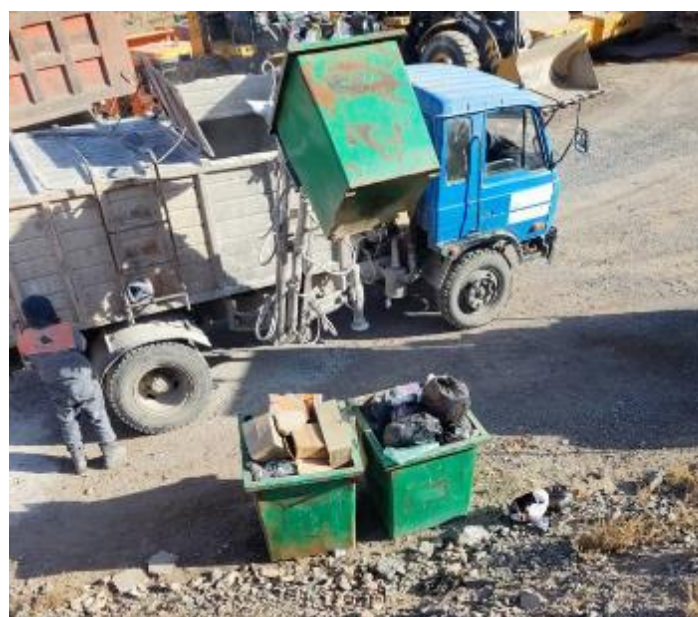
87. Solid domestic waste is removed (photos 87, 88 and 93) and placed in municipal landfill in Balykchy and Cholpon villages. Cholpon. Wastewater is transported (photos 89, 90 and 92) to treatment facilities of Balykchy in accordance with contract with the municipal enterprise of Balykchy - "Gorvodokanal". Balykchy - "Gorvodokanal".

Photo 87-88. Lot 1 Removal of solid domestic waste

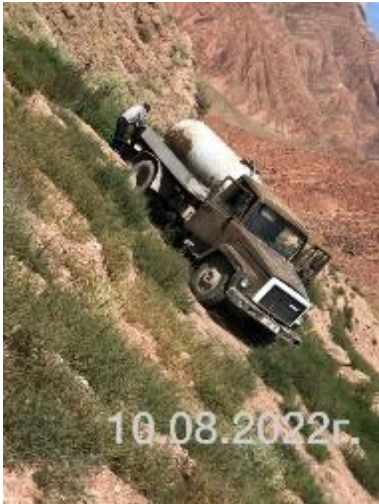
Photos 89-90. Lot 1. Liquid waste removal. Photo 91. Waste Log for Lot 1.
